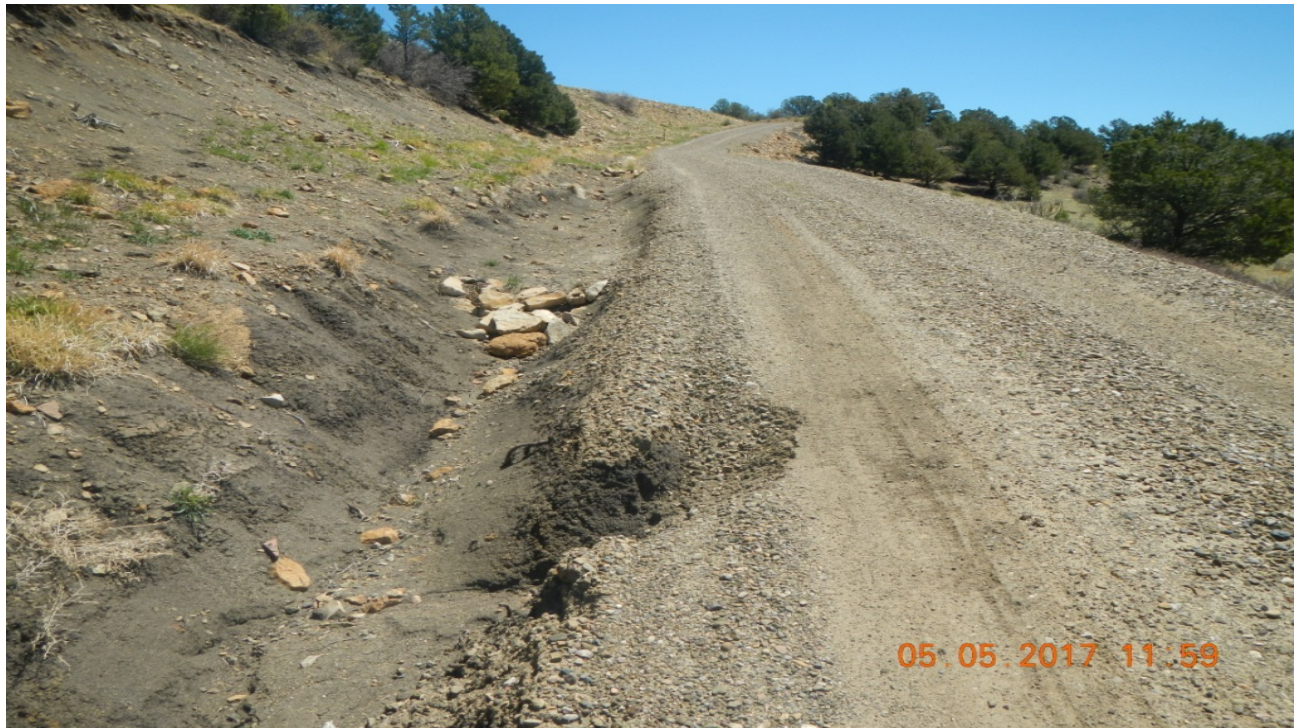
photo 1: There is erosion occurring along the access road and rock check dams have filled in with sediment.

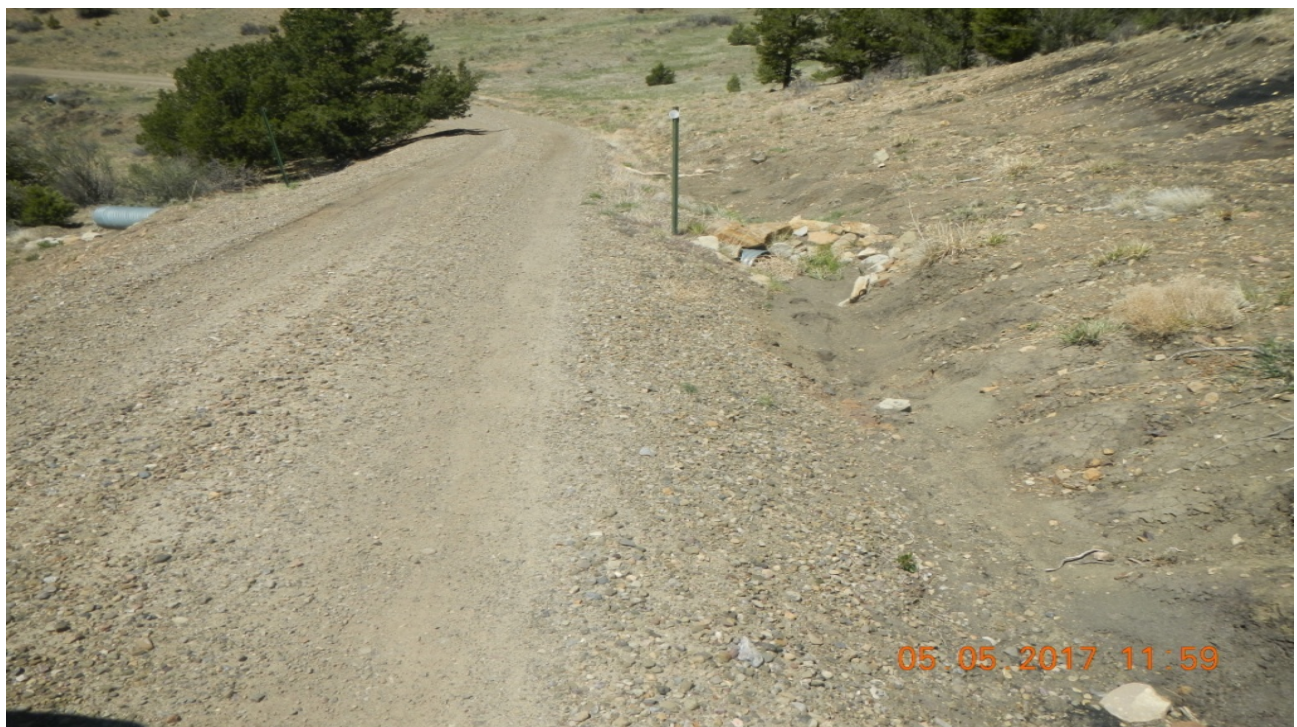
photo 2: Facing back toward the west. The culvert along the access road is filling in with sediment.

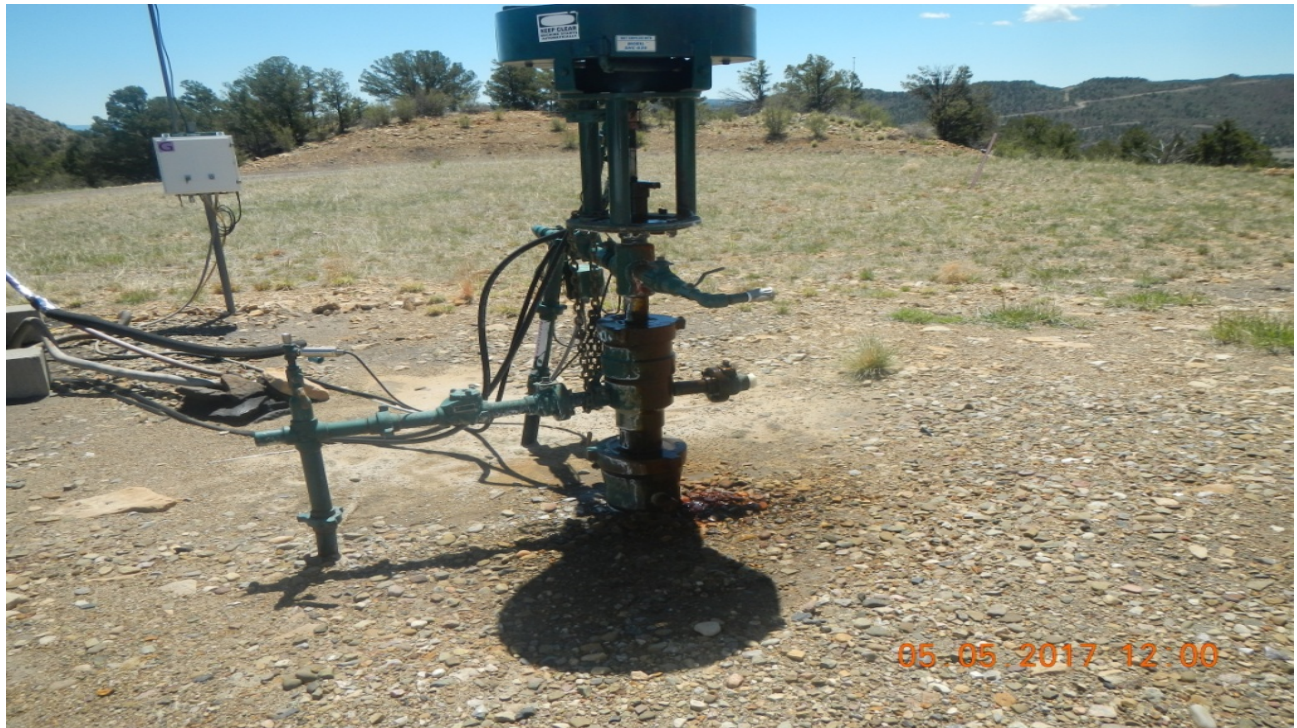
photo 3: The dripping water leak at the east wellhead has been reduced.

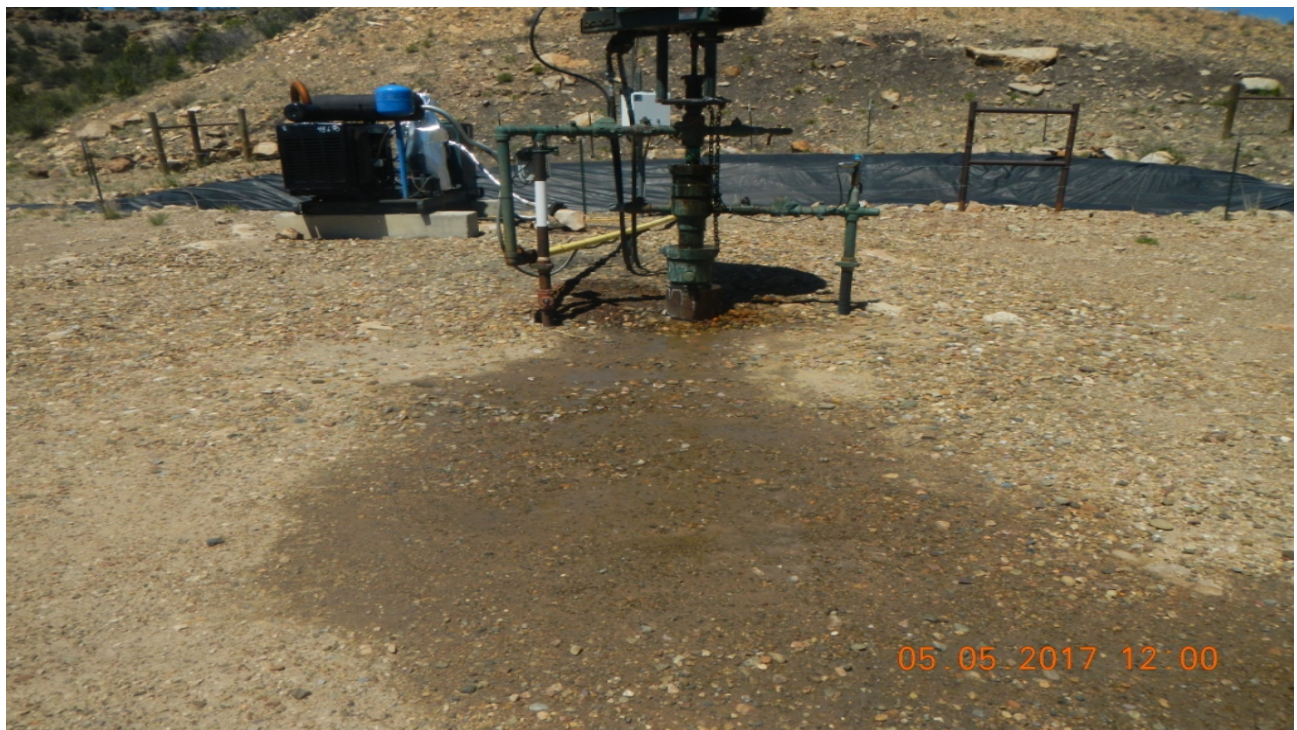
photo 4: The wellhead at the west side of the location is now leaking water.
