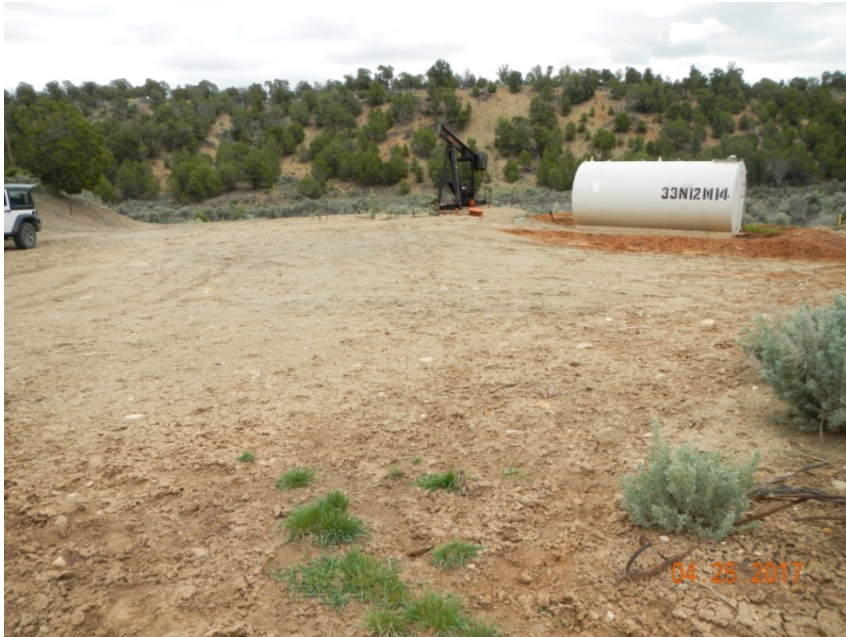
**Photo 1:** View of the project area from the northwestern corner facing center.

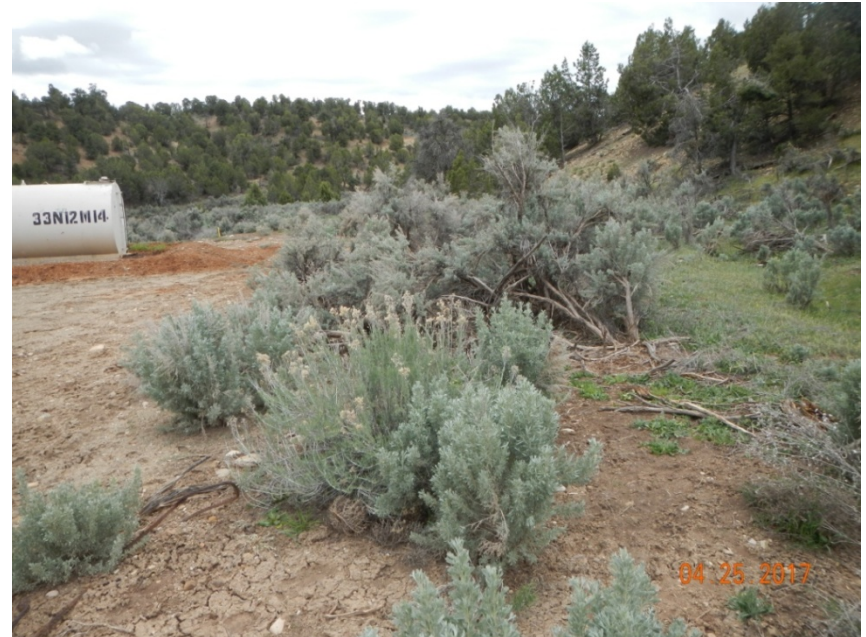
**Photo 2:** View of the western portion of the project area from the northwestern corner facing southward. Vegetation is comprised of big sagebrush (*Artemisia tridentata*), cheat grass (*Bromus tectorum*), smooth brome (*Bromus inermis*), Russian knapweed (*Acroptilon repens*).

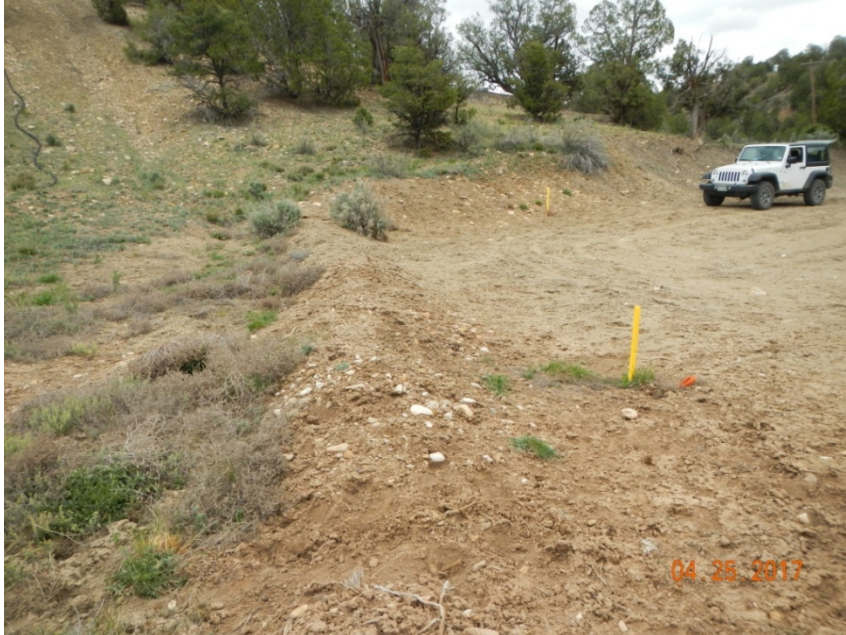
**Photo 3: View of the northern portion of the project area from the northwestern corner facing eastward.**

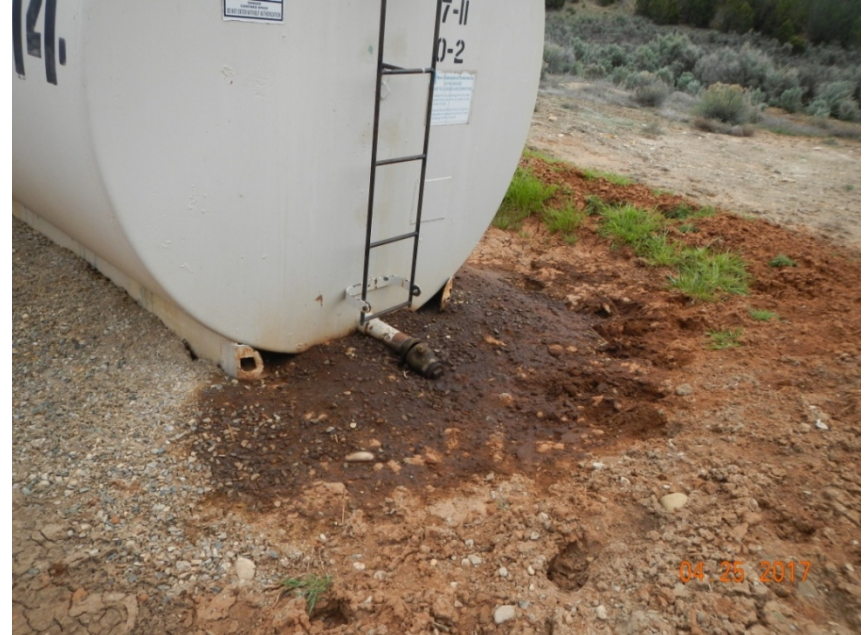
**Photo 4: View of stained soils at the tank in the southwestern portion of the project area.**

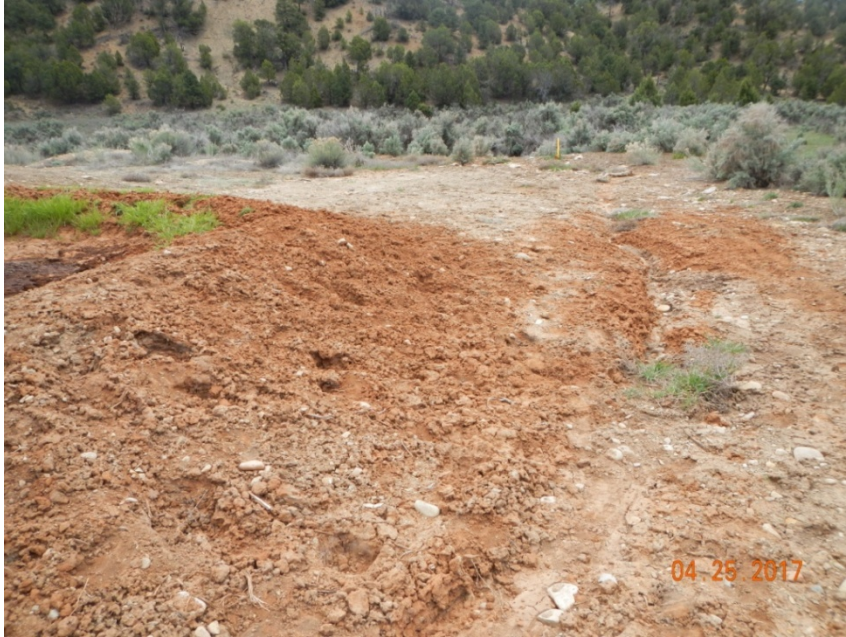
**Photo 5: View of area in the southwestern portion of the project area where stormwater flows off of the corner of the project area.**

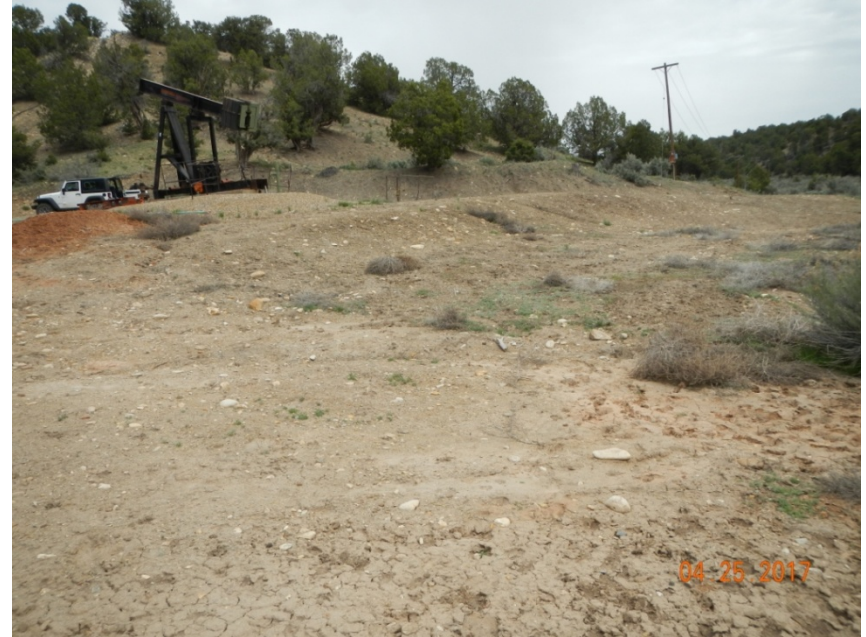
**Photo 6: View of the southwestern edge facing eastward. Erosional channels are forming all along the southern edge.**

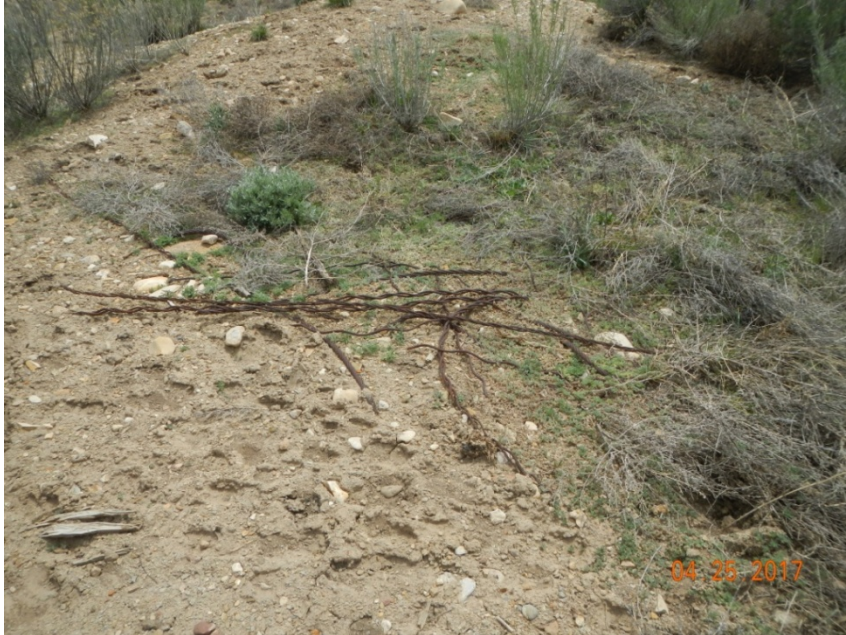
**Photo 7: View of metal debris within the project area.**

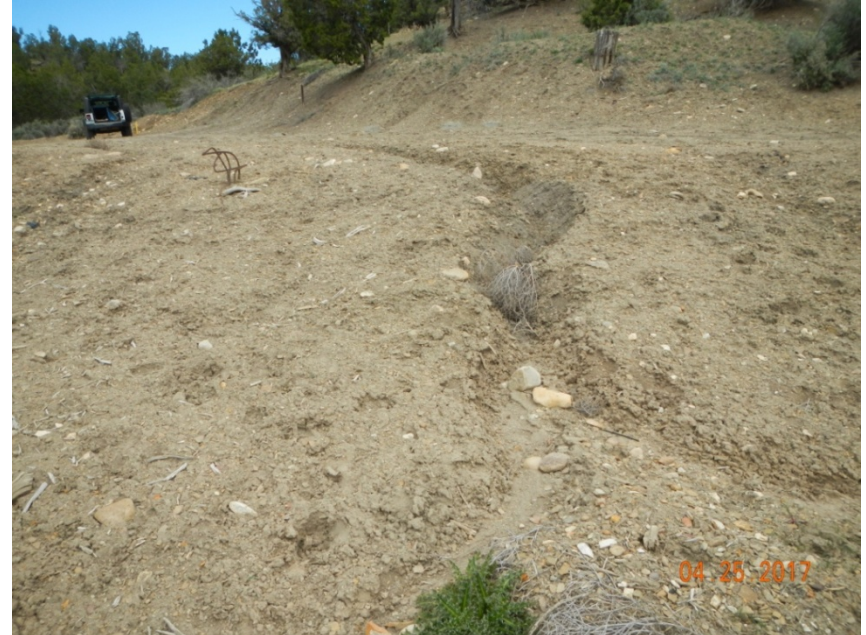
**Photo 8: View of the eastern portion of the project area from the southeastern corner facing northward. Erosional channel in the foreground.**

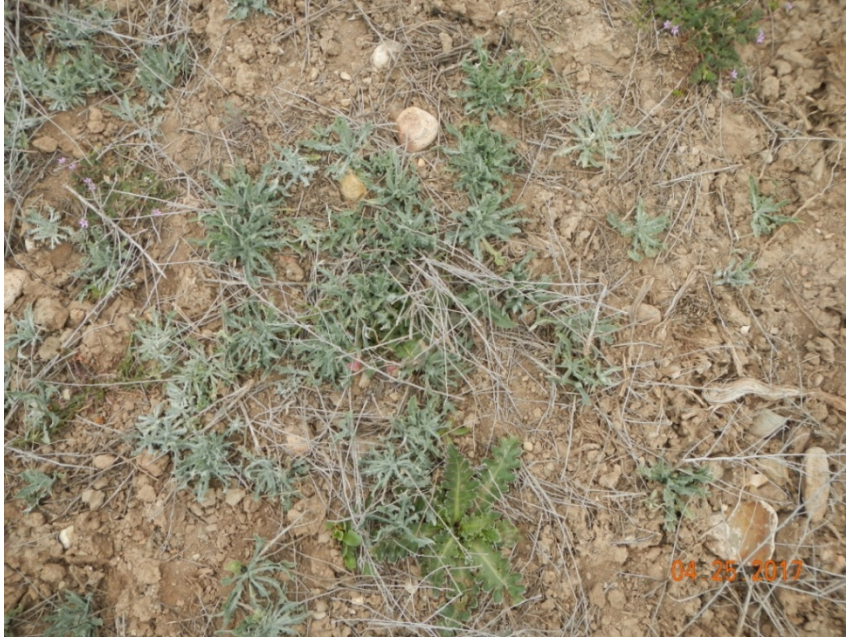
**Photo 8: View of Russian knapweed and musk thistles in the northern portion of the project area.**

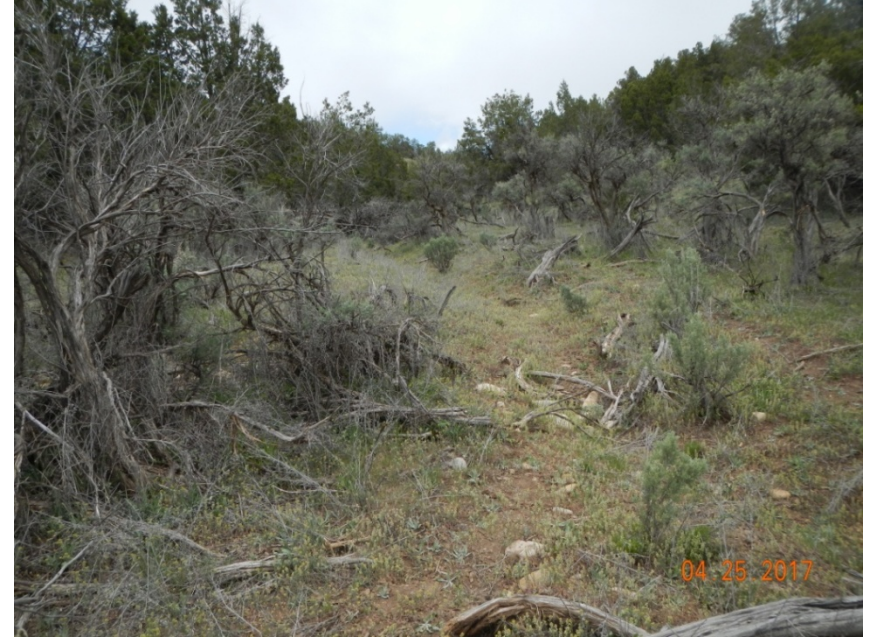
**Photo 9: View of reference area which is comprised of mixed pinion juniper and sagebrush woodland north of the project area.**
