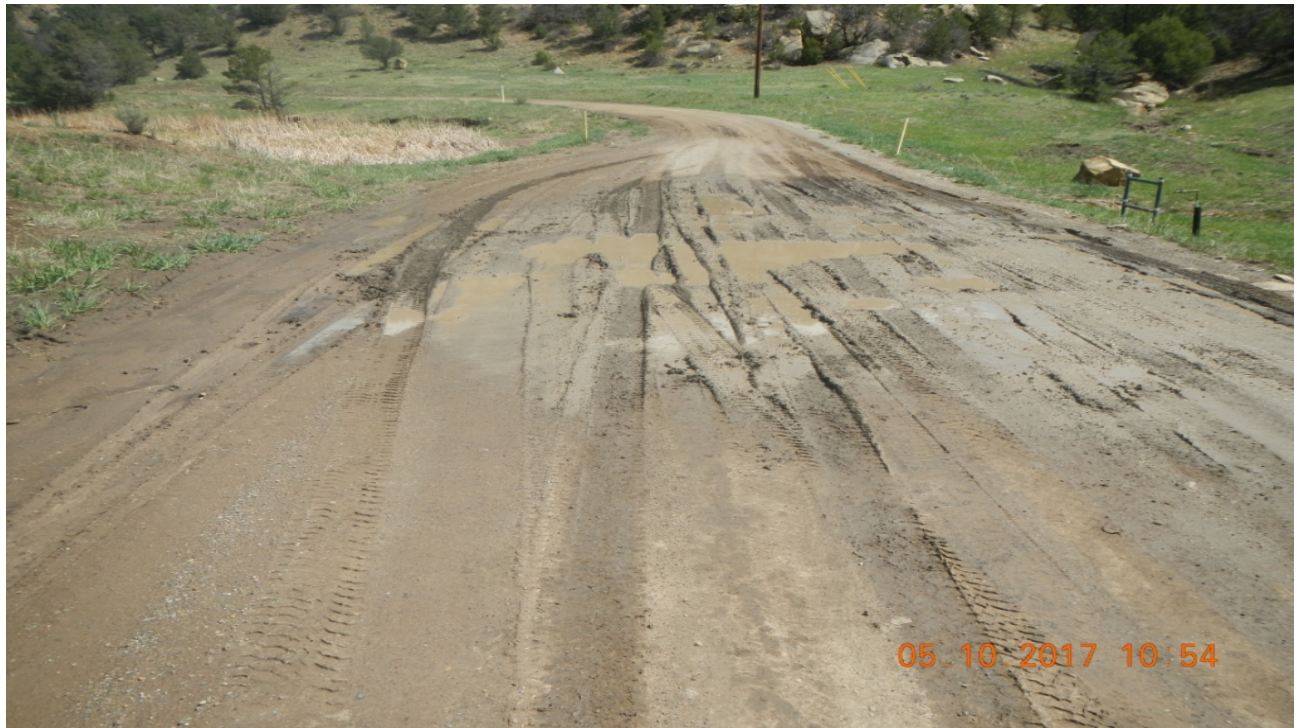
photo 1: Facing northeast along the main access road. There is vehicle rutting and potholes in this area of the road.

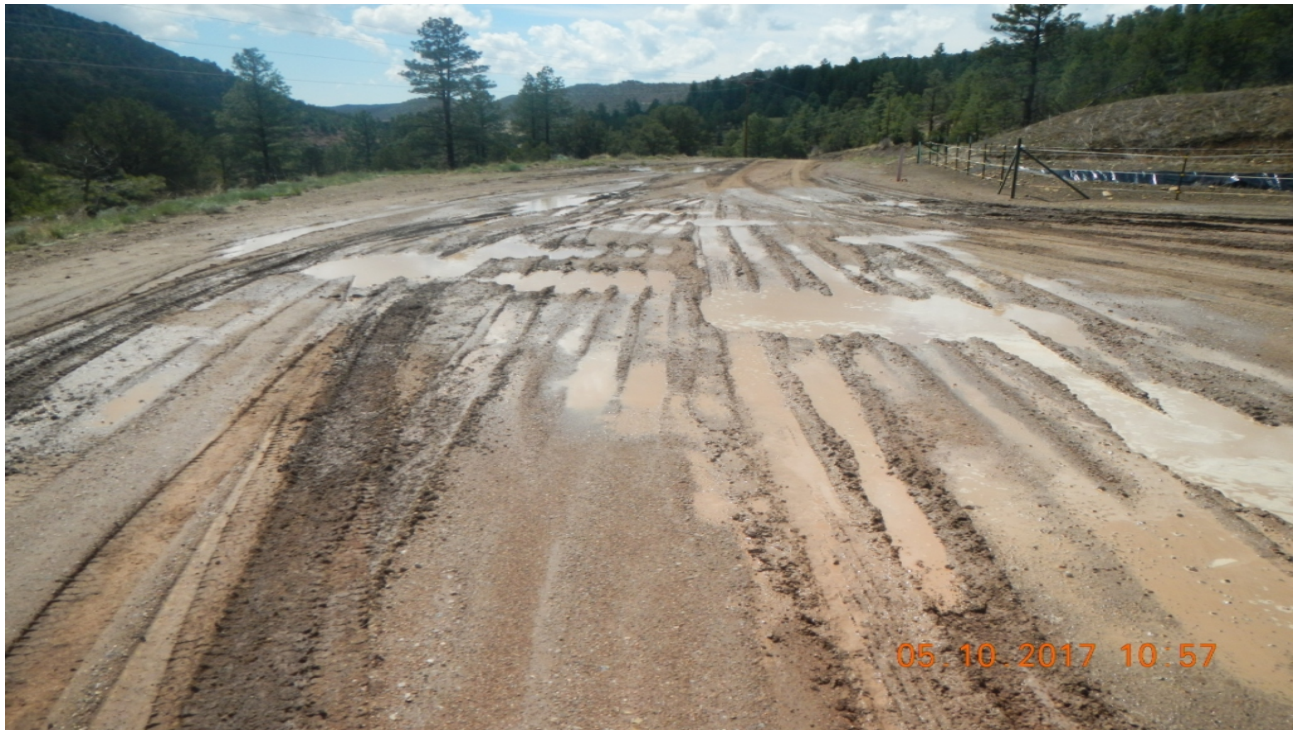
photo 3: Facing south along the main road which goes thru the location. There is vehicle rutting and potholes in this area of the road.
