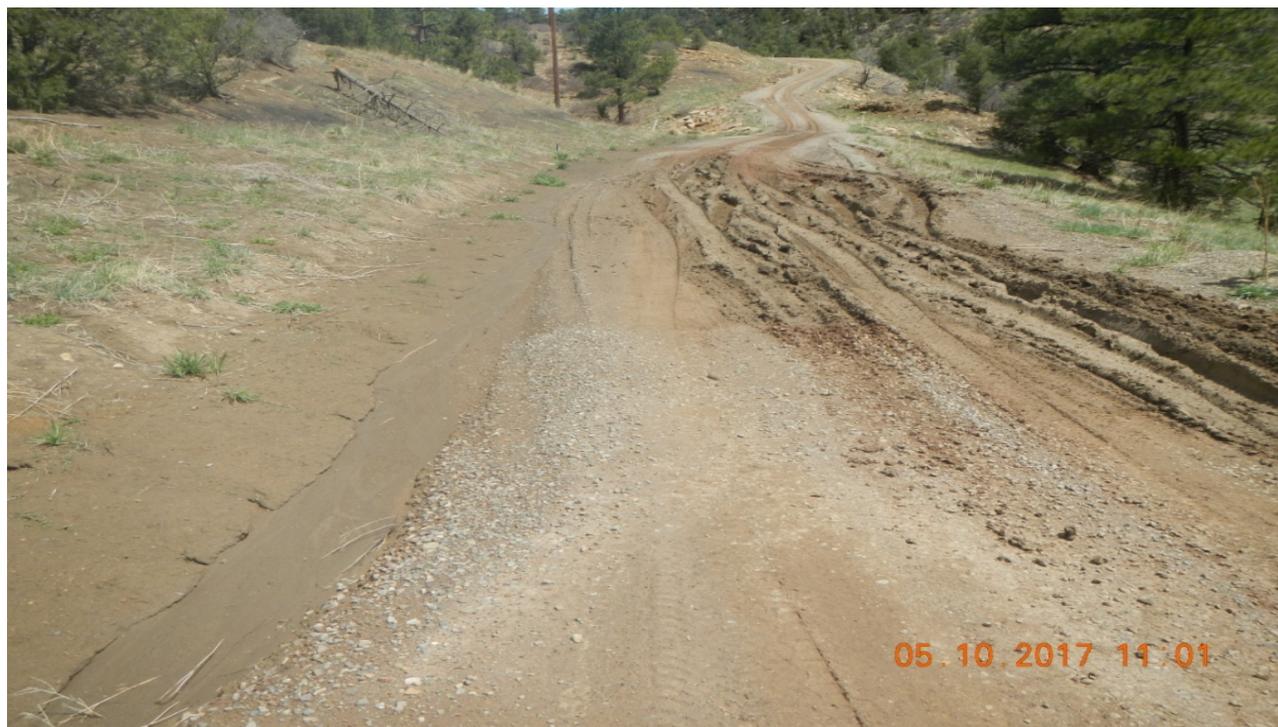
photo 1: Facing northeast along the main access road. There is vehicle rutting in this area of the road.

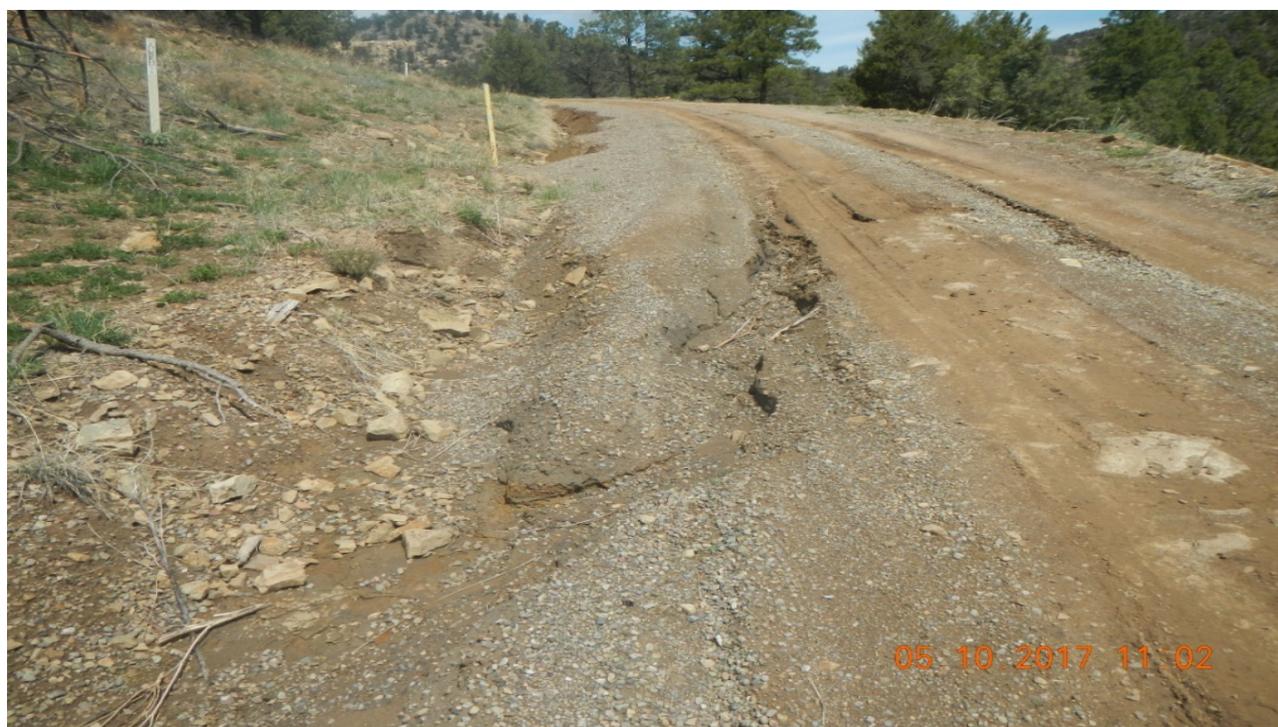
photo 2: There are signs of erosion in areas of the main road.

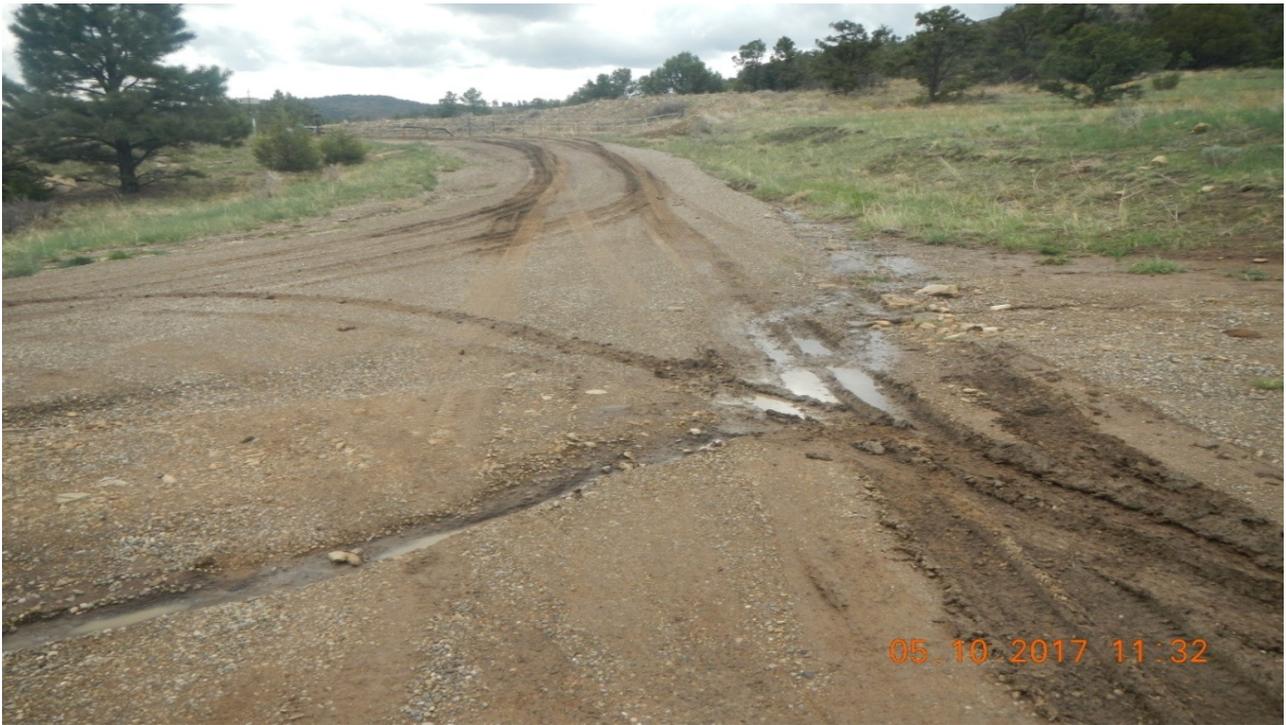
photo 3: Facing south toward the access road.

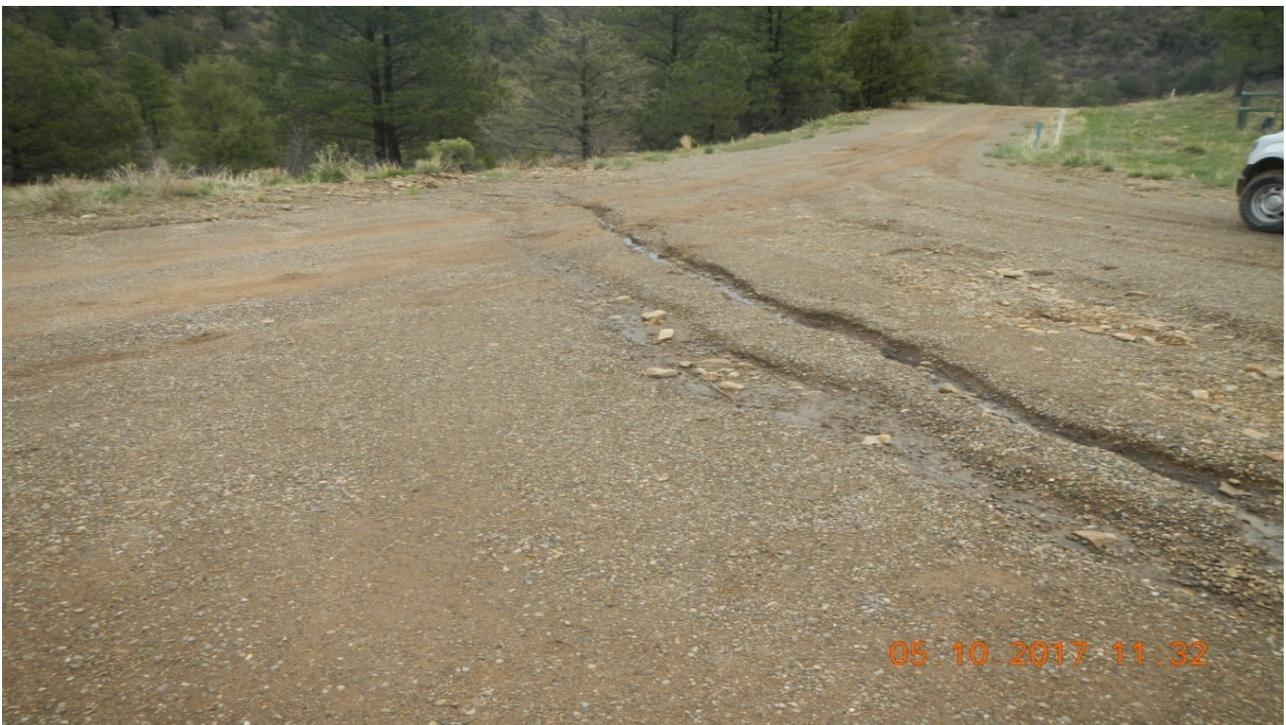
photo 4: Stormwater from the above photo is causing erosion across the main road.
