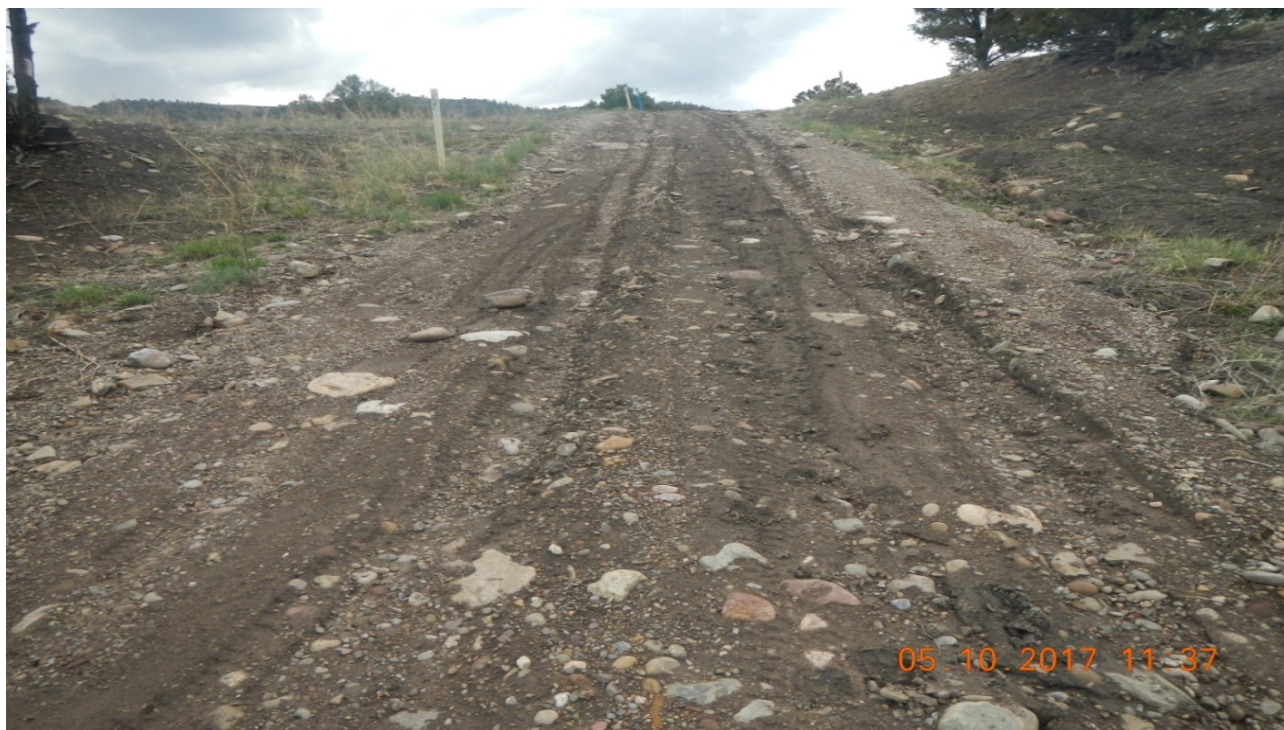
photo 1: Facing southwest along the access road. This portion of the access road has signs of vehicle rutting .

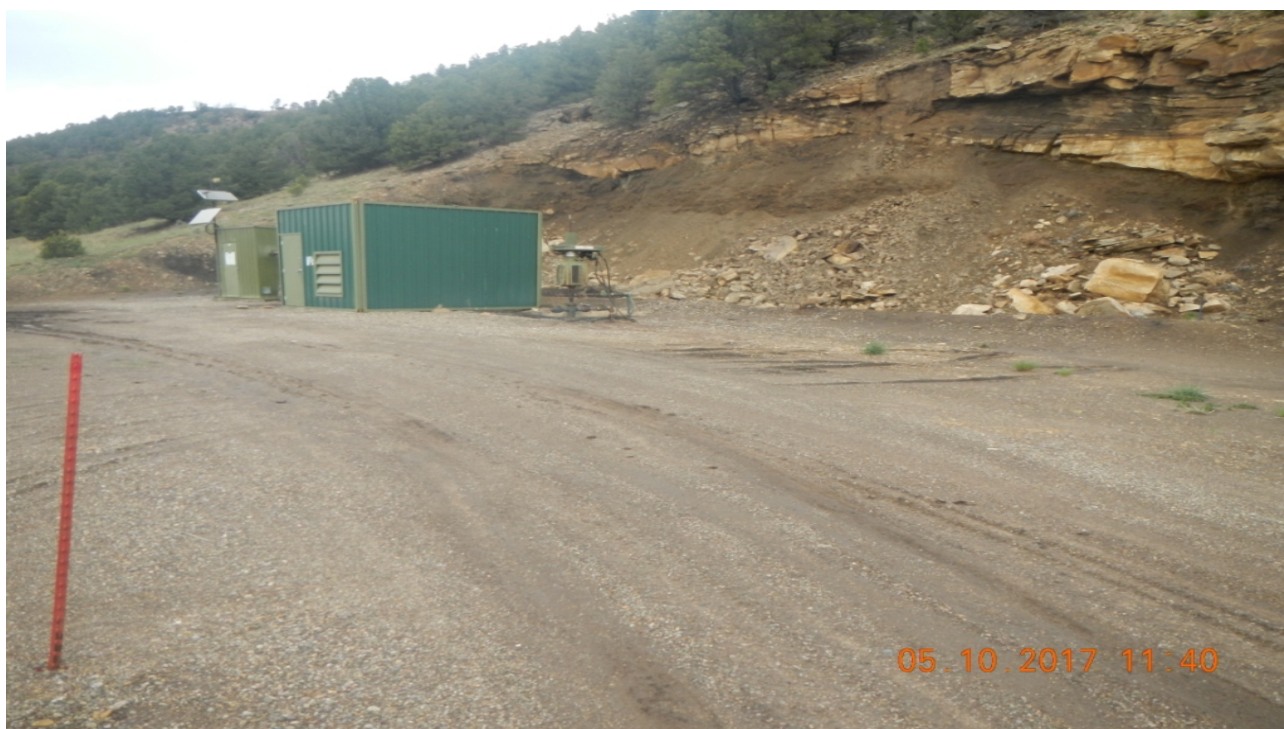
photo 2: Facing toward the location.
