# Construction and Stormwater Inspection

May 5 & 11, 2017

Operator: KERR MCGEE OIL & GAS ONSHORE LP- #47120

Location ID: 336284

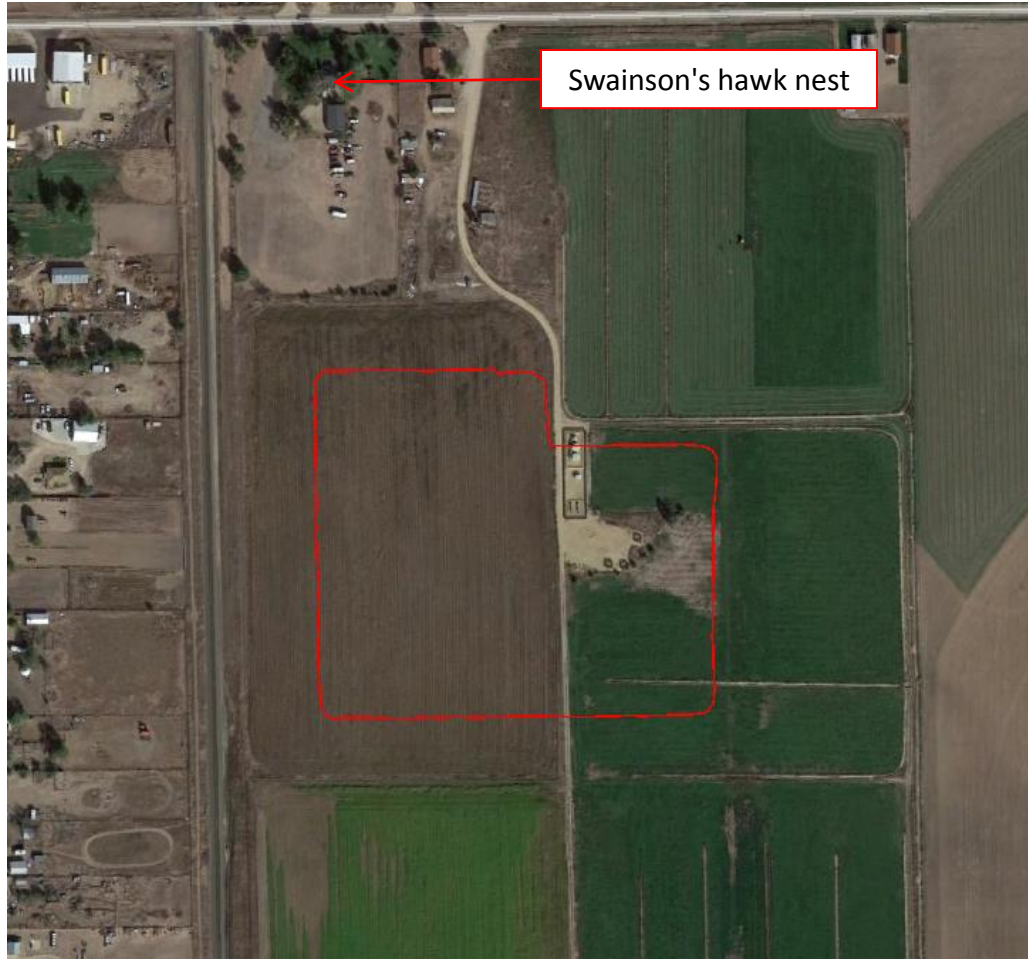
Google Earth aerial imagery taken October 9, 2015 of the location overlaid with field collected data using a Trimble handheld GPS. Field collected data on May 5, 2017 using a Trimble handheld GPS would indicate construction disturbance totaled 10.26 acres. Aerial imagery also illustrates the location and a potentially active Swainson's hawk nest observed during the inspection.

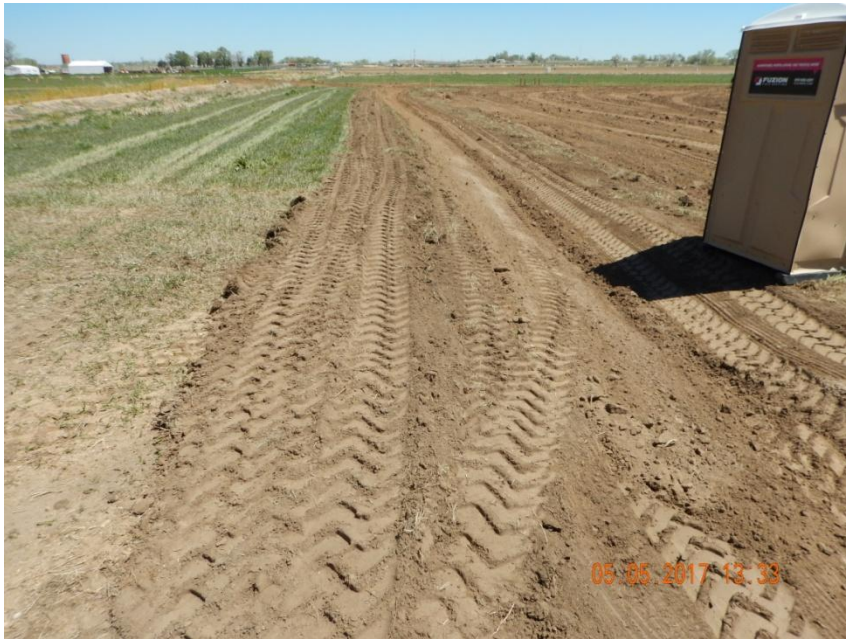
**Photo 1.** Photo taken May 5, 2017 from the northern location, facing East. A ditch and berm BMP has been installed around the perimeter of the location.

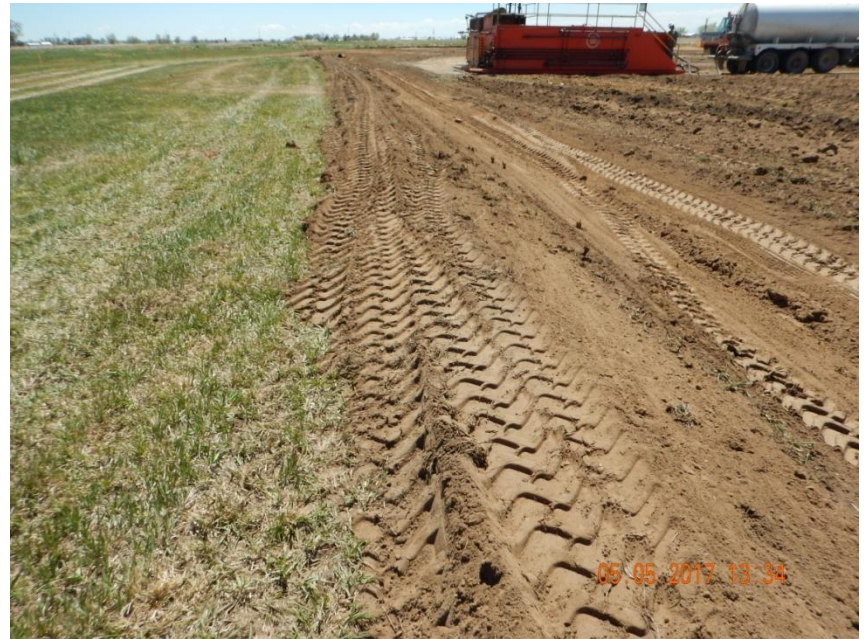
**Photo 2.** Photo taken May 5, 2017 from the northeastern location, facing South. A ditch and berm BMP has been installed around the perimeter of the location.

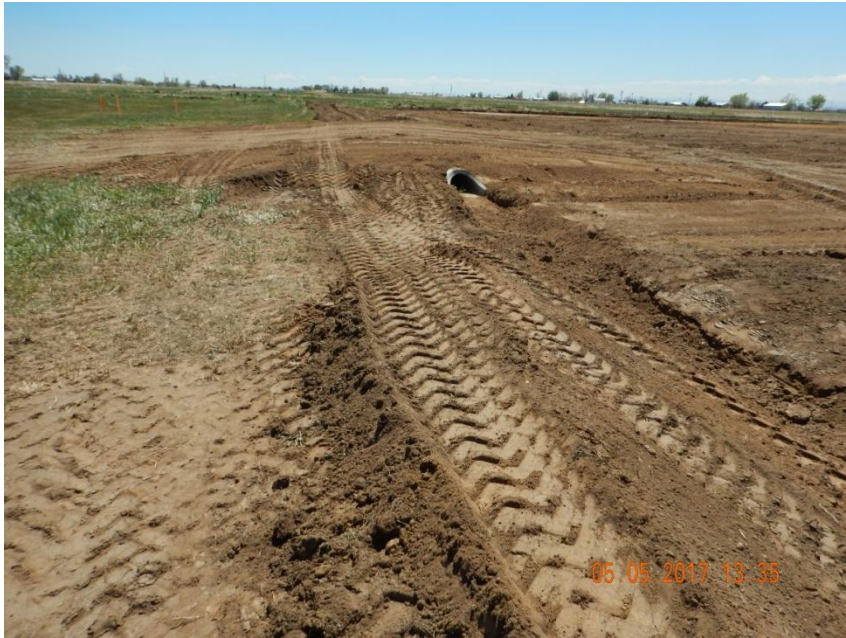
**Photo 3.** Photo taken May 5, 2017 from the eastern location, facing South. A ditch and berm BMP has been installed around the perimeter of the location. During the May 5, 2017 inspection, berm material did not appear consistently compacted throughout the location. Berm BMPs appeared to be further compacted during the May 11, 2017 inspection.

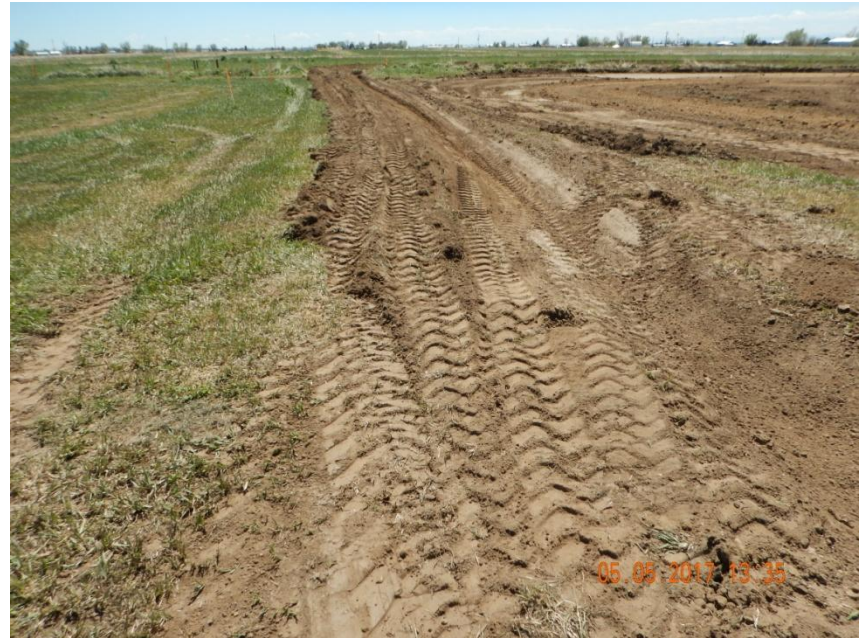
**Photo 4.** Photo taken May 5, 2017 from the eastern location, facing South. A ditch and berm BMP has been installed around the perimeter of the location. During the May 5, 2017 inspection, berm material did not appear consistently compacted throughout the location. Berm BMPs appeared to be further compacted during the May 11, 2017 inspection.

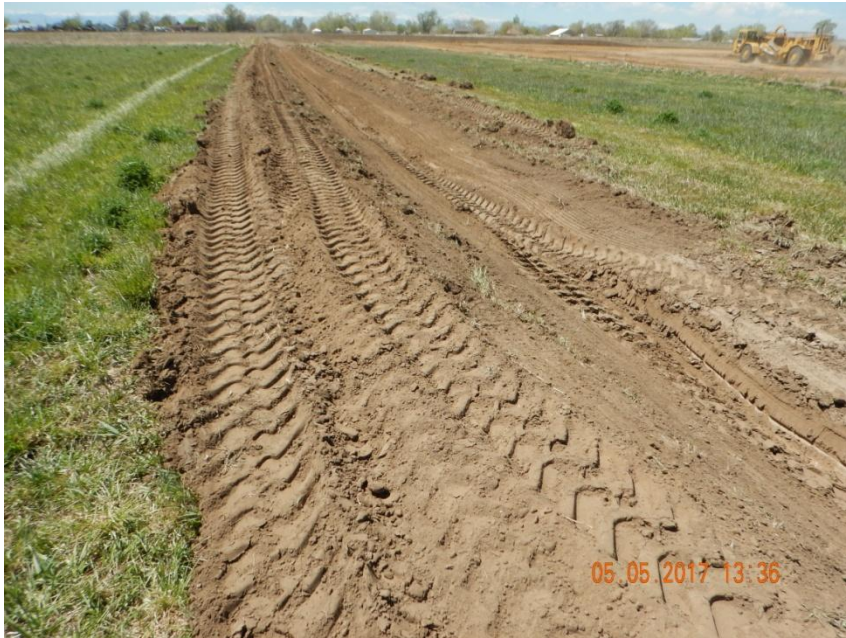
**Photo 5.** Photo taken May 5, 2017 from the southeastern location, facing West. A ditch and berm BMP has been installed around the perimeter of the location. During the May 5, 2017 inspection, berm material did not appear consistently compacted throughout the location. Berm BMPs appeared to be further compacted during the May 11, 2017 inspection.

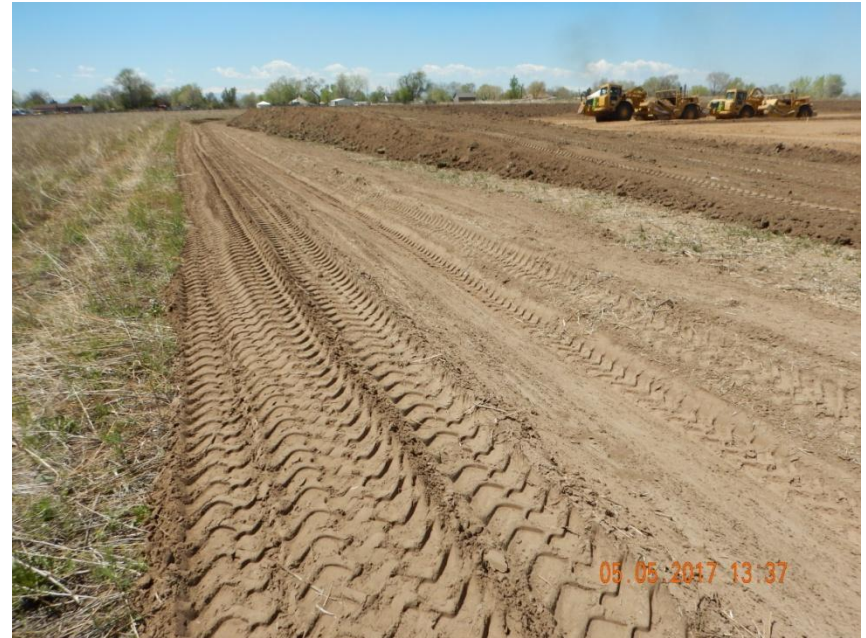
**Photo 6.** Photo taken May 5, 2017 from the southern location, facing West. A ditch and berm BMP has been installed around the perimeter of the location.

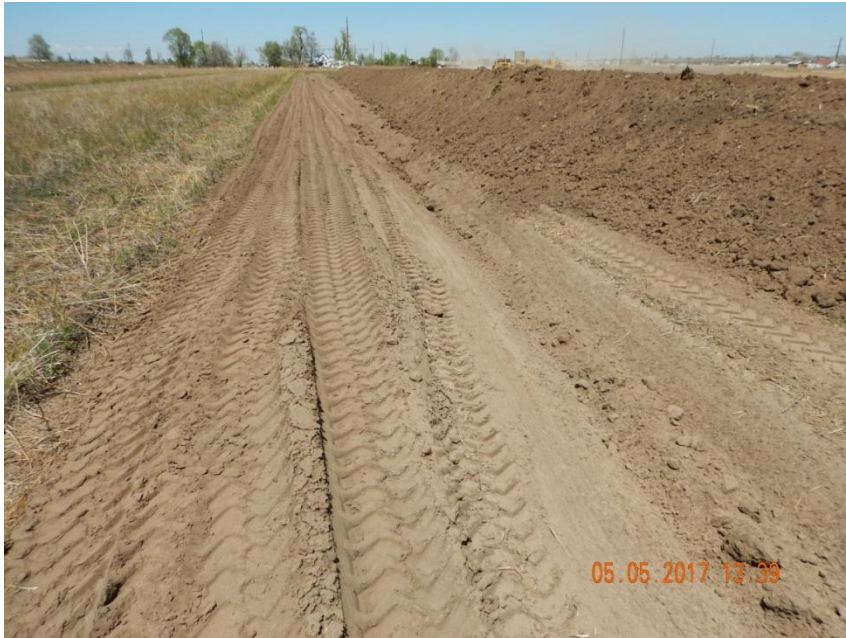
**Photo 7.** Photo taken May 5, 2017 from the western location, facing North. A ditch and berm BMP has been installed around the perimeter of the location. Topsoil stockpile has been salvaged and stored along the western location. Topsoil side slopes appear steep and may be difficult to stabilize.

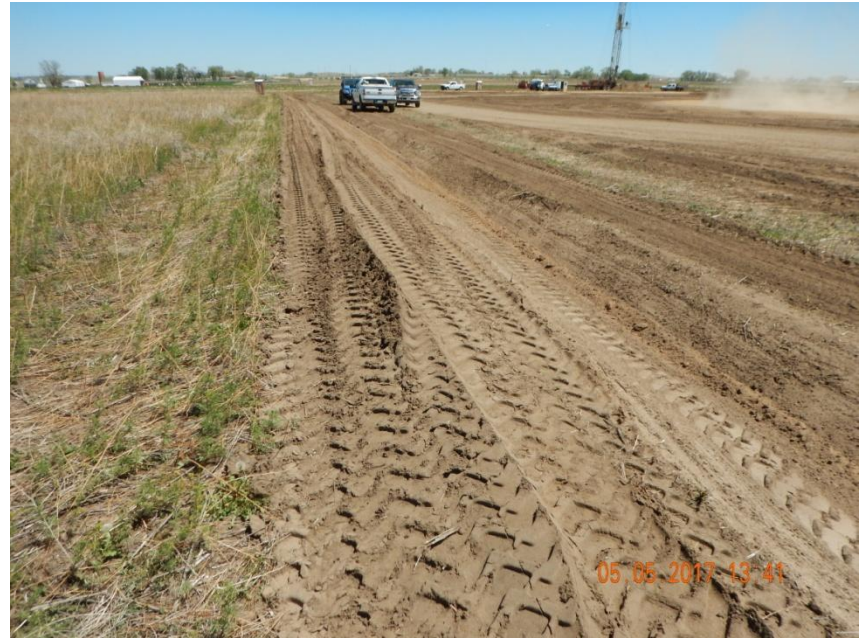
**Photo 8.** Photo taken May 5, 2017 from the northwestern location, facing East. A ditch and berm BMP has been installed around the perimeter of the location.

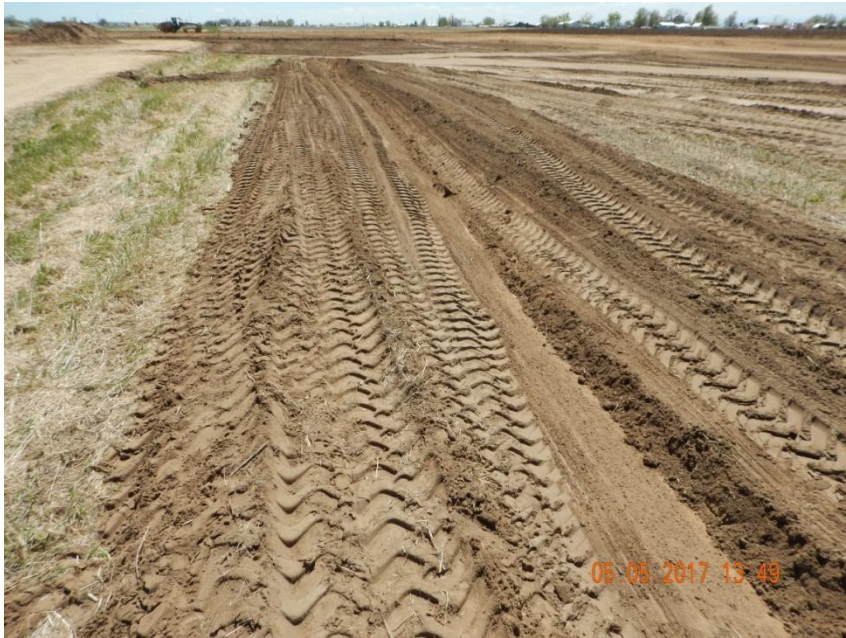
**Photo 9.** Photo taken May 5, 2017 from the northern location, facing South. A ditch and berm BMP has been installed around the perimeter of the location.

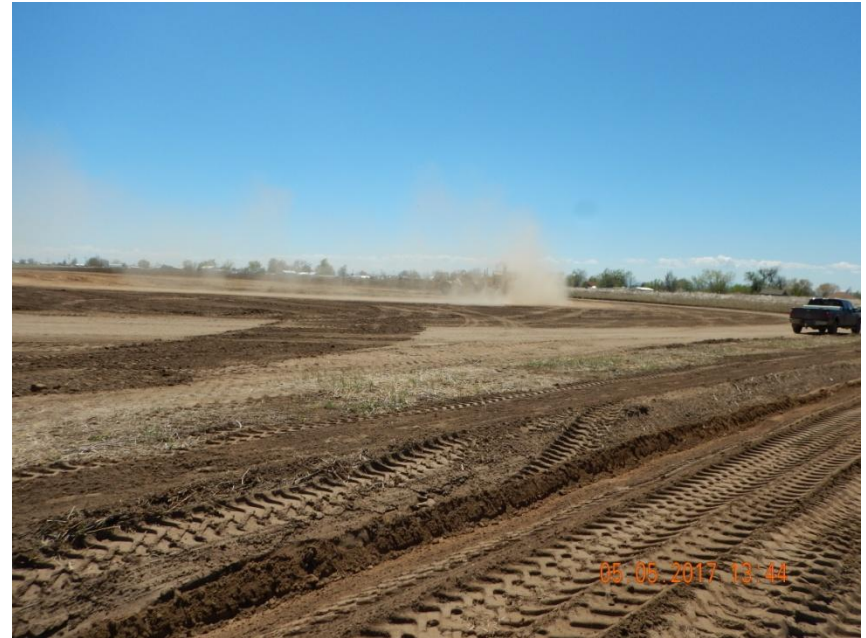
**Photo 10.** Photo taken May 5, 2017 from the northern location, facing South. Fugitive dust was evident during operations. COGCC contacted the Operator and the Operator communicated to COGCC that there was a water at location.

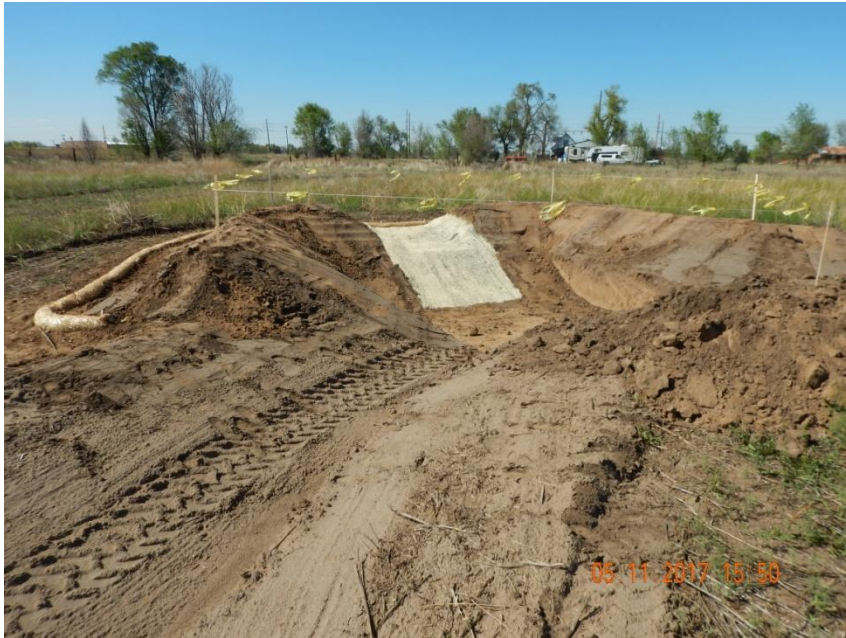
**Photo 11.** Photo taken May 11, 2017 from the northwest location, facing North. A sediment trap has been installed with both outlet protection devices. Portions of the sediment trap berm do not appear consistently compacted.

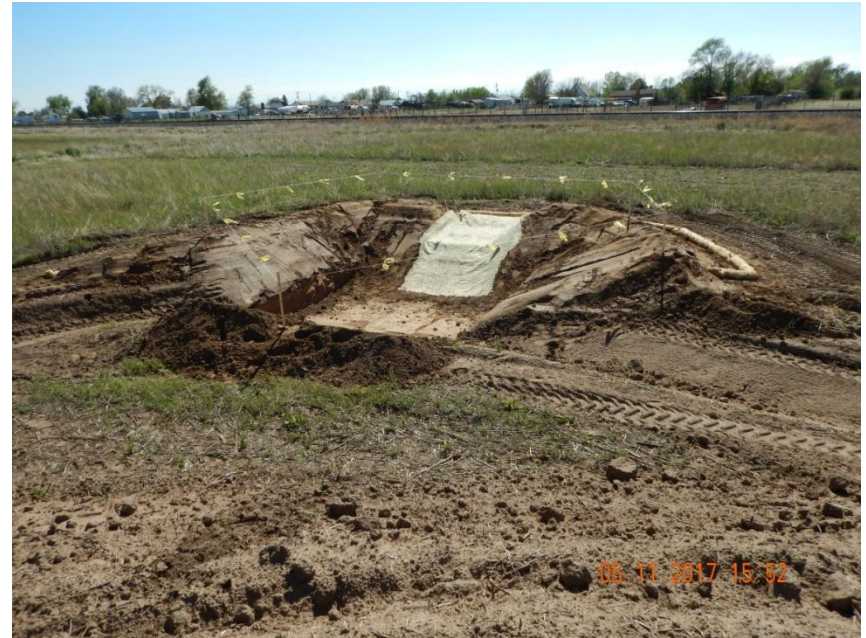
**Photo 12.** Photo taken May 11, 2017 from the southwest location, facing Southwest. A sediment trap has been installed with both outlet protection devices. Portions of the sediment trap berm do not appear consistently compacted.

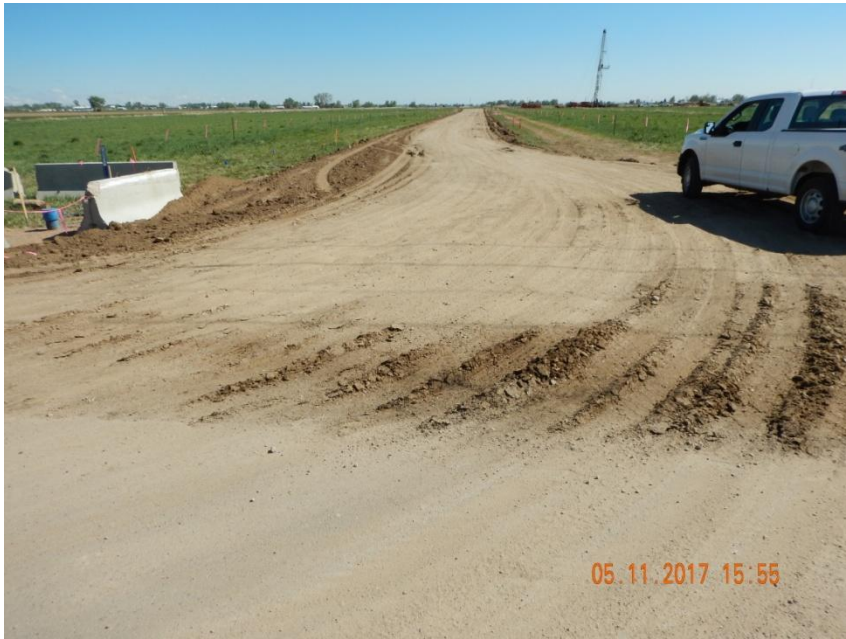
**Photo 13.** Photo taken May 11, 2017 from the entrance of location, facing South. Did not observe a tracking pad. COGCC staff contacted the Operator and the Operator communicated to COGCC staff that tracking pad material was supposed to be installed on that day. The Operator said street sweeping operations were being conducted.

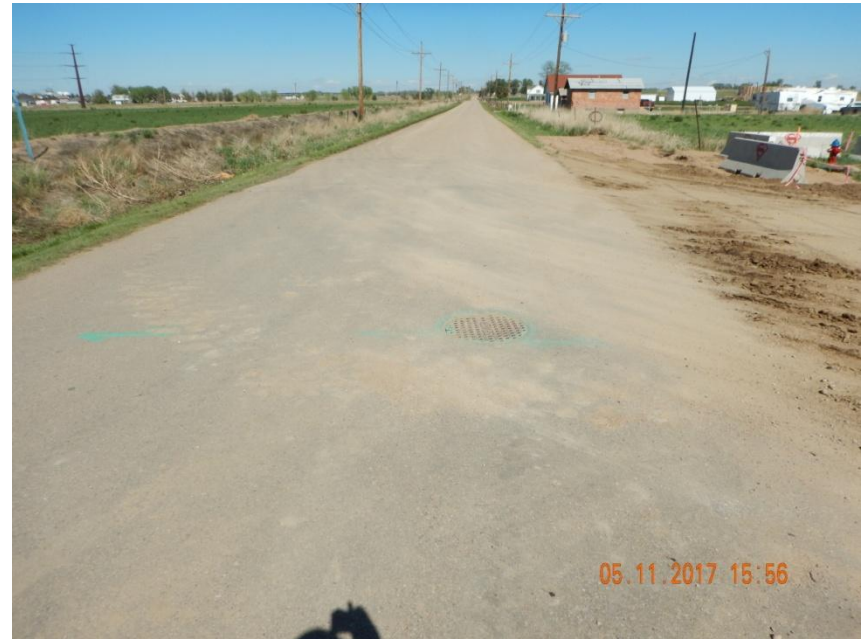
**Photo 14.** Photo taken May 11, 2017, from the entrance of location, facing East. It appears that the Operator has performed street sweeping operations.
