Inspection Photos

Operator: Bill Barrett Corp #10071

Location ID: 449306

Inspection Doc. Number: 682501979

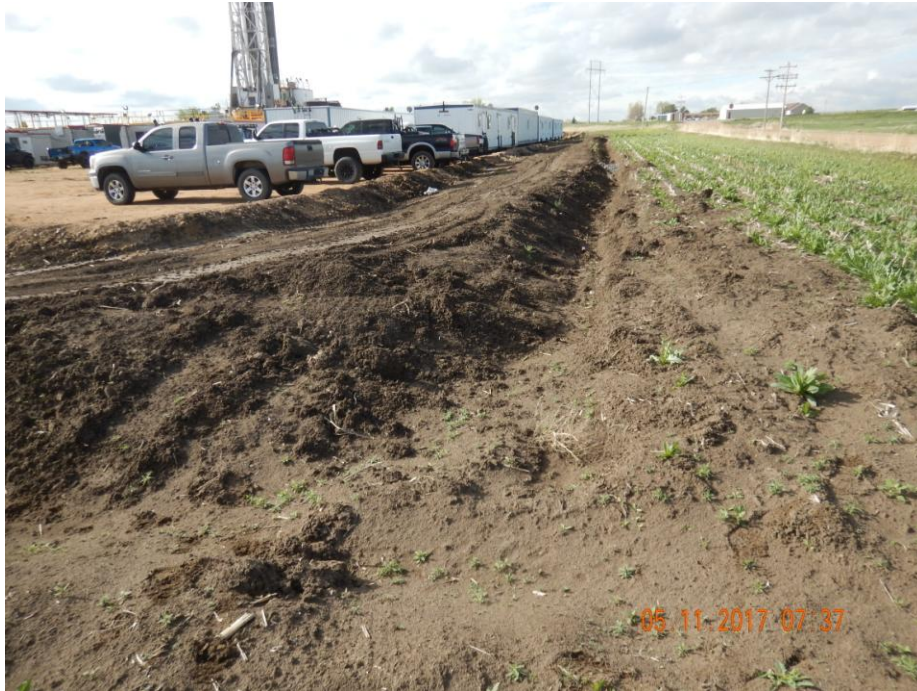
Photo 1: Photo taken from the northwest end of the location, facing south. Photo shows ditch along perimeter of the location. Ditches along perimeter location have been constructed with a step grade and/or have not been consolidated. Without proper consolidation and grade, ditch will increase the sediment laden stormwater runoff from the location.

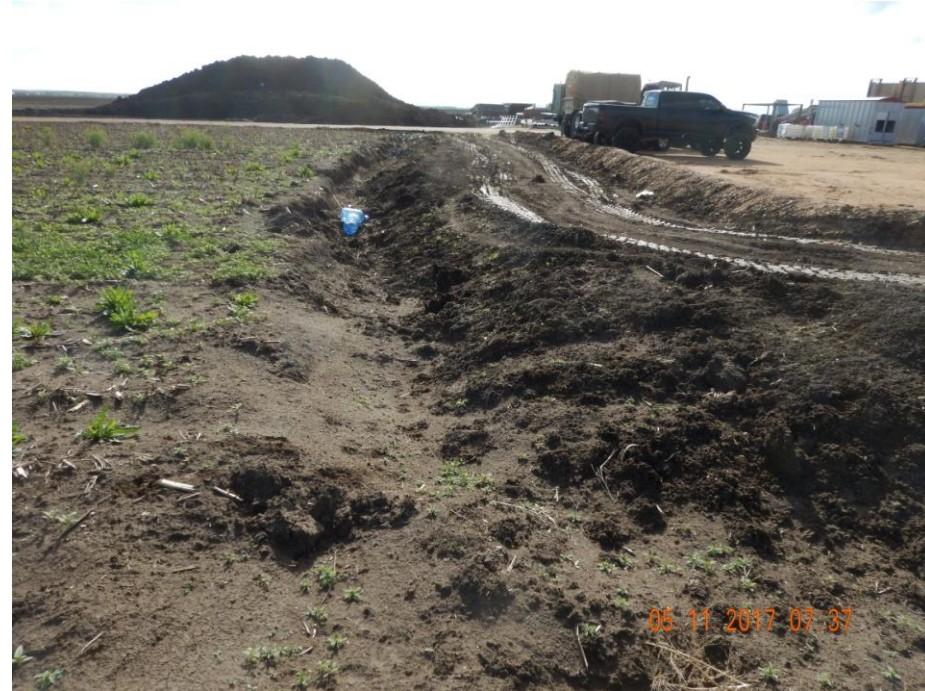
Photo 2: Photo taken from the northwest end of the location, facing east. Photo shows ditch along perimeter of the location. Ditches along perimeter location have been constructed with a step grade and/or have not been consolidated. Without proper consolidation and grade, ditch will increase the sediment laden stormwater runoff from the location.

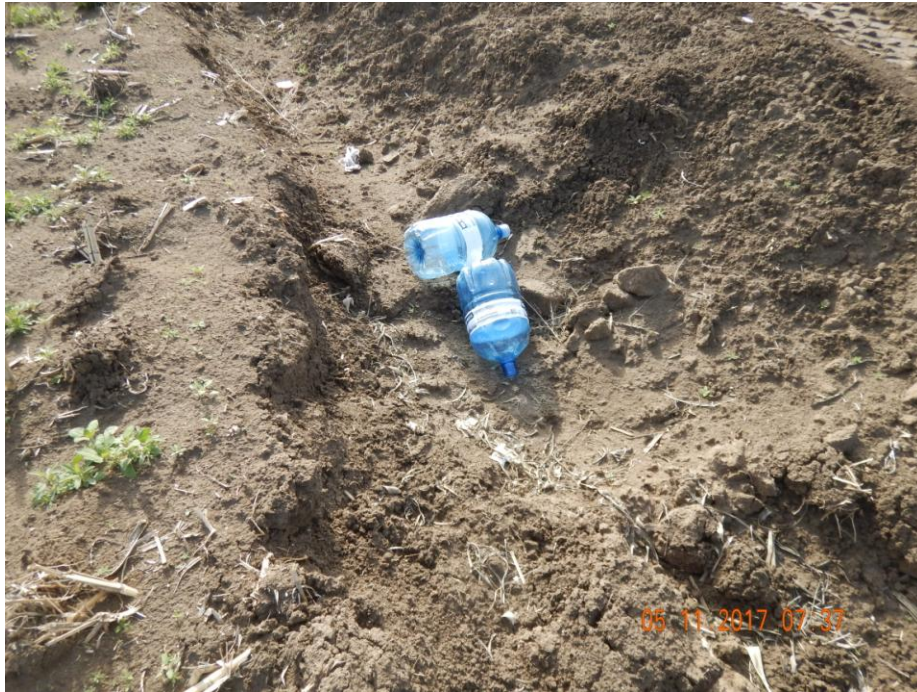
Photo 3: Photo taken from the north end of the location. Photo shows trash debris in ditch.

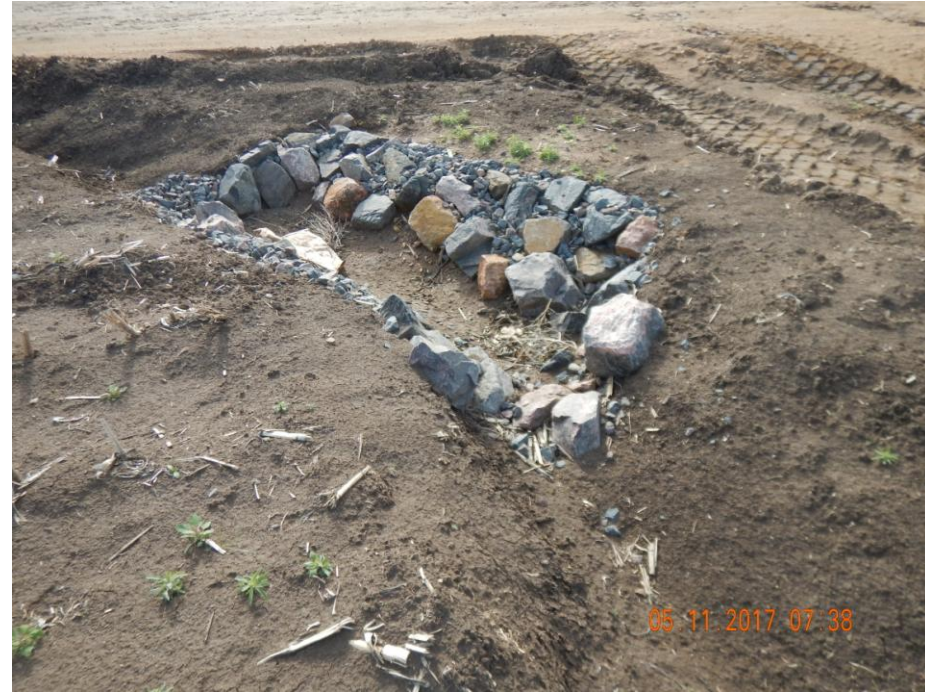
Photo 4: Photo taken from the sediment trap on the northwest end of the location. FIRR #401258606 states "Sediment traps were enlarged, smaller diameter aggregate placed at inlet and outlet. Outlet equipped with some type of filter media (straw wattle or hay bale)". This is the only trap for the entire location. Per on-site conversations between BBC and COGCC staff, sediment trap on location was determined to not have been constructed with good engineering practices. No improvements have been made since these discussions; trap has not been enlarged w/ filter media. Inlet armoring does not appear to be sufficient.

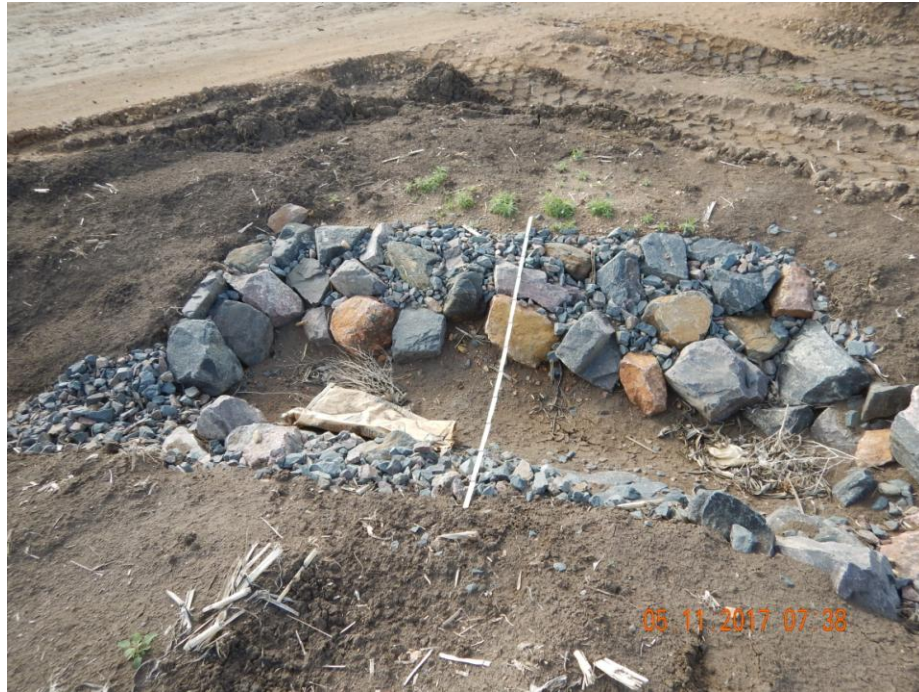
Photo 5: Photo taken from the sediment trap on the northwest end of the location. FIRR #401258606 states "Sediment traps were enlarged, smaller diameter aggregate placed at inlet and outlet. Outlet equipped with some type of filter media (straw wattle or hay bale)". This is the only trap for the entire location. Per on-site conversations between BBC and COGCC staff, sediment trap on location was determined to not have been constructed with good engineering practices. No improvements have been made since these discussions; trap has not been enlarged w/ filter media. Inlet armoring does not appear to be sufficient. 6 foot measuring stick for reference.

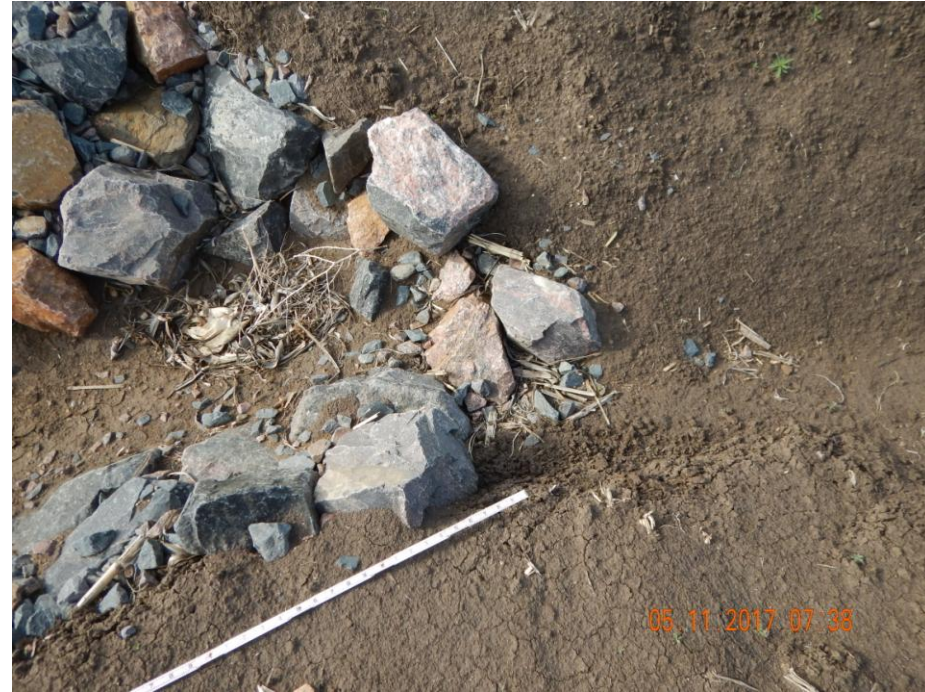
Photo 6: Photo taken from the sediment trap on the northwest end of the location. FIRR #401258606 states "Sediment traps were enlarged, smaller diameter aggregate placed at inlet and outlet. Outlet equipped with some type of filter media (straw wattle or hay bale)". This is the only trap for the entire location. Per on-site conversations between BBC and COGCC staff, sediment trap on location was determined to not have been constructed with good engineering practices. No improvements have been made since these discussions; trap has not been enlarged w/ filter media. Inlet armoring does not appear to be sufficient.

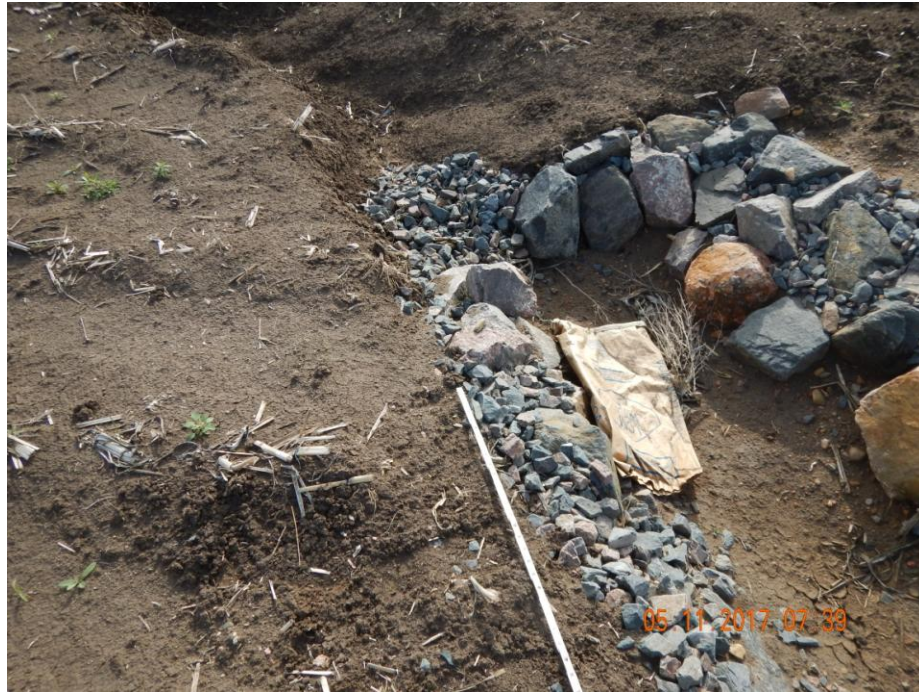
Photo 7: Photo taken from the sediment trap on the northwest end of the location. FIRR #401258606 states "Sediment traps were enlarged, smaller diameter aggregate placed at inlet and outlet. Outlet equipped with some type of filter media (straw wattle or hay bale)". This is the only trap for the entire location. Per on-site conversations between BBC and COGCC staff, sediment trap on location was determined to not have been constructed with good engineering practices. No improvements have been made since these discussions; trap has not been enlarged w/ filter media. Inlet armoring does not appear to be sufficient.

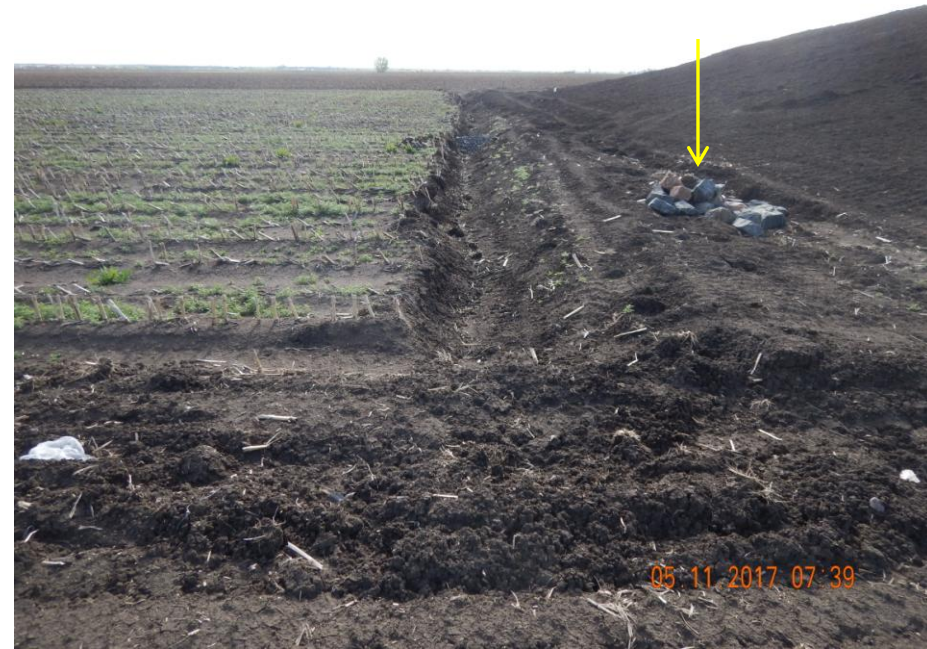
Photo 8: Photo taken from the northeast end of the location, facing east. Photo shows sediment trap that had previously existed has been removed (yellow arrow). Ditch on this portion of the location ends abruptly without any outlet BMP in place to allow for adequate sediment laden free stormwater discharge. Per on-site conversations with BBC on 4/6/2017, COGCC staff were under the impression that additional BMPs to allow for adequate sediment laden free stormwater discharge would be installed on the northeast end of the location.

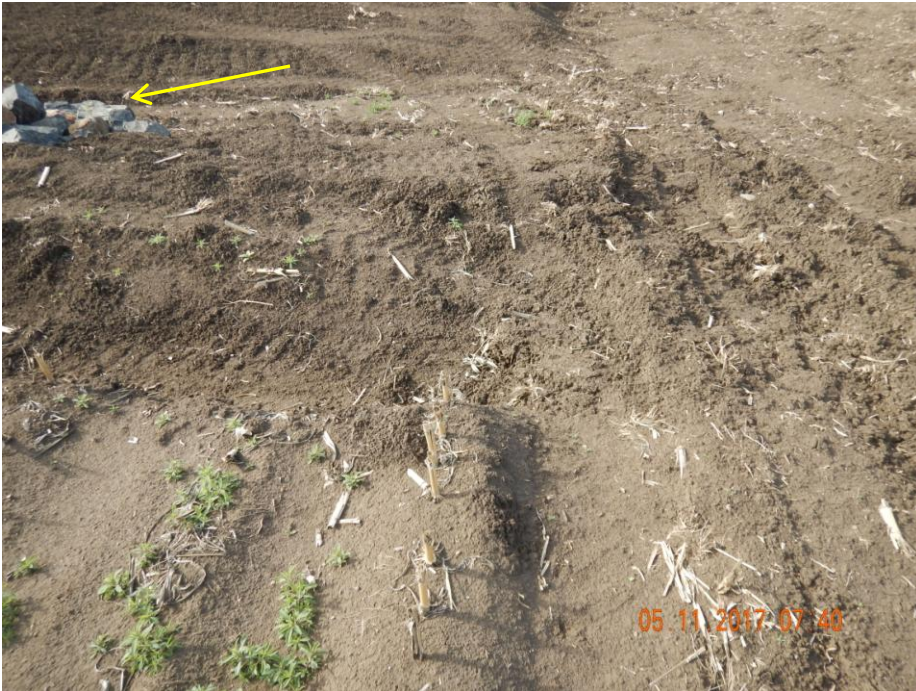
Photo 9: Photo taken from the northeast end of the location. Photo shows sediment trap that had previously existed has been removed (yellow arrow). Ditch on this portion of the location ends abruptly without any outlet BMP in place to allow for adequate sediment laden free stormwater discharge. Per on-site conversations with BBC on 4/6/2017, COGCC staff were under the impression that additional BMPs to allow for adequate sediment laden free stormwater discharge would be installed on the northeast end of the location.

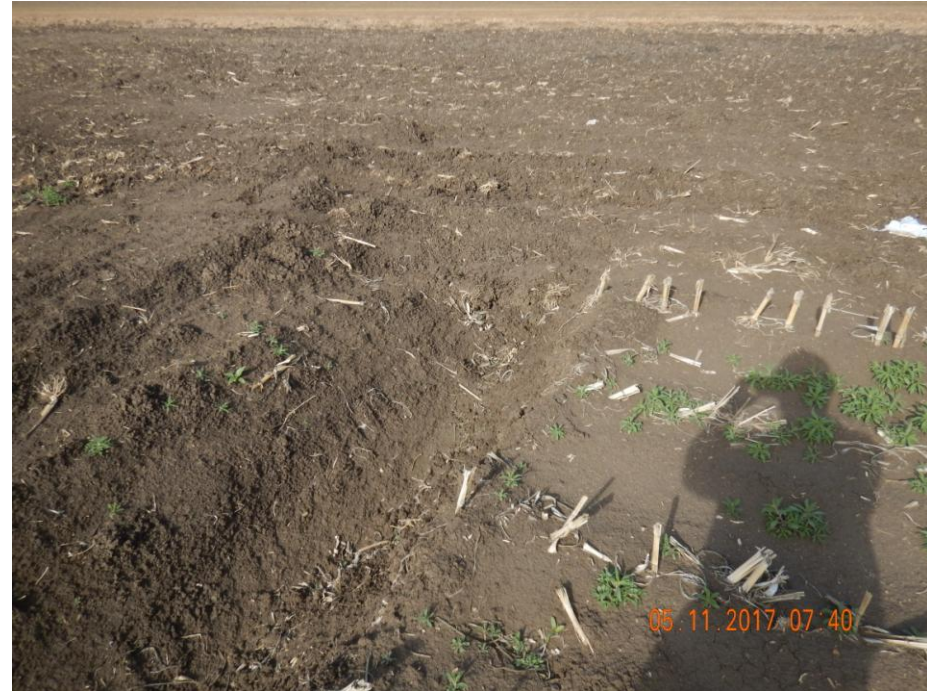
Photo 10: Photo taken from the northeast end of the location. Photo shows ditch on this portion of the location ends abruptly without any outlet BMP in place to allow for adequate sediment laden free stormwater discharge. Per on-site conversations with BBC on 4/6/2017, COGCC staff were under the impression that additional BMPs to allow for adequate sediment laden free stormwater discharge would be installed on the northeast end of the location.

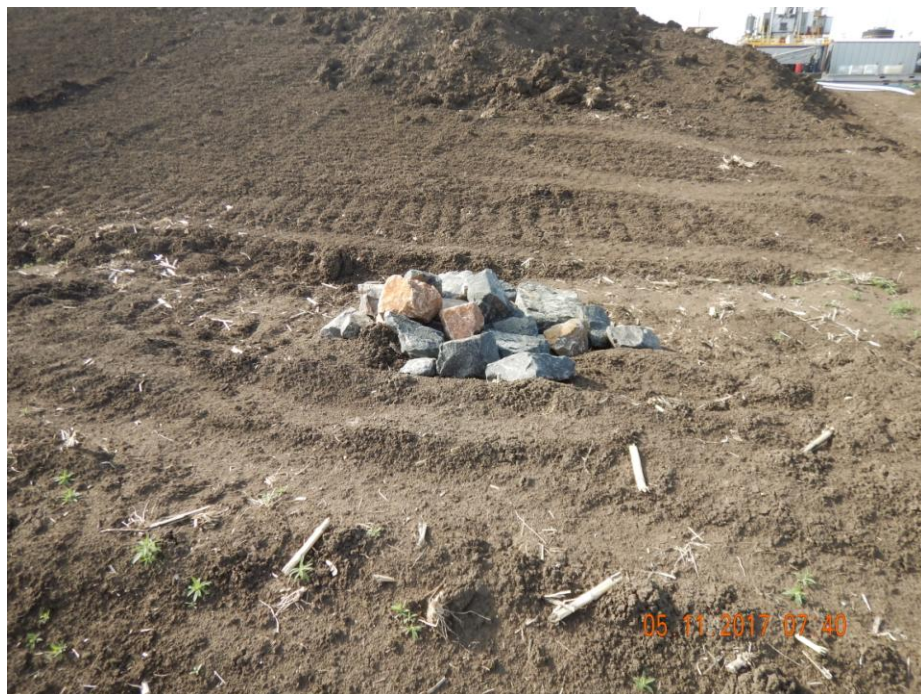
Photo 11: Photo taken from the northeast end of the location. Photo shows sediment trap that had previously existed has been removed .

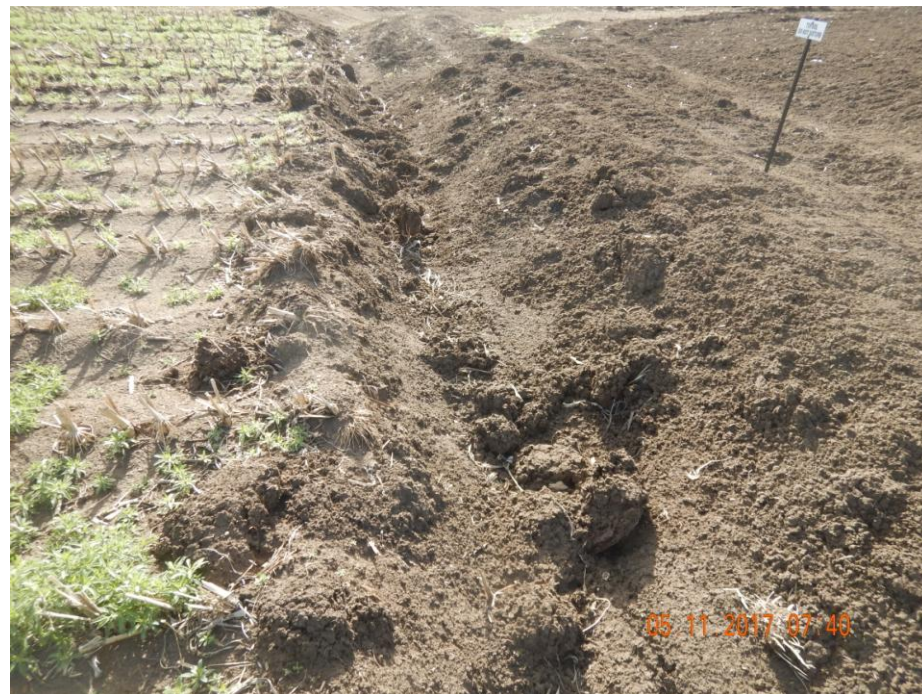
Photo 12: Photo taken from the ditch on the northeast end of the location. Photo shows ditch remain constructed with a steep grade and/or have not been consolidated. Soil has “sloughed off” from the walls in areas of the ditch.

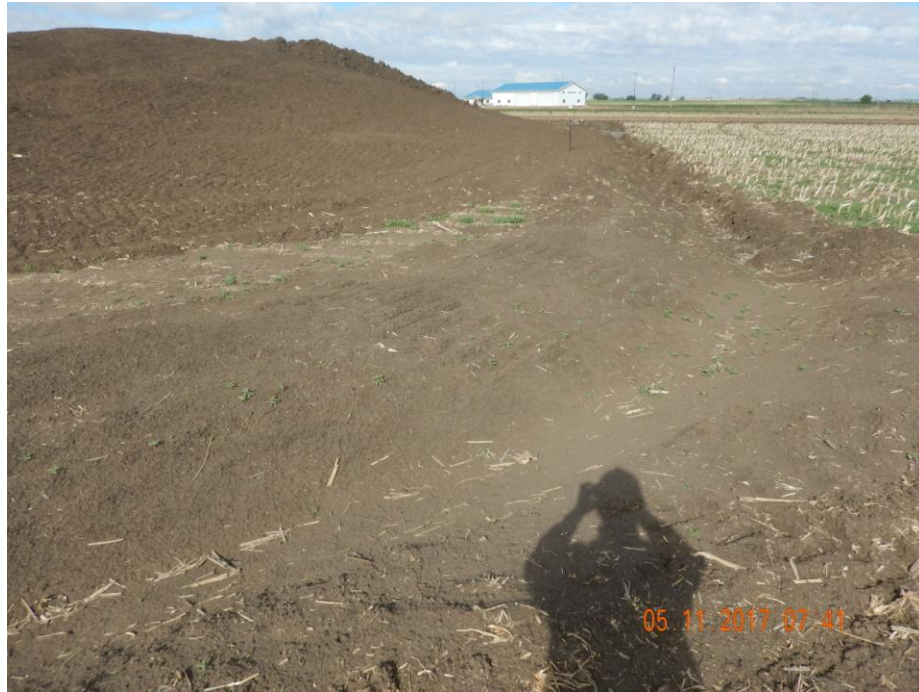
Photo 13: Photo taken from the northeast end of the location, facing west. Photo shows a low point in the northeast end; Per on-site conversations with BBC on 4/6/2017, COGCC staff were under the impression that additional BMPs to allow for adequate sediment laden free stormwater discharge would be installed on the northeast end of the location.

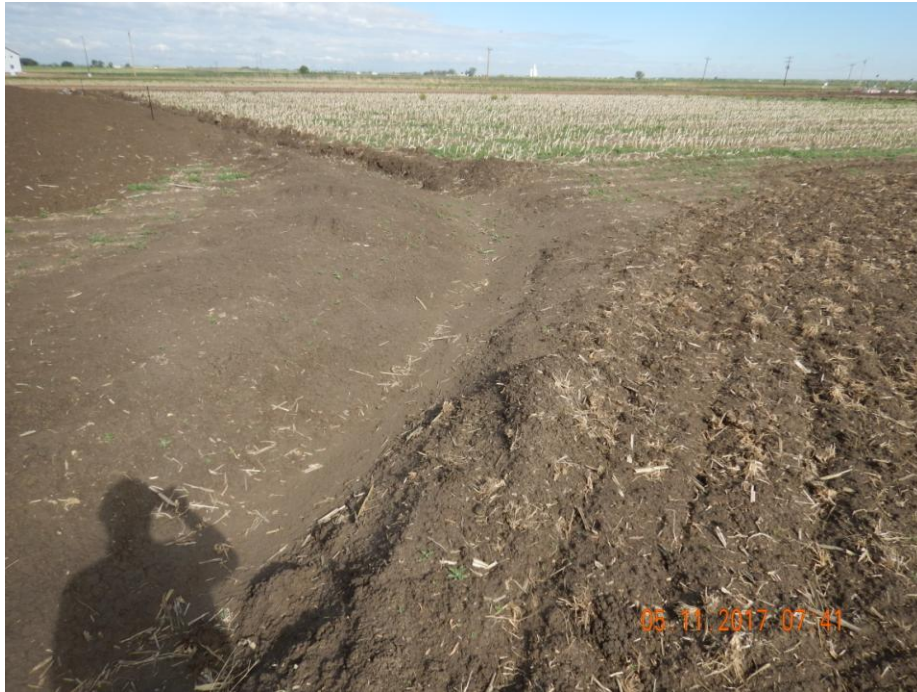
Photo 15: Photo taken from the northeast end of the location, facing north. Photo shows a low point in the northeast end; Per on-site conversations with BBC on 4/6/2017, COGCC staff were under the impression that additional BMPs to allow for adequate sediment laden free stormwater discharge would be installed on the northeast end of the location.

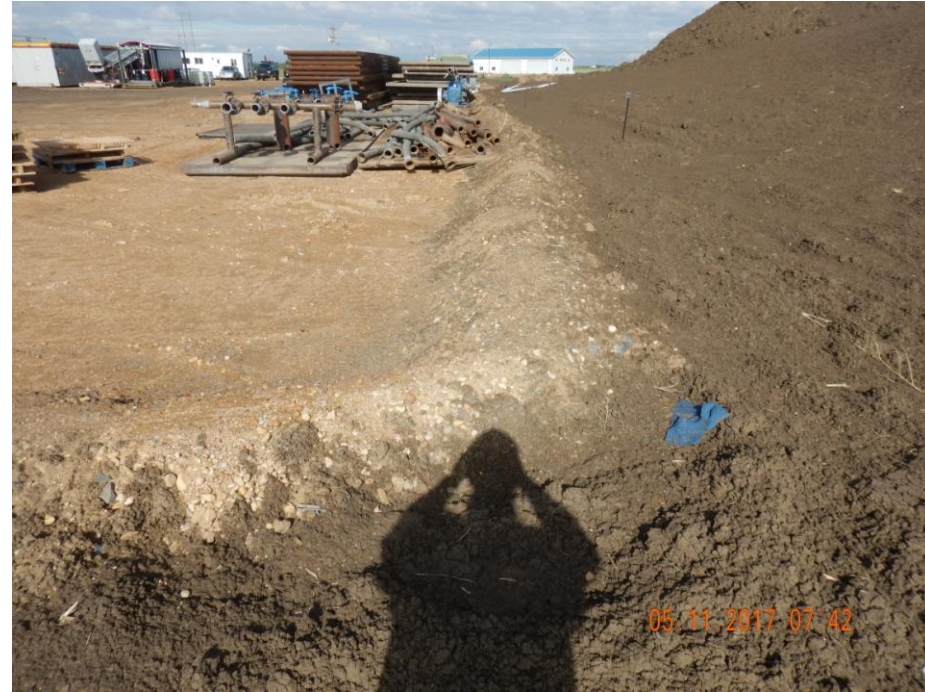
Photo 16: Photo taken from the north end of the location. Photo shows berms on location appear to be consolidated and in proper functioning condition.

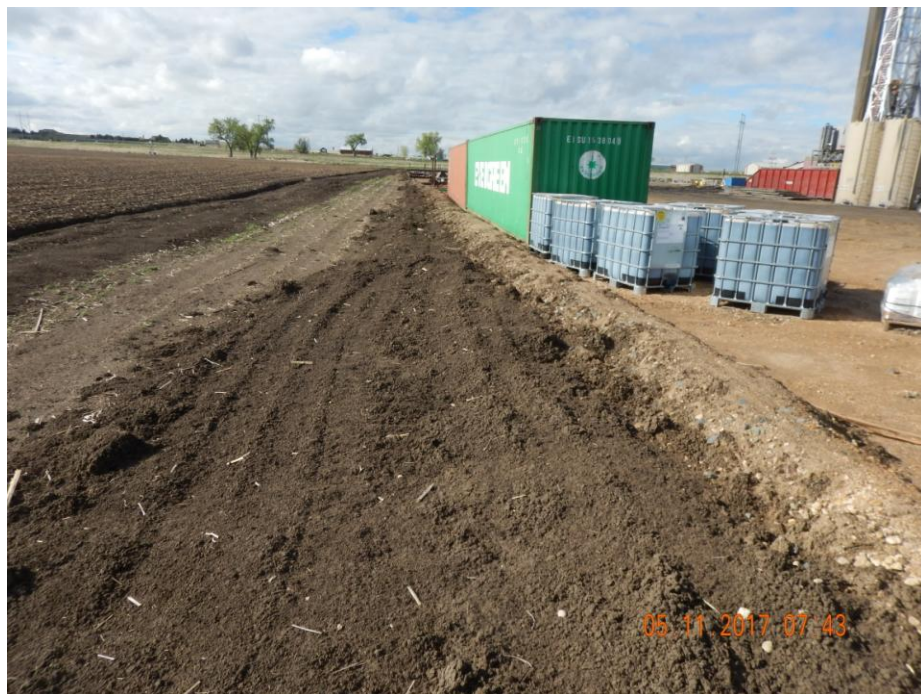
Photo 17: Photo taken from the northeast end of the location, facing south. Photo shows berms on location appear to be consolidated and in proper functioning condition.

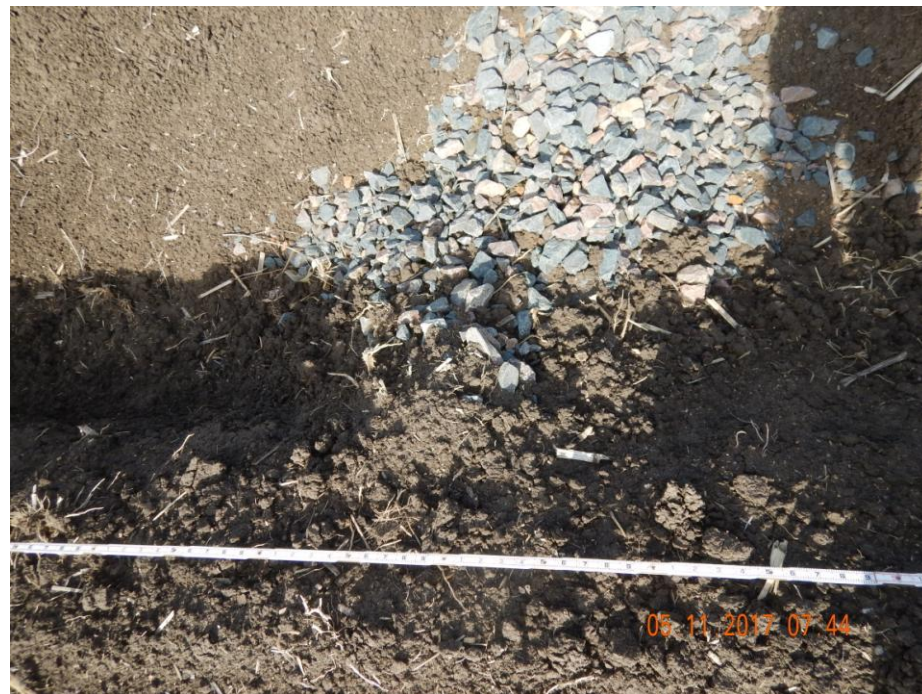
Photo 18: Photo taken from the ditch on the east end of the location. Photo also shows soil has “sloughed off” from the walls in areas of the ditch, or is beginning to erode off into the ditch. Rock aggregate is a check dam that has become inundated with sediment from the wall. 6 foot measuring stick for reference.

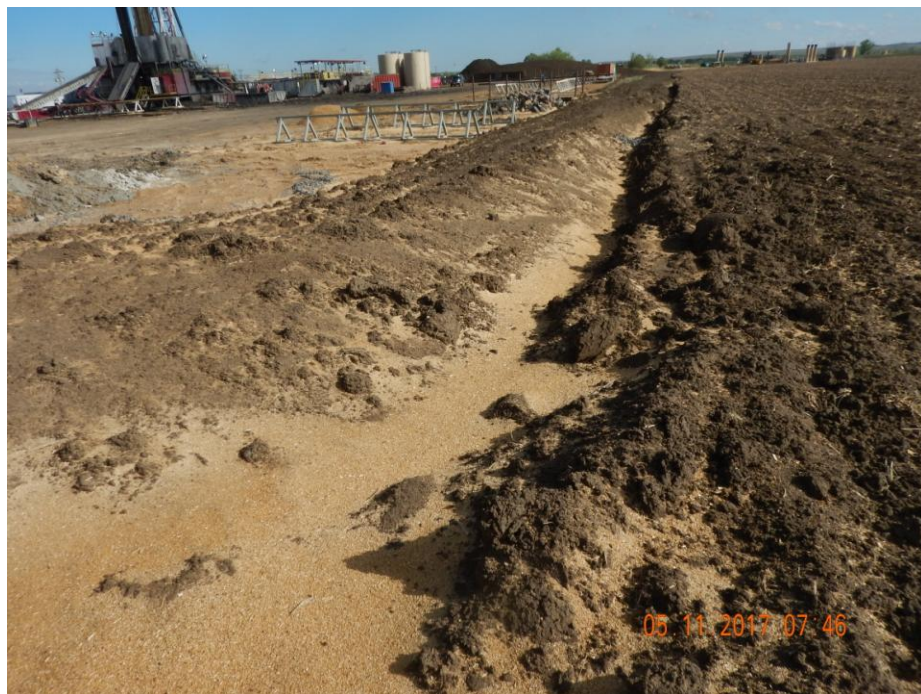
Photo 19: Photo taken from the southeast end of the location, facing north. Photo shows what appears to be saw dust has blown from the location and begun inundating the ditch.

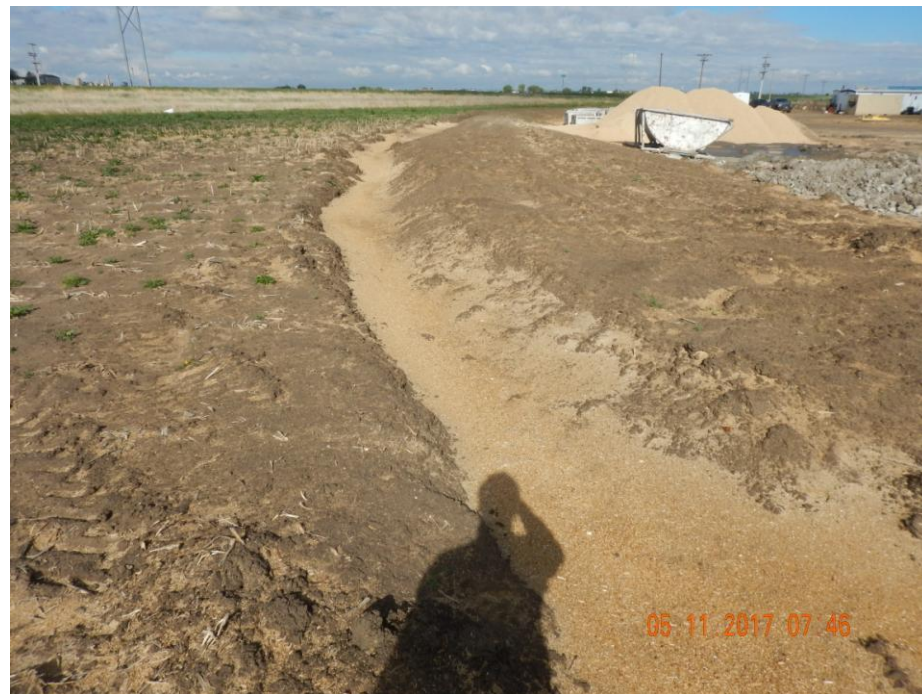
Photo 20: Photo taken from the southeast end of the location, facing west. Photo shows what appears to be saw dust has blown from the location and begun inundating the ditch.

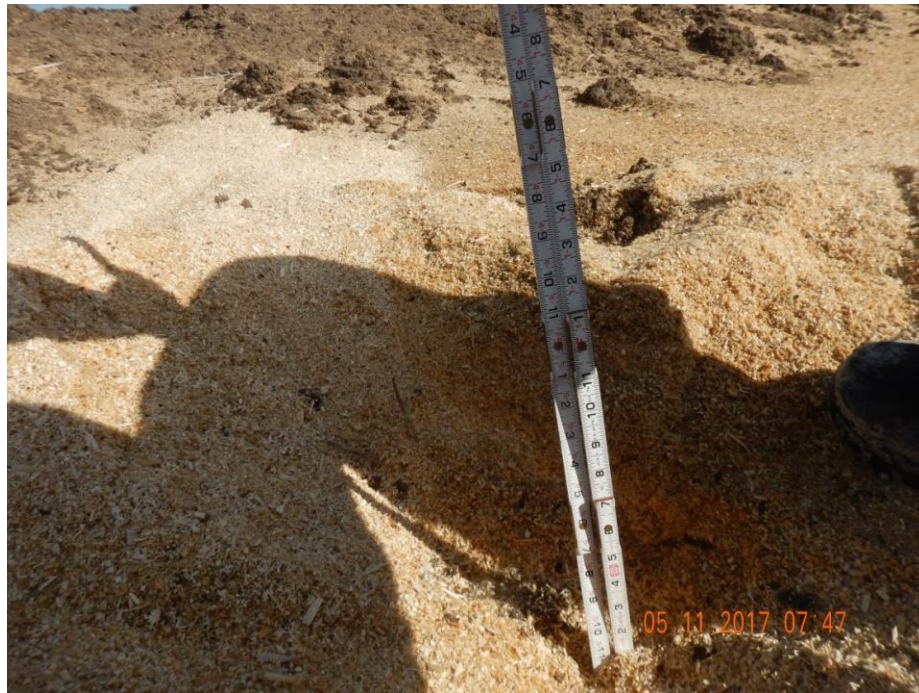
Photo 22: Photo taken from the southeast end of the location. Photo shows what appears to be saw dust has blown from the location and begun inundating the ditch. Saw dust has filled the ditch up over a foot in some areas. Advise removing before ditch is no longer in proper functioning condition.

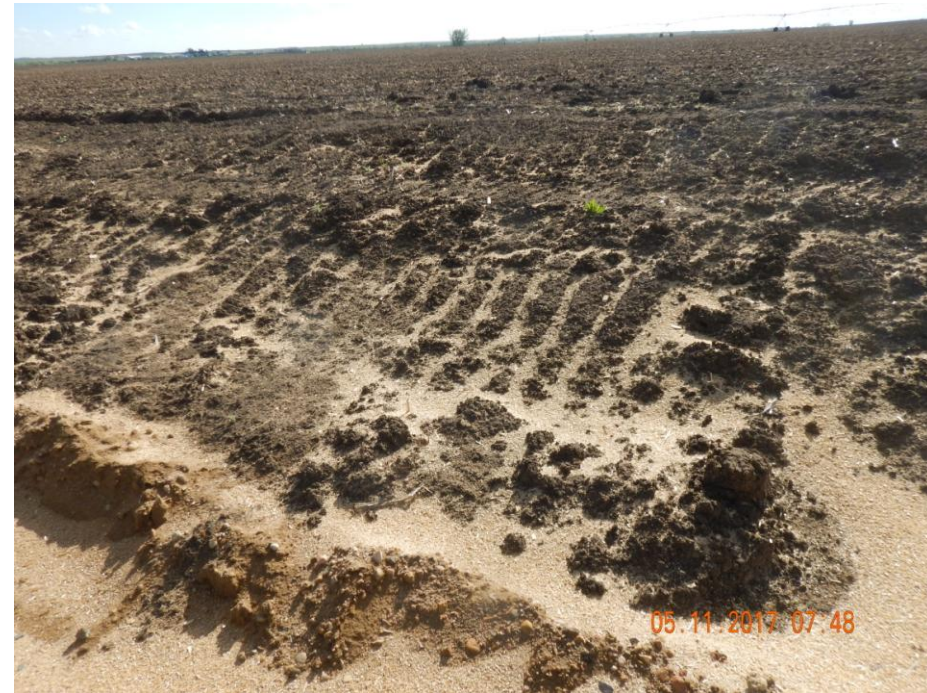
Photo 23: Photo taken from the southeast end of the location, facing east. FIRR #401258606 from operator states "The slopes on the eastern perimeter have been retracted". Photo shows that the slopes on the eastern perimeter of the location have not been retracted as stated in the FIRR.

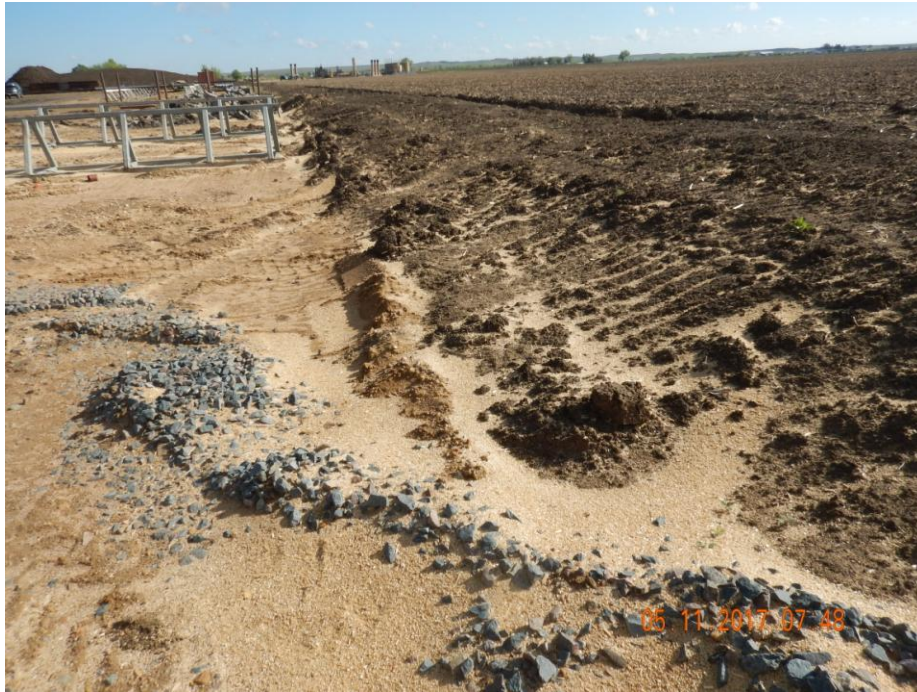
Photo 24: Photo taken from the southeast end of the location, facing north. FIRR #401258606 from operator states "The slopes on the eastern perimeter have been retracked". Photo shows that the slopes on the eastern perimeter of the location have not been retracked as stated in the FIRR.

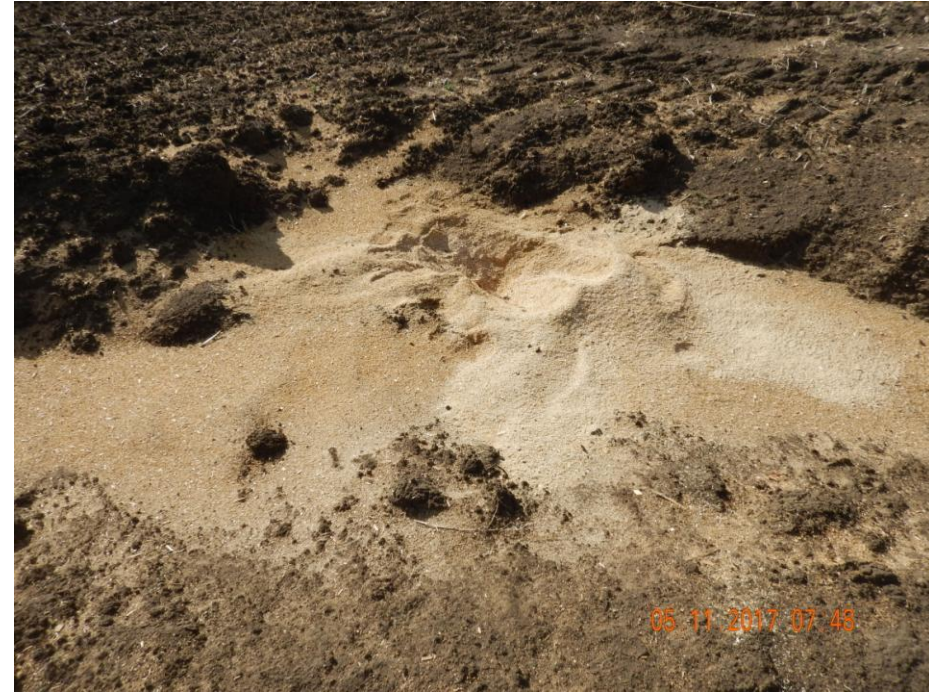
Photo 25: Photo taken from the southeast end of the location. Photo shows what appears to be saw dust has blown from the location and begun inundating the ditch. Saw dust has filled the ditch up over a foot in some areas. Advise removing before ditch is no longer in proper functioning condition.

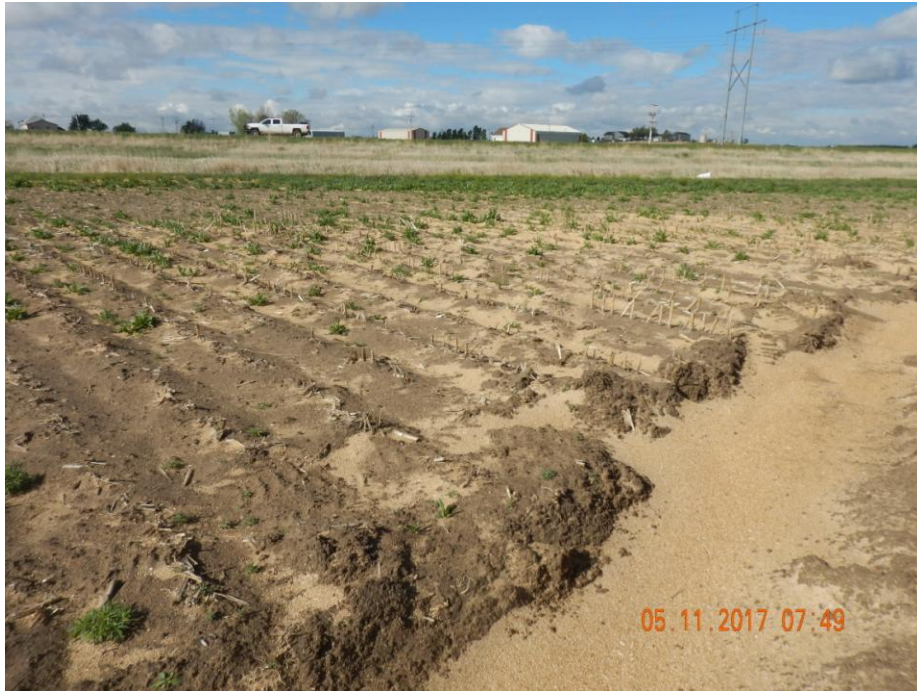
Photo 26: Photo taken from the southeast end of the location. Photo shows what appears to be saw dust has blown from the location and begun inundating the ditch, and encroaching onto adjacent lands. Saw dust has filled the ditch up over a foot in some areas. Advise removing before ditch is no longer in proper functioning condition.

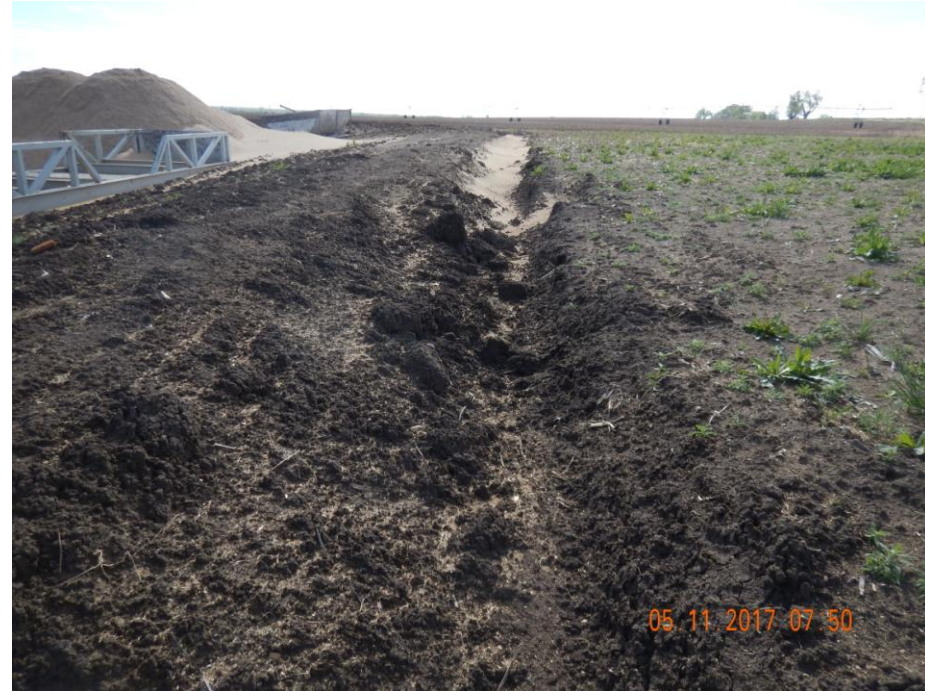
Photo 27: Photo taken from the ditch on the southwest end of the location, facing east. Photo shows ditch remains constructed with a steep grade and/or have not been consolidated. Photo also shows soil has “sloughed off” from the walls in areas of the ditch, or is beginning to erode off into the ditch.

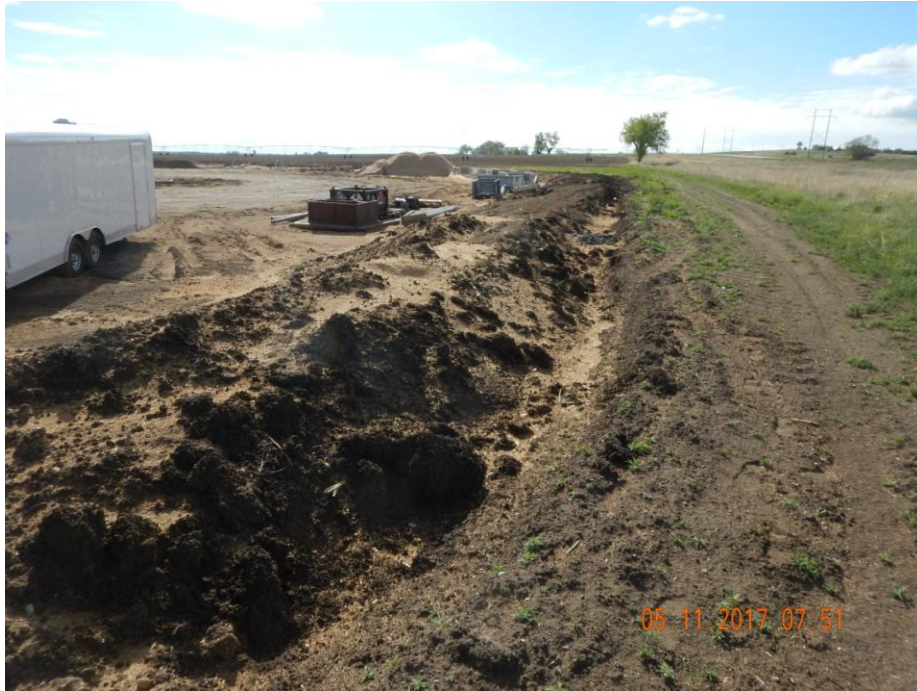
Photo 28: Photo taken from the ditch on the southwest end of the location, facing east. Photo shows ditch remains constructed with a steep grade and/or have not been consolidated. Photo also shows soil has “sloughed off” from the walls in areas of the ditch, or is beginning to erode off into the ditch.

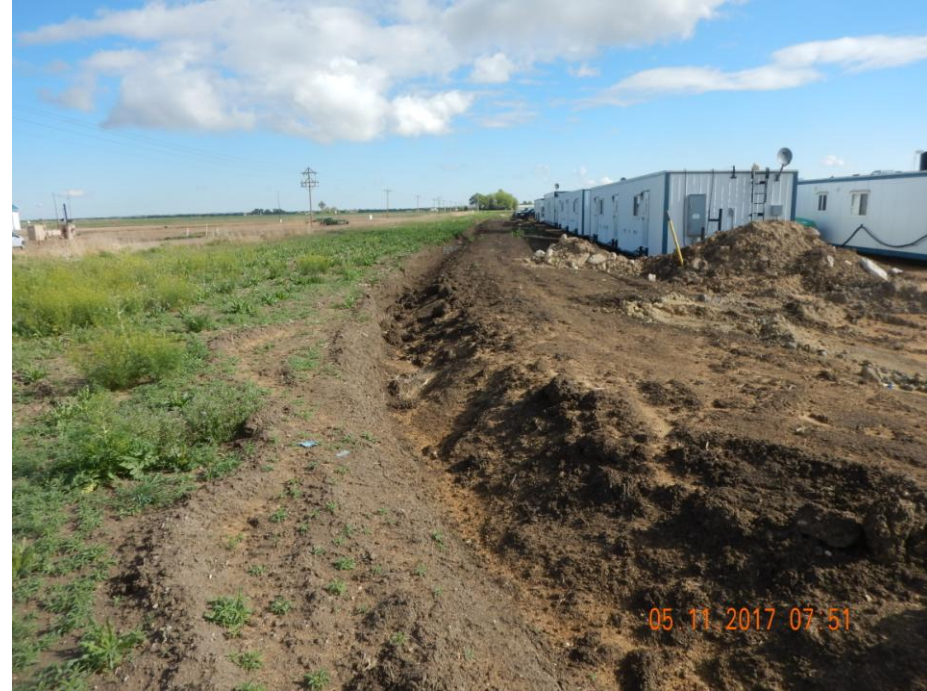
Photo 29: Photo taken from the ditch on the southwest end of the location, facing north. Photo shows ditch remains constructed with a steep grade and/or have not been consolidated. Photo also shows soil has “sloughed off” from the walls in areas of the ditch, or is beginning to erode off into the ditch.

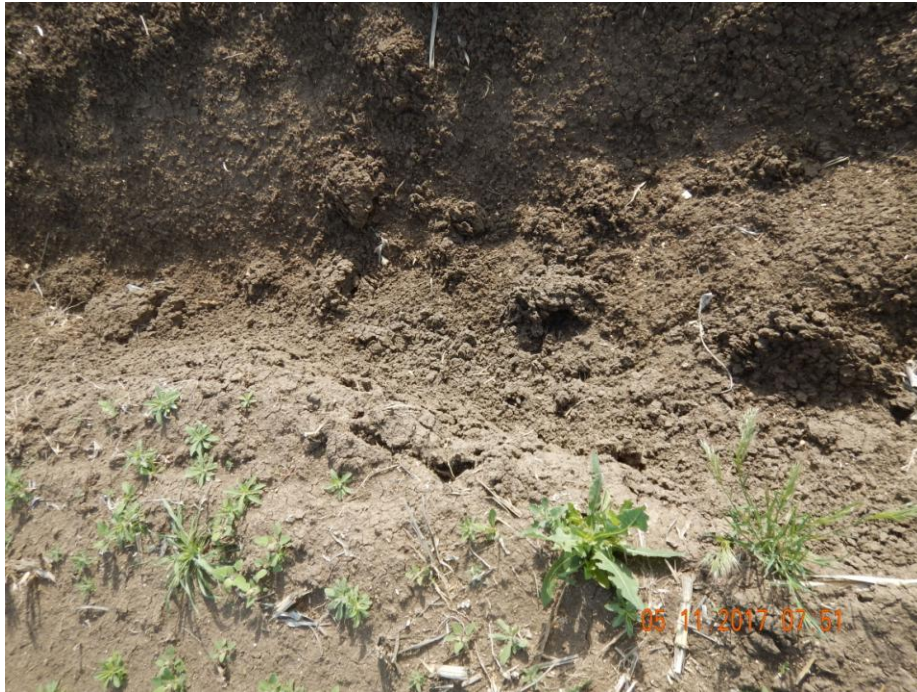
Photo 30: Photo taken from the ditch on the southwest end of the location. Photo shows ditch remain constructed with a steep grade and/or have not been consolidated. Photo also shows soil has “sloughed off” from the walls in areas of the ditch, or is beginning to erode off into the ditch.

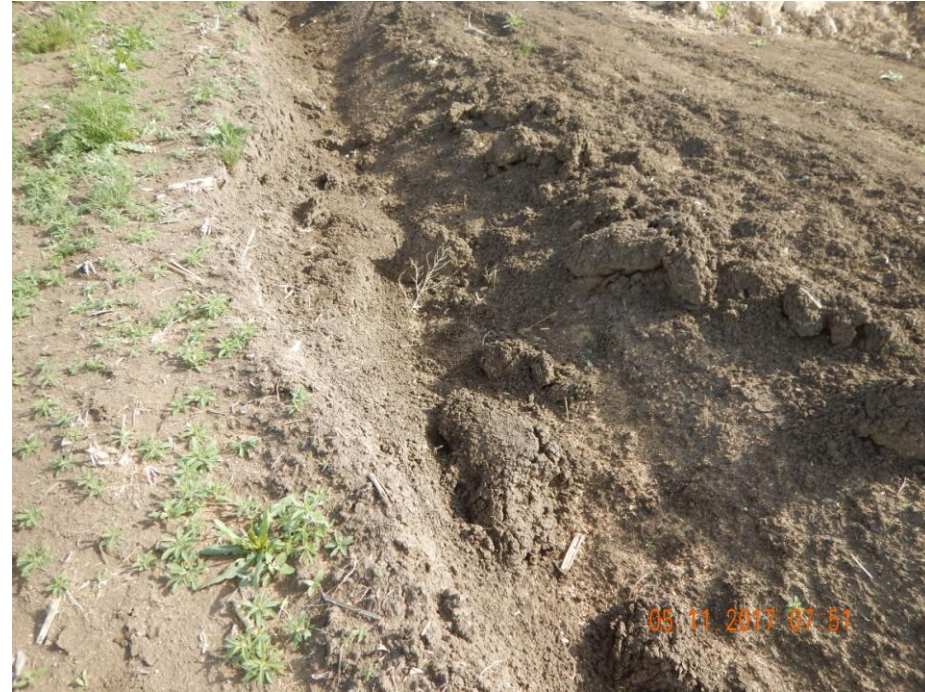
Photo 31: Photo taken from the ditch on the southwest end of the location. Photo shows ditch remain constructed with a steep grade and/or have not been consolidated. Photo also shows soil has “sloughed off” from the walls in areas of the ditch, or is beginning to erode off into the ditch.
