# Inspection Photos

Operator: Bill Barrett Corp #10071

Location ID: 449383

Inspection Doc. Number: 682501981

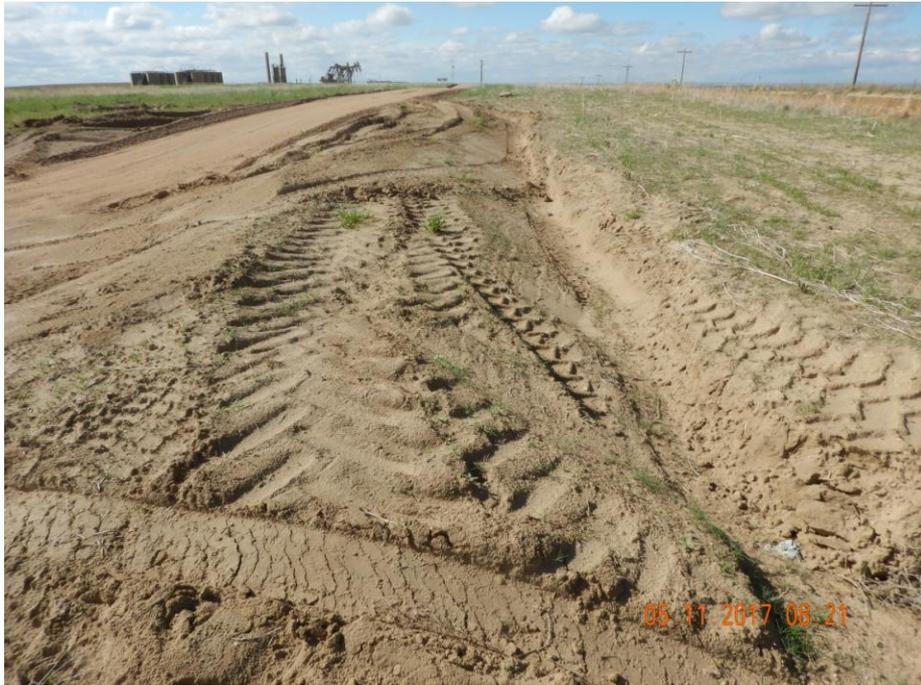
**Photo 1:** Photo taken from the southwest end of the location, facing south. Photo shows ditch along perimeter of the location.

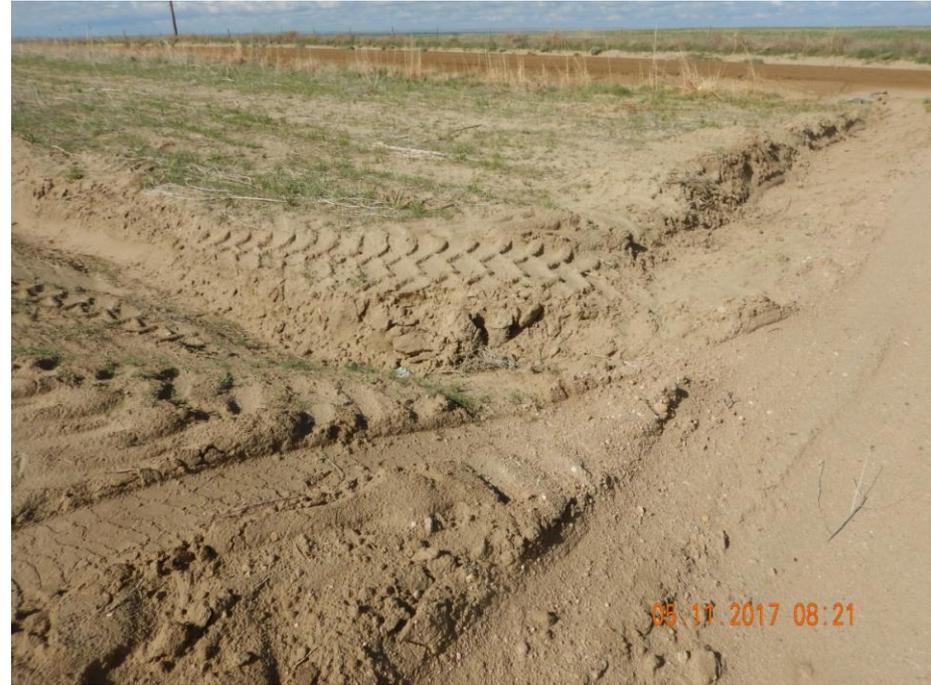
**Photo 2:** Photo taken from the southwest end of the location, facing southwest. Photo shows ditch along perimeter of the location.

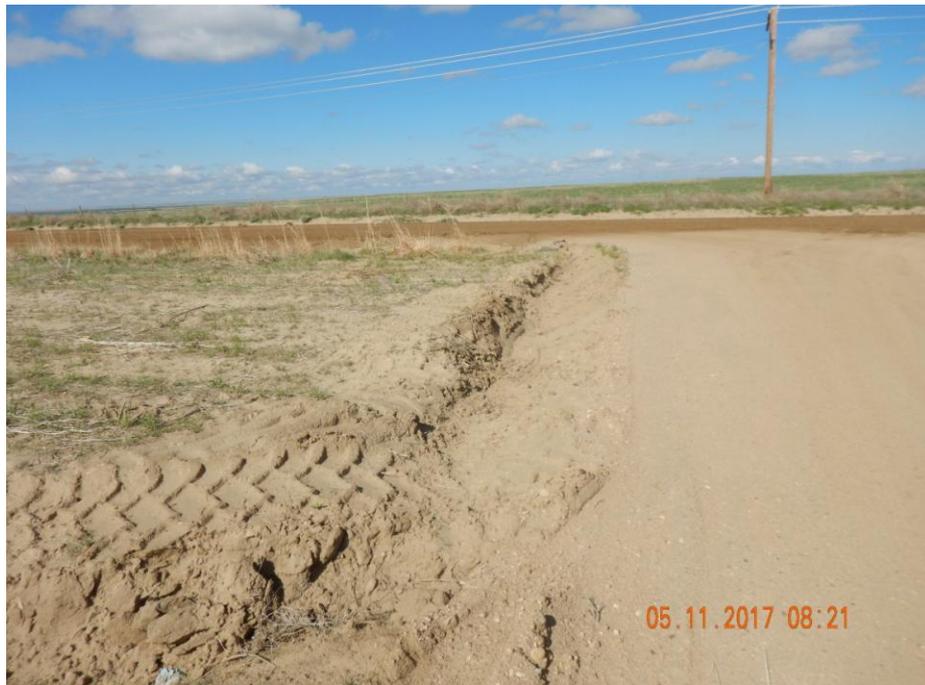
**Photo 3:** Photo taken from the southwest end of the location, facing southwest. Photo shows ditch along perimeter of the location.

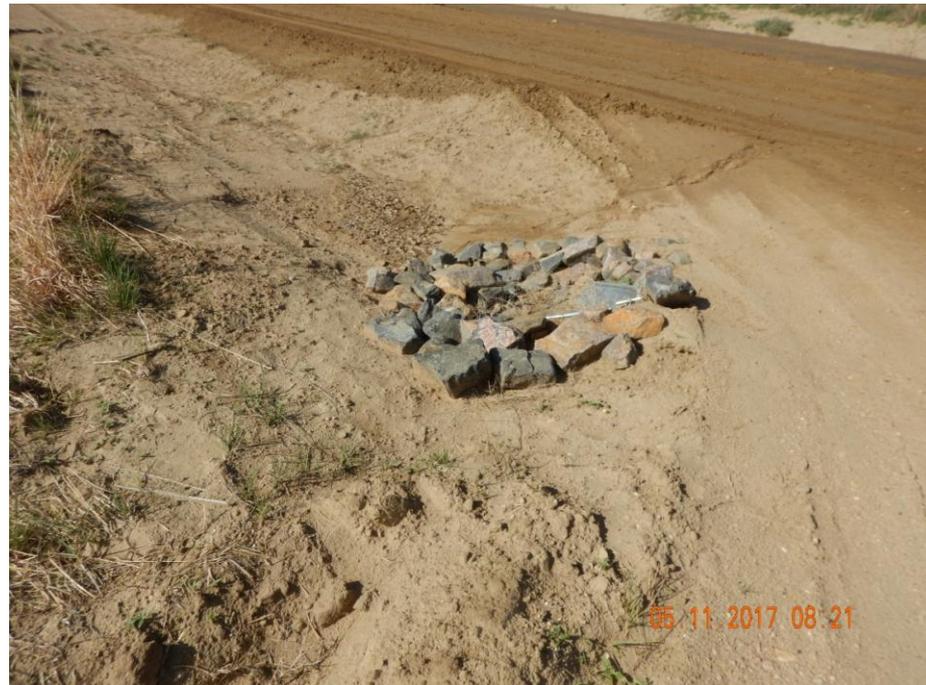
**Photo 4:** Photo taken from access road on the southwest end of the location. Photo shows culver with rock armoring.

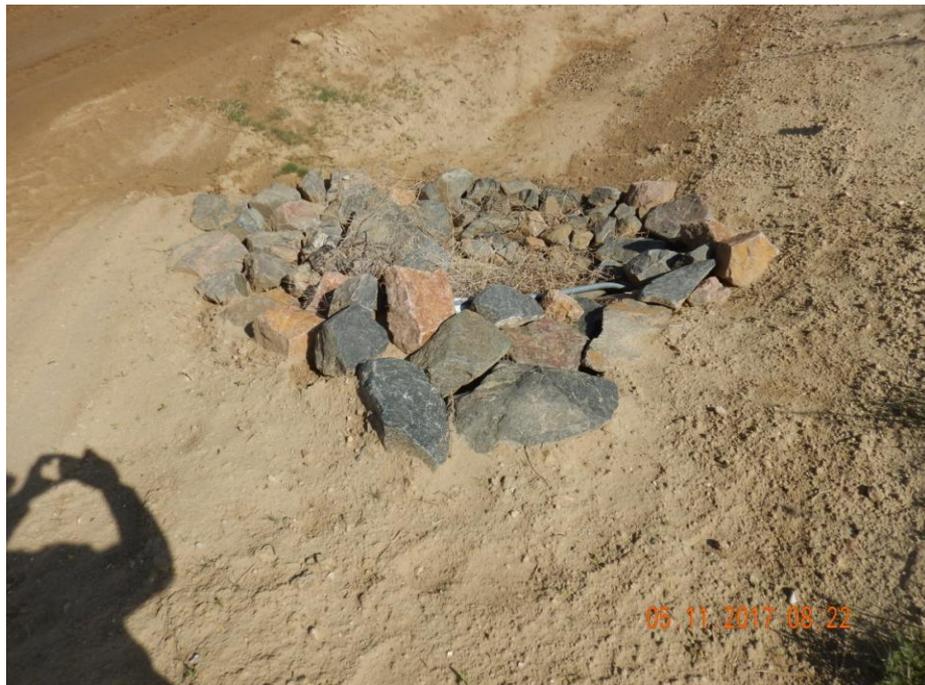
**Photo 5:** Photo taken from access road on the southwest end of the location. Photo shows culver with rock armoring.

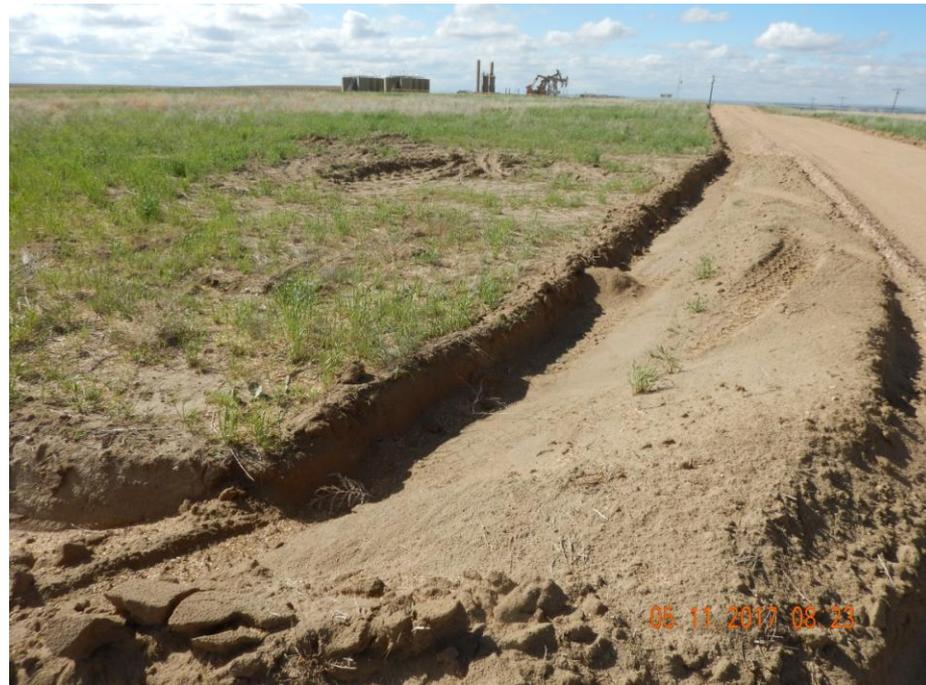
**Photo 6:** Photo taken from the southwest end of the location, facing south. Photo shows perimeter ditch remains constructed with a steep grade and/or have not been consolidated.

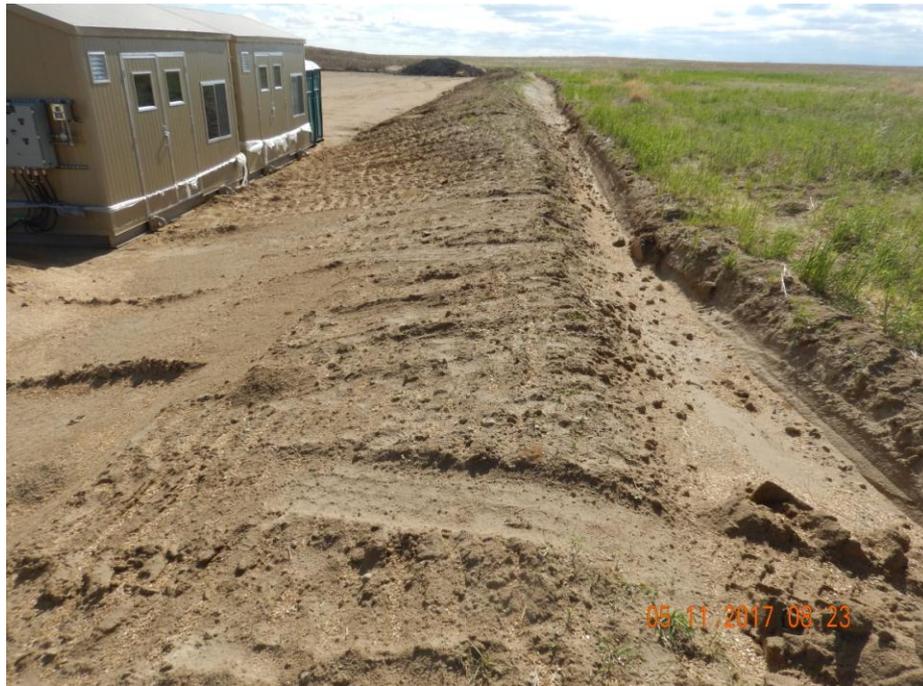
**Photo 7:** Photo taken from the southwest end of the location, facing east. Photo shows perimeter ditch remains constructed with a steep grade and/or have not been consolidated.

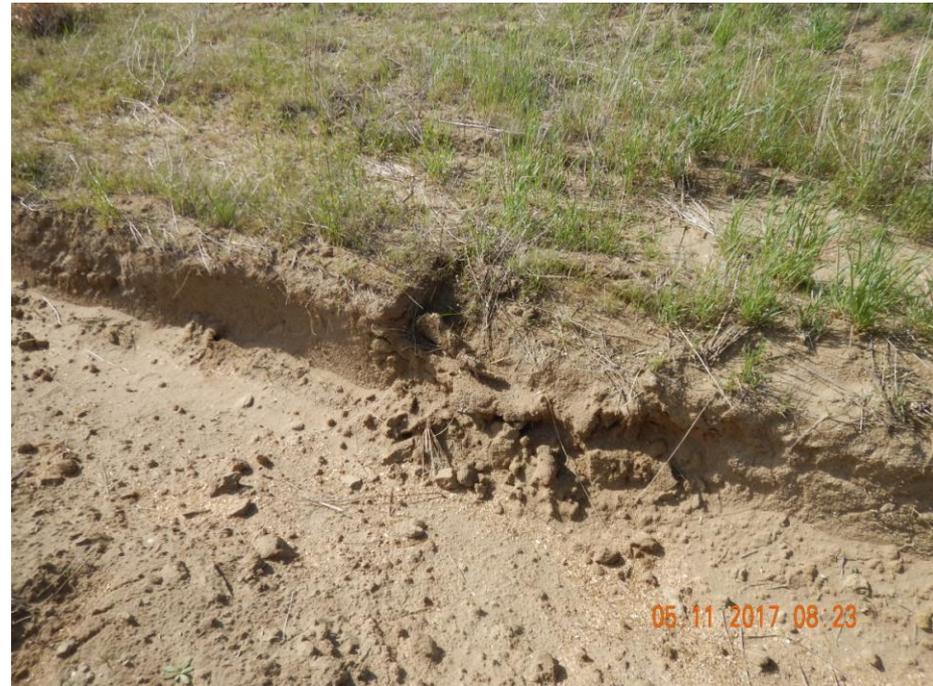
**Photo 8:** Photo taken from the south end of the location. Photo shows portions of the ditch that area beginning to “slough off”, or erode due to poor engineering along ditch.

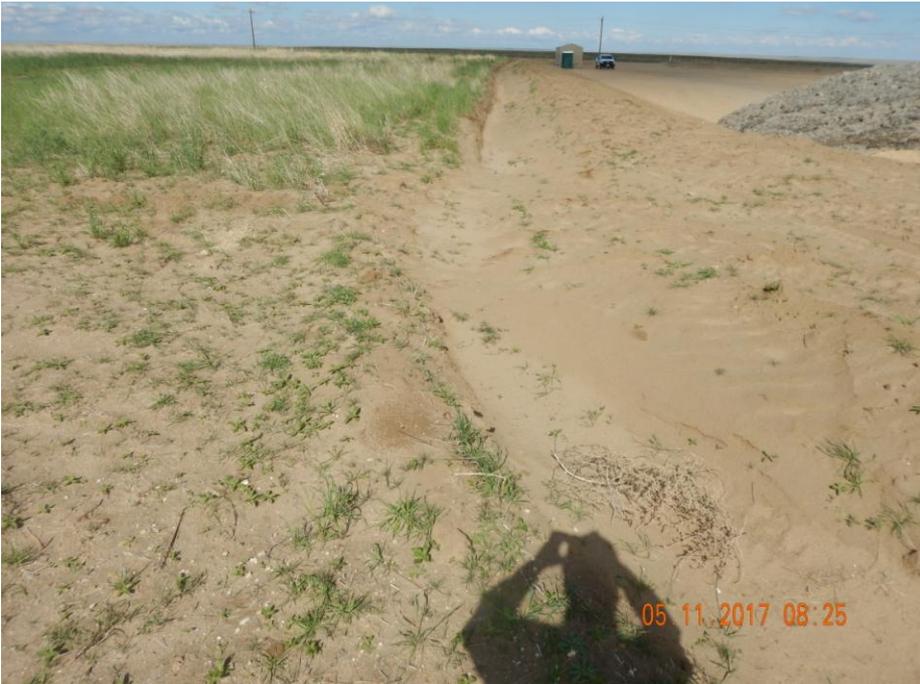
**Photo 9:** Photo taken from the southeast end of the location. Inspection #401245397 states “areas of the ditch has become filled w/ sediment and required maintenance”. FIRR #401258682 submitted by operator states “perimeter ditch maintenance conducted and sediment removed”. Photo shows ditch remains filled w/ sediment, maintenance has not been conducted as indicated by operator.

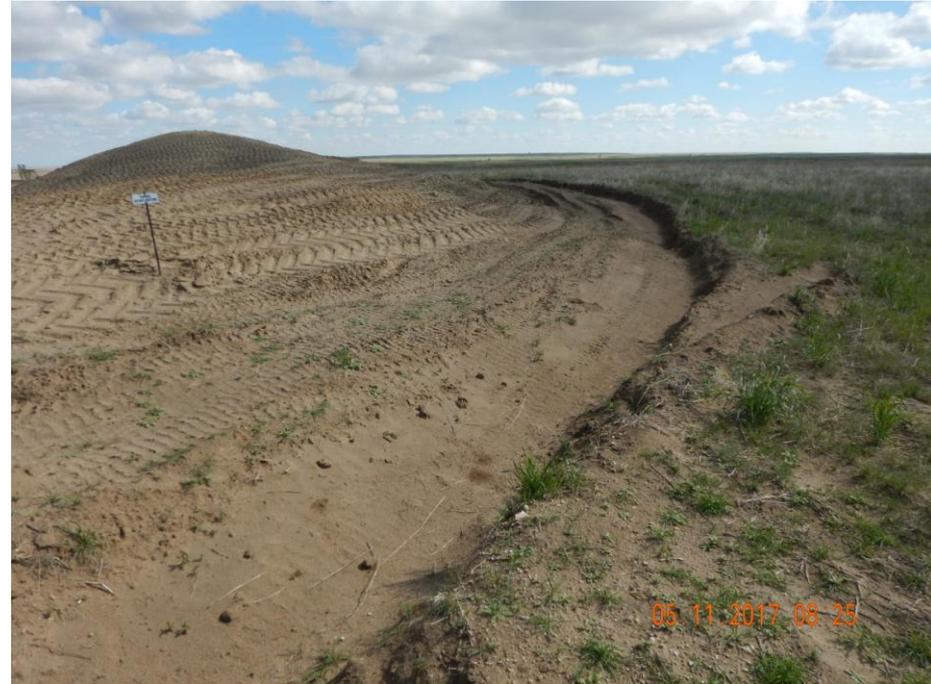
**Photo 10:** Photo taken from the southeast end of the location, facing north. Photo shows perimeter ditch remains constructed with a steep grade and/or have not been consolidated.

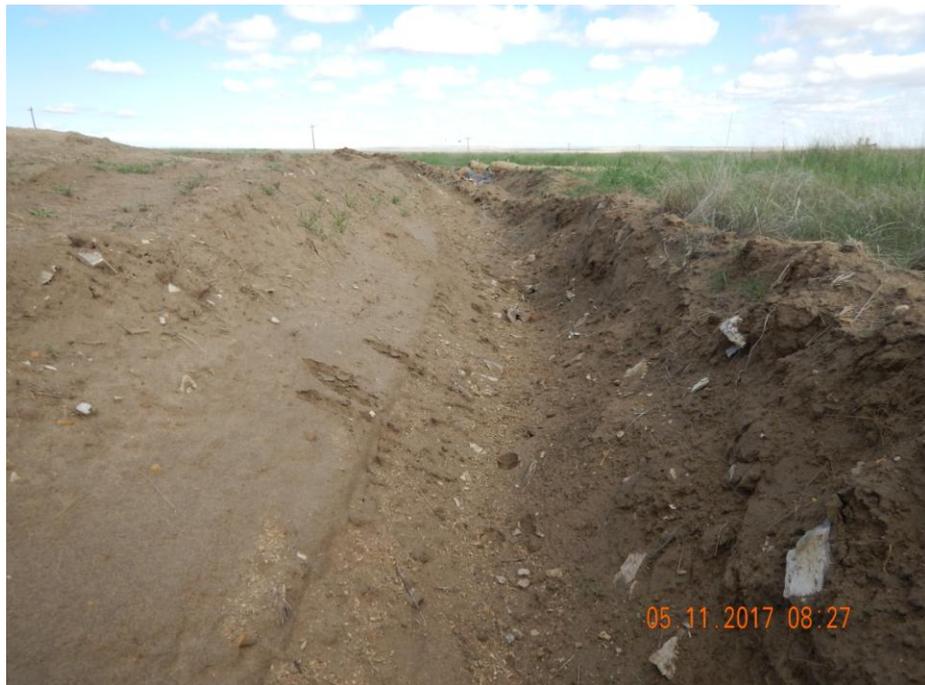
**Photo 11:** Photo taken from the southeast end of the location, facing north. Photo shows perimeter ditch remains constructed with a steep grade and/or have not been consolidated.

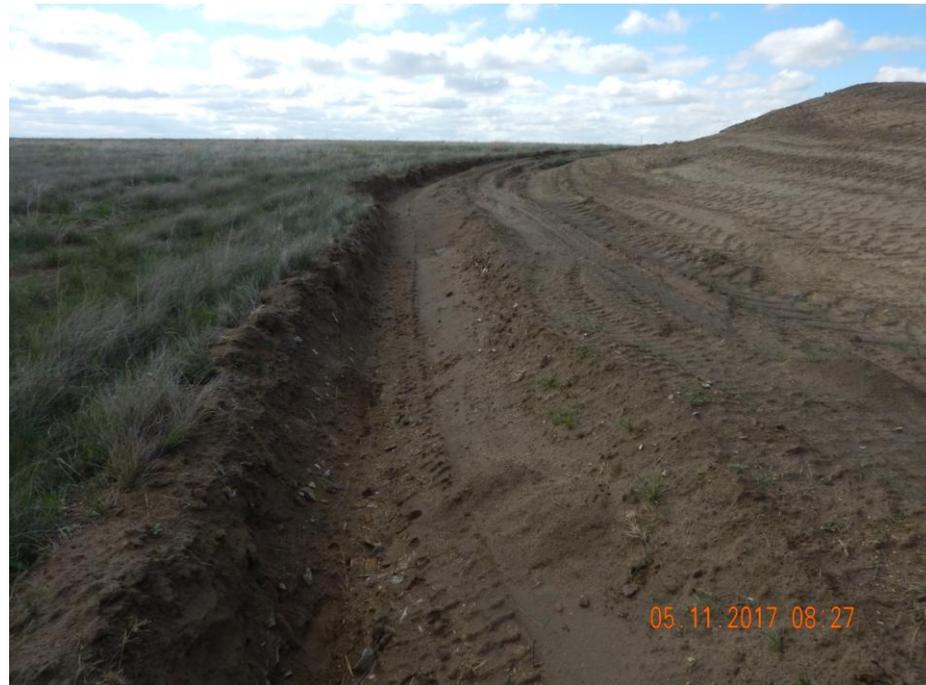
**Photo 12:** Photo taken from the northeast end of the location, facing south. Photo shows perimeter ditch remains constructed with a steep grade and/or have not been consolidated.

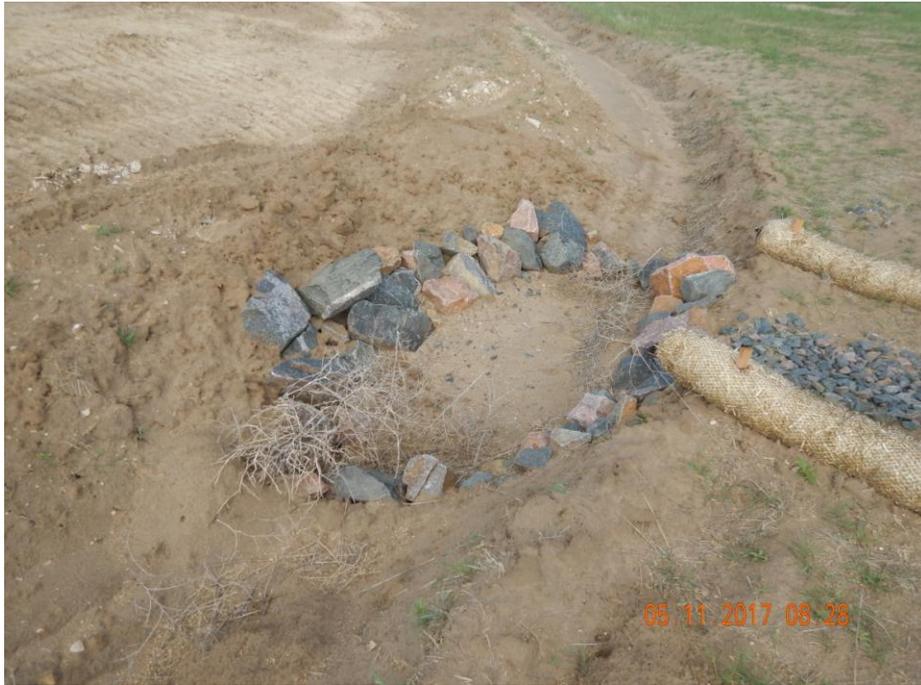
**Photo 13:** Photo taken from the sediment trap on the northeast end of the location. Per on-site conversations between BBC and COGCC staff 4/6/2017, sediment trap on location was determined to not have been constructed with good engineering practices. FIRR #401258682 states "Sediment traps were enlarged, smaller diameter aggregate placed at inlet and outlet. Outlet equipped with some type of filter media (straw wattle or hay bale)". Wattles have been installed; wattles are barriers that pond run off and do not filter stormwater. Wattles will not allow for adequate stormwater discharge from a sediment trap and should not be incorporated at the outlet of the sediment traps. Inlet armoring does not appear to be sufficient.

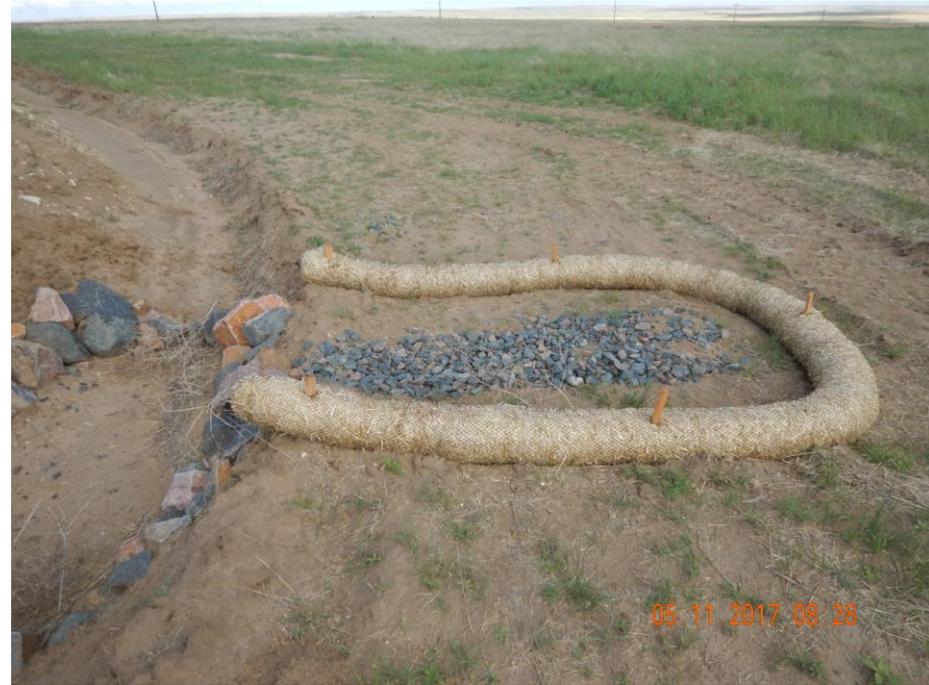
**Photo 14:** Photo taken from the sediment trap on the northeast end of the location. Per on-site conversations between BBC and COGCC staff 4/6/2017, sediment trap on location was determined to not have been constructed with good engineering practices. FIRR #401258682 states "Sediment traps were enlarged, smaller diameter aggregate placed at inlet and outlet. Outlet equipped with some type of filter media (straw wattle or hay bale)". Wattles have been installed; wattles are barriers that pond run off and do not filter stormwater. Wattles will not allow for adequate stormwater discharge from a sediment trap and should not be incorporated at the outlet of the sediment traps. Inlet armoring does not appear to be sufficient.

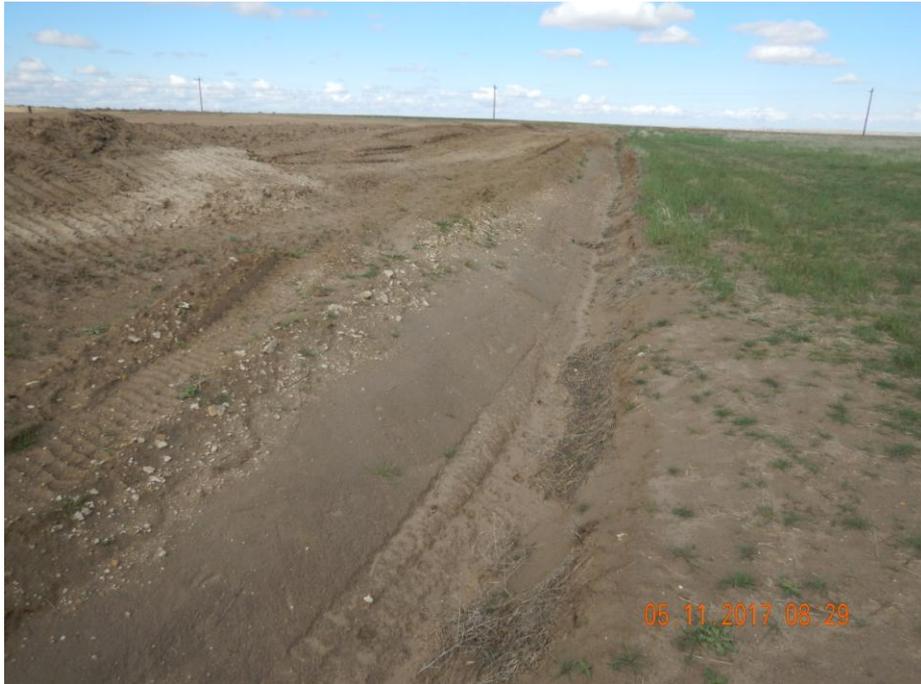
**Photo 15:** Photo taken from the northeast end of the location, facing west. Photo shows perimeter ditch remains constructed with a steep grade and/or have not been consolidated.

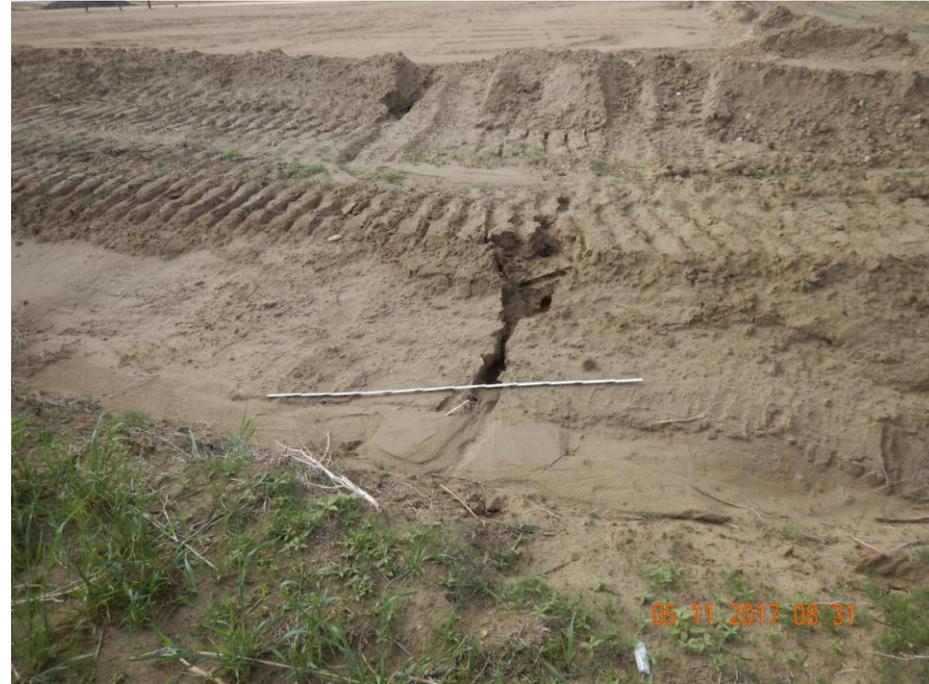
**Photo 16:** Photo taken from the northwest end of the location. Photo shows stormwater erosion has degraded the berm /slope/ditch of the location. Berms do not appear to be sufficiently consolidated on this area of the location. 6 foot measuring stick for reference.

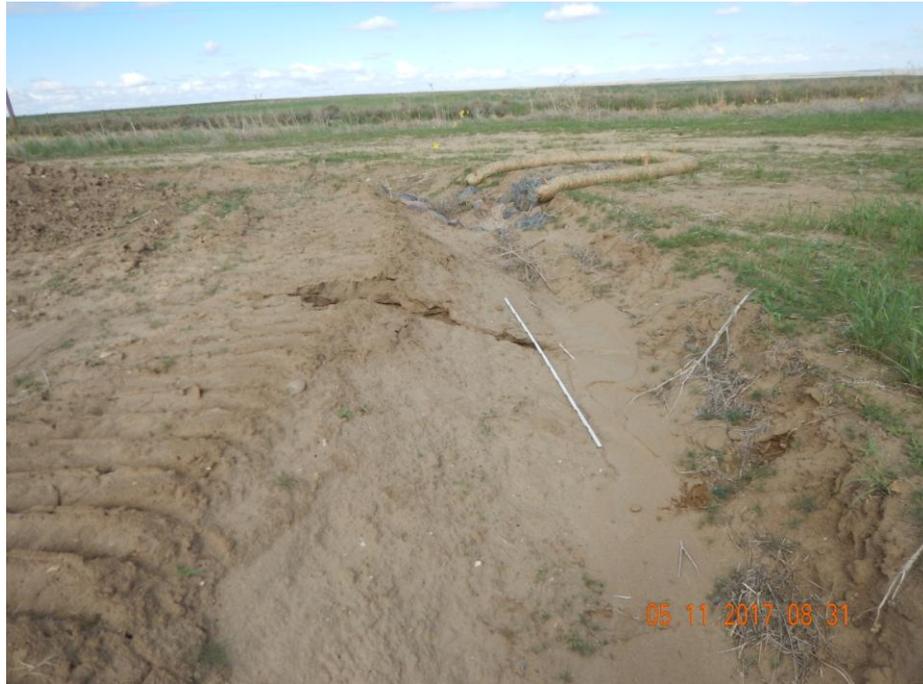
**Photo 17:** Photo taken from the northwest end of the location. Photo shows stormwater erosion has degraded the berm/slope/ditch of the location. Berms do not appear to be sufficiently consolidated on this area of the location. 6 foot measuring stick for reference.

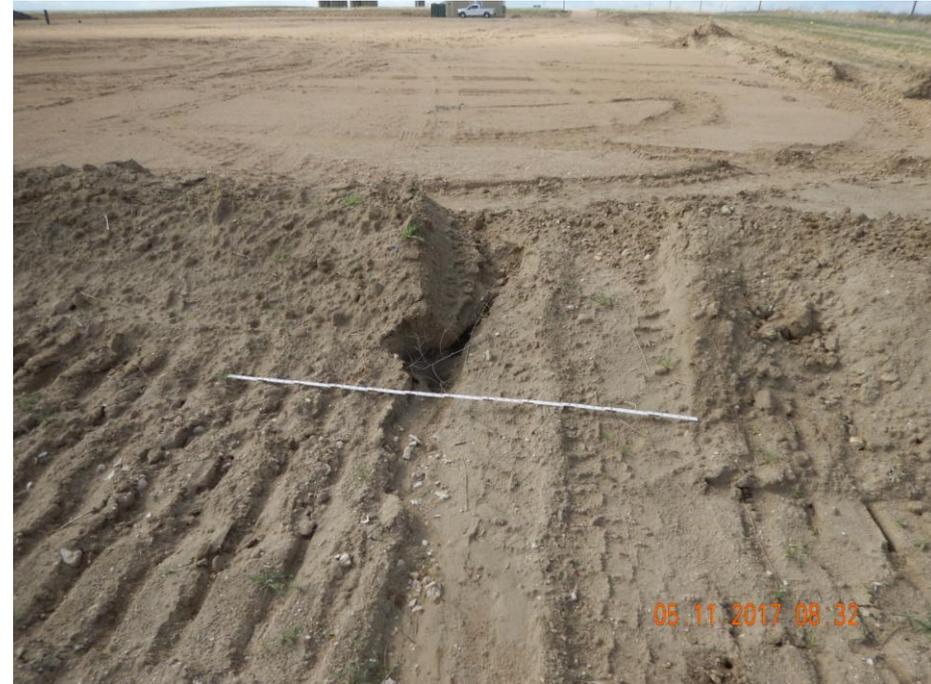
**Photo 18:** Photo taken from the northwest end of the location. Photo shows stormwater erosion has degraded the berm and slope of the location. Berms do not appear to be sufficiently consolidated on this area of the location. Vehicle traffic appears to have rendered the berm inadequate and allowed for stormwater degradation. 6 foot measuring stick for reference.

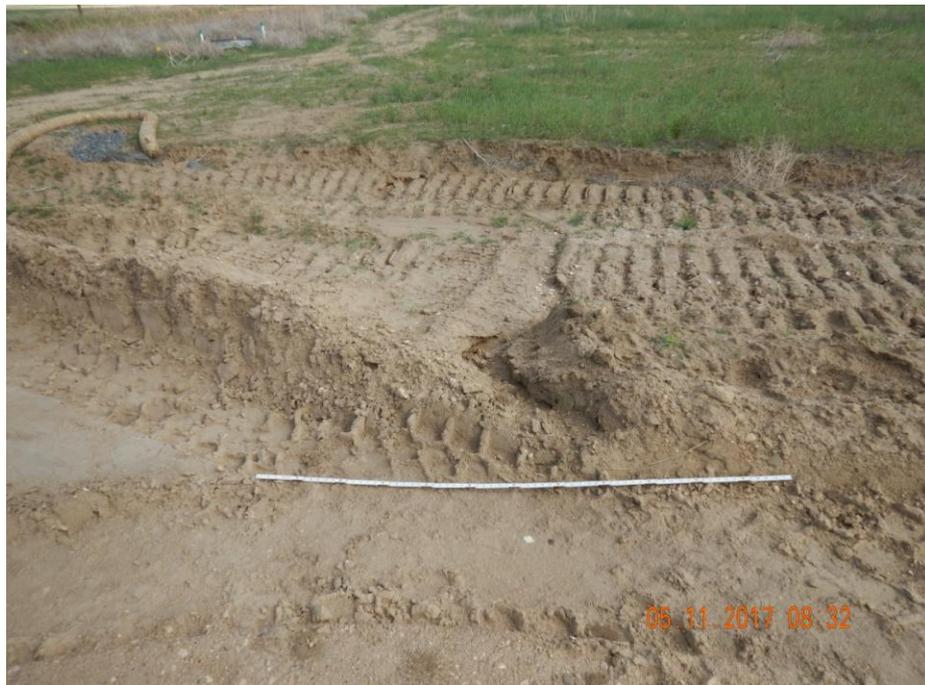
**Photo 19:** Photo taken from the northwest end of the location. Photo shows stormwater erosion has degraded the berm and slope of the location. Berms do not appear to be sufficiently consolidated on this area of the location. Vehicle traffic appears to have rendered the berm inadequate and allowed for stormwater degradation. 6 foot measuring stick for reference.

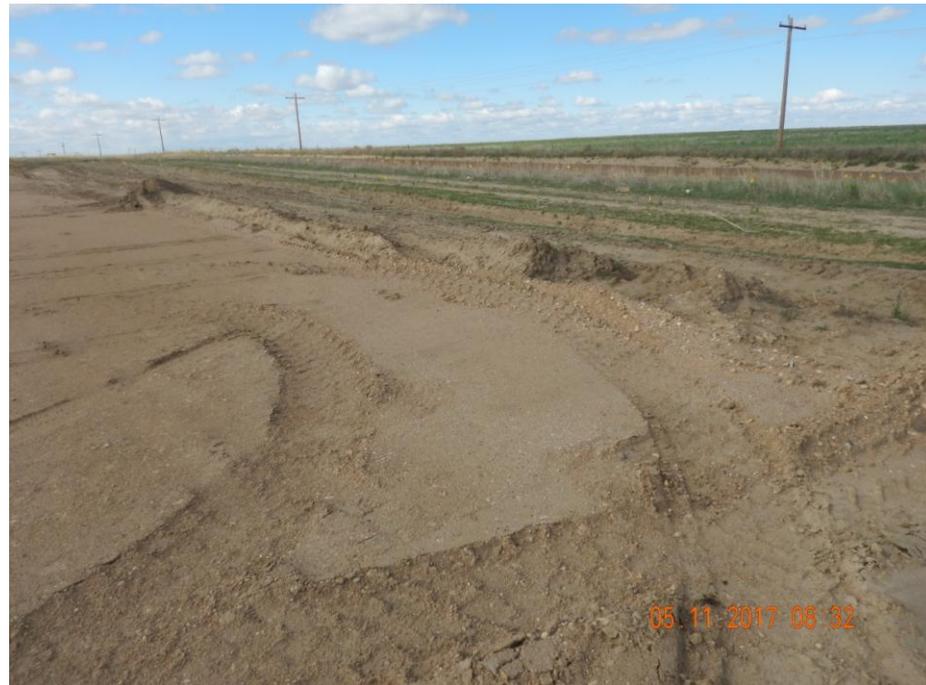
**Photo 20:** Photo taken from the northwest end of the location, facing southwest. Photo shows berms on the location have do not appear to be consolidated.

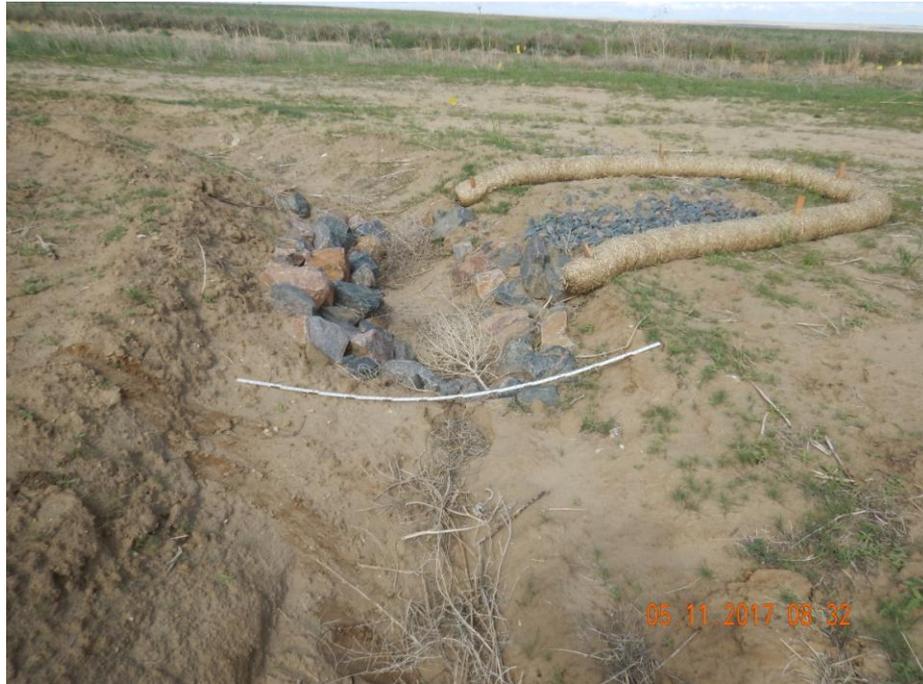
**Photo 22:** Photo taken from the sediment trap on the northwest end of the location. Per on-site conversations between BBC and COGCC staff 4/6/2017, sediment trap on location was determined to not have been constructed with good engineering practices. FIRR #401258682 states "Sediment traps were enlarged, smaller diameter aggregate placed at inlet and outlet. Outlet equipped with some type of filter media (straw wattle or hay bale)". Wattles have been installed; wattles are barriers that pond run off and do not filter stormwater. Wattles will not allow for adequate stormwater discharge from a sediment trap and should not be incorporated at the outlet of the sediment traps. Inlet armoring does not appear to be sufficient. 6 foot measuring stick for reference.

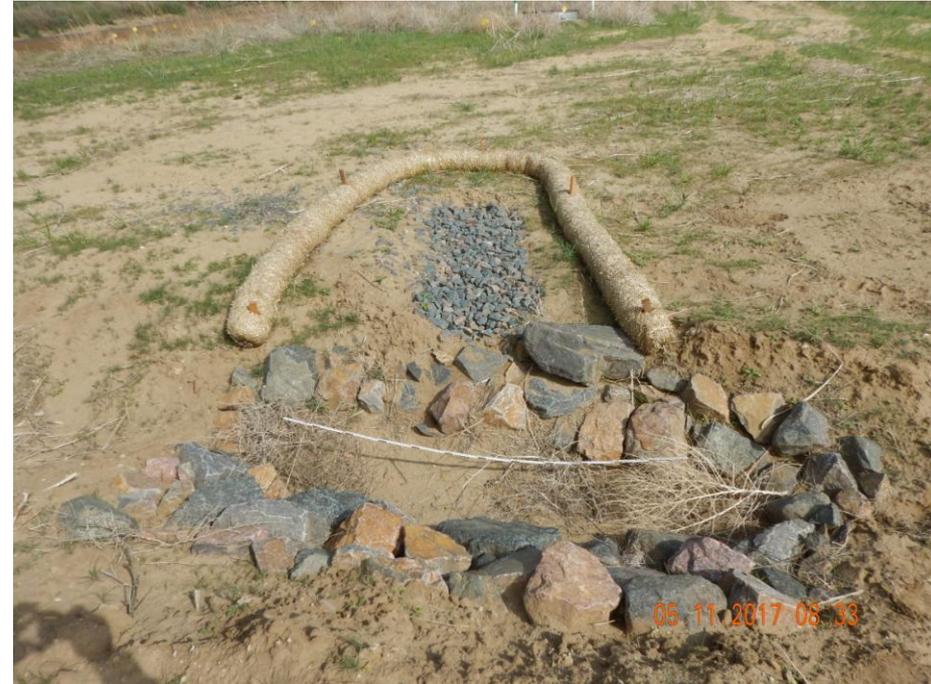
**Photo 23:** Photo taken from the sediment trap on the northwest end of the location. Per on-site conversations between BBC and COGCC staff 4/6/2017, sediment trap on location was determined to not have been constructed with good engineering practices. FIRR #401258682 states "Sediment traps were enlarged, smaller diameter aggregate placed at inlet and outlet. Outlet equipped with some type of filter media (straw wattle or hay bale)". Wattles have been installed; wattles are barriers that pond run off and do not filter stormwater. Wattles will not allow for adequate stormwater discharge from a sediment trap and should not be incorporated at the outlet of the sediment traps. Inlet armoring does not appear to be sufficient. 6 foot measuring stick for reference.

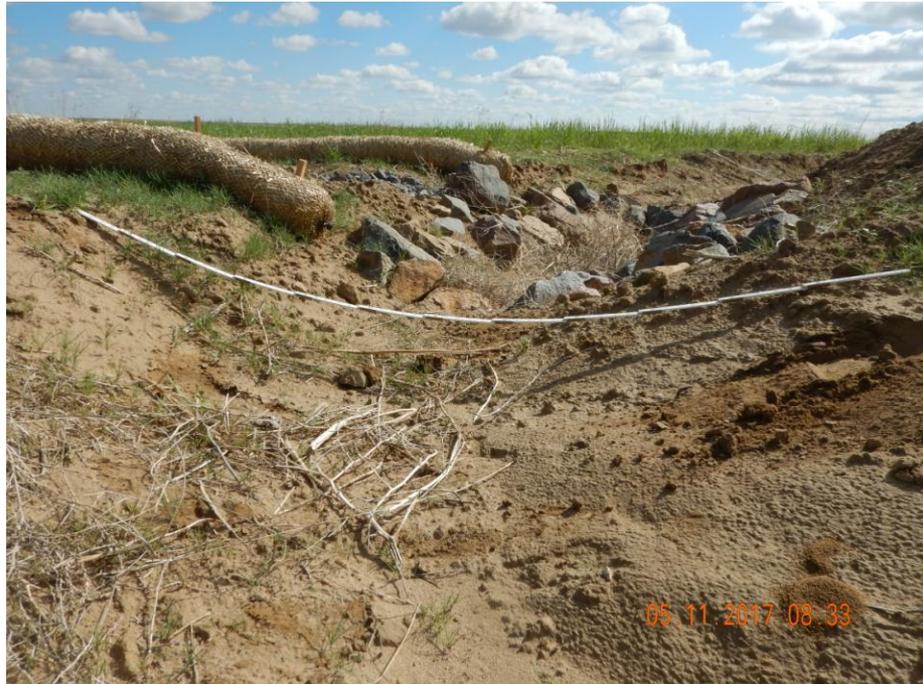
**Photo 24:** Photo taken from the sediment trap on the northwest end of the location. Per on-site conversations between BBC and COGCC staff 4/6/2017, sediment trap on location was determined to not have been constructed with good engineering practices. FIRR #401258682 states "Sediment traps were enlarged, smaller diameter aggregate placed at inlet and outlet. Outlet equipped with some type of filter media (straw wattle or hay bale)". Wattles have been installed; wattles are barriers that pond run off and do not filter stormwater. Wattles will not allow for adequate stormwater discharge from a sediment trap and should not be incorporated at the outlet of the sediment traps. Inlet armoring does not appear to be sufficient. 6 foot measuring stick for reference.

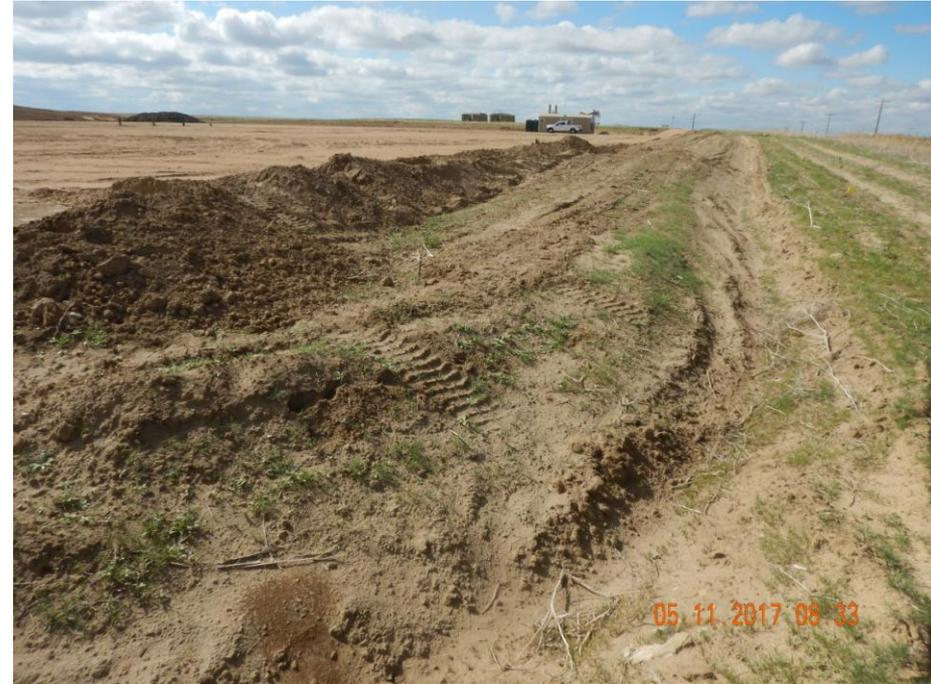
**Photo 25:** Photo taken from the northwest end of the location, facing south. Photo shows berms on the location have do not appear to be consolidated.
