Inspection Photos
Location Name: State 6-81-24-4
API: 05-057-06510

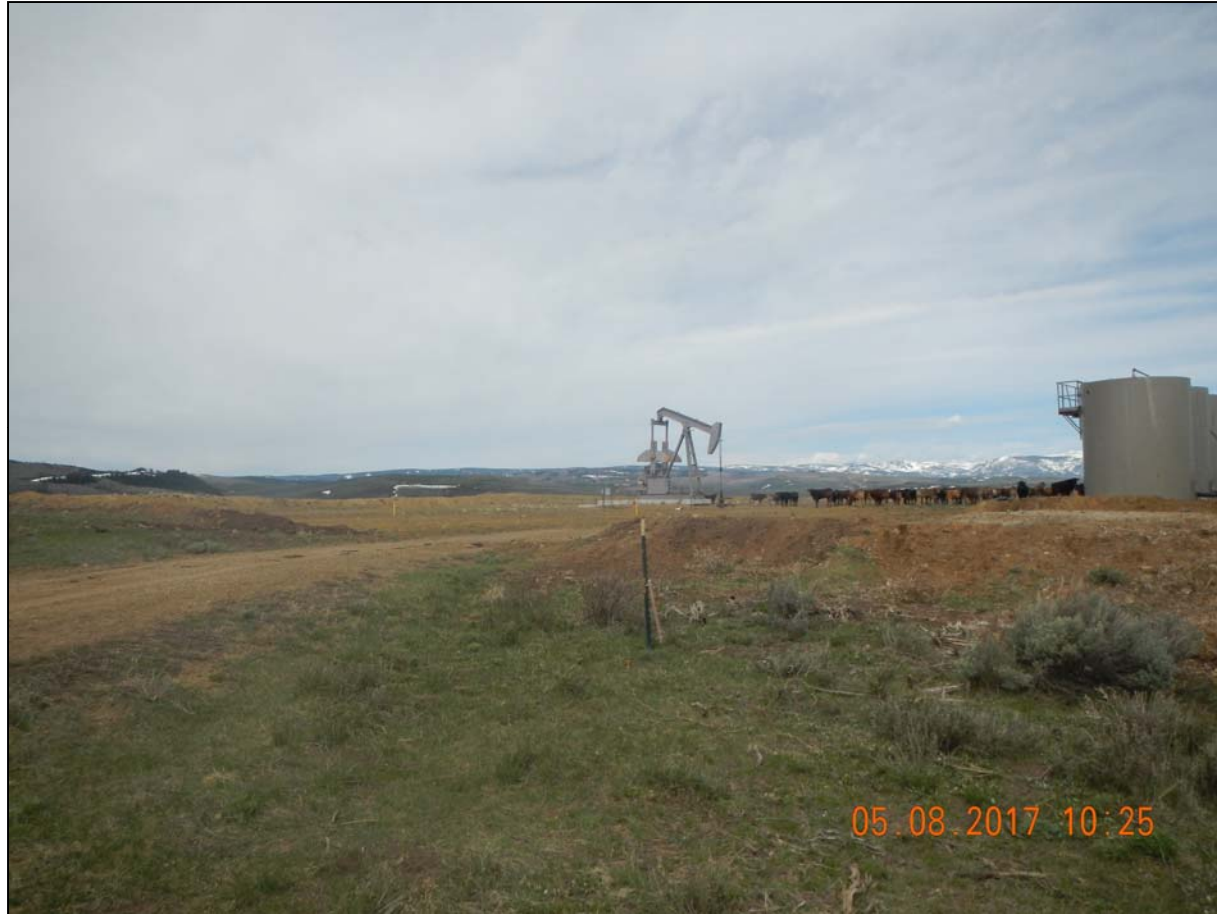
Photo 1. View at entrance to location facing west. No interim reclamation apparent. Batter sign on right in foreground is has been knocked off and turned around.

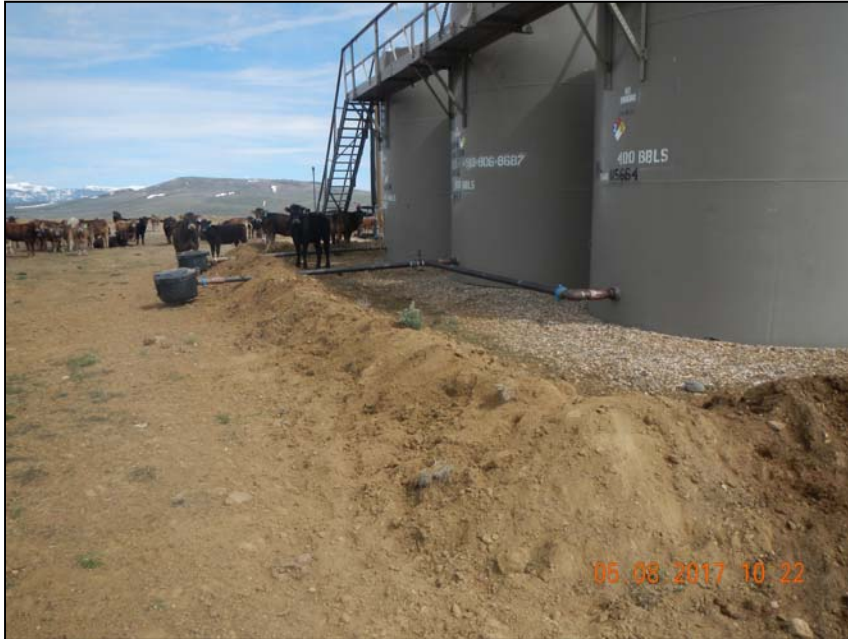
Photo 2. Unconsolidated, pervious berm.

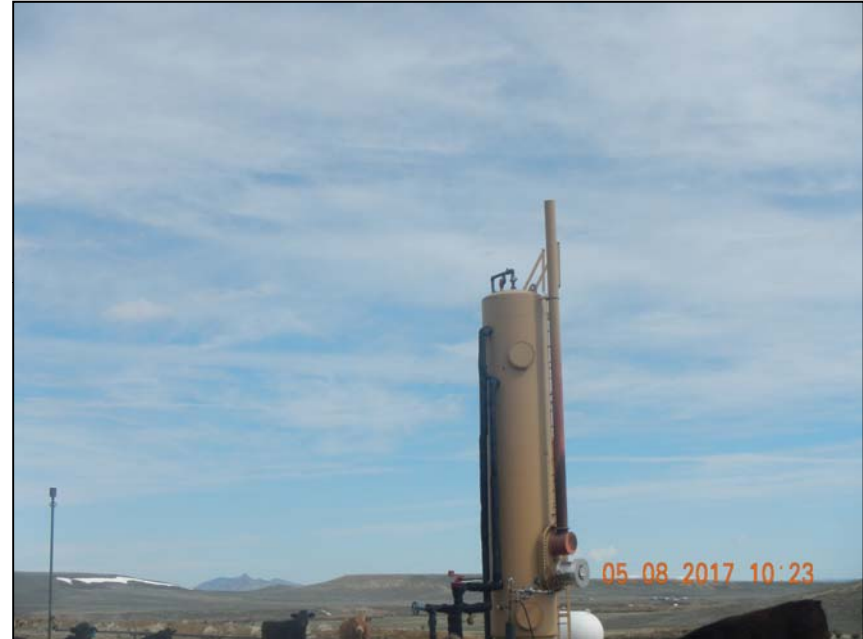
Photo 3. No wildlife protection apparent on exhaust.

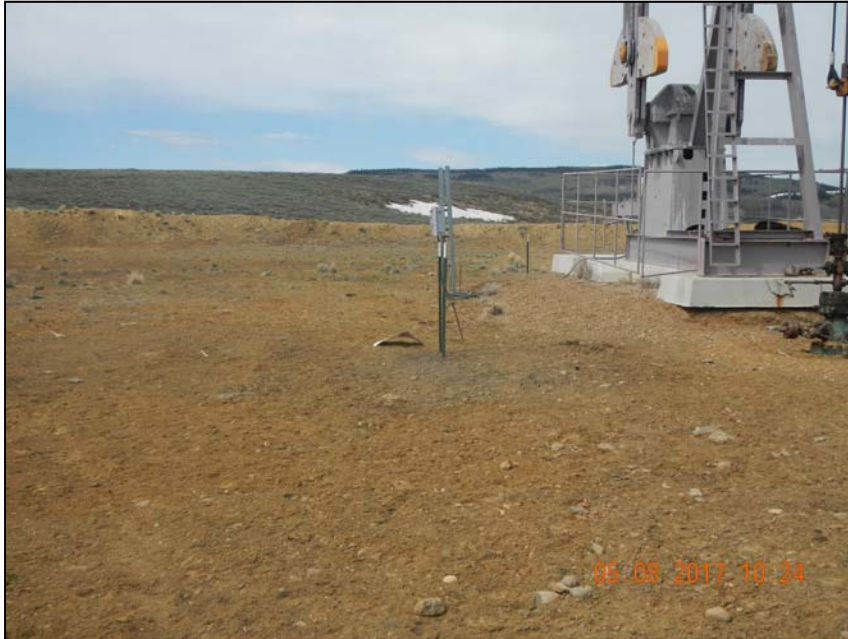
Photo 4. Wellhead sign knocked down.

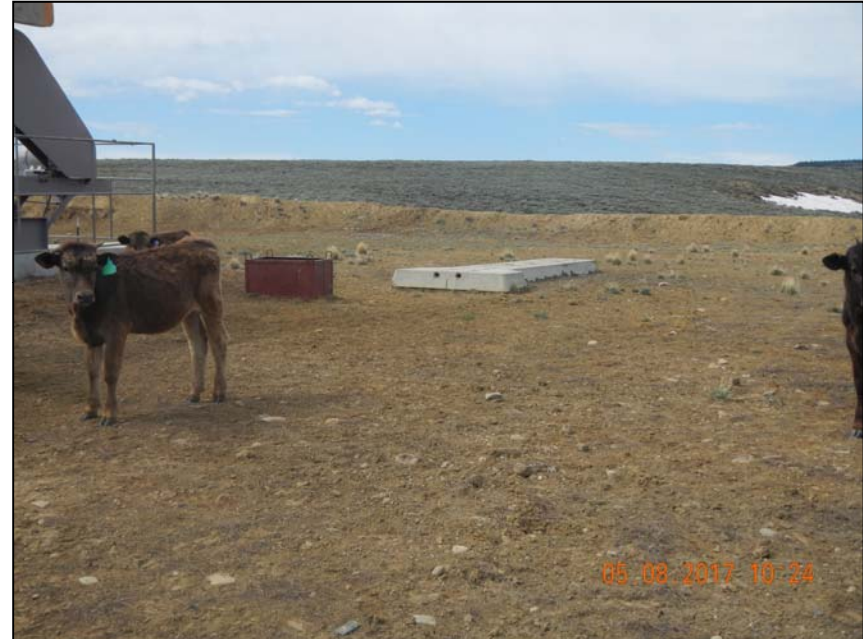
Photo 5. Storage of concrete base and metal container.
