Inspection Photos
Location Name: Fuqua 19-02-10-1H
API: 05-057-06483

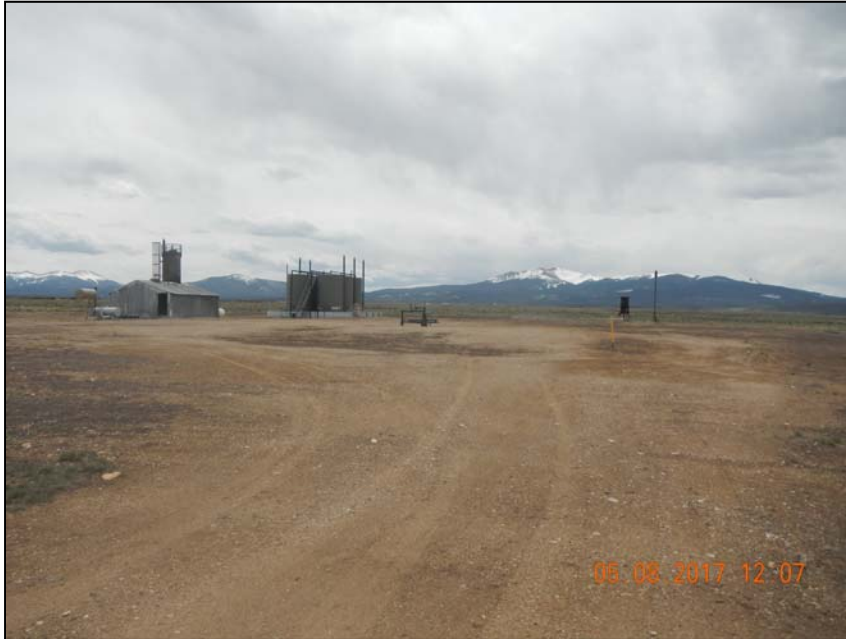
Photo 1. View of location at entrance facing south. No interim reclamation apparent.

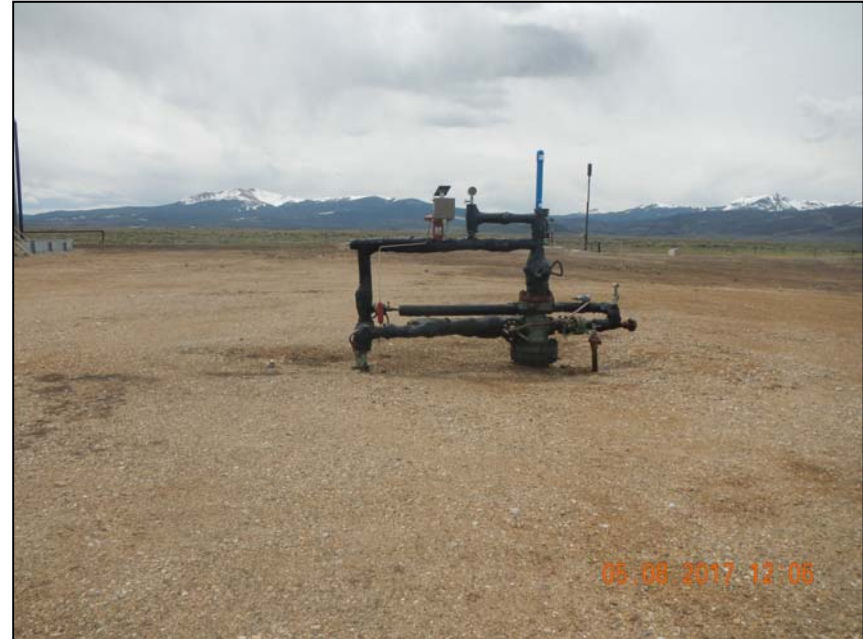
Photo 2. No wellhead sign.

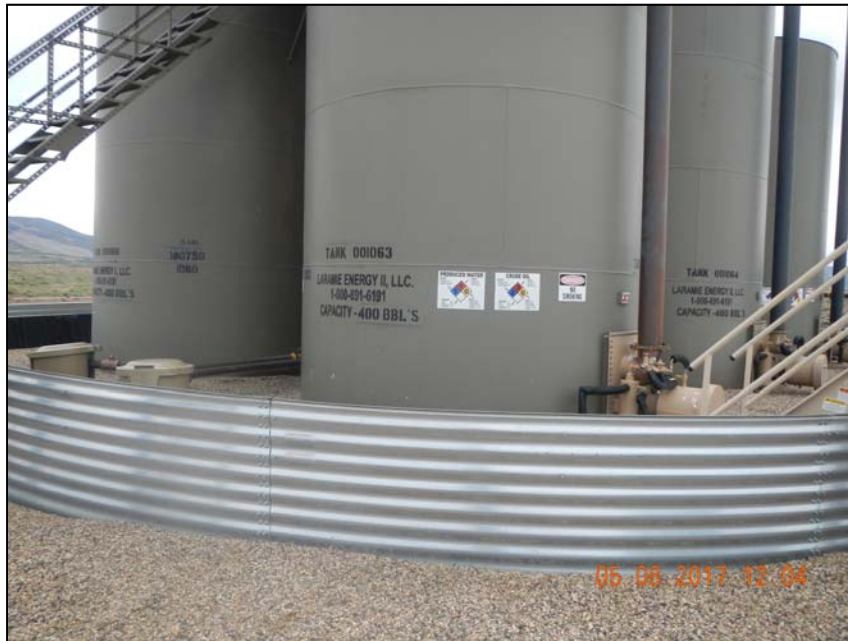
Photo 3. Tanks labeled with multiple contents.

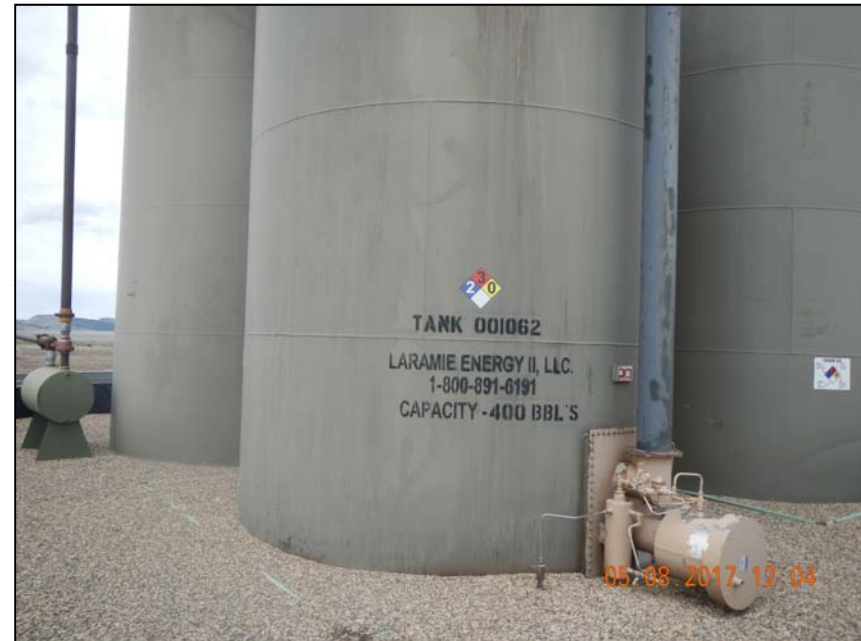
Photo 4. Previous operator on tanks.

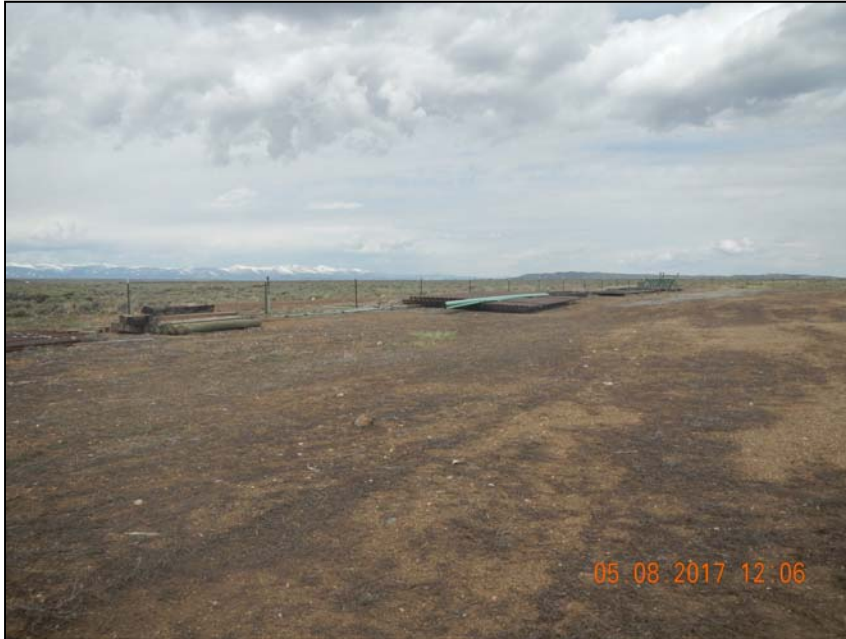
Photo 5. Equipment stored on location. No interim reclamation apparent.

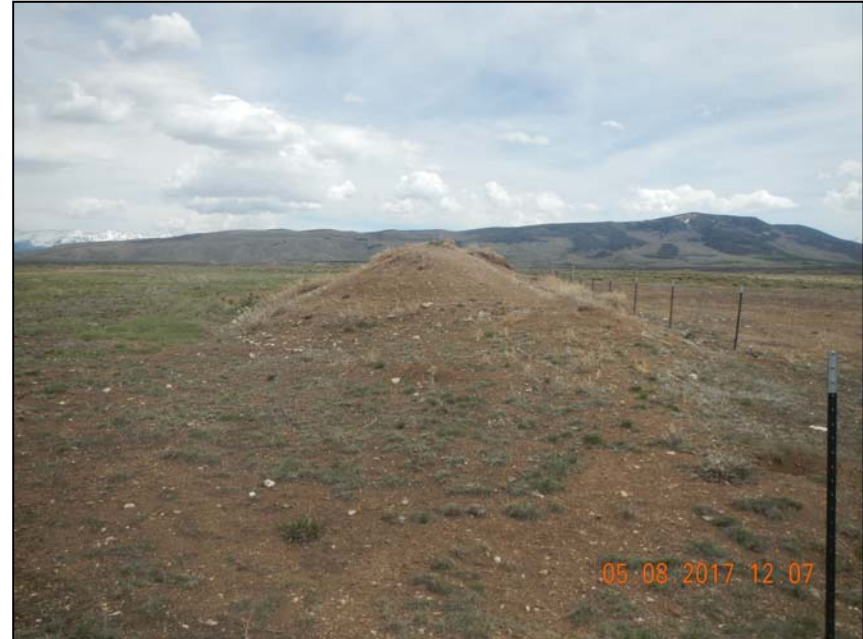
Photo 6. Dried annual weeds in topsoil pile.
