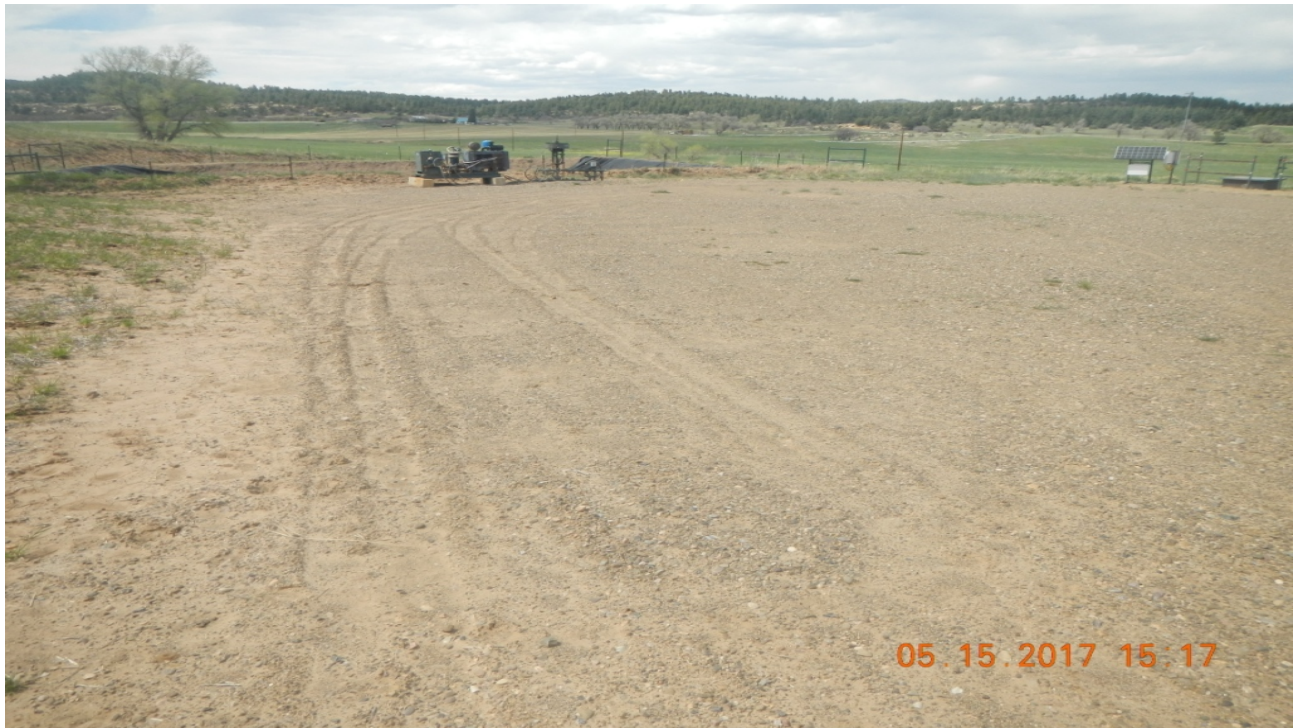
**photo 1:** Facing north toward the location.

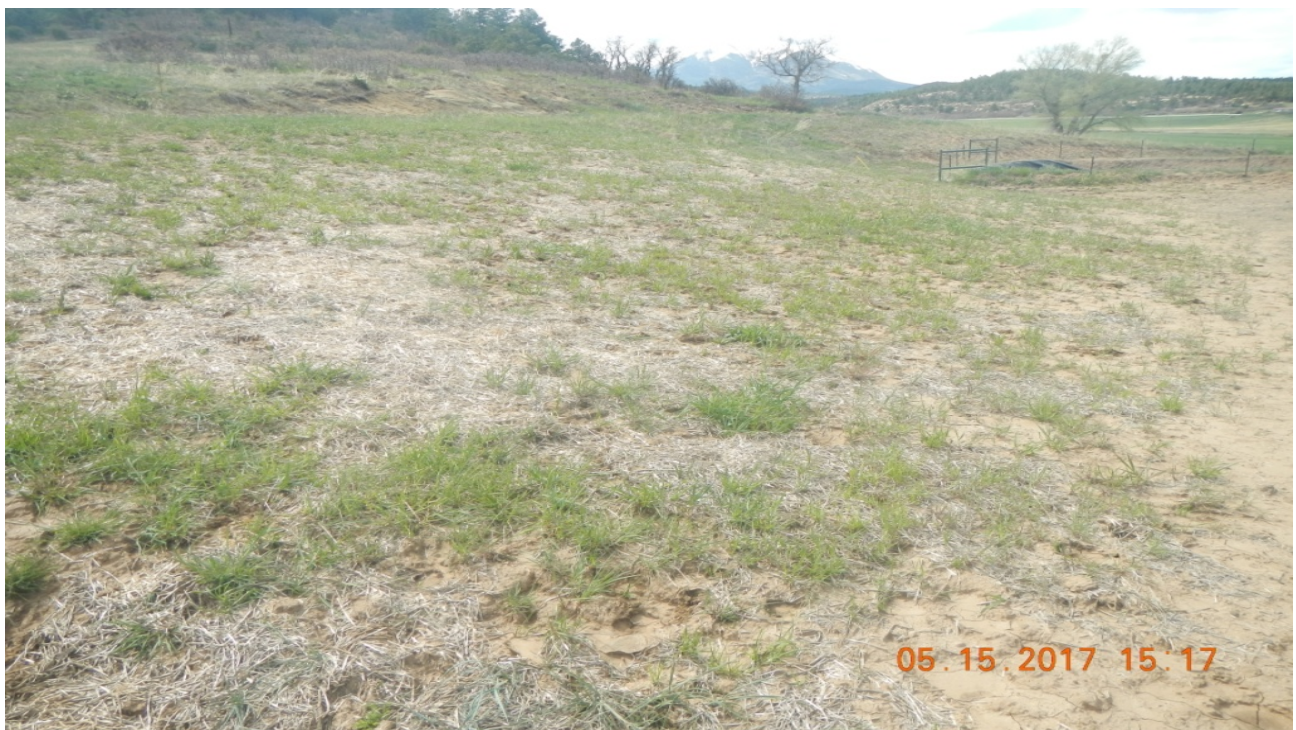
**photo 2:** Facing along west cut slope.

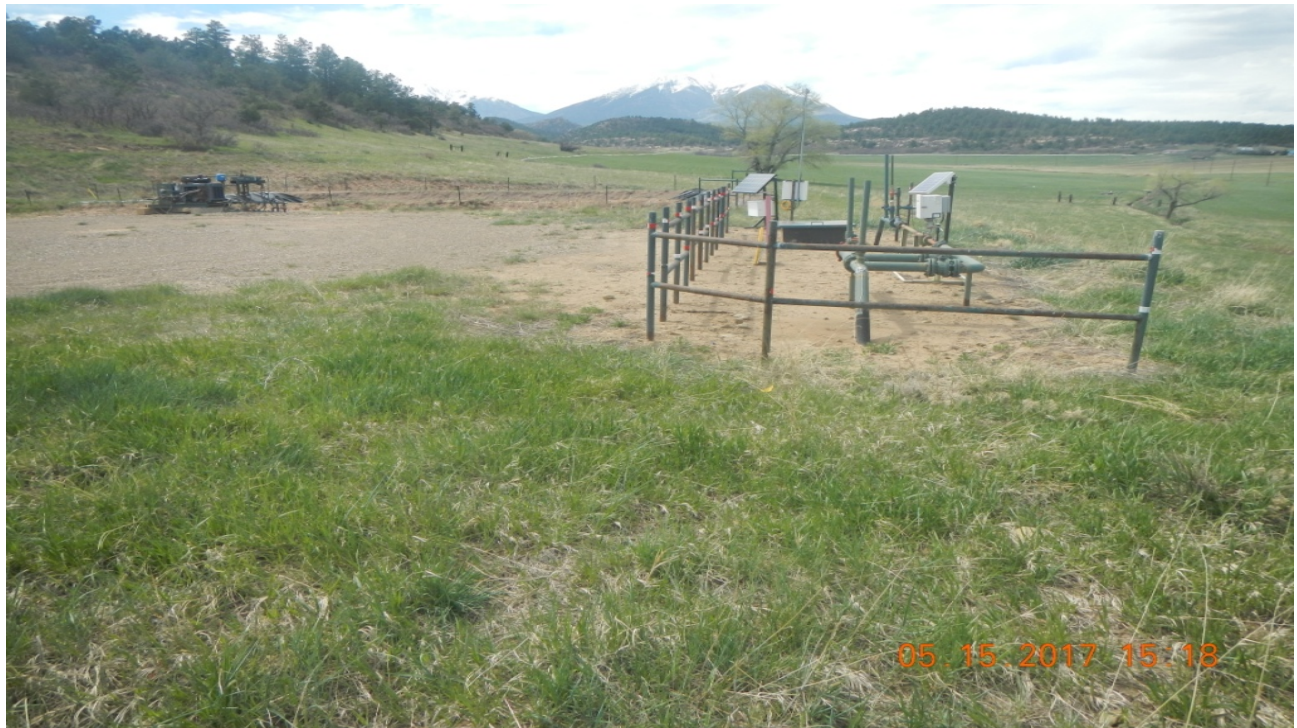
**photo 3:** Facing north at south side of the location.

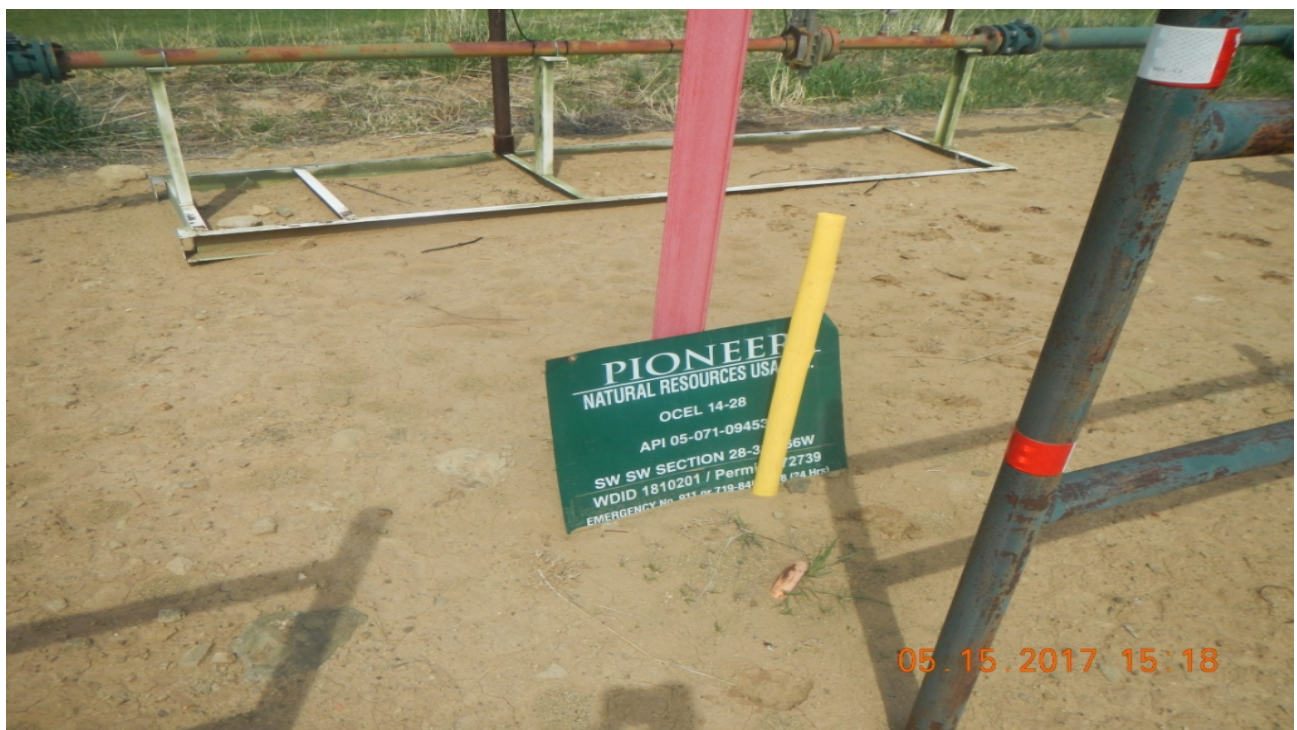
**photo 4:** Well sign is not appropriately attached.
