Staff's Objection with Exhibits

BEFORE THE OIL AND GAS CONSERVATION COMMISSION
OF THE STATE OF COLORADO

IN THE MATTER OF THE APPLICATION OF RED)	CAUSE NO. 1
MESA HOLDINGS/O&G LLC. FOR AN INACTIVE)	
WELL FINANCIAL ASSURANCE VARIANCE, LA)	DOCKET NO. 150300176
PLATA COUNTY, COLORADO)	
)	TYPE: GENERAL
		ADMINISTRATIVE

STAFF OBJECTION

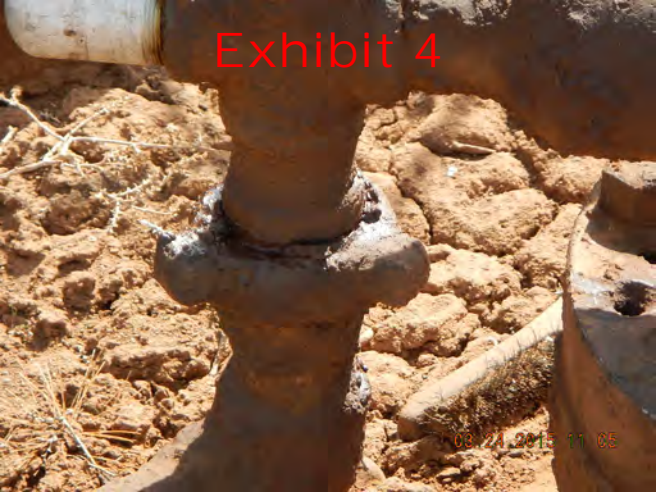
Yes/No	Comment
YES	Well is leaking gas at wellhead (hammer union area). Audible natural gas leak can be readily identified. Repair leaking equipment by 3/30/15.

S/A/V: **ACTION REQUIRED**Corrective Date: **04/23/2015**Comment: **Storm water run off erosion on location. BMPs along southern edge of location have failed.**CA: **Properly install and maintain storm water BMPs to control and prevent storm water erosion.**Pits: ☐ NO SURFACE INDICATION OF PIT**Attached Documents**You can go to COGCC Images (<https://cogcc.state.co.us/weblink/>) and search by document number:

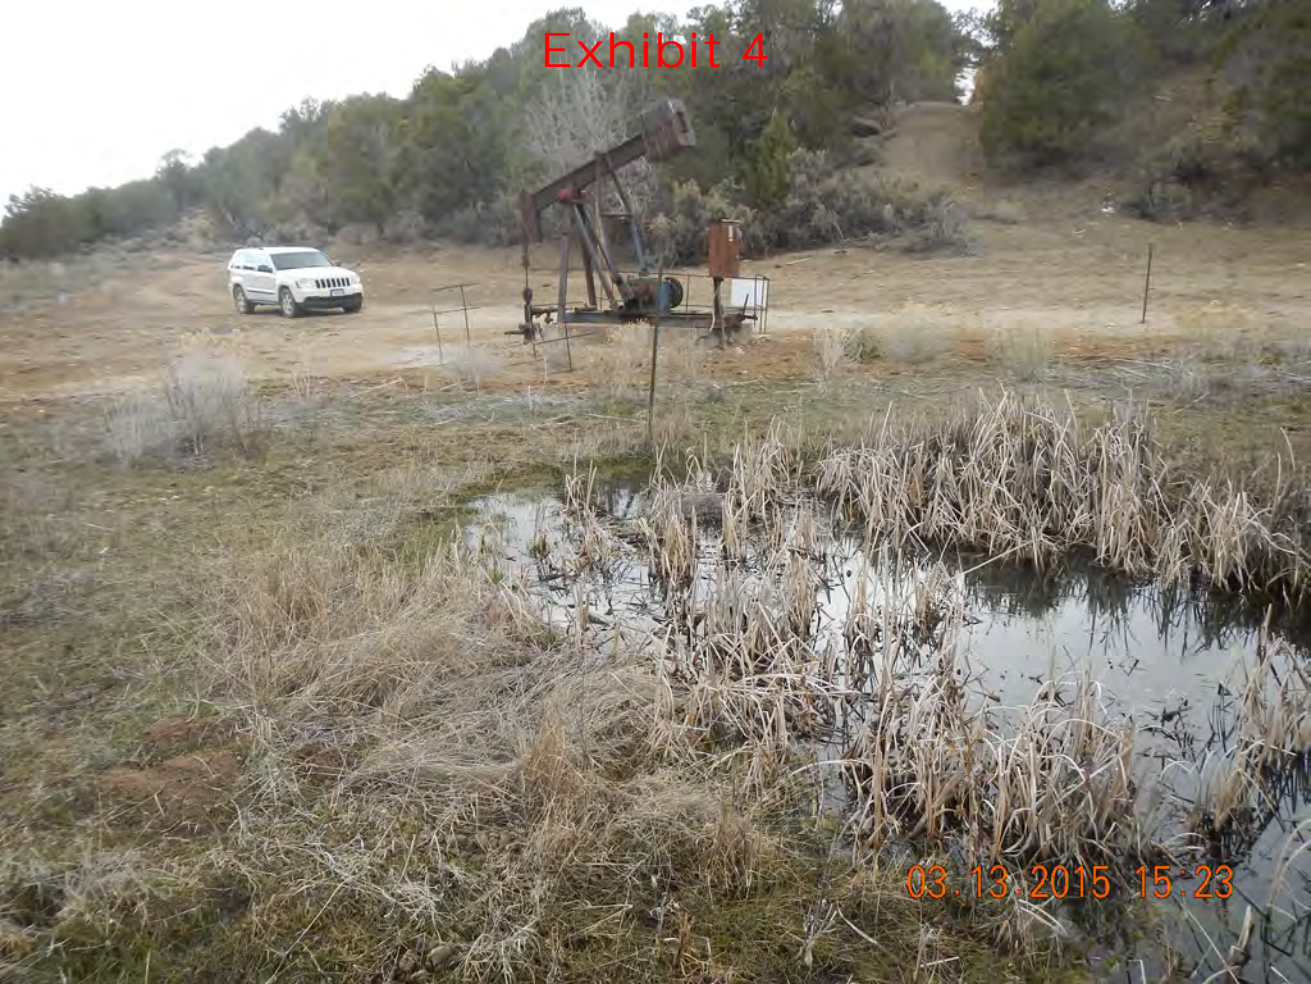
03.13.2015 15:23

Pump Jack	1	ACTION REQUIRED	Lube oil leak onto concrete pad. Electric motor has been removed.	Remove/repair leaking equipment from location. Proximity to wetlands/creek warrant quick response.	03/23/2015
-----------	---	------------------------	--	---	------------

Comment: Well head and surrounding area stained with oil and white residue.

Corrective Action: Remove/remediate stained soils around well head. Date: 03/23/2015
