Inspection Photos - 2017 Flowline NTO
Inspection 1000' Buffer
Location Name: Jones 1-11
API: 05-107-06093

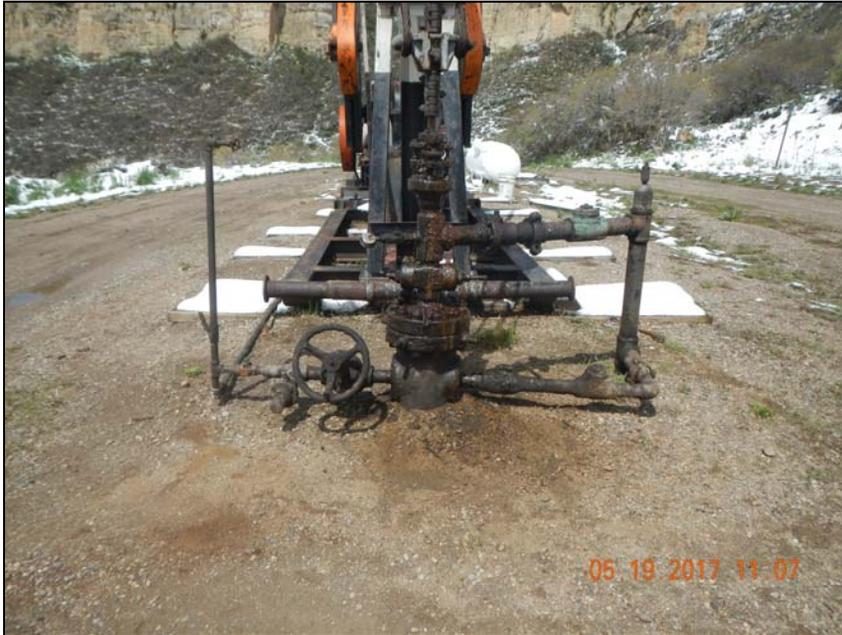
Photo 1. Wellhead with 2 steel risers. 1" on left 2" on right.

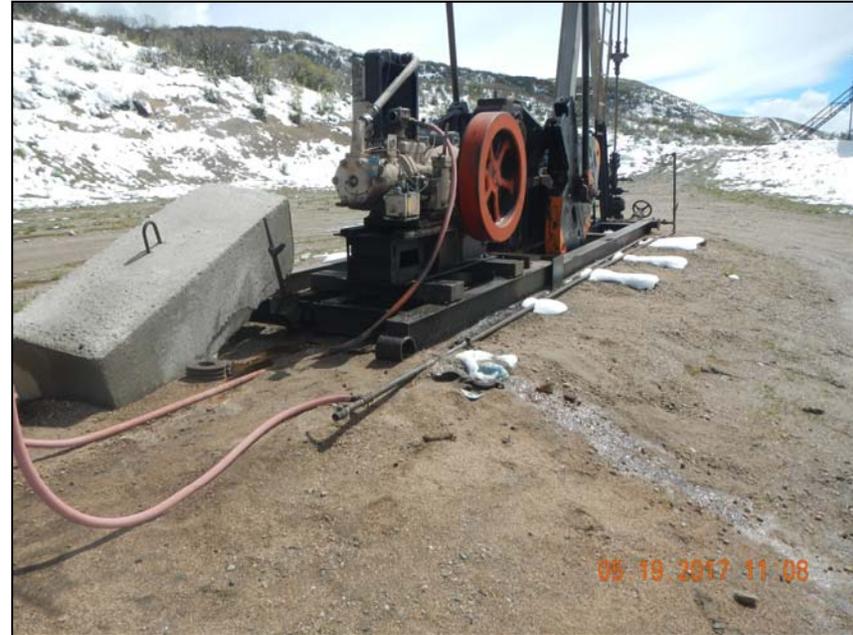
Photo 2. 1" steel flowline from wellhead to separator.

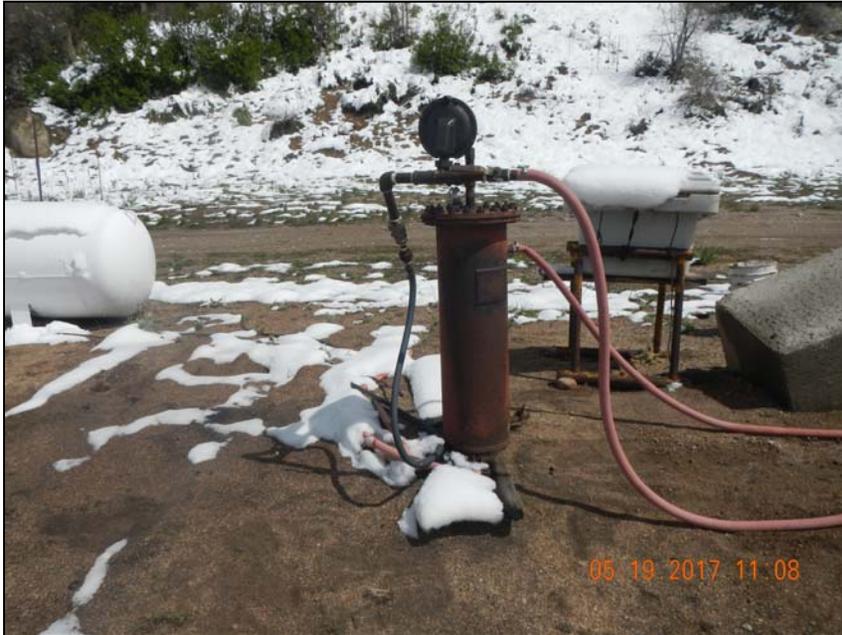
Photo 3. Separator for casing gas with 2 - 1" poly lines. One going to propane tank one going to pump jack motor.

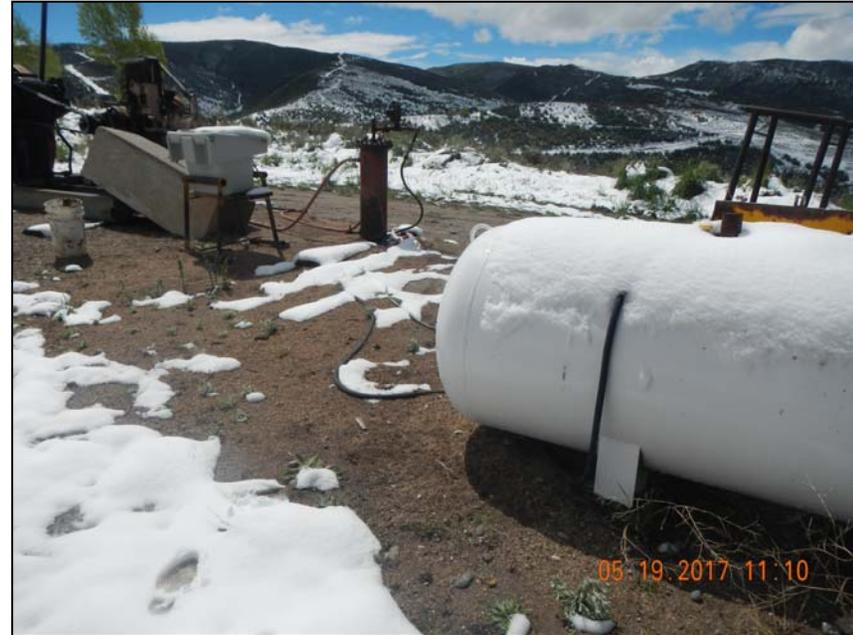
Photo 4. 2 - 1" poly lines extending from separator to propane tank and pump jack motor.

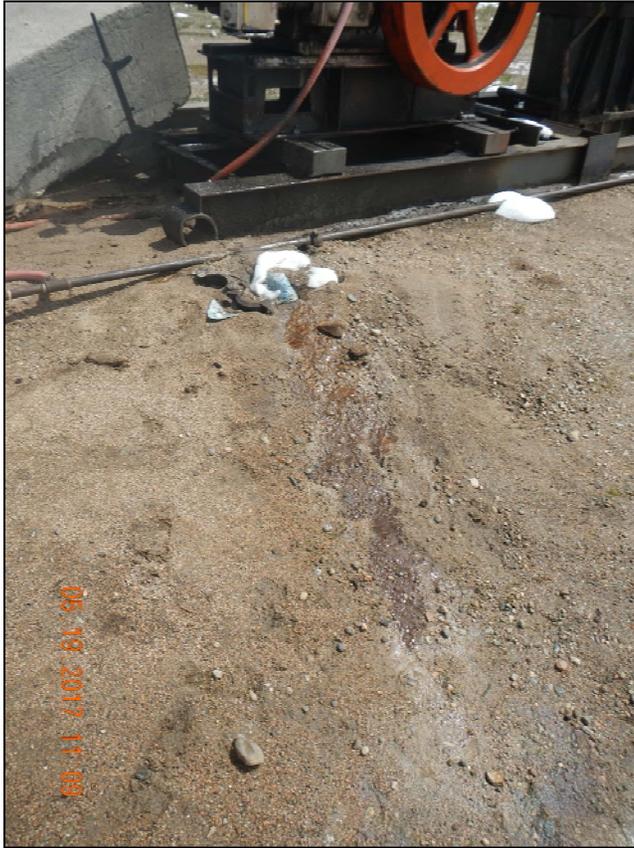
Photo 5. Lube oil leaking from side of pump jack motor.

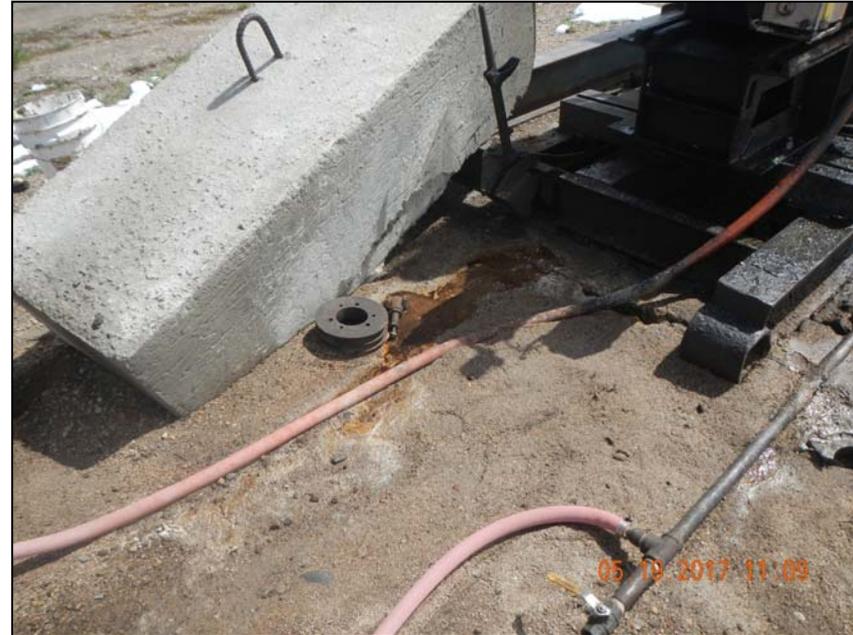
Photo 6. Oil leaking from rear of pump jack motor.

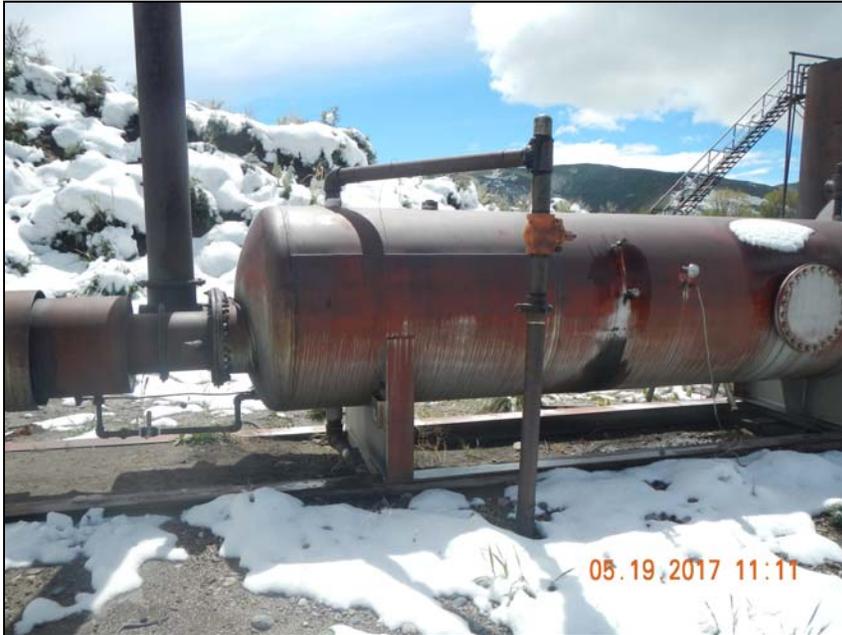
Photo 7. 2" steel riser at separator.

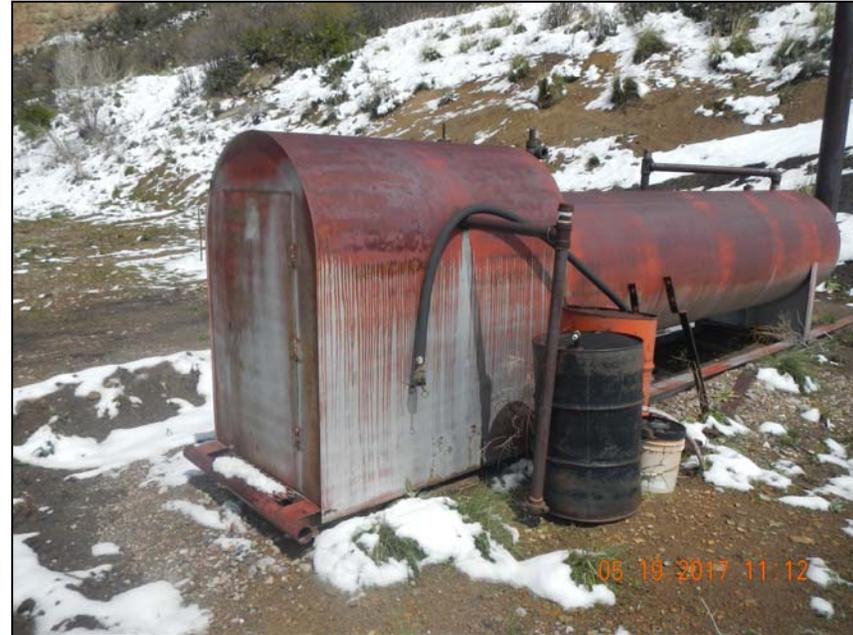
Photo 8. 3" steel riser at separator.

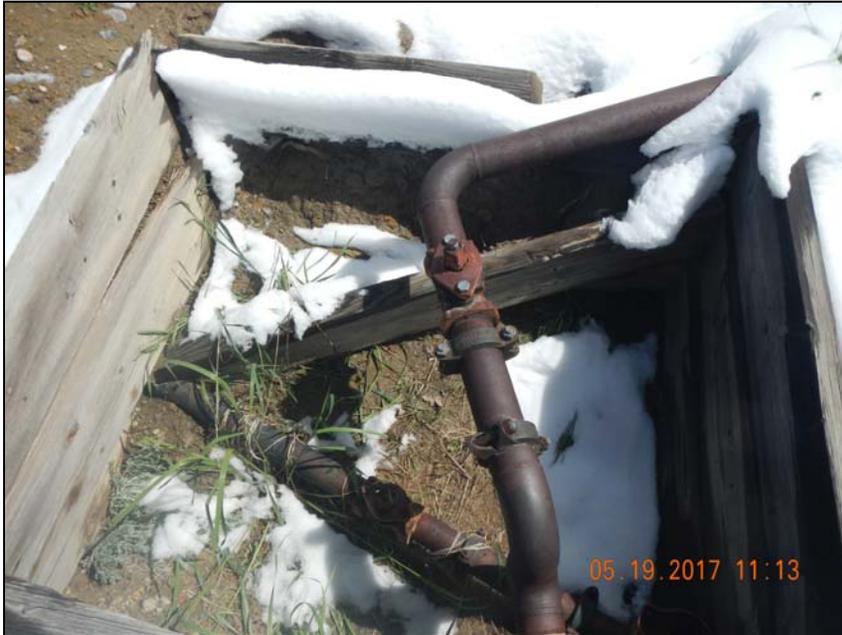
Photo 9. 3" and 4" steel risers at manifold between tank and separator.

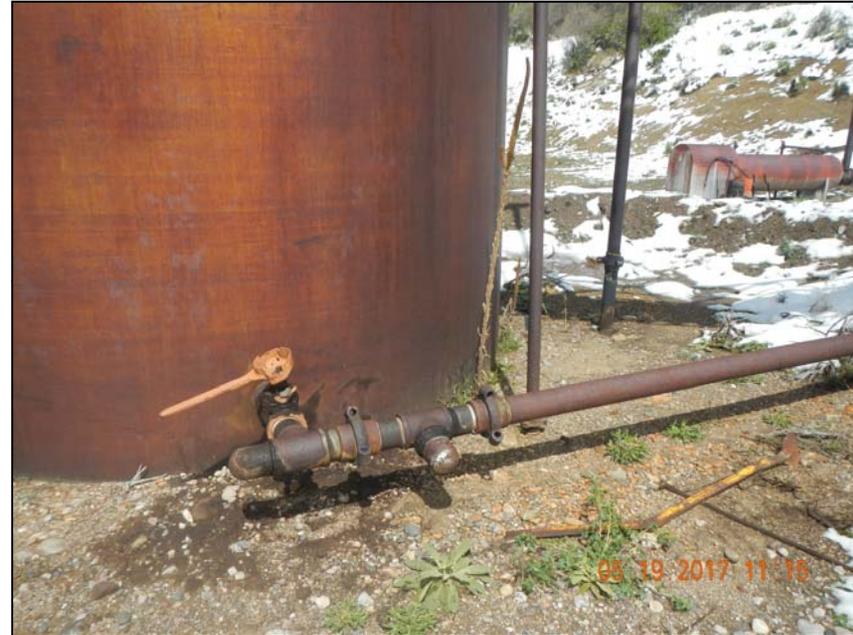
Photo 10. Stained soil at tank base. 2", 3" 4" steel flowlines.

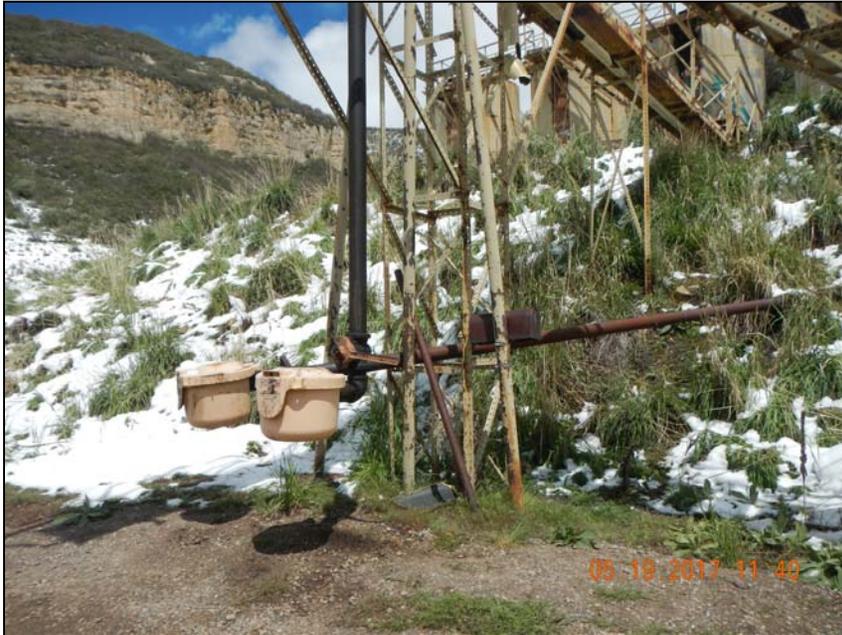
Photo 11. 2 – 4" steel flowlines at tank load out at base of hill.

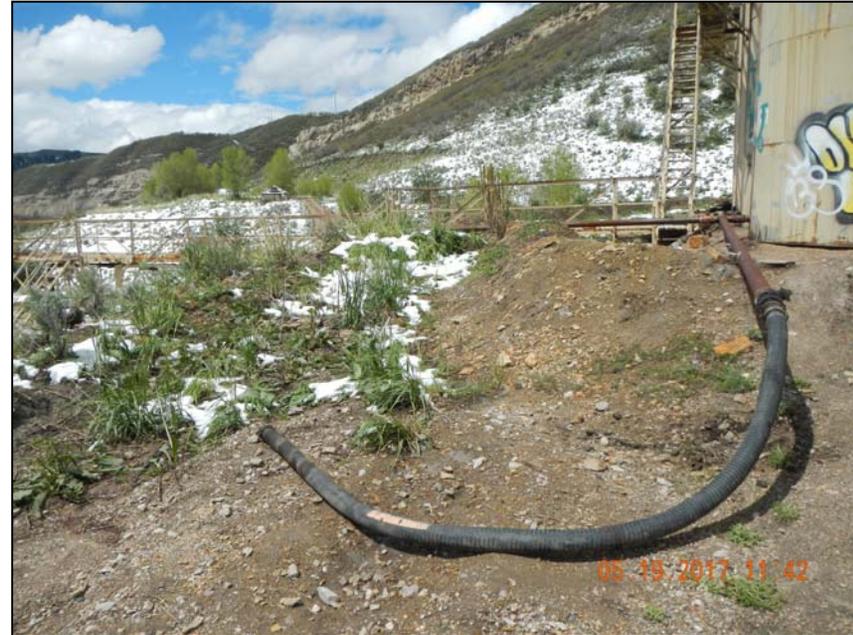
Photo 12. 1 – 4 " steel flowline at battery load out.

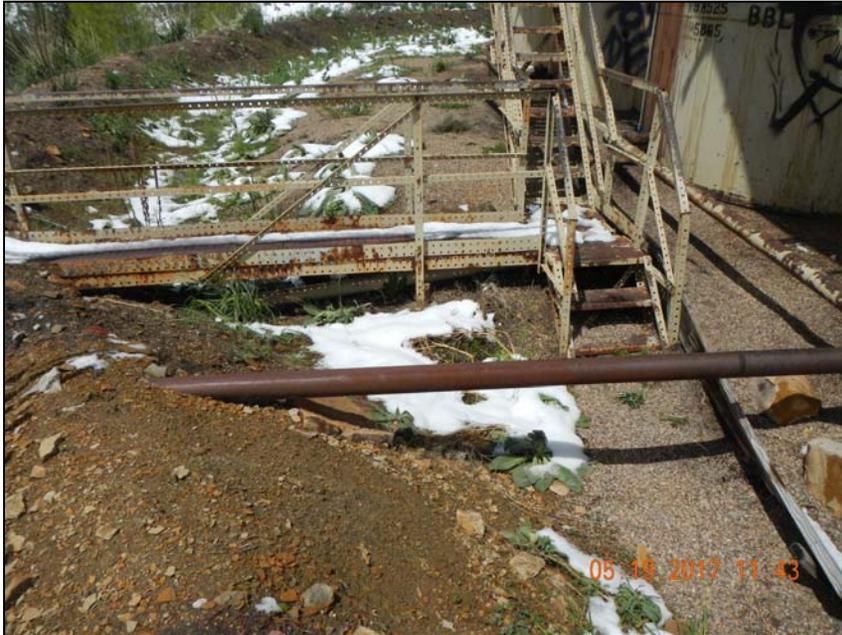
Photo 13. 2 – 4" steel flowlines at tanks.

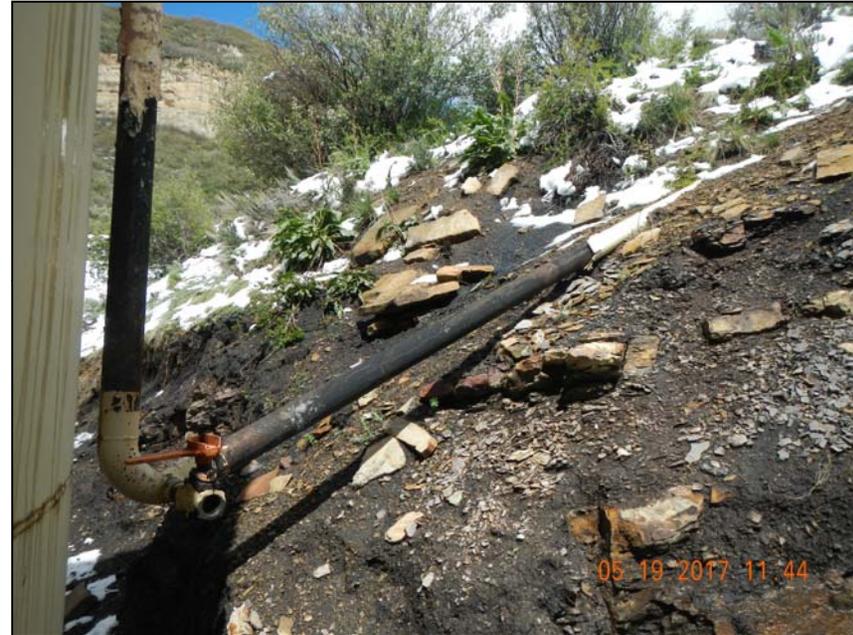
Photo 14. 4" steel flowline from uphill at wellhead.
