Inspection Photos – 2017 Flowline NTO
Inspection
Location Name: Robidoux 13-12-89 1
API: 05-081-06986

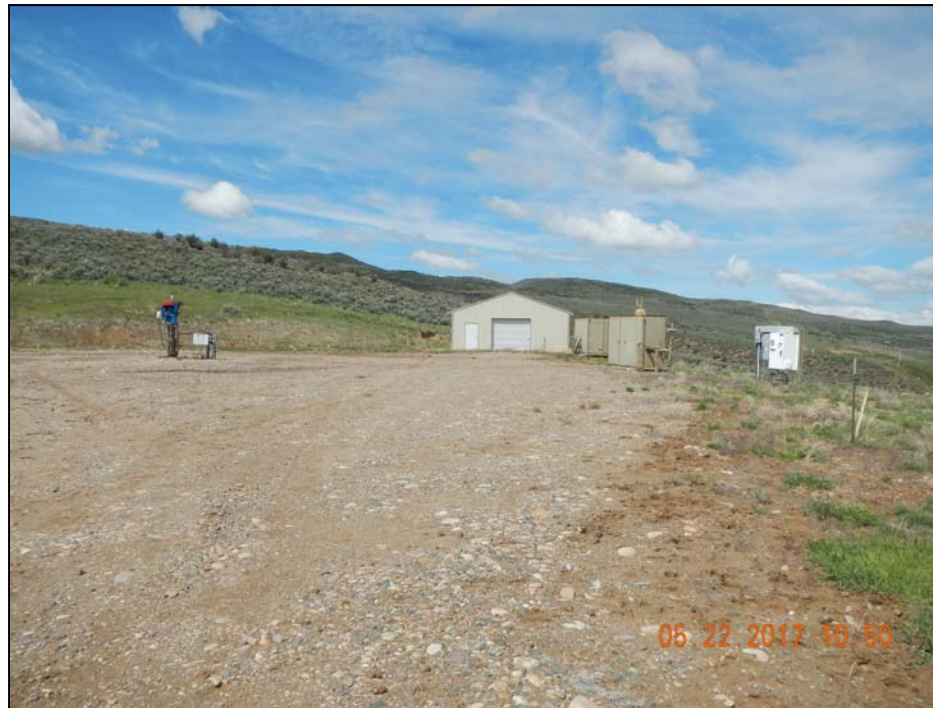
Photo 1. Overview of location taken at the entrance facing west.

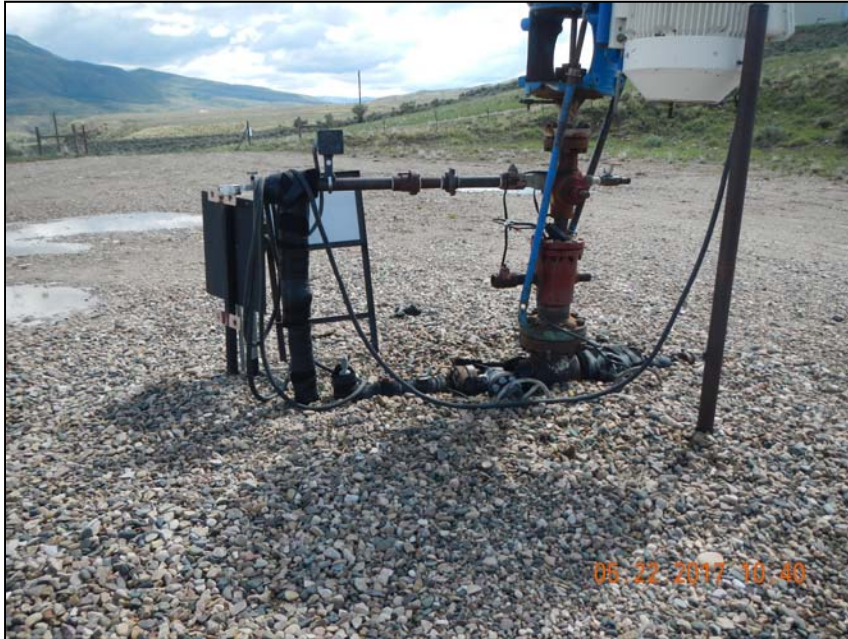
Photo 2. 2 -2" insulated risers at wellhead.

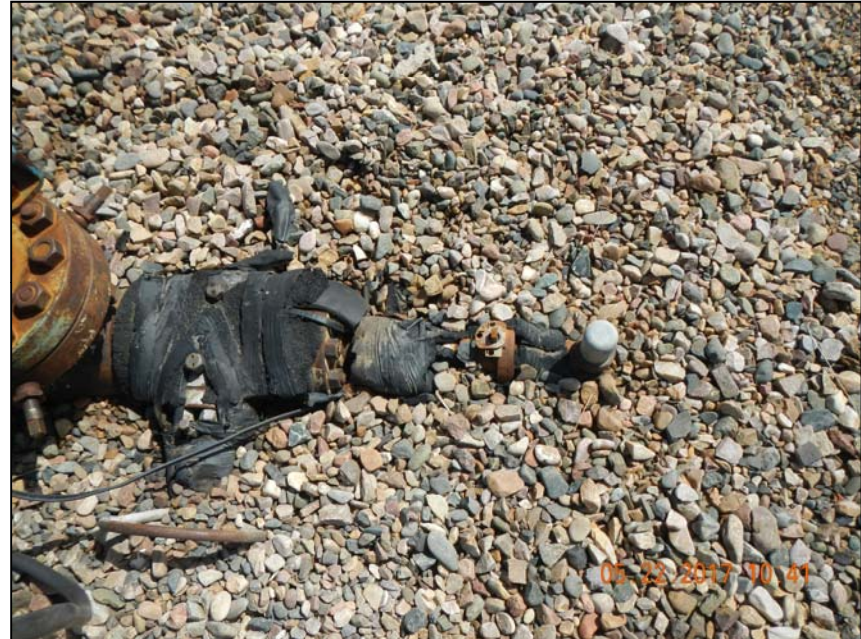
Photo 3. 1 -2" steel riser with no marking and no LOTO.

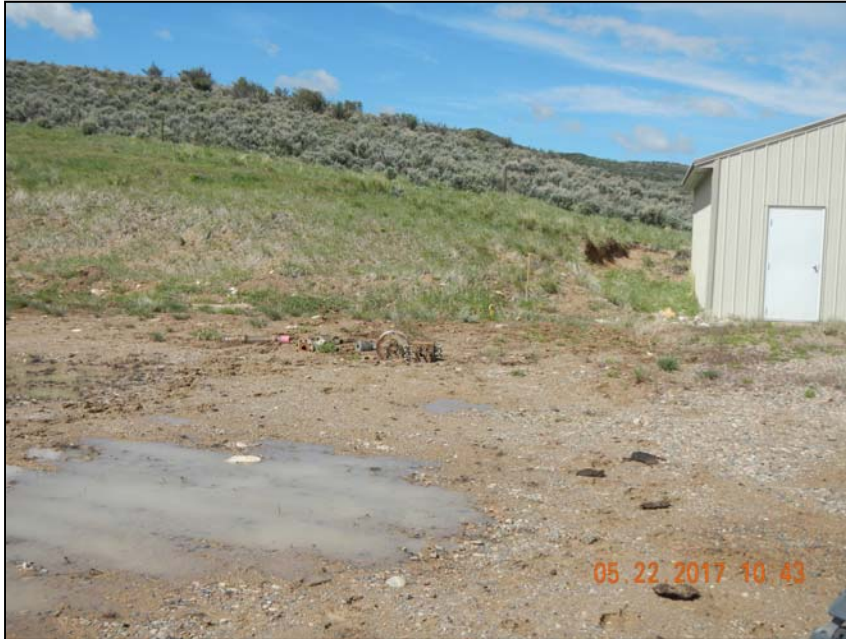
Photo 4. Misc equipment left on location.

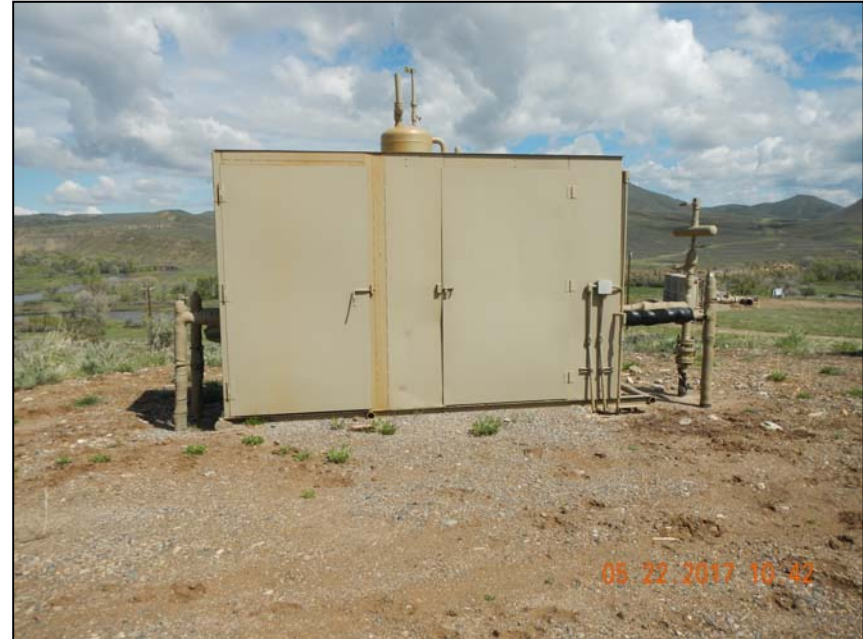
Photo 5. Dehydrator with 2 -2" risers on each side.
