Inspection Photos – 2017 Flowline NTO  
Inspection  
Location Name: SD Federal 24-9DL  
API: 05-081-07624

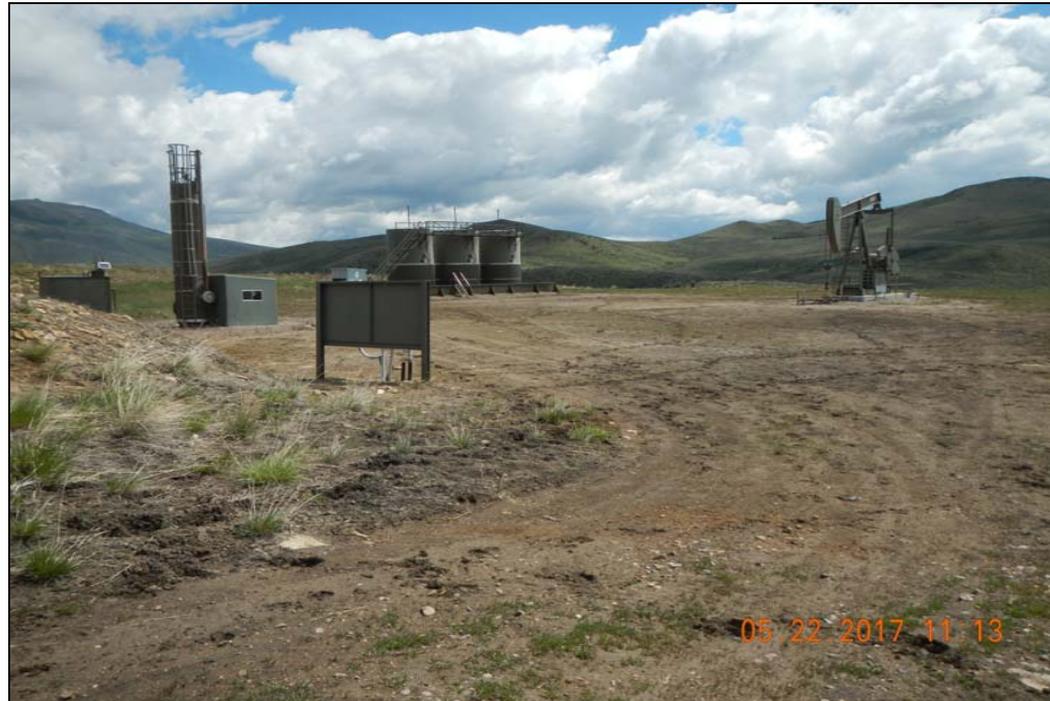
**Photo 1. Overview of location taken at the entrance facing west.**

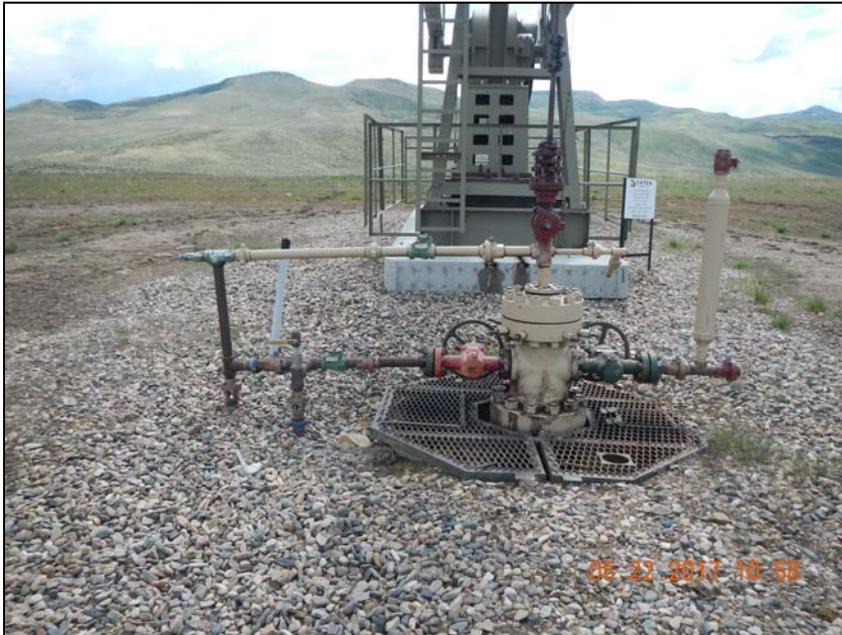
Photo 2. 2 -2" steel risers at wellhead.

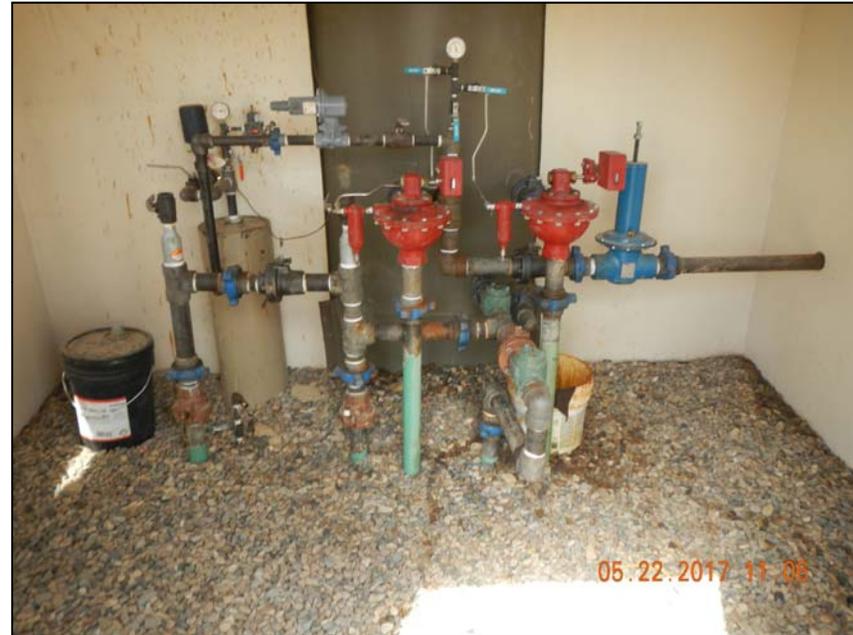
Photo 3. 5 - 2" steel risers inside separator shack

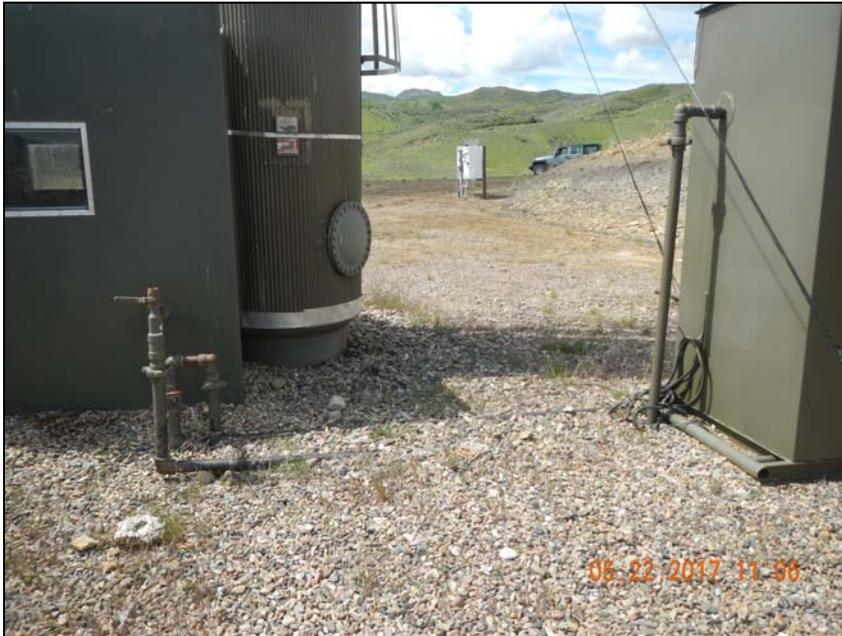
Photo 4. 2 -2" steel risers at separator and dehydrator.

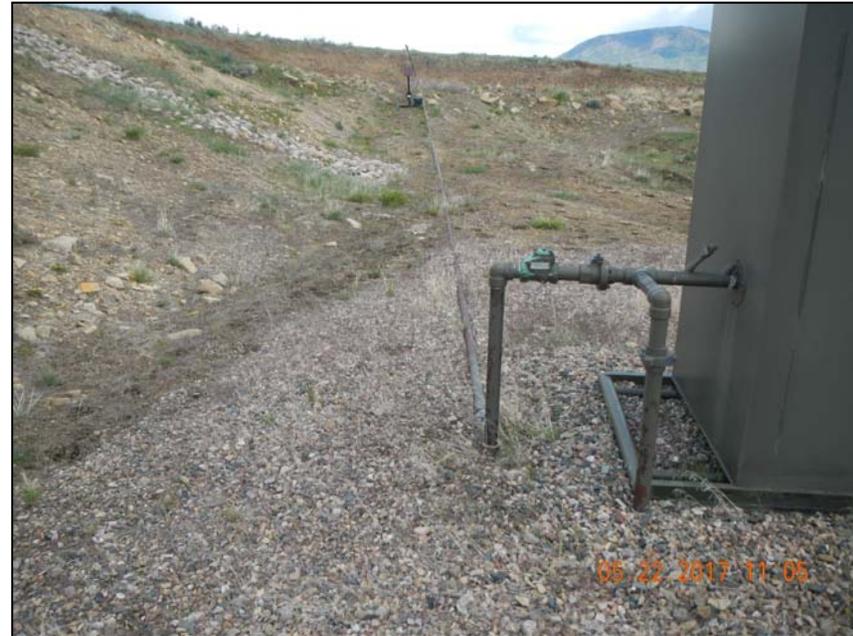
Photo 5. 1 -2" steel riser. 1 -2" steel flowline going to flare visible in background.

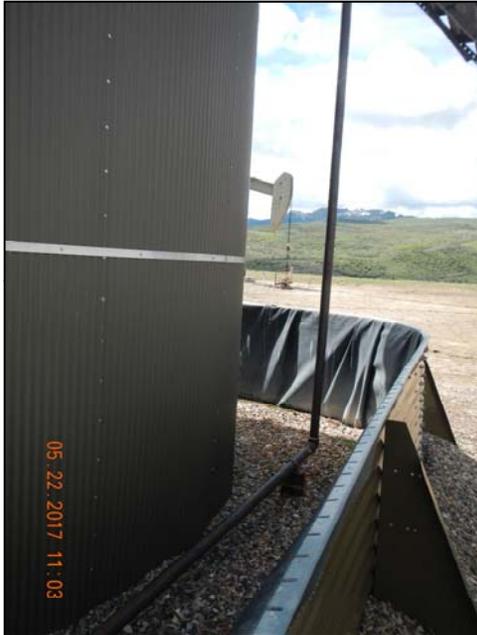
Photo 6. 1- 2" steel flowline from tank top.

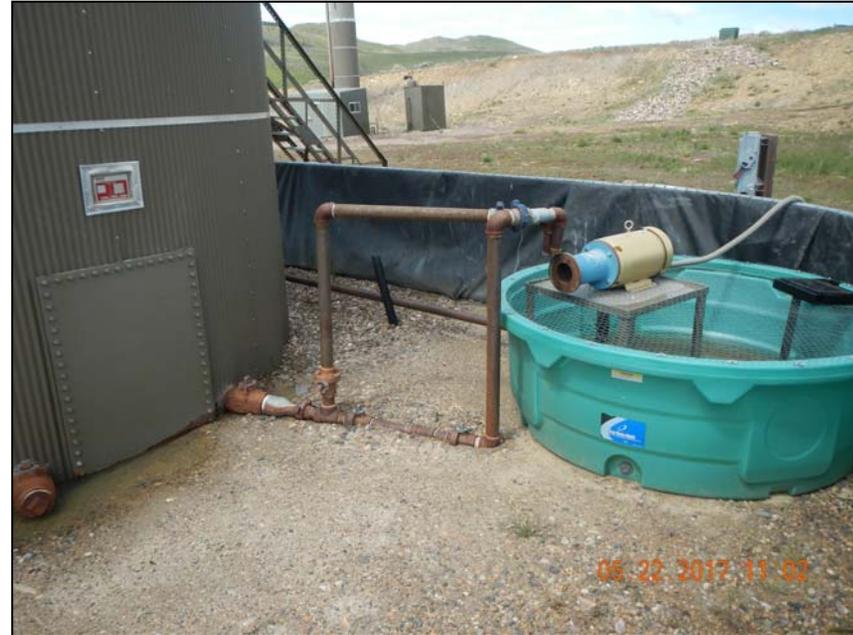
Photo 7. 2" line from left picture in background. 2 -2" steel risers from tank.
