Inspection Photos - 2017 Flowline NTO
Inspection
Location Name: Robidoux 24-3
API: 05-081-07292

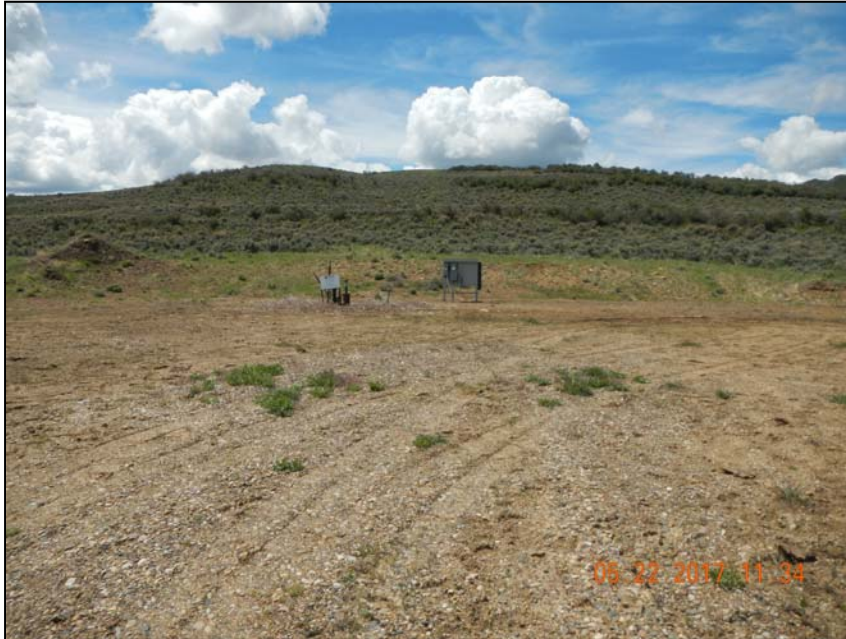
Photo 1. Overview of location at entrance facing southwest.

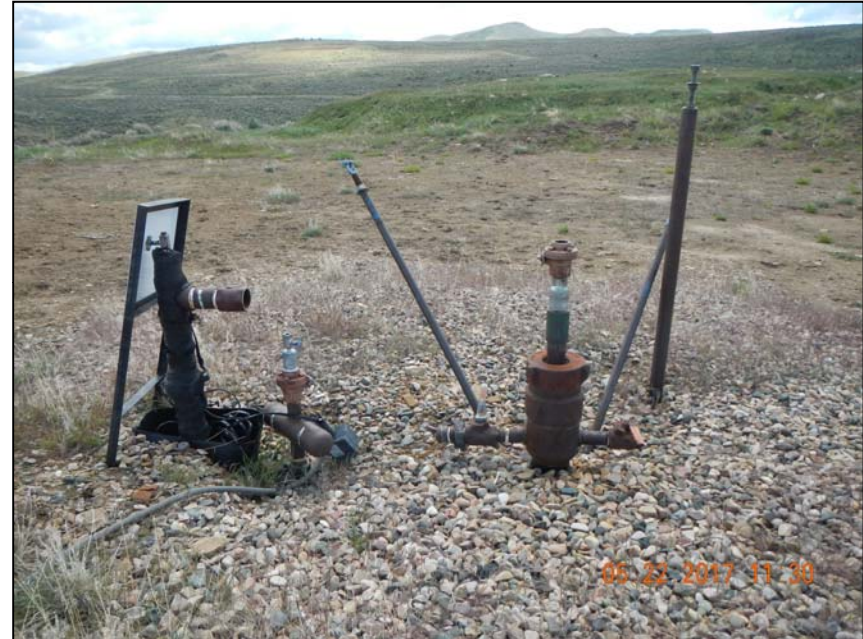
Photo 2. 2 -2" and 1 - 3" steel risers at wellhead
