Inspection Photos – 2017 Flowline NTO
Inspection
Location Name: Robidoux 23-13
API: 05-081-06973

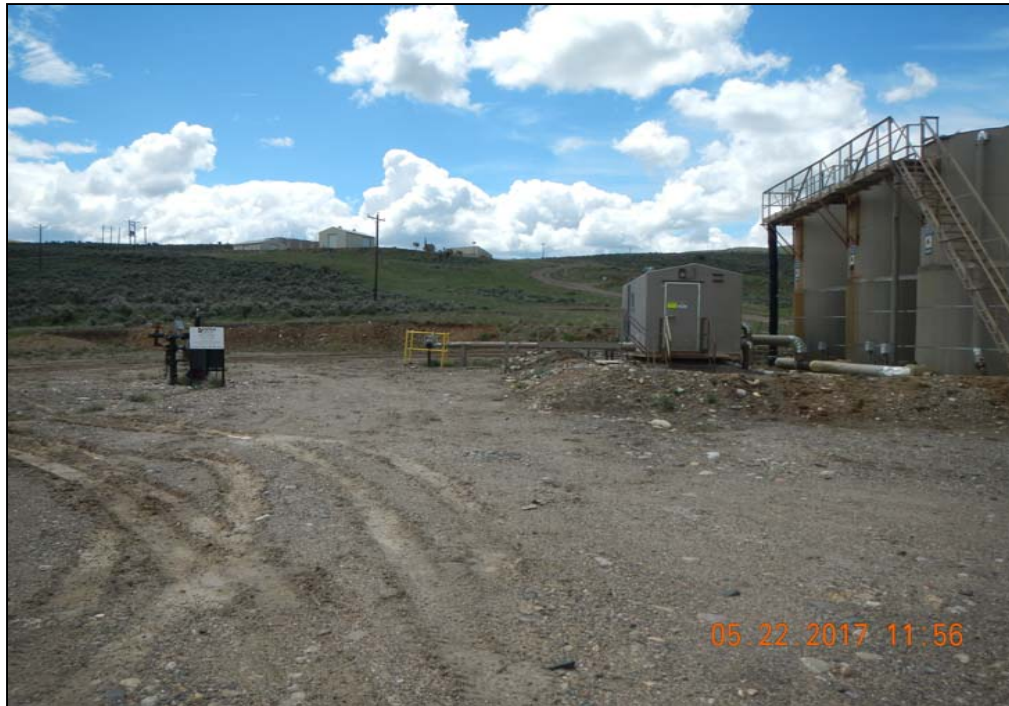
Photo 1. Overview of location taken at the entrance facing south.

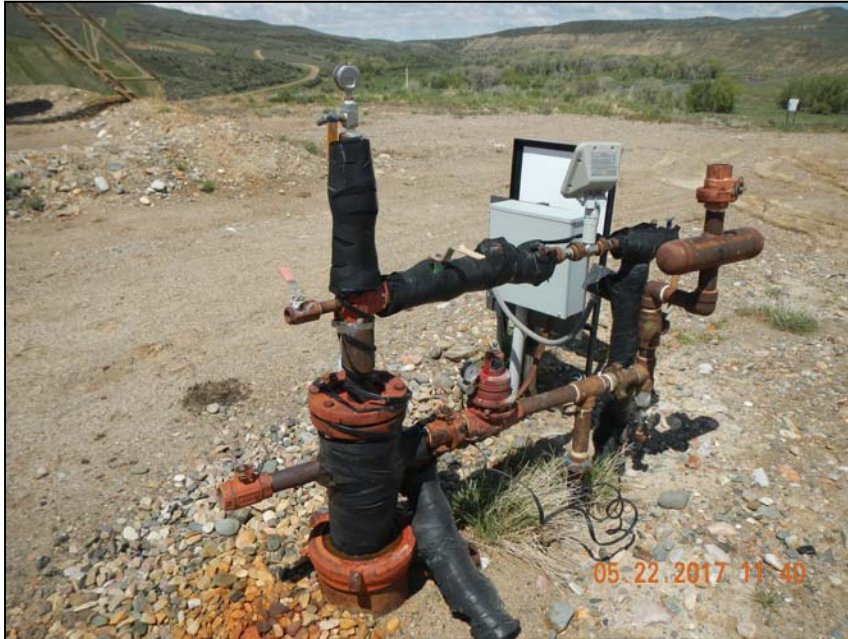
Photo 2. 1 -2" steel riser and 1 -2" insulated riser at wellhead.

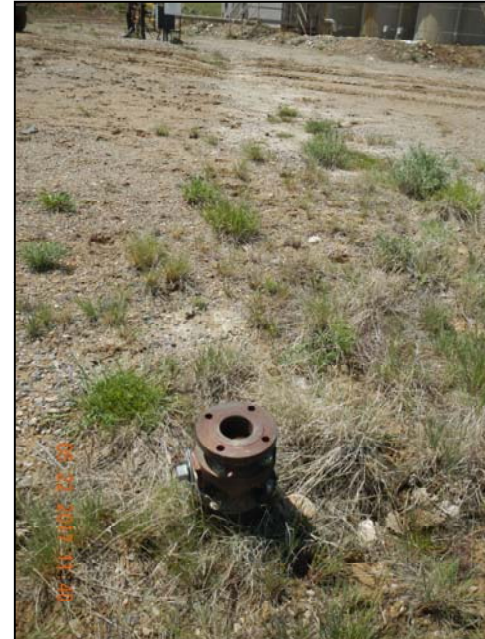
Photo 3. 1 -4" riser where separator used to be.

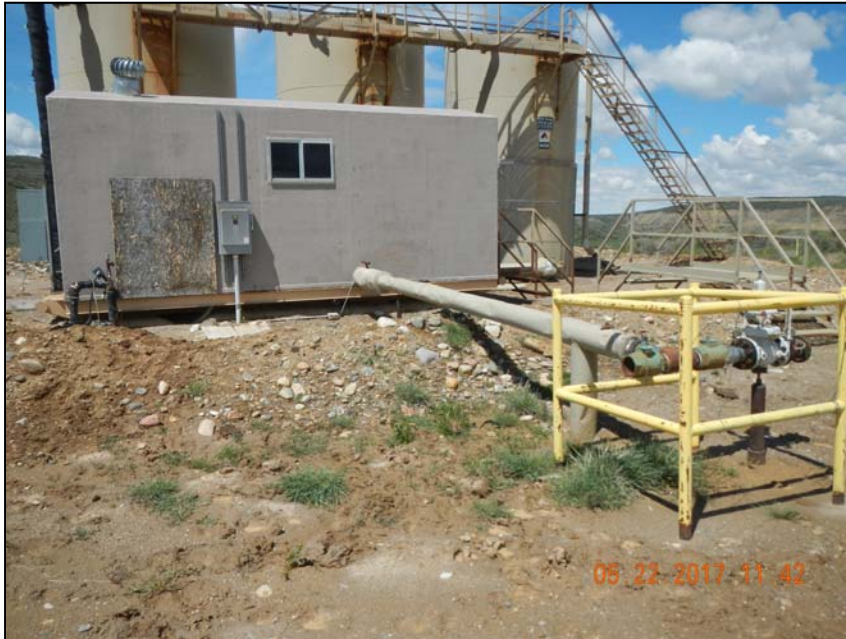
Photo 4. 1 – 4” insulated flowline at compressor.

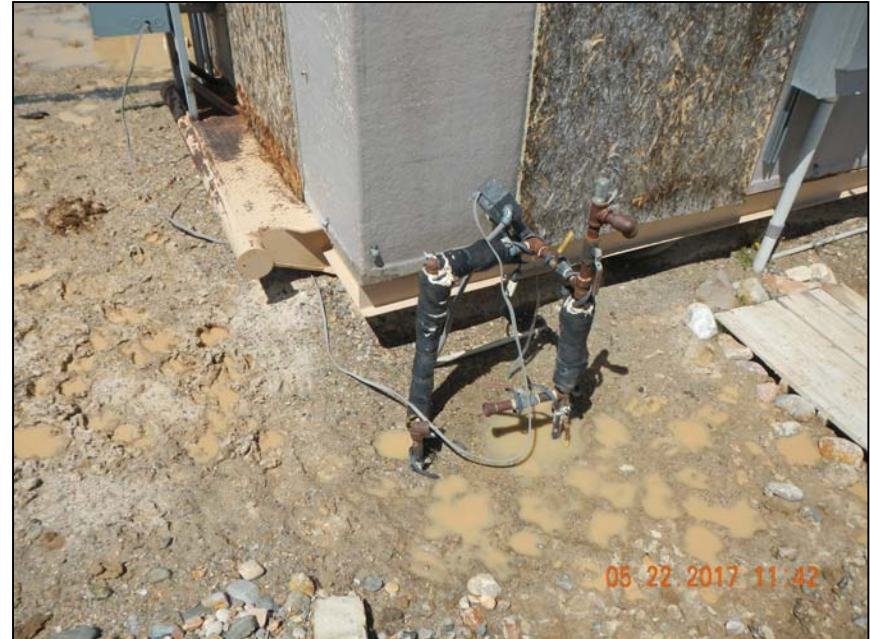
Photo 5. 2 -1” insulated risers at compressor corner.

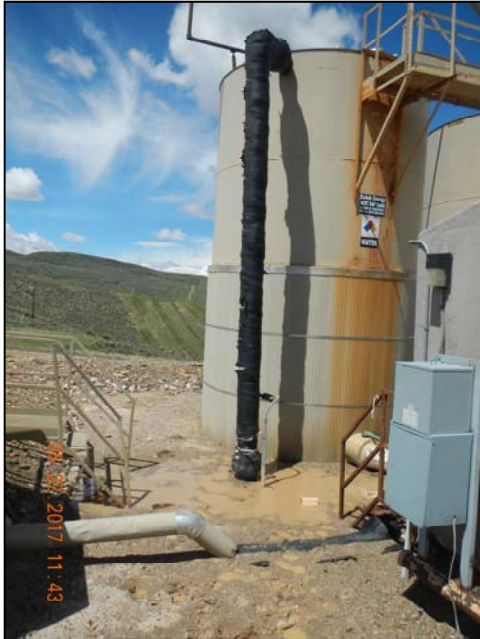
**Photo 6. 1 -6" insulated flowline from tank. 1 -
4"insulated flowline from meter run.**

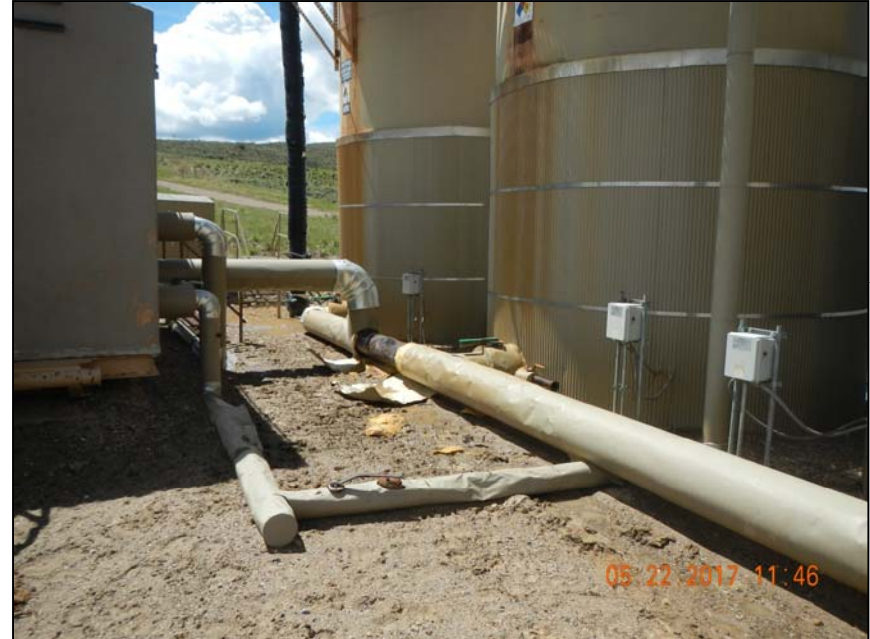
Photo 7. 1 -6" insulated flowline.

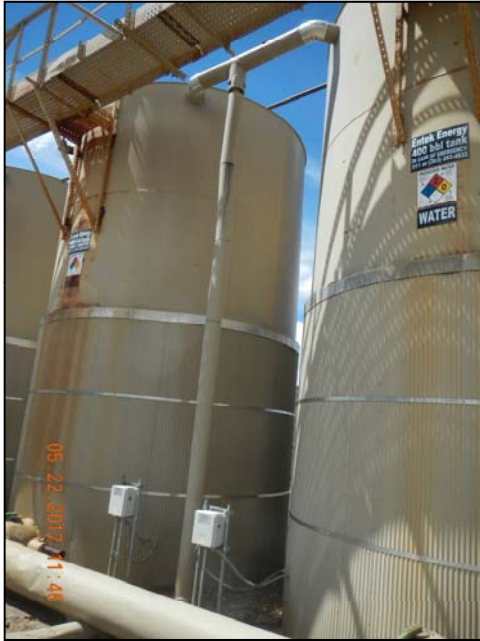
Photo 8. 2 -4" insulated flowlines going into 6" insulated line at base.

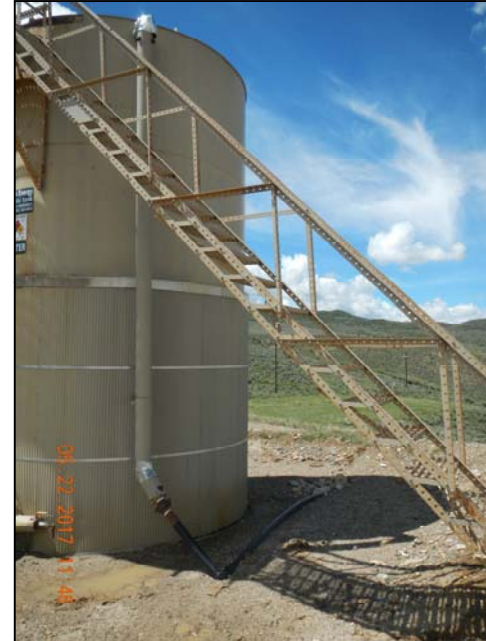
Photo 9. 1 -2" insulated flowline changing to poly line at tank base.

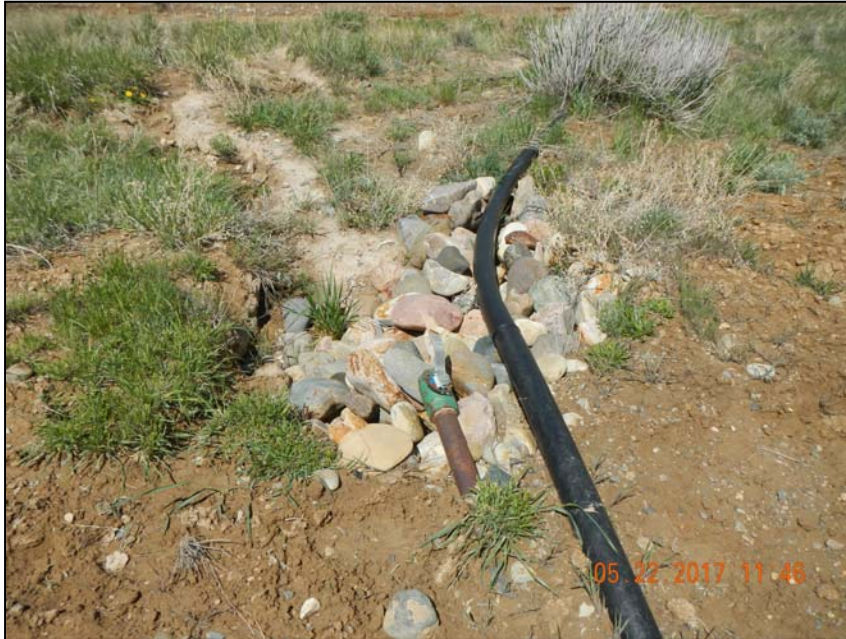
Photo 10. 1 -2" poly flowline. 1 -2" steel flowline.

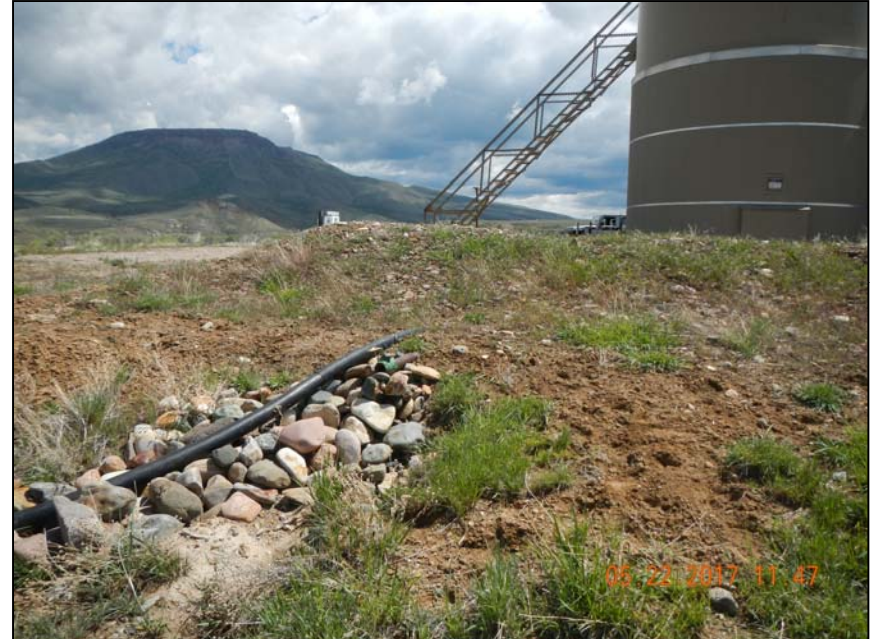
Photo 11. Poly and steel line from left photo. Poly line from tank. No point A identified for steel line.
