Inspection Photos – 2017 Flowline NTO
Inspection
Location Name: Robidoux 13-7
API: 05-081-07232

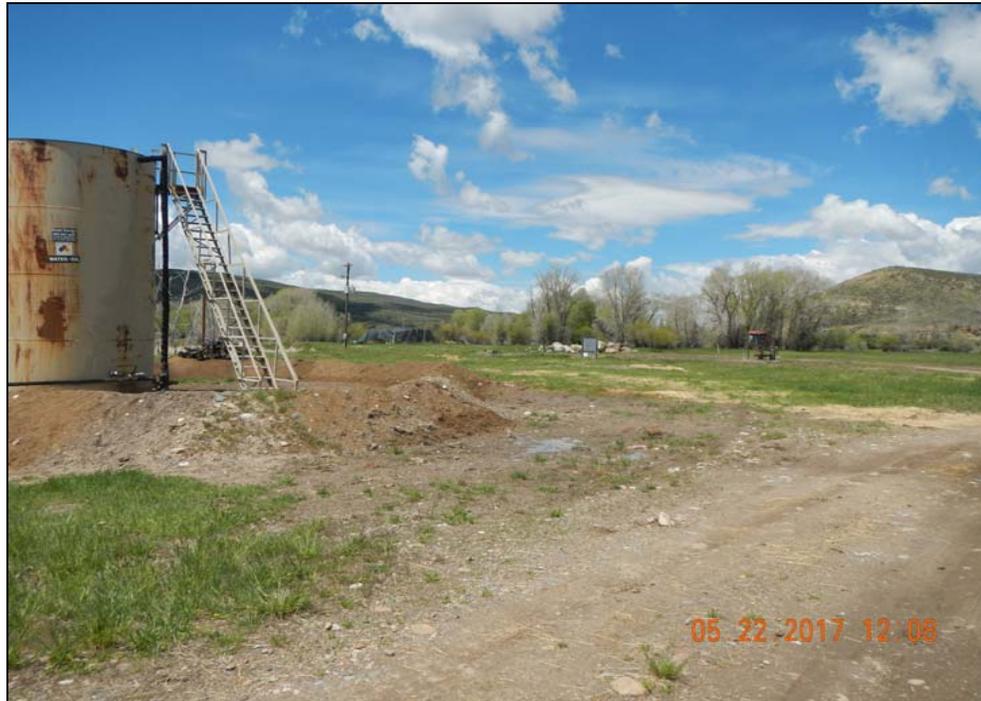
Photo 1. Overview of location taken at the entrance facing northwest.

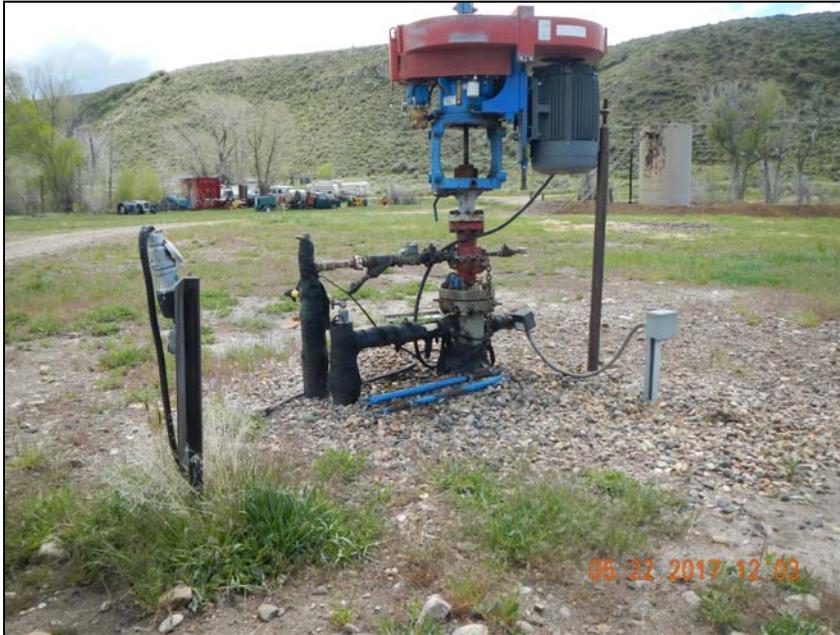
Photo 2. 2 -2" insulated risers at wellhead.

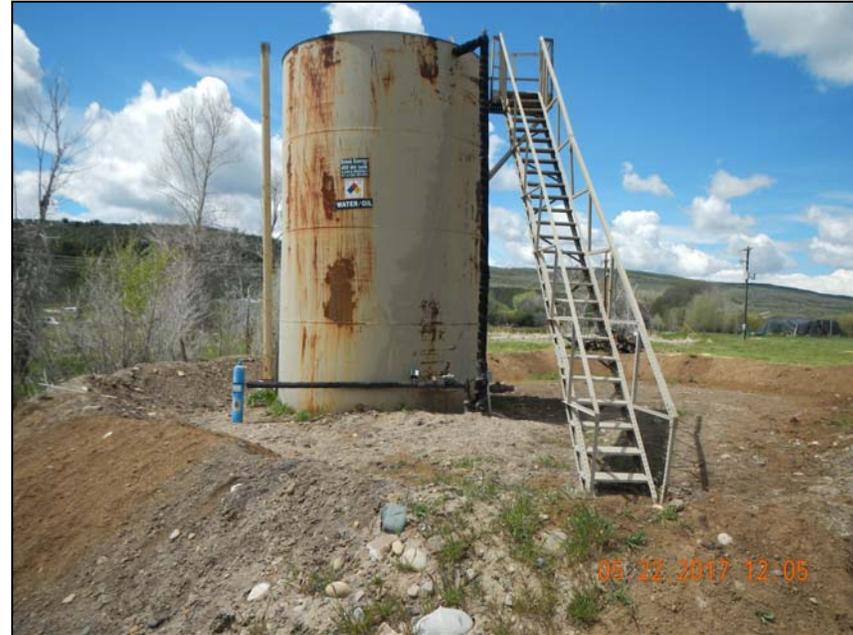
Photo 3. 2 – 2" insulated risers at tank.
NFPA diamond still only for produced water.
