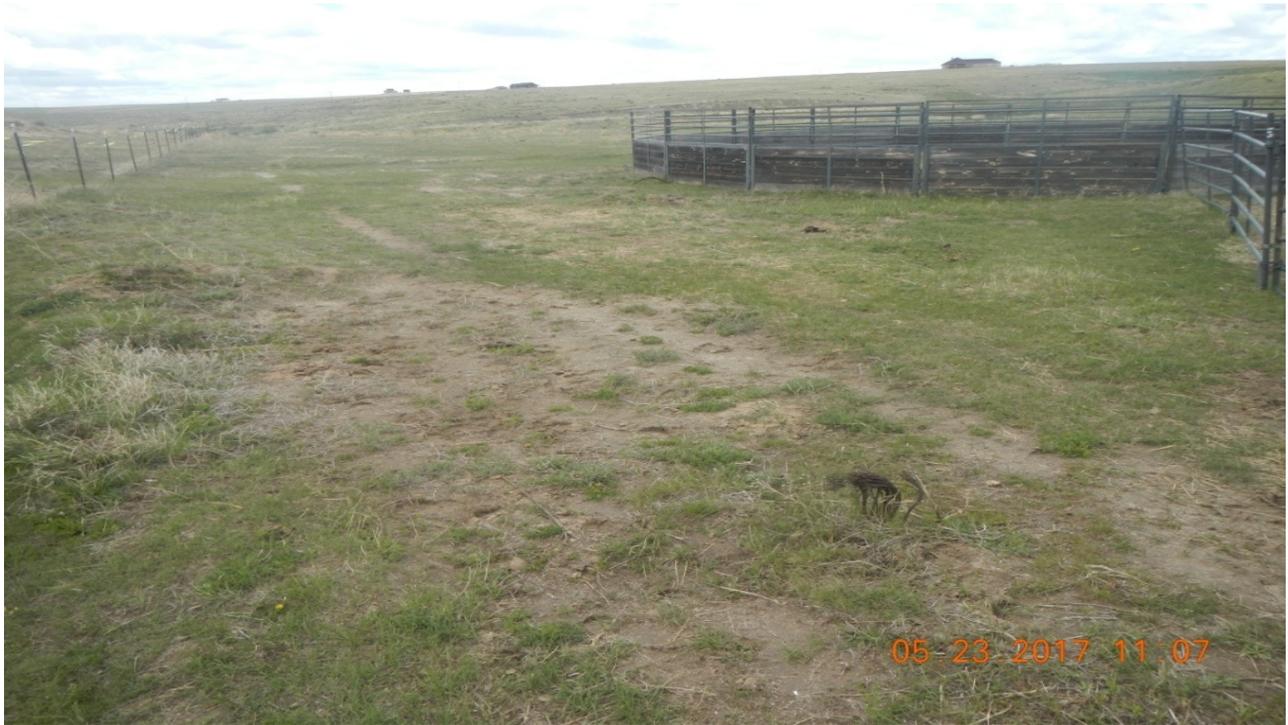
photo 1: Facing southwest toward former location.

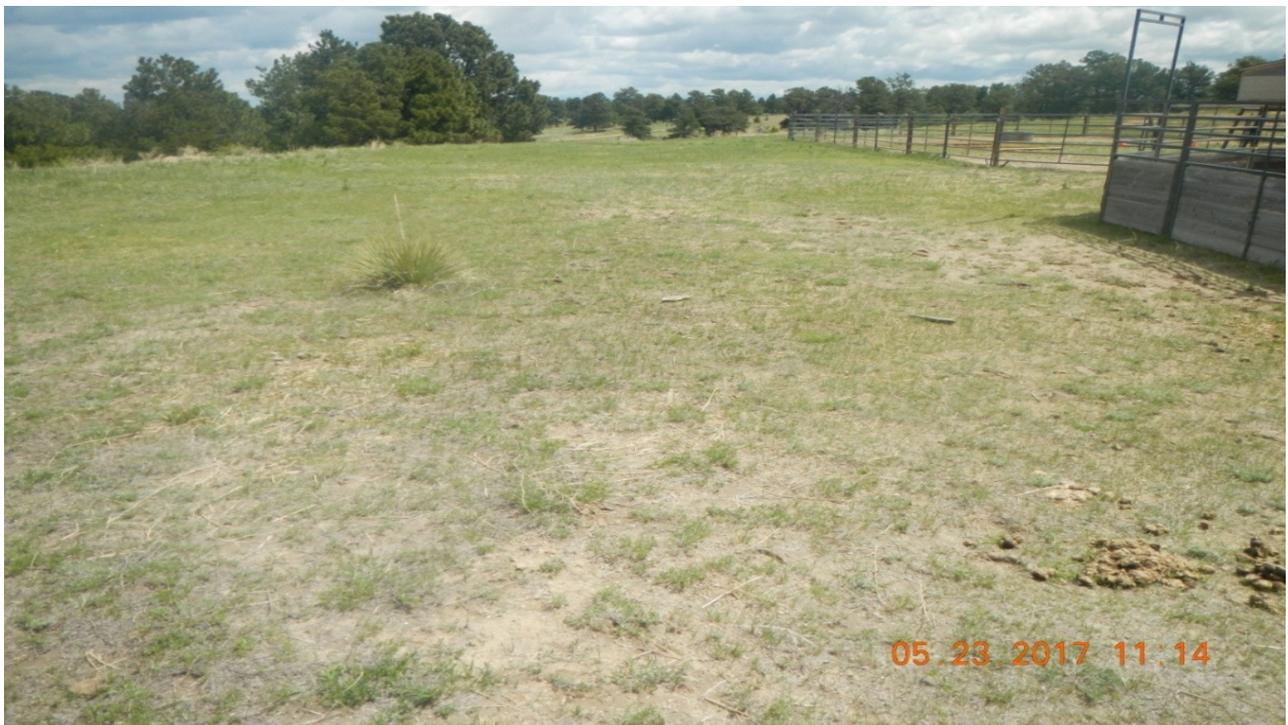
photo 2: Facing north at the location.

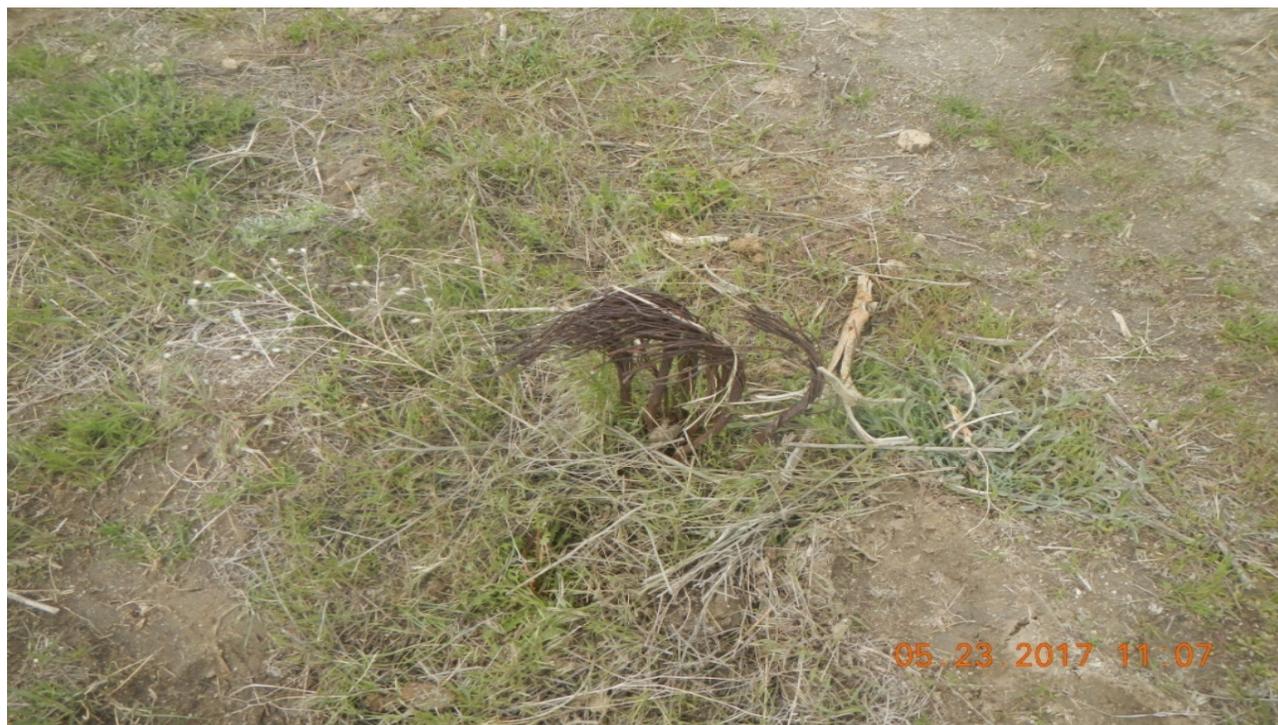
photo 3: A cable was found extending out of the ground which was cut off below ground during this inspection.

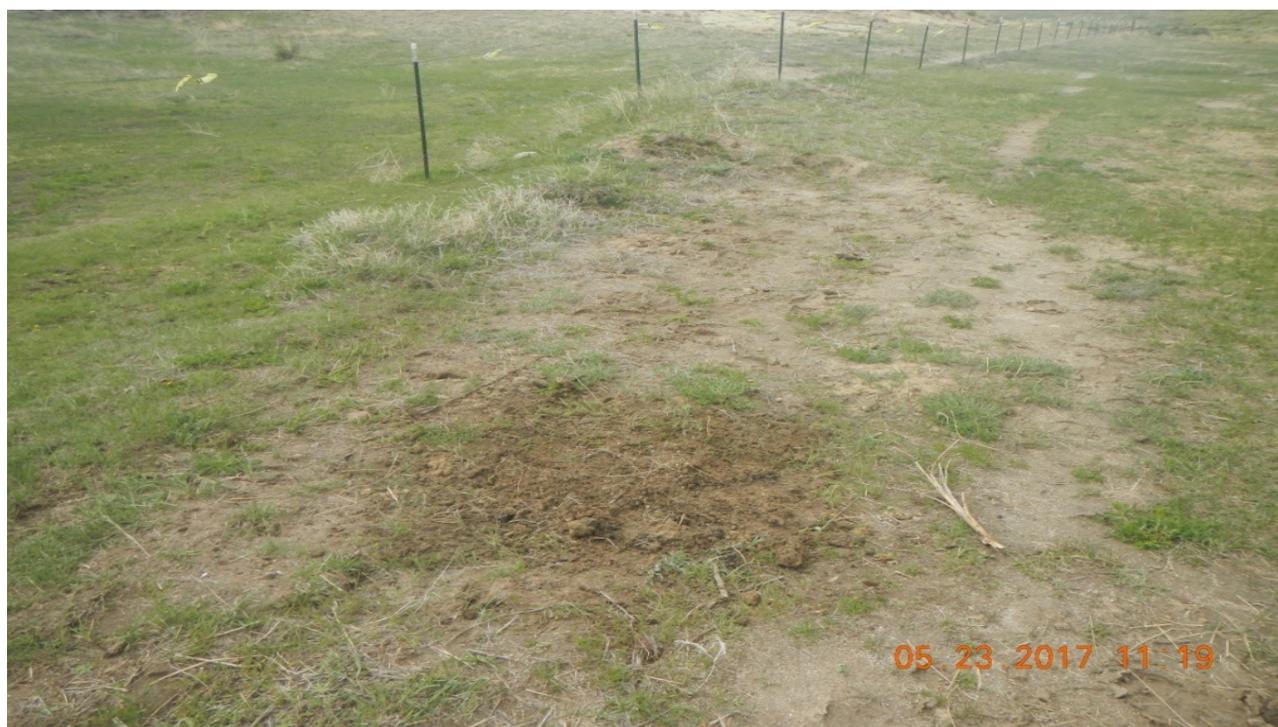
photo 4: After the cable was removed.
