**Inspection Photos**  
**Location Name: Lot Holdings 8-12**  
**API: 05-123-20319**

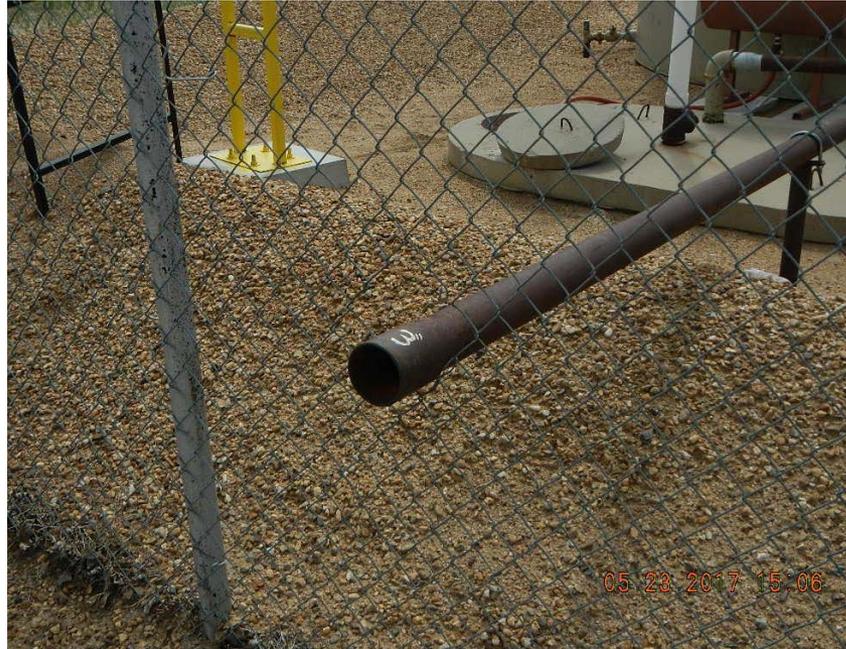
**Produced water vault load line**

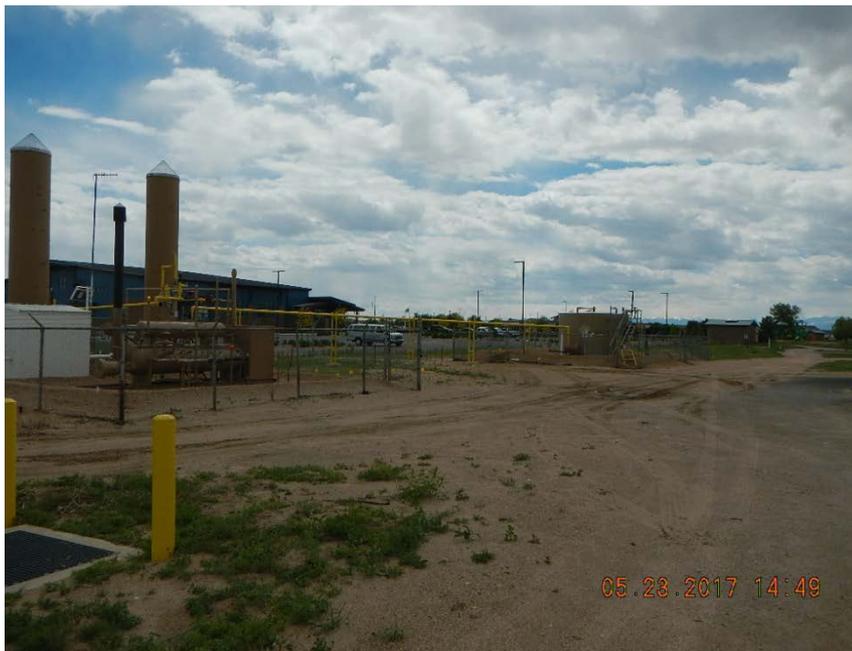
Production facility

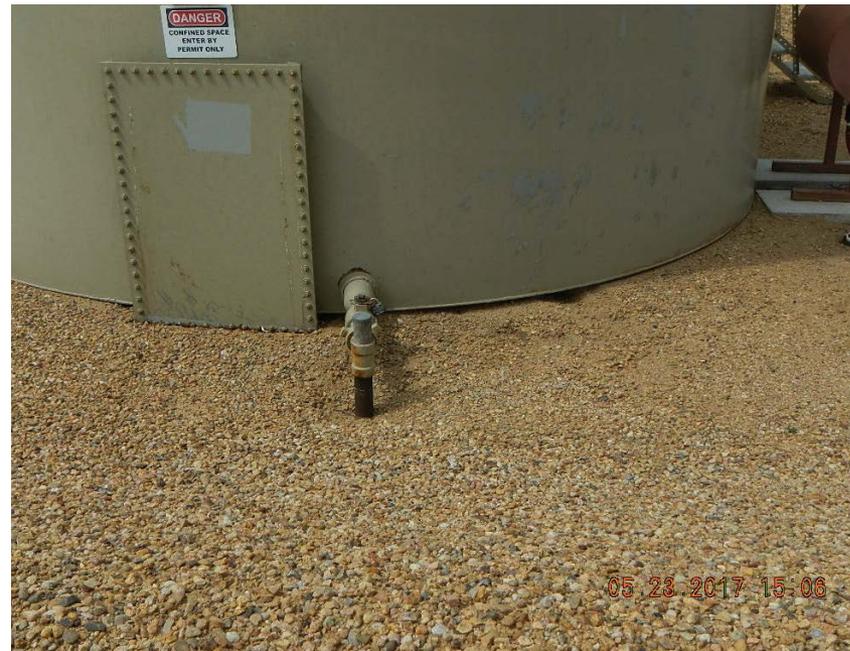
Drain valve riser

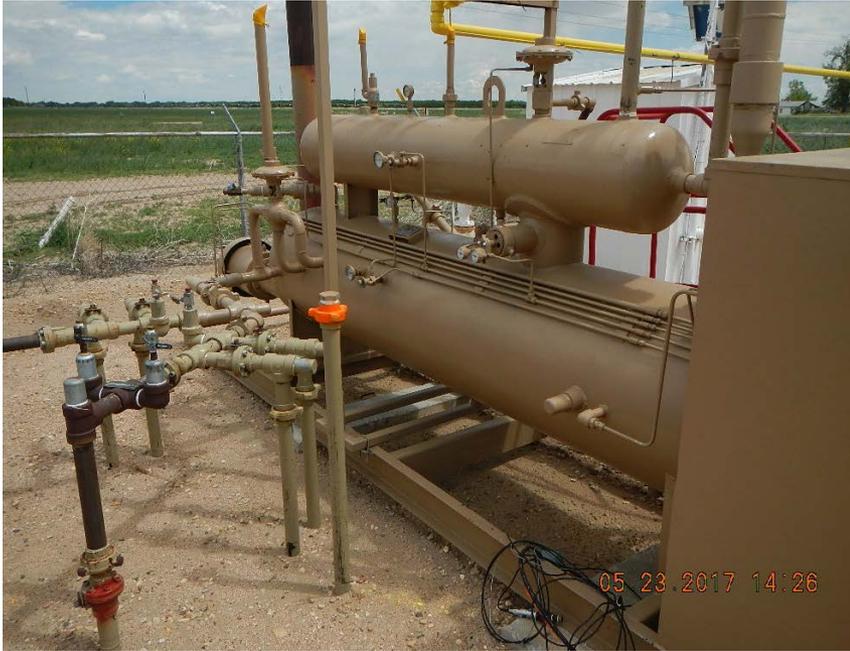
**Separator inlet lines N40.32746 W-104.83070**

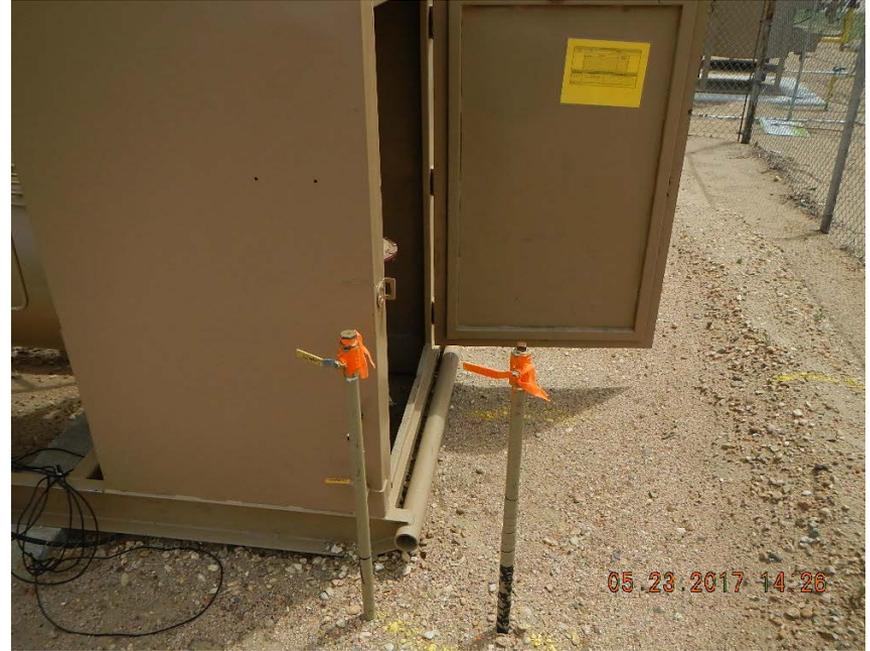
**1" process risers N40.32746 W-104.83073**

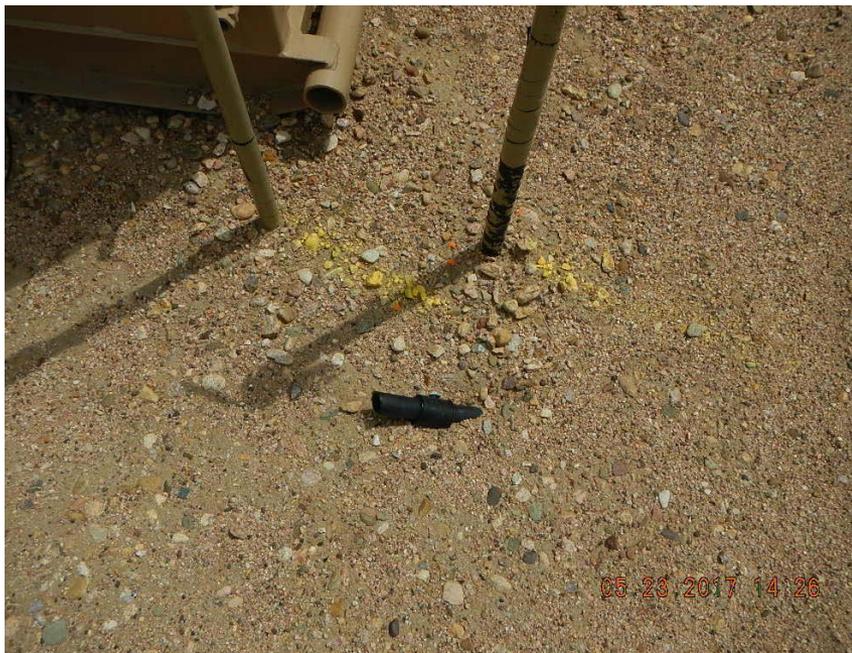
**Cut 1" poly process line N40.32746 W-104.83073**

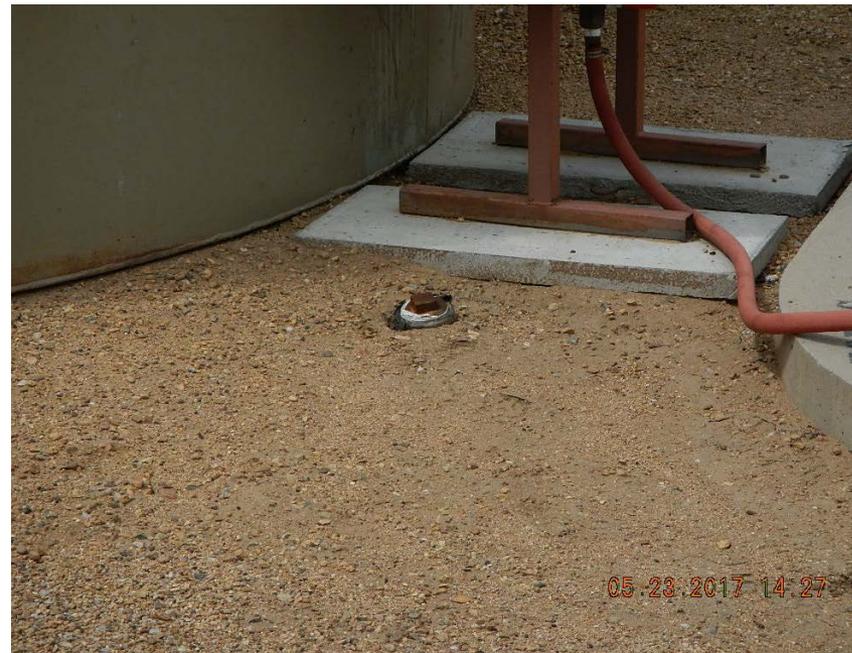
**3" riser at crude oil tank N40.32741 W-104.83102**

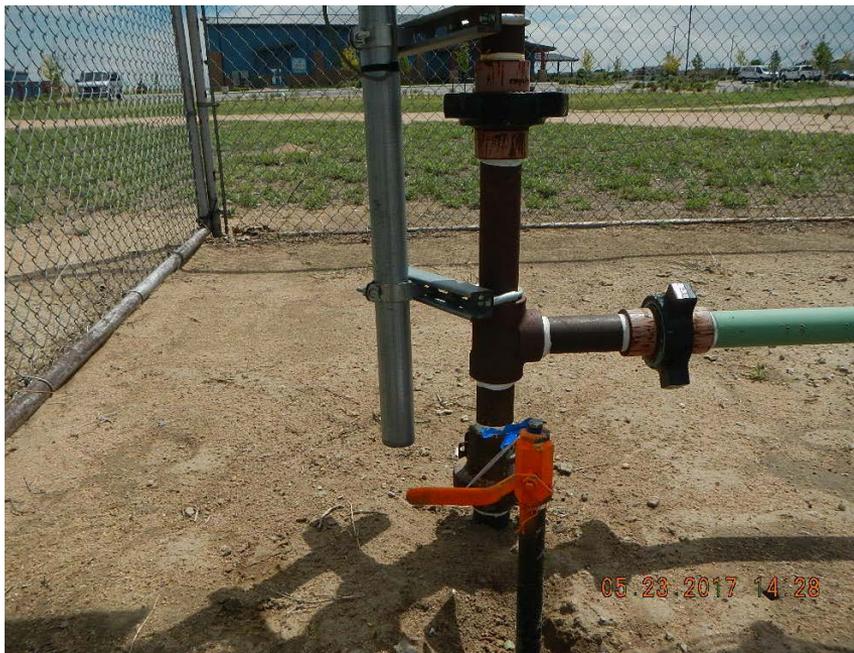
**Wellhead flow line risers**

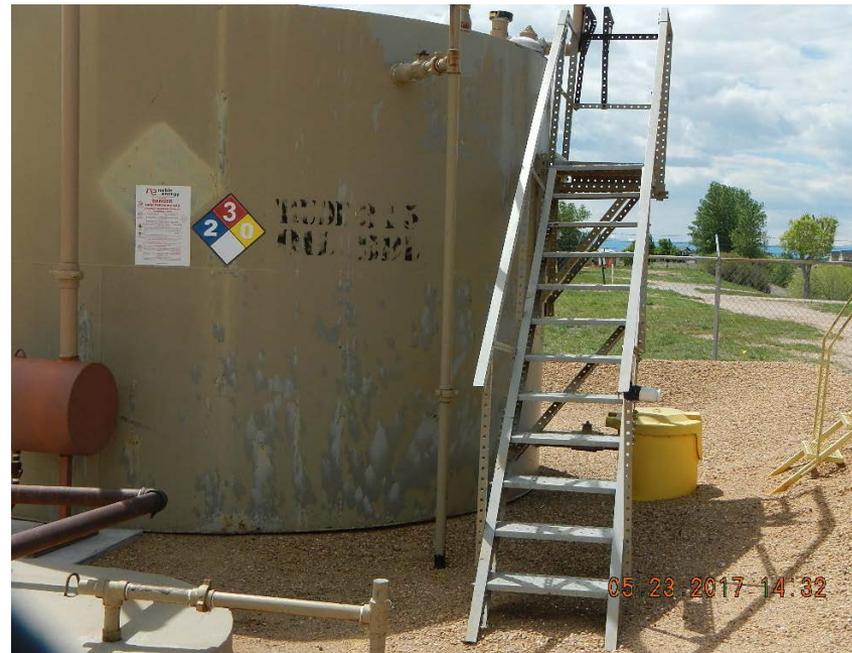
**Crude oil tank contents/capacity placard and paint**

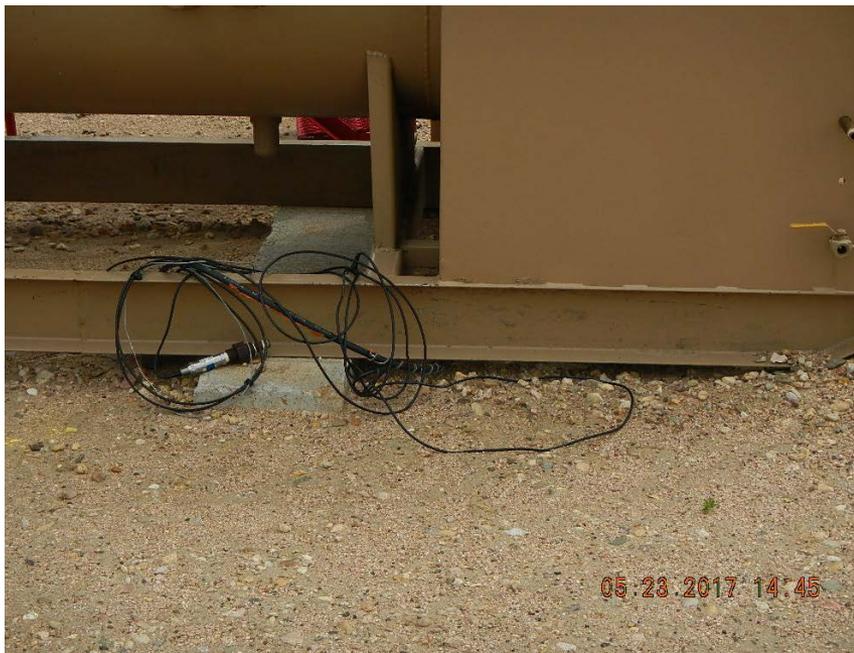
**Unused automation equipment**

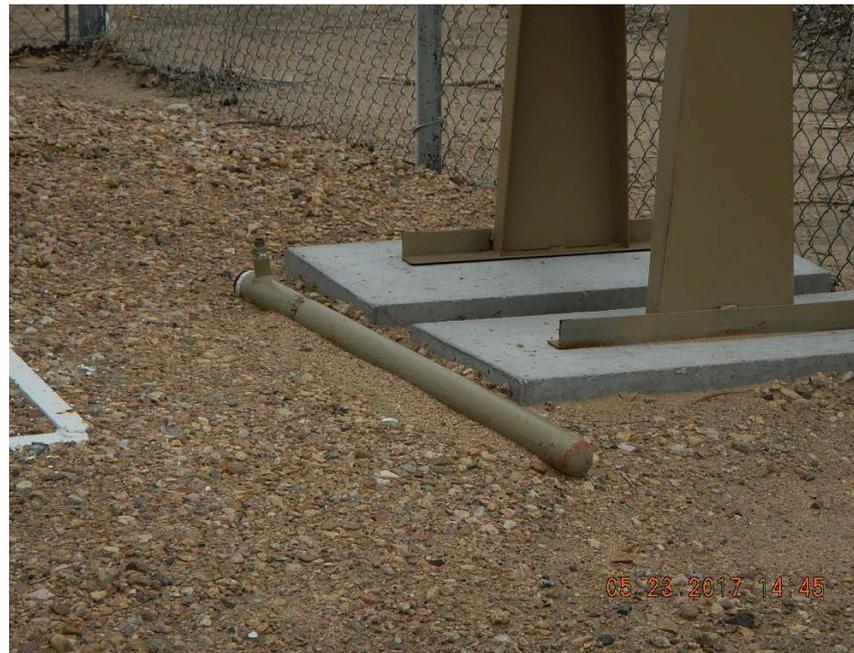
**Unused dry gas tower**
