Flowline Inspection Photos
Location Name: Purvis SE-10
API: 05-123-32473

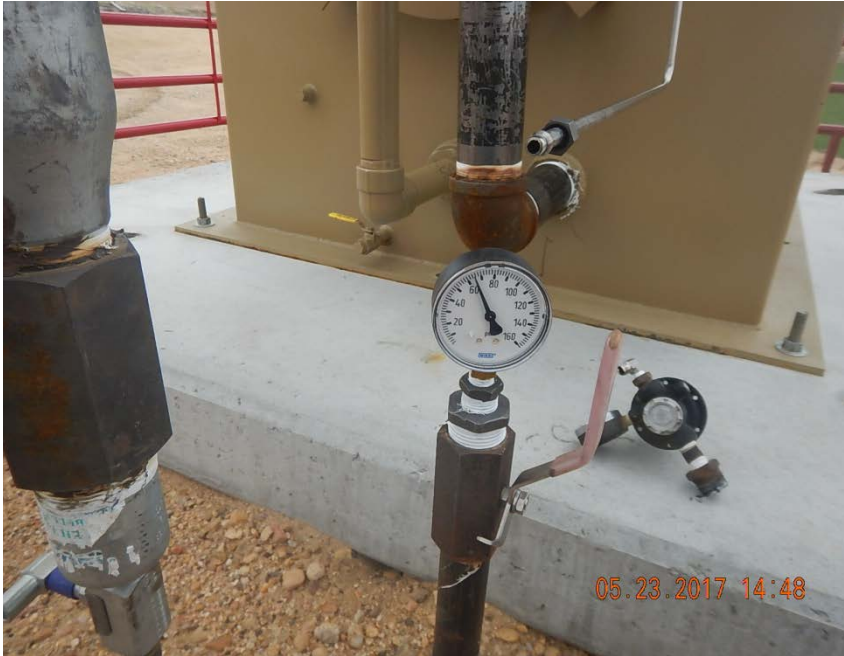
Photo 1: Pressure test on ECD supply line

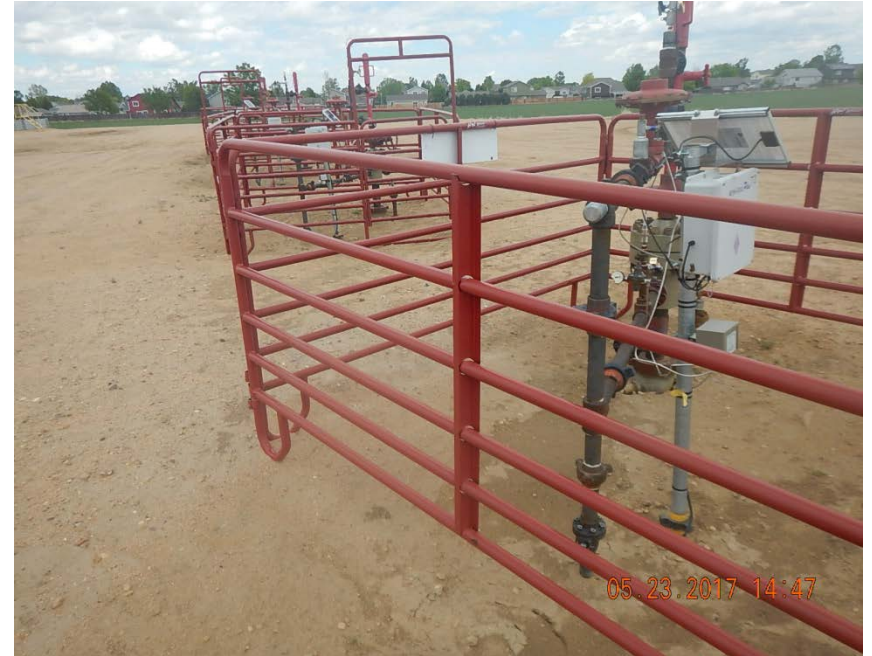
Photo 2: flowlines at wellheads

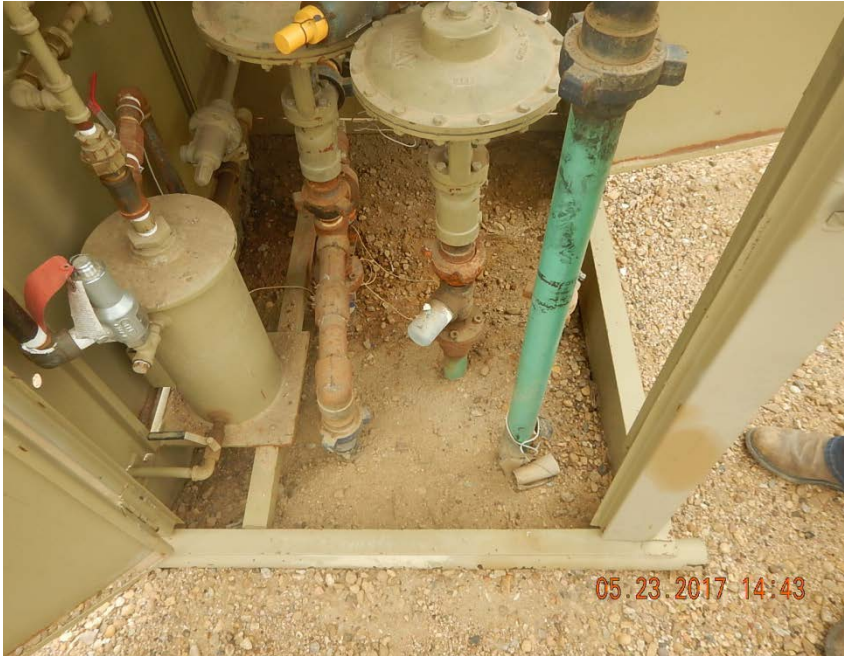
Photo 3: Flowlines in separator house

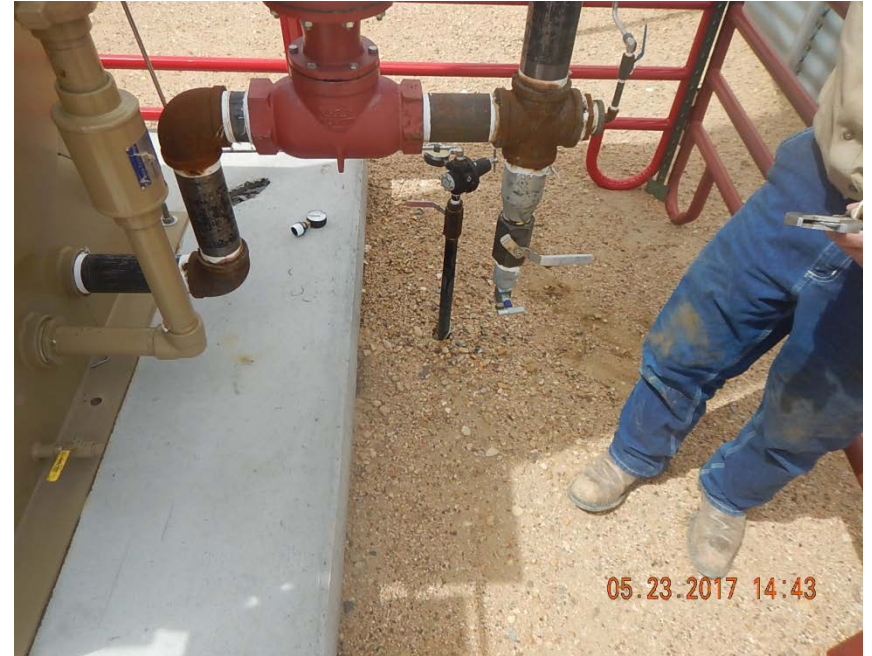
Photo 4: Risers at ECD

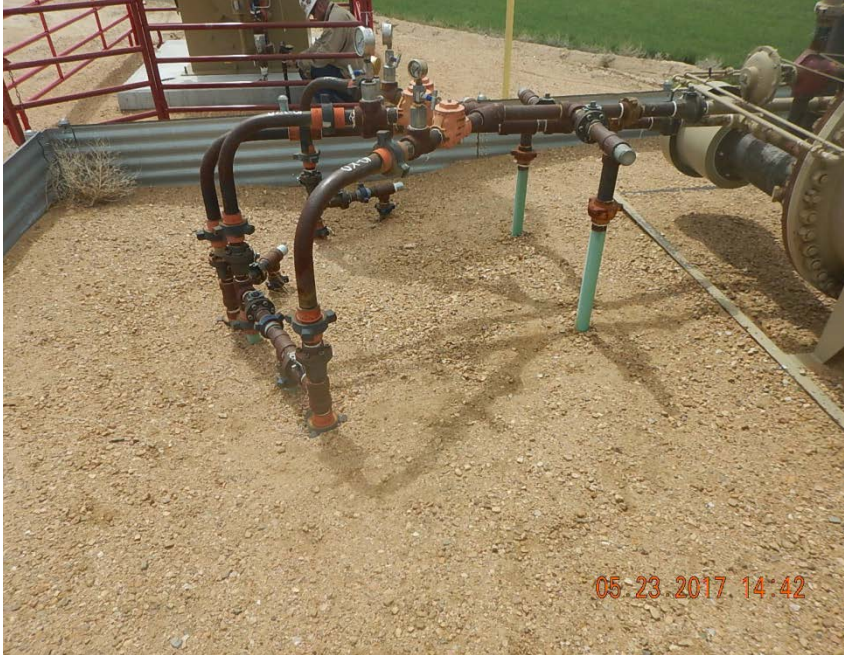
Photo 5: Risers at separator

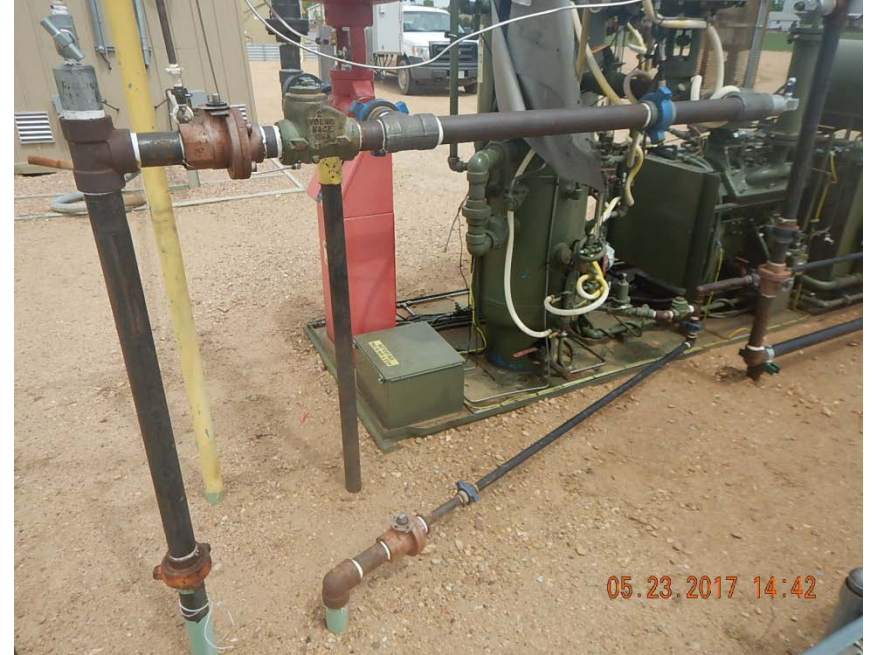
Photo 6: Risers at compressor

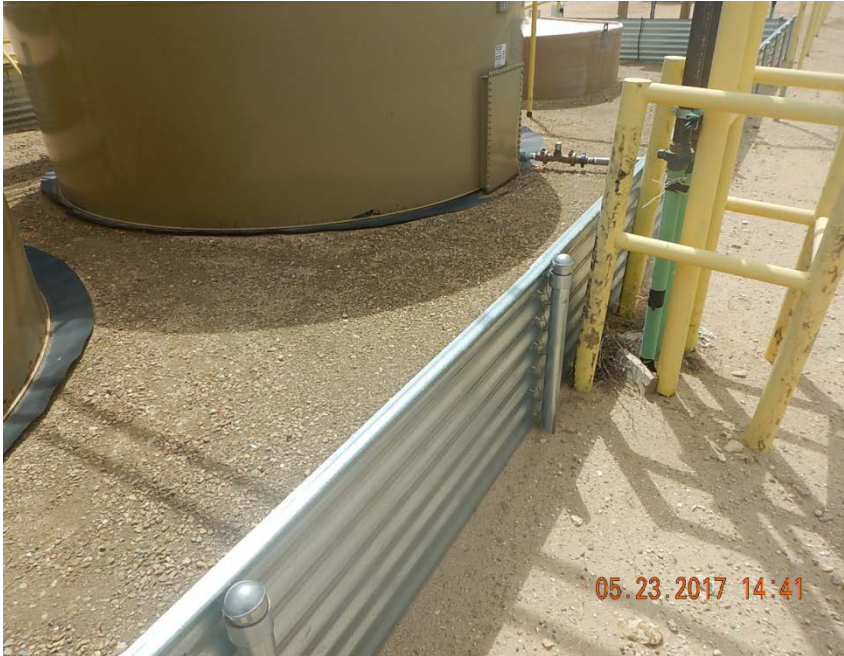
Photo 7: Risers at tank battery
