Inspection Photos - 2017 Flowline NTO
Inspection
Location Name: Govt-Winder 1
API: 05-081-05370

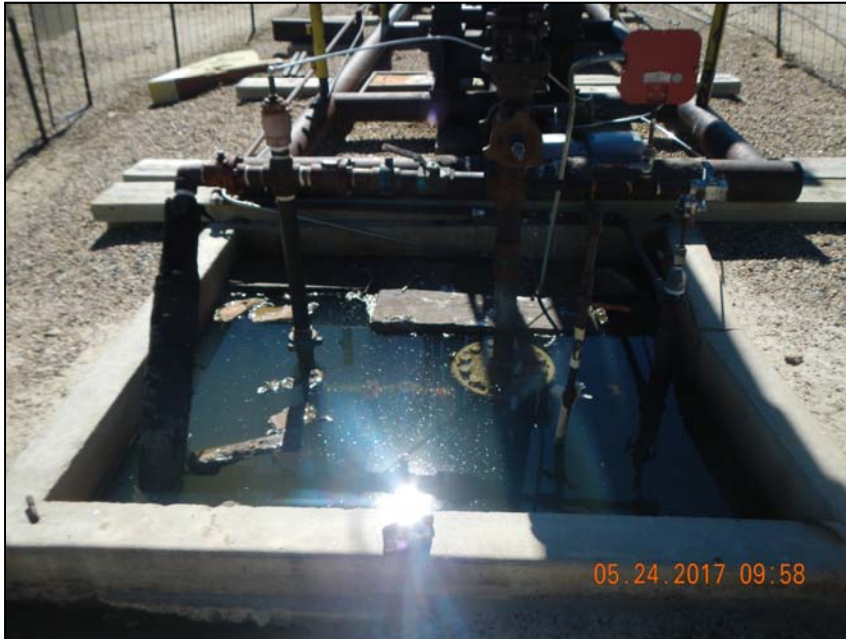
Photo 1. Wellhead with 1- 2" steel riser in use.

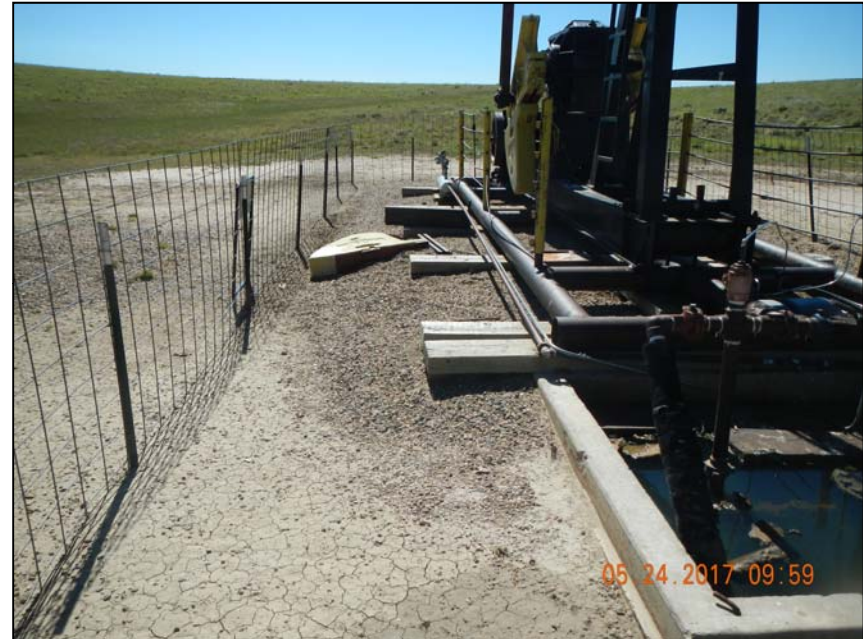
Photo 2. 1" steel flowline from wellhead to separator.

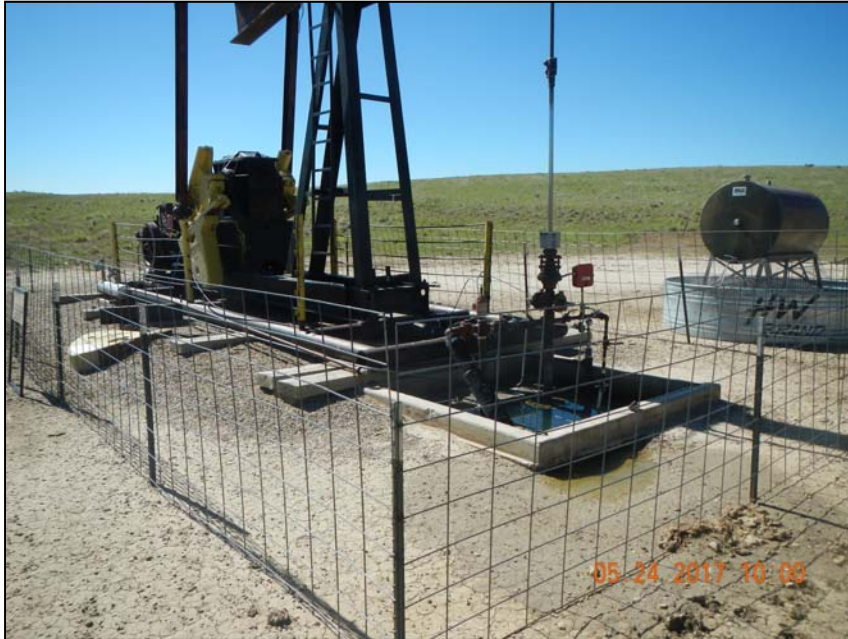
Photo 3. Lines going to separator and motor. Unlabeled methanol tank.

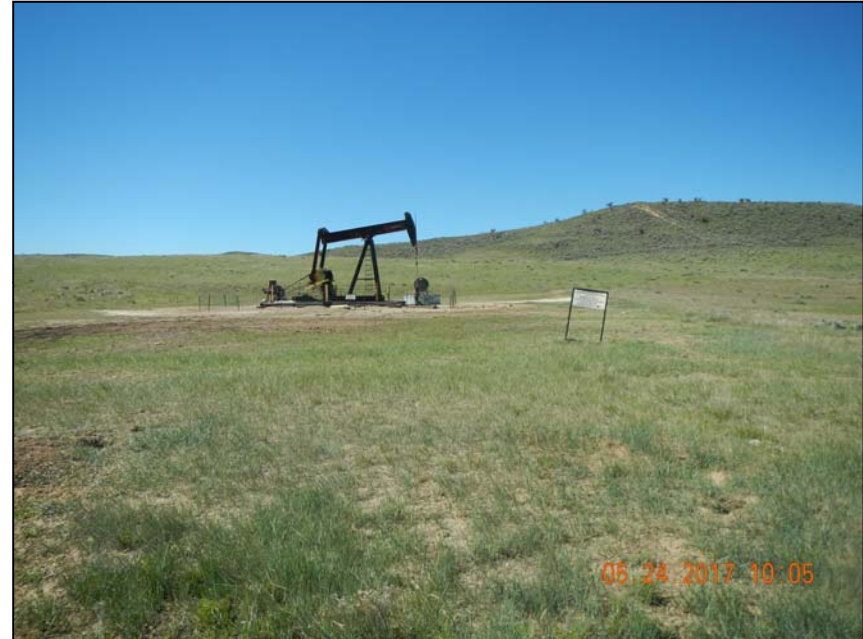
Photo 4. Location overview taken at entrance to location facing south.
