Inspection Photos - 2017 Flowline NTO
Inspection
Location Name: Brunner 1
API: 05-081-05368

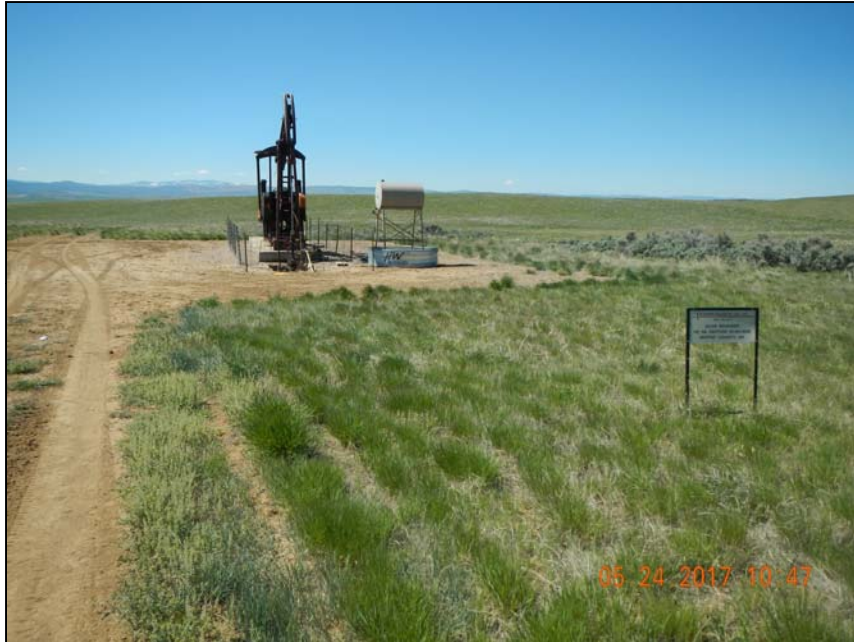
Photo 1. Location overview taken at entrance to location facing south.

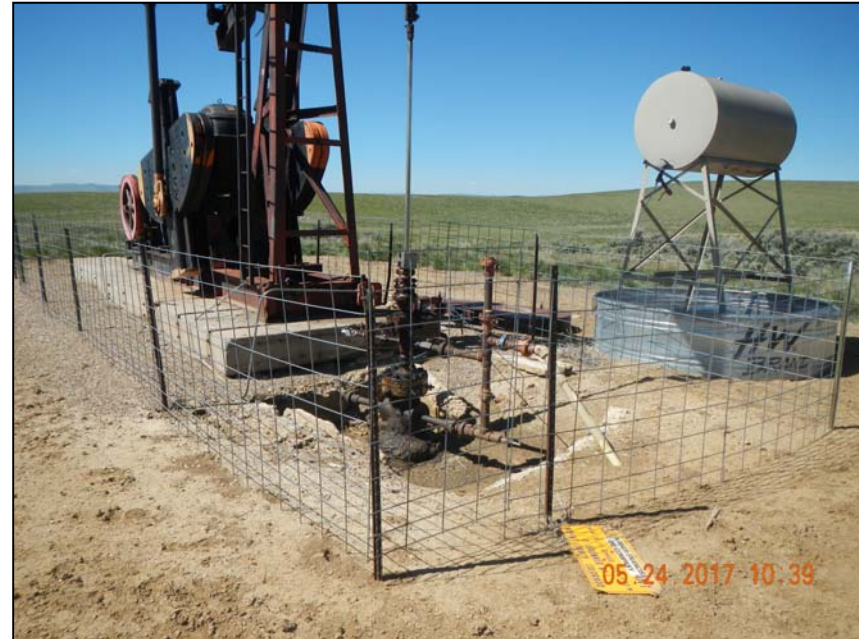
Photo 2. Overview of wellhead assembly with fallen wellhead sign and unlabeled methanol container visible.

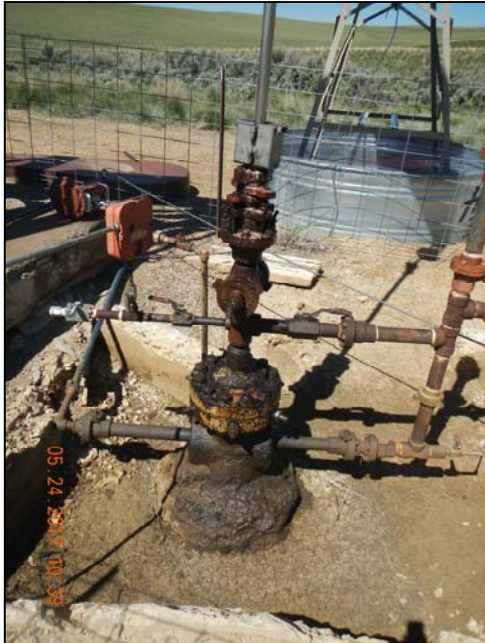
Photo 3. Stained soil at wellhead.

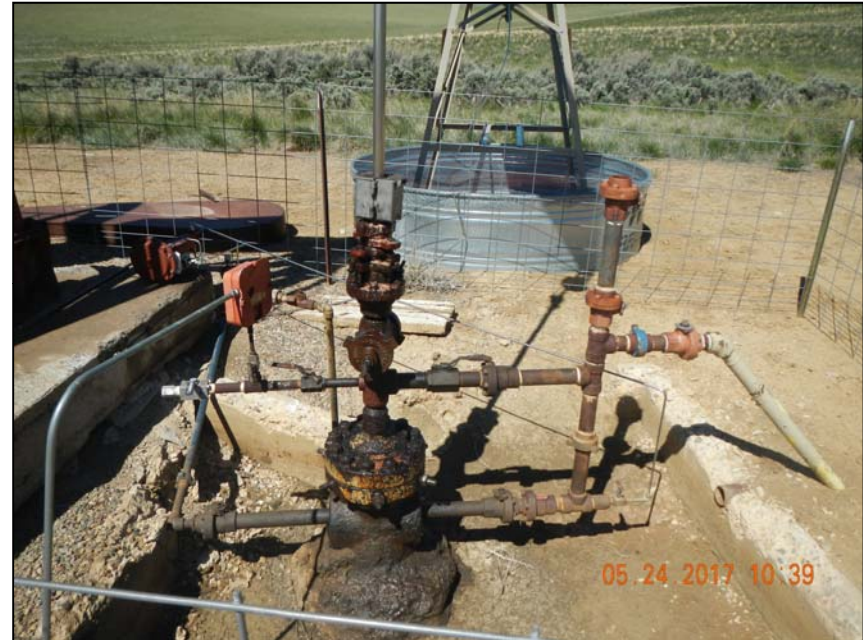
Photo 4. Wellhead assembly with 1 -2" steel riser in use, methanol lines, 1 - 1" steel riser not in use.

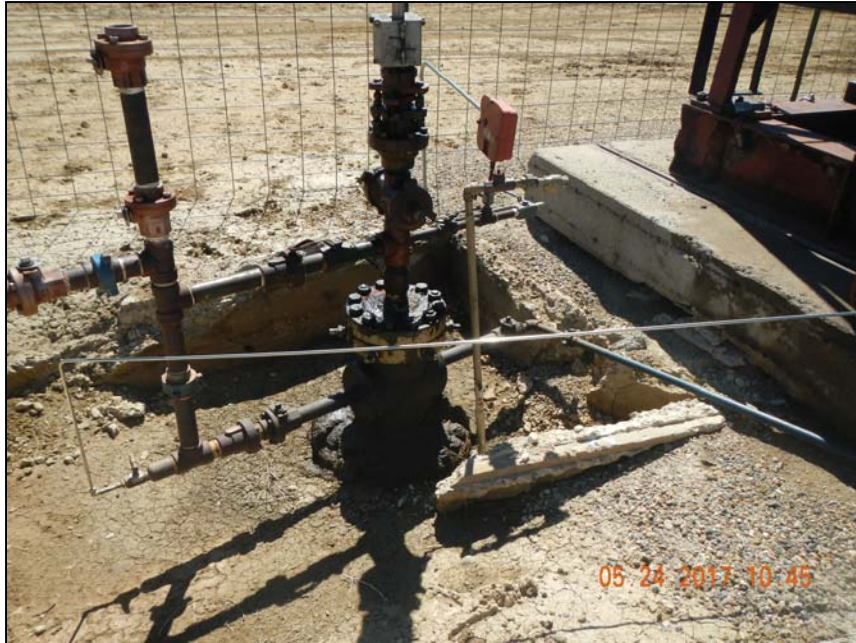
Photo 5. 1 -1" steel riser not in use, alternate angle.

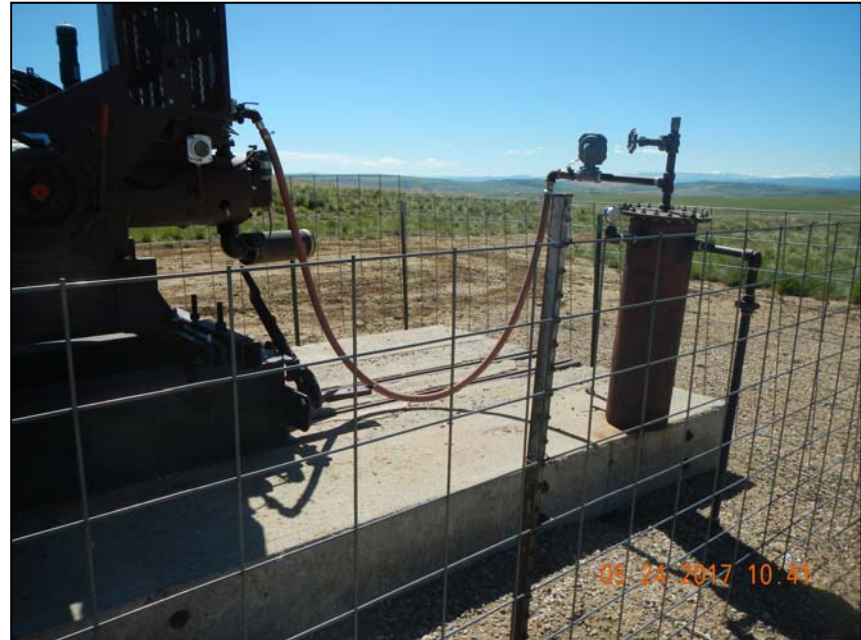
Photo 6. Lines connecting separator and motor.
