Inspection Photos - 2017 Flowline NTO
Inspection
Location Name: W W McWilliams 1-29
API: 05-081-05377

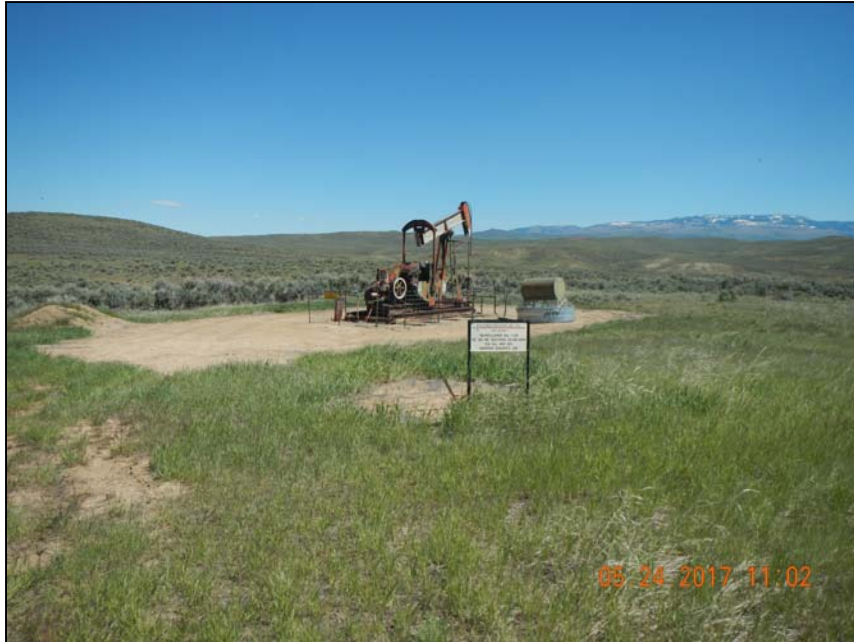
Photo 1. Location overview taken at entrance to location facing northeast.

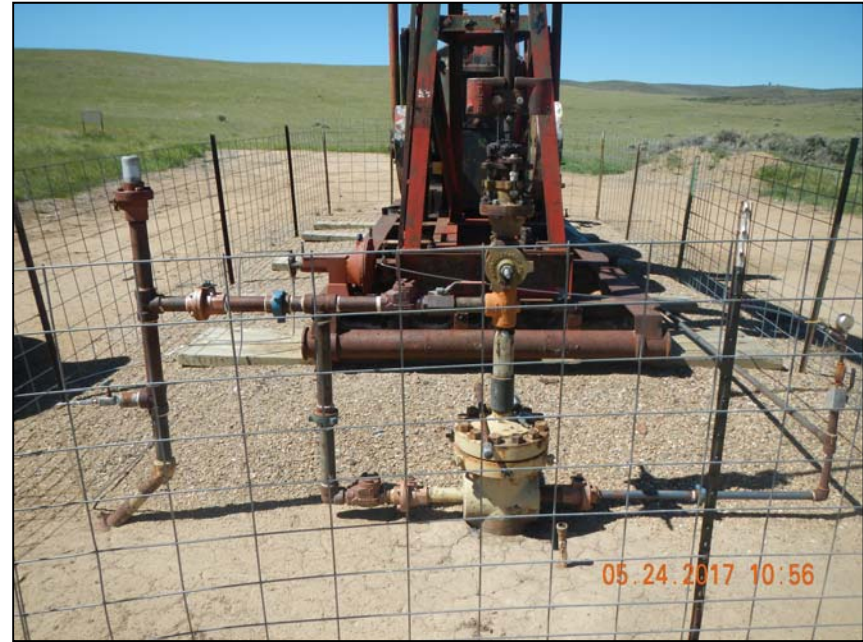
Photo 2. Overview of wellhead assembly.

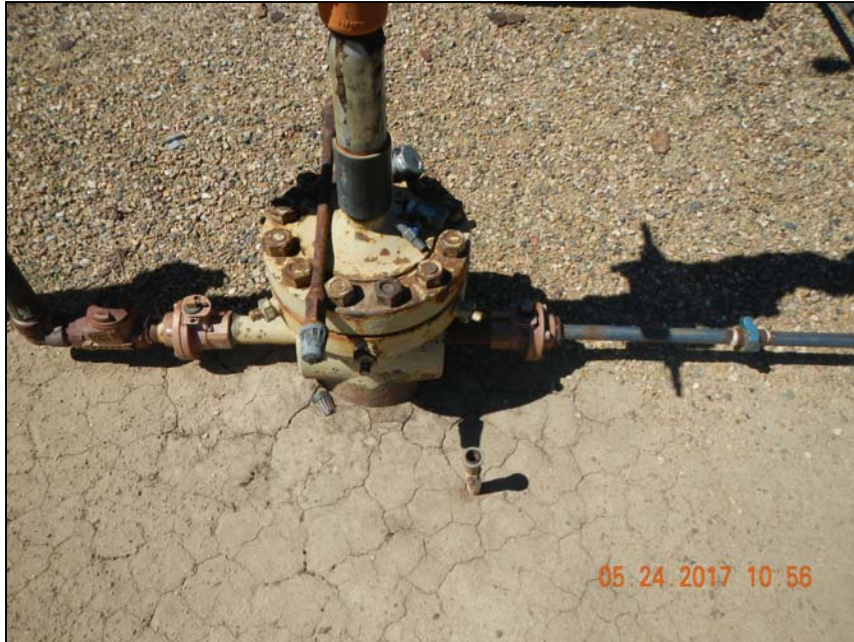
Photo 3. 1 -1" steel riser not in use at wellhead.

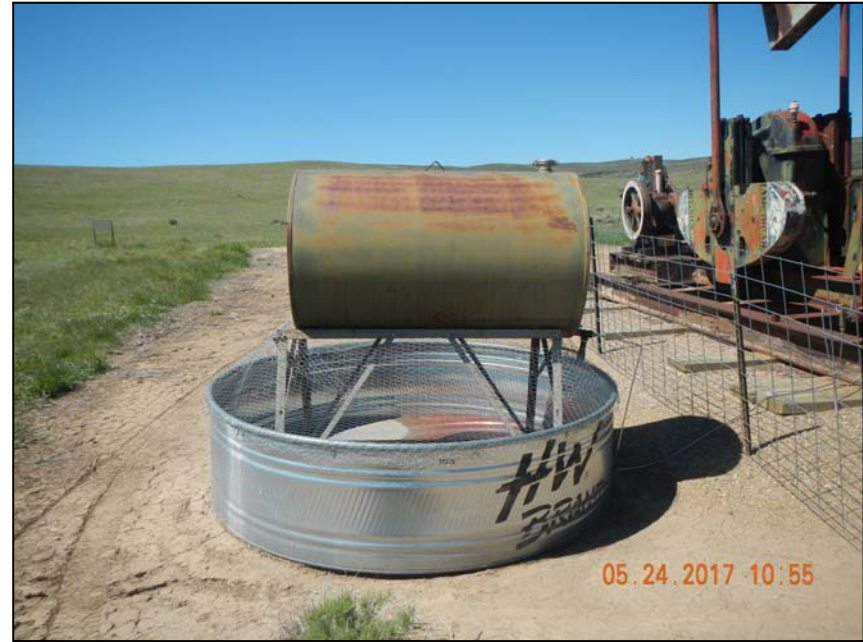
Photo 4. Unlabeled methanol tank.

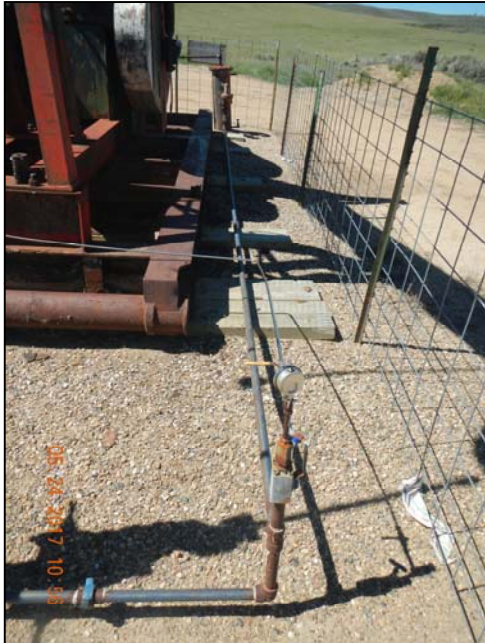
Photo 5. 1' steel line running to separator.

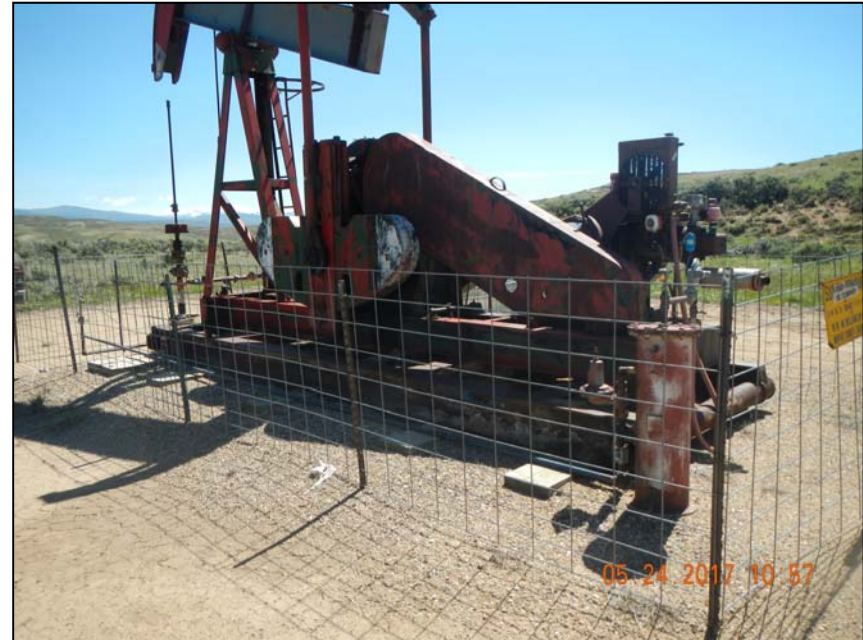
Photo 6. 1 – 1" steel line to separator and 1 1" poly line to motor.
