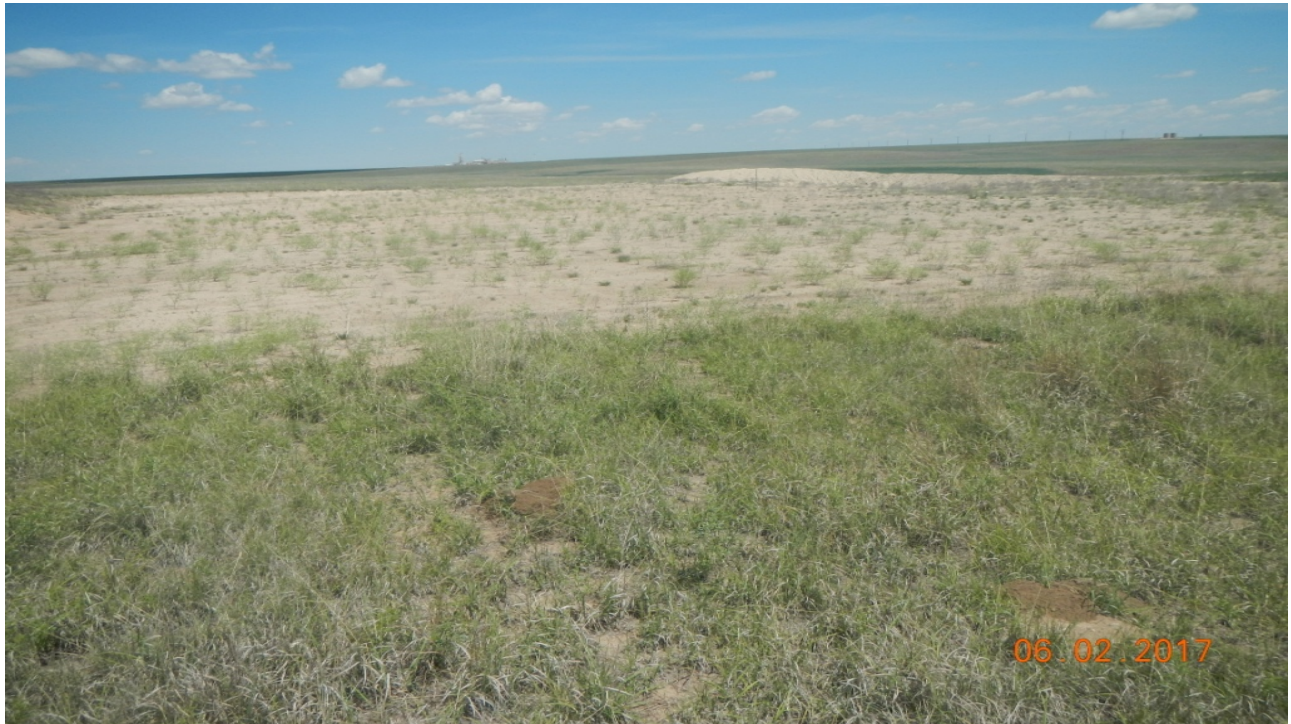
**photo 1:** Facing northeast toward the location. The location has been built and has not been reclaimed.

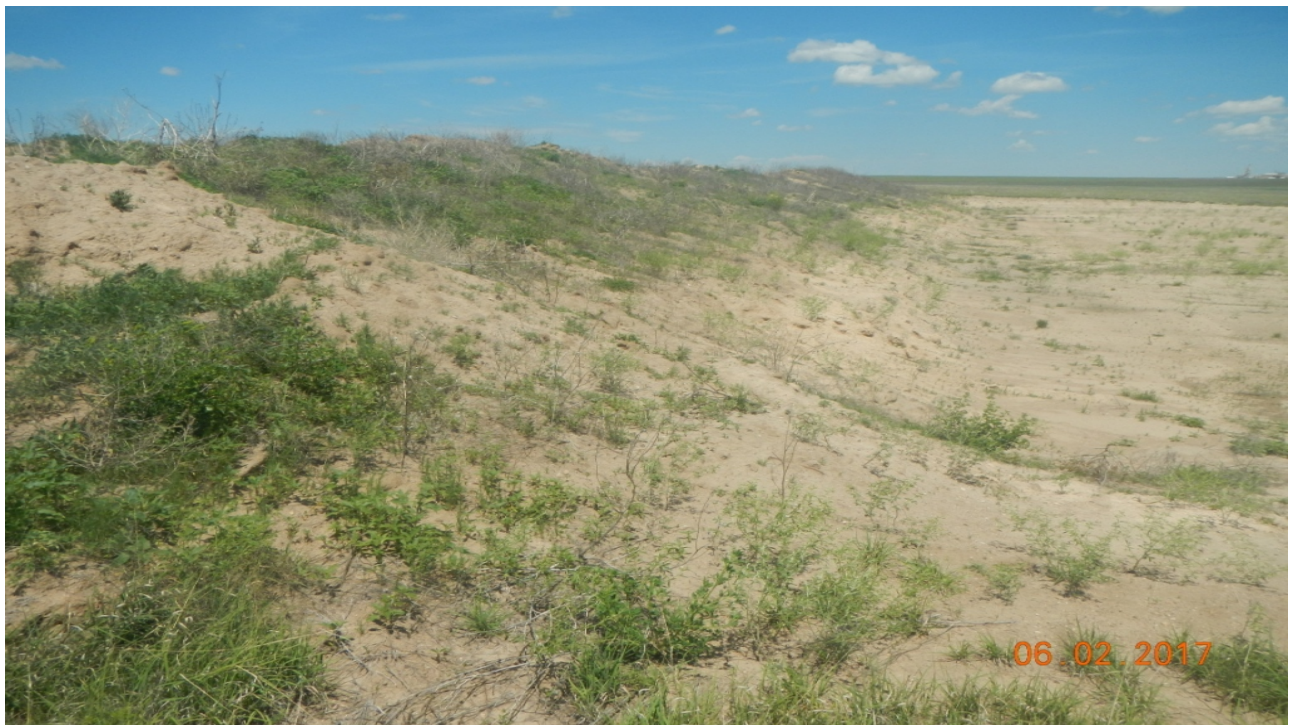
**photo 2:** Facing north along the topsoil pile at the west side of the location. There are weed issues and signs of erosion occurring along the topsoil pile.

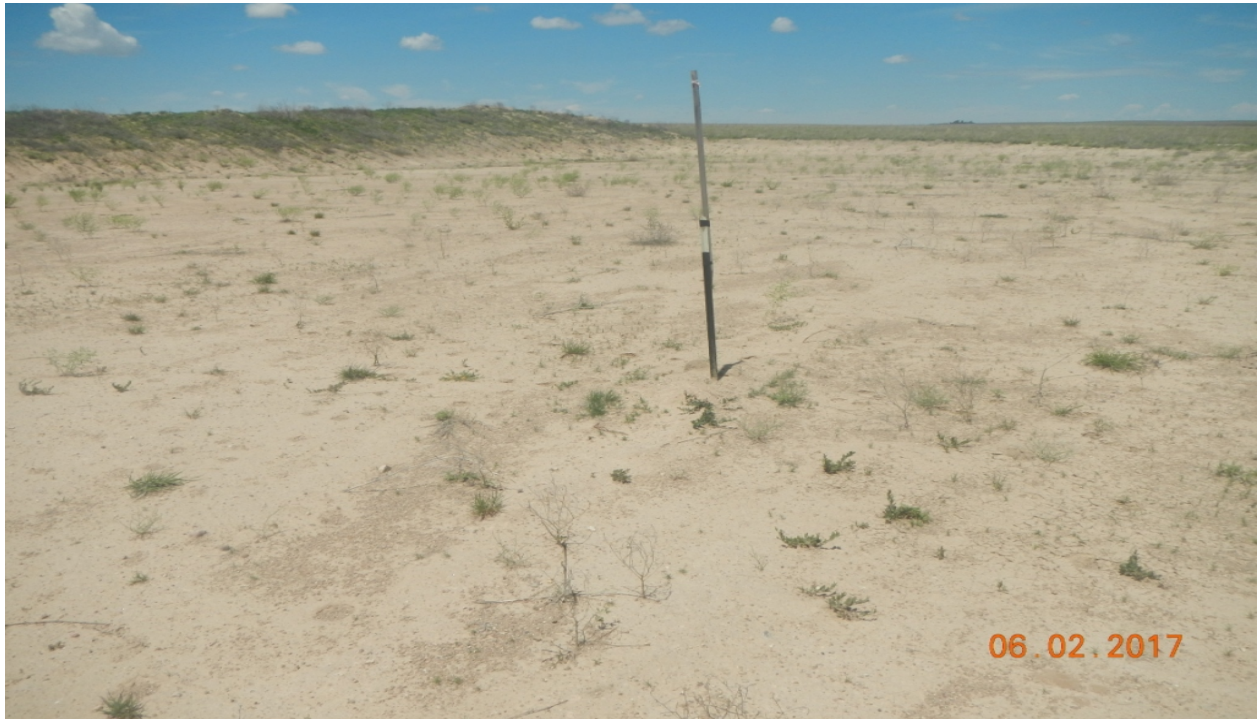
**photo 3:** There is a marker at the center of the location and there is no signs of drilling at the location.

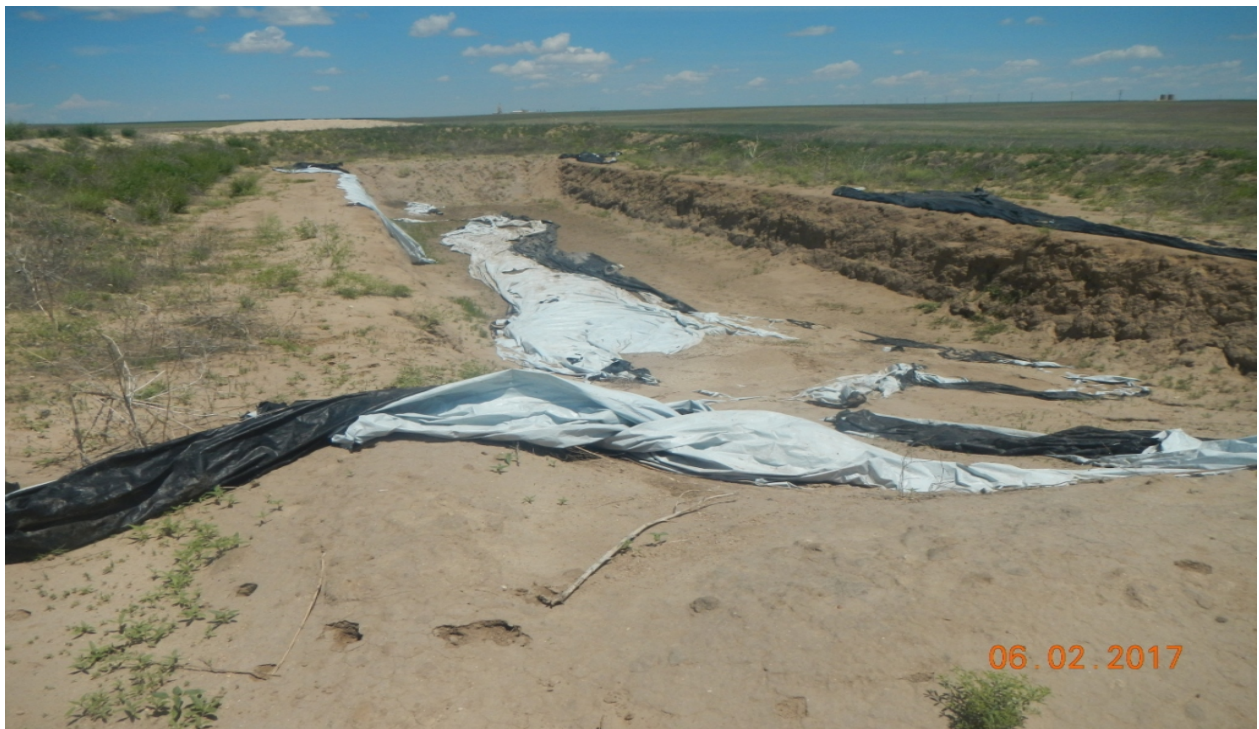
**photo 4:** There is a pit at the east side of the location which has torn liner debris.

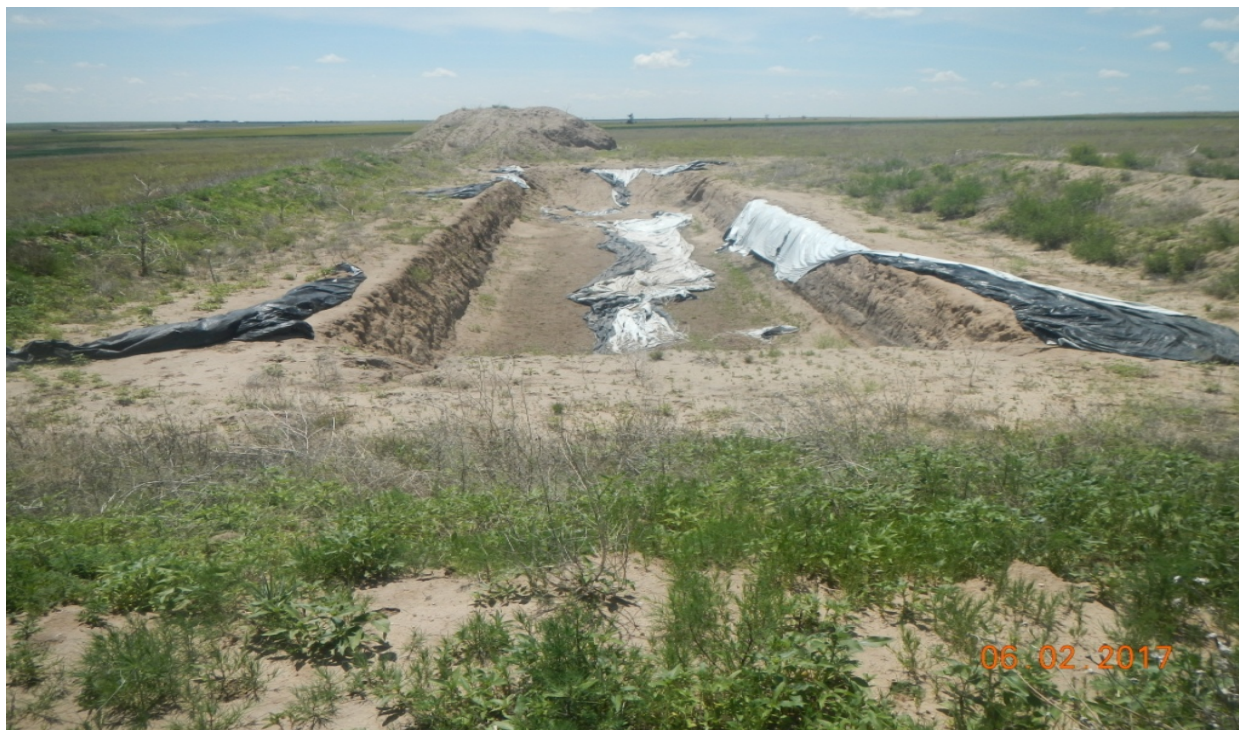
**photo 5:** Facing south at the east side of the location toward the pit.

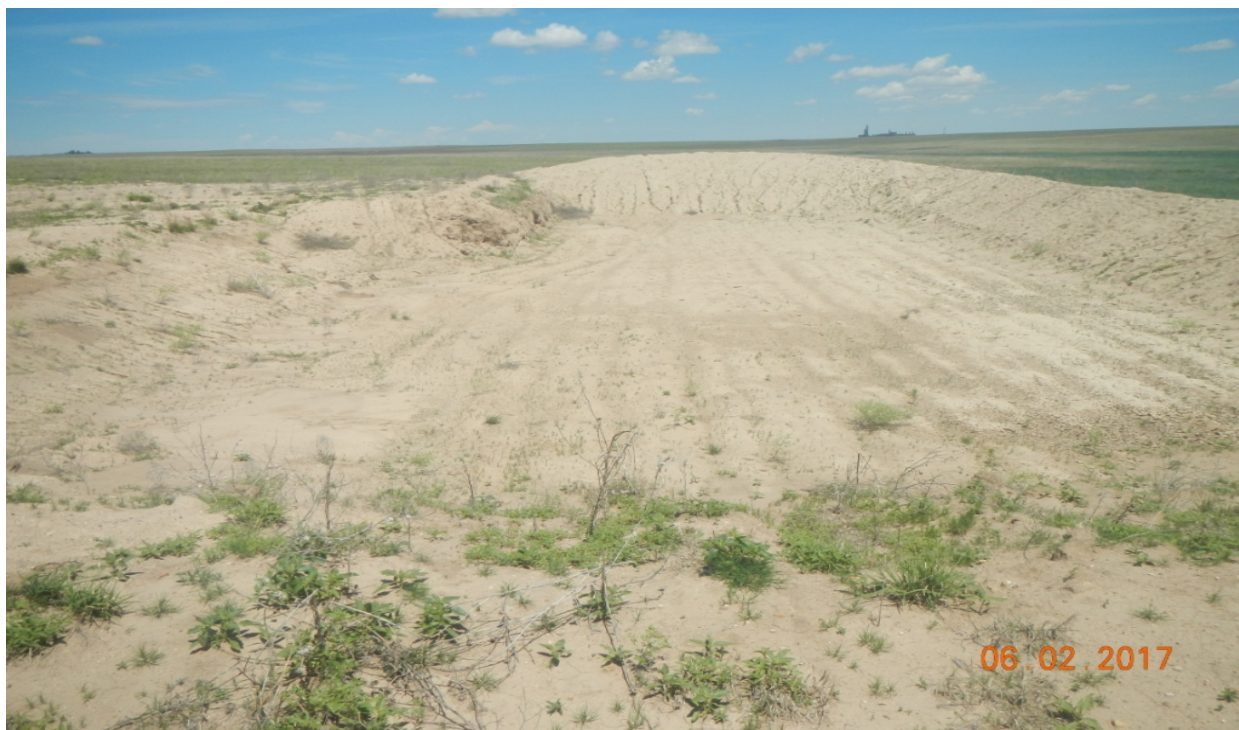
**photo 6:** A second pit remains open at the northeast side of the location.

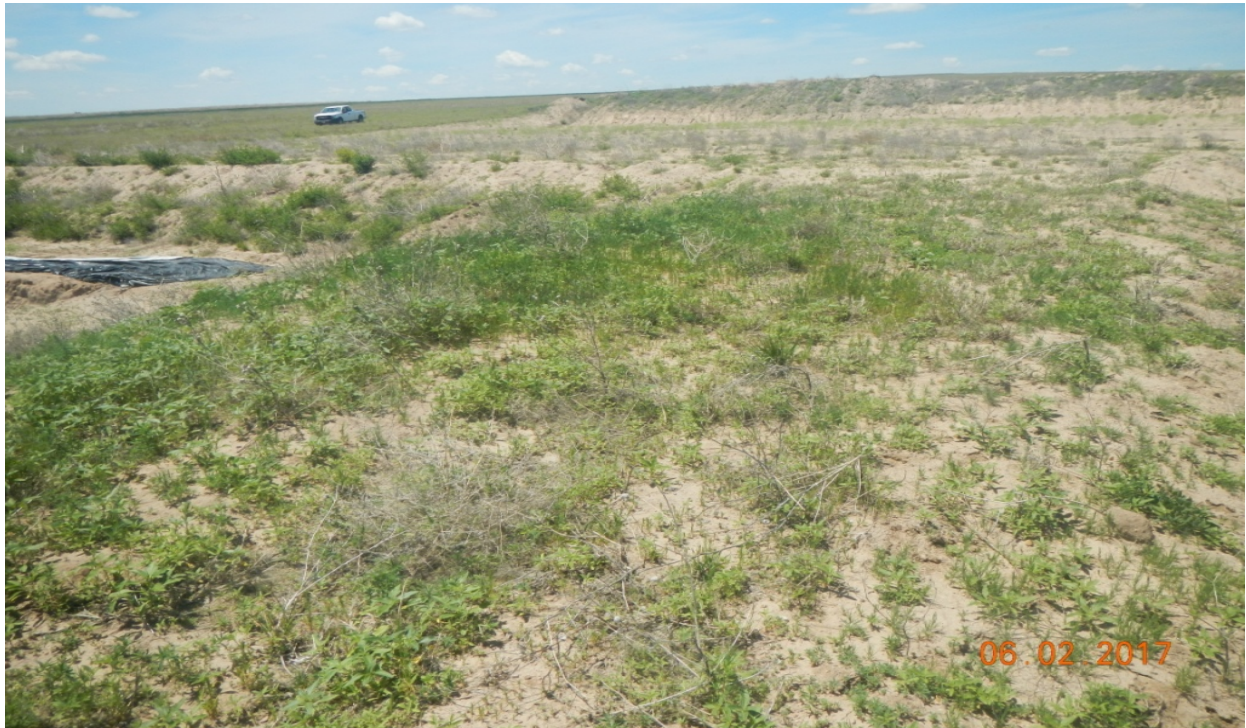
**photo 7:** East side of the location facing southwest.

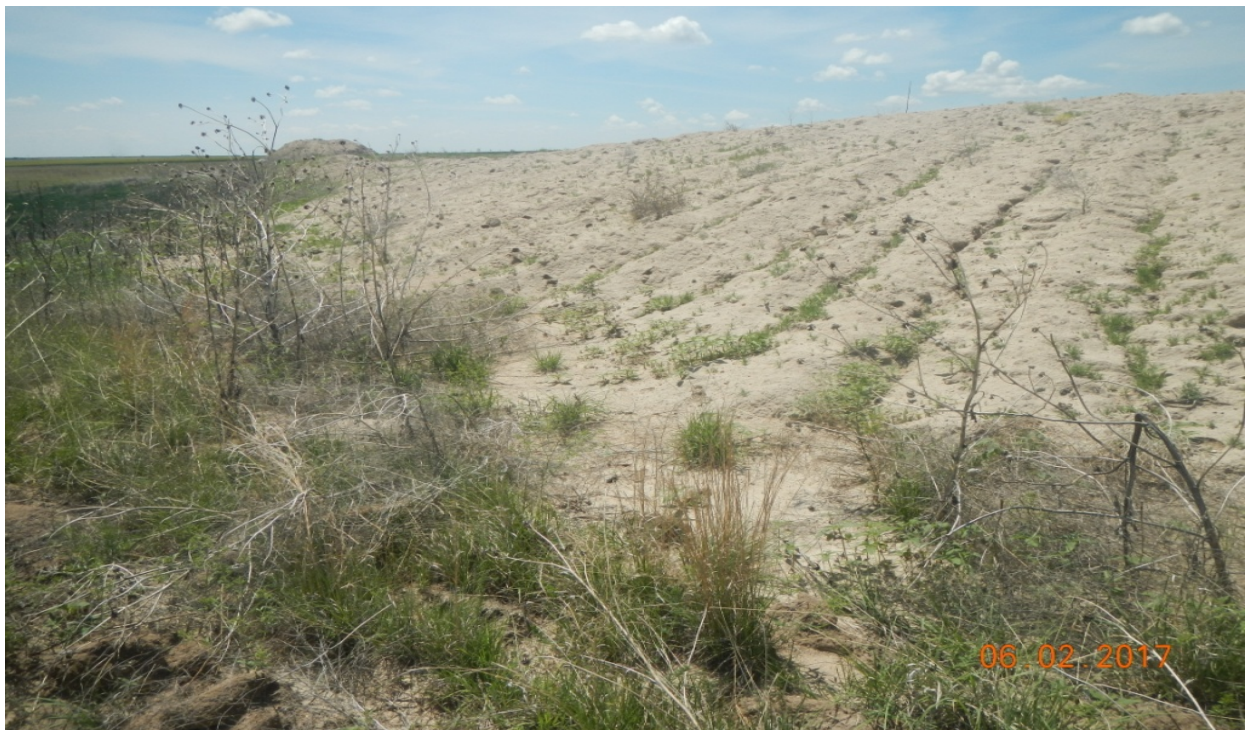
**photo 8:** Facing south along the east fill slope. There are signs of erosion occurring around the location.

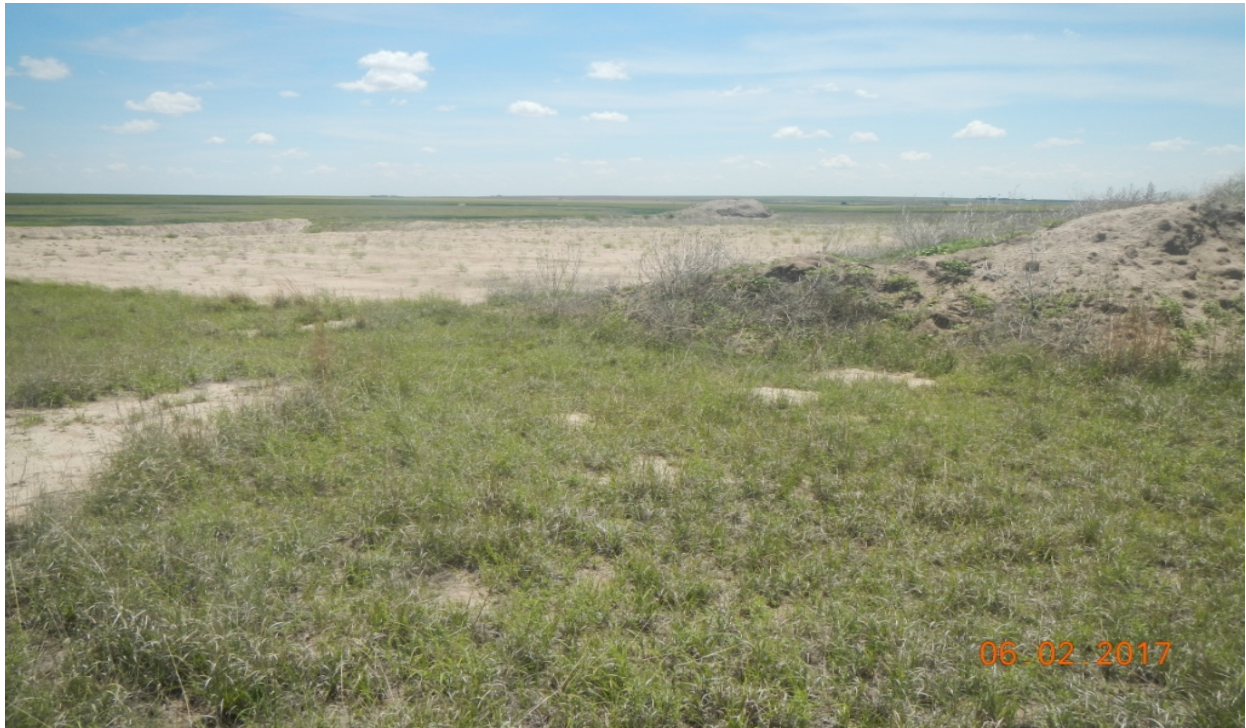
**photo 9:** Northeast corner of the location facing southeast.

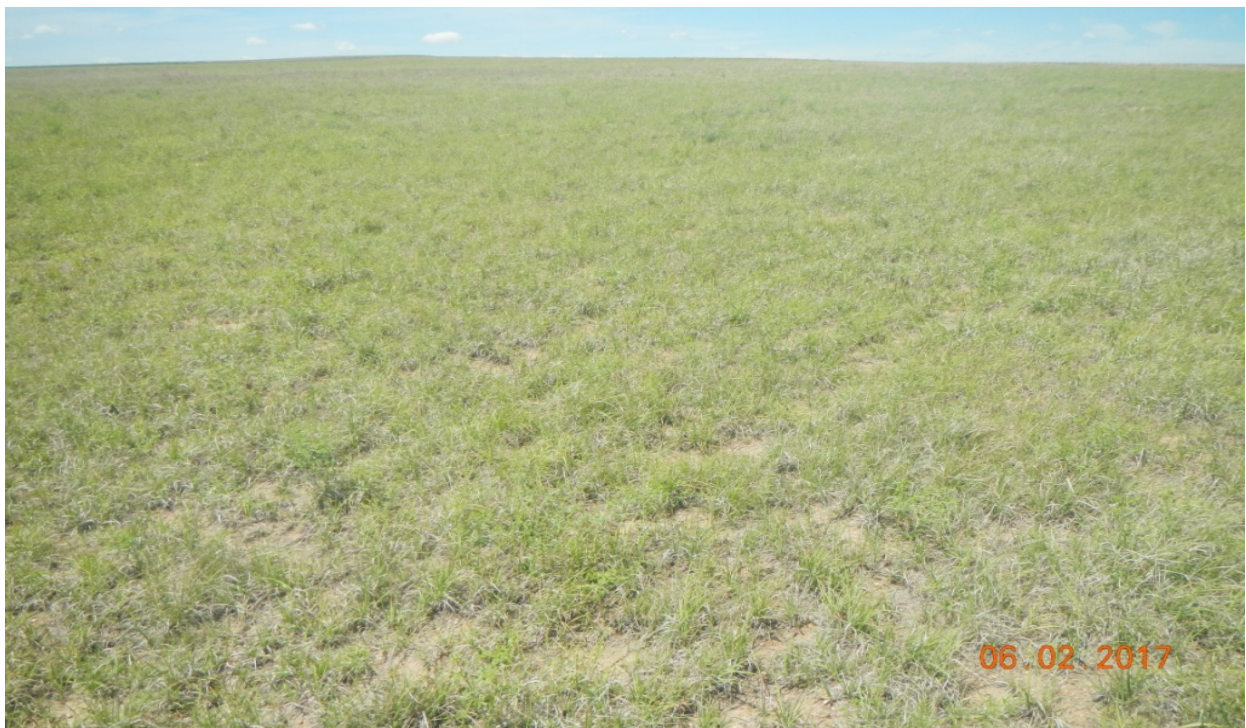
**photo 10:** Facing west at the surrounding undisturbed reference area.
