Loloff-Sand 1
API 05-123-12574
COGCC Site Inspection Photographs
June 5, 2017

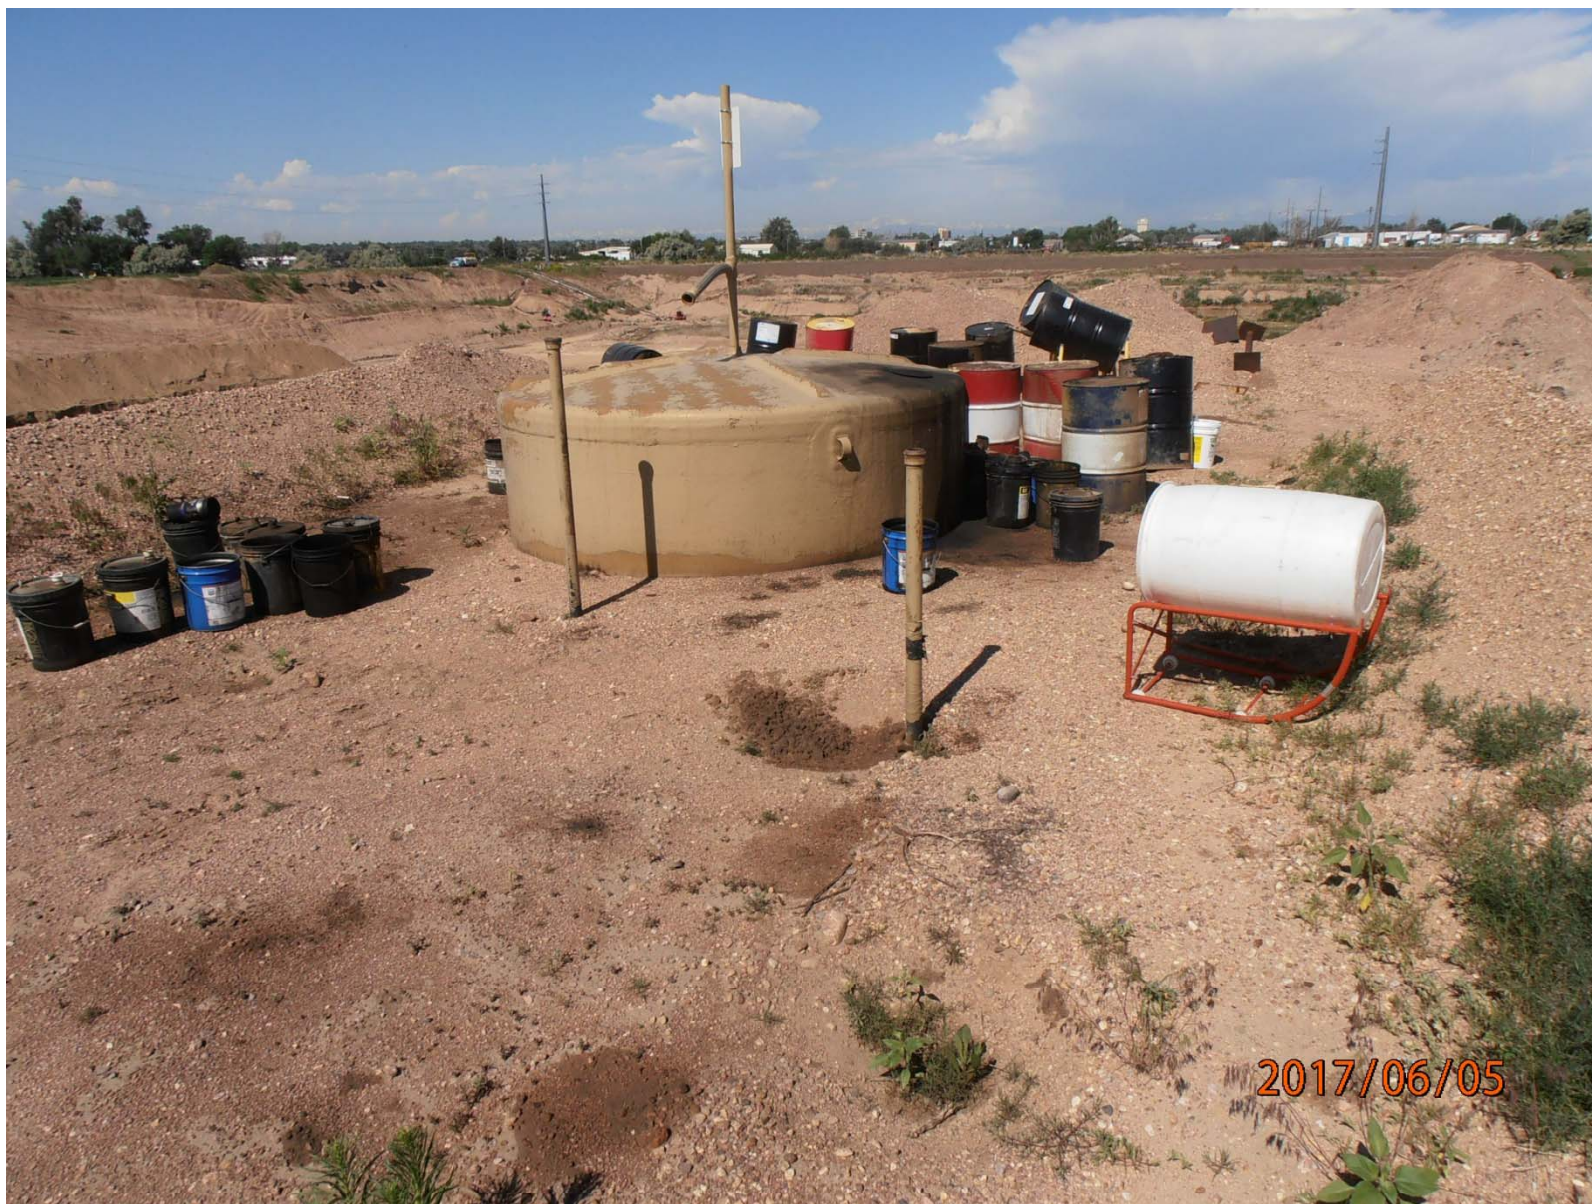
Former production facility showing risers for product piping and remaining partially buried fiberglass produced water vessel. Standing in northeast corner of containment looking west.

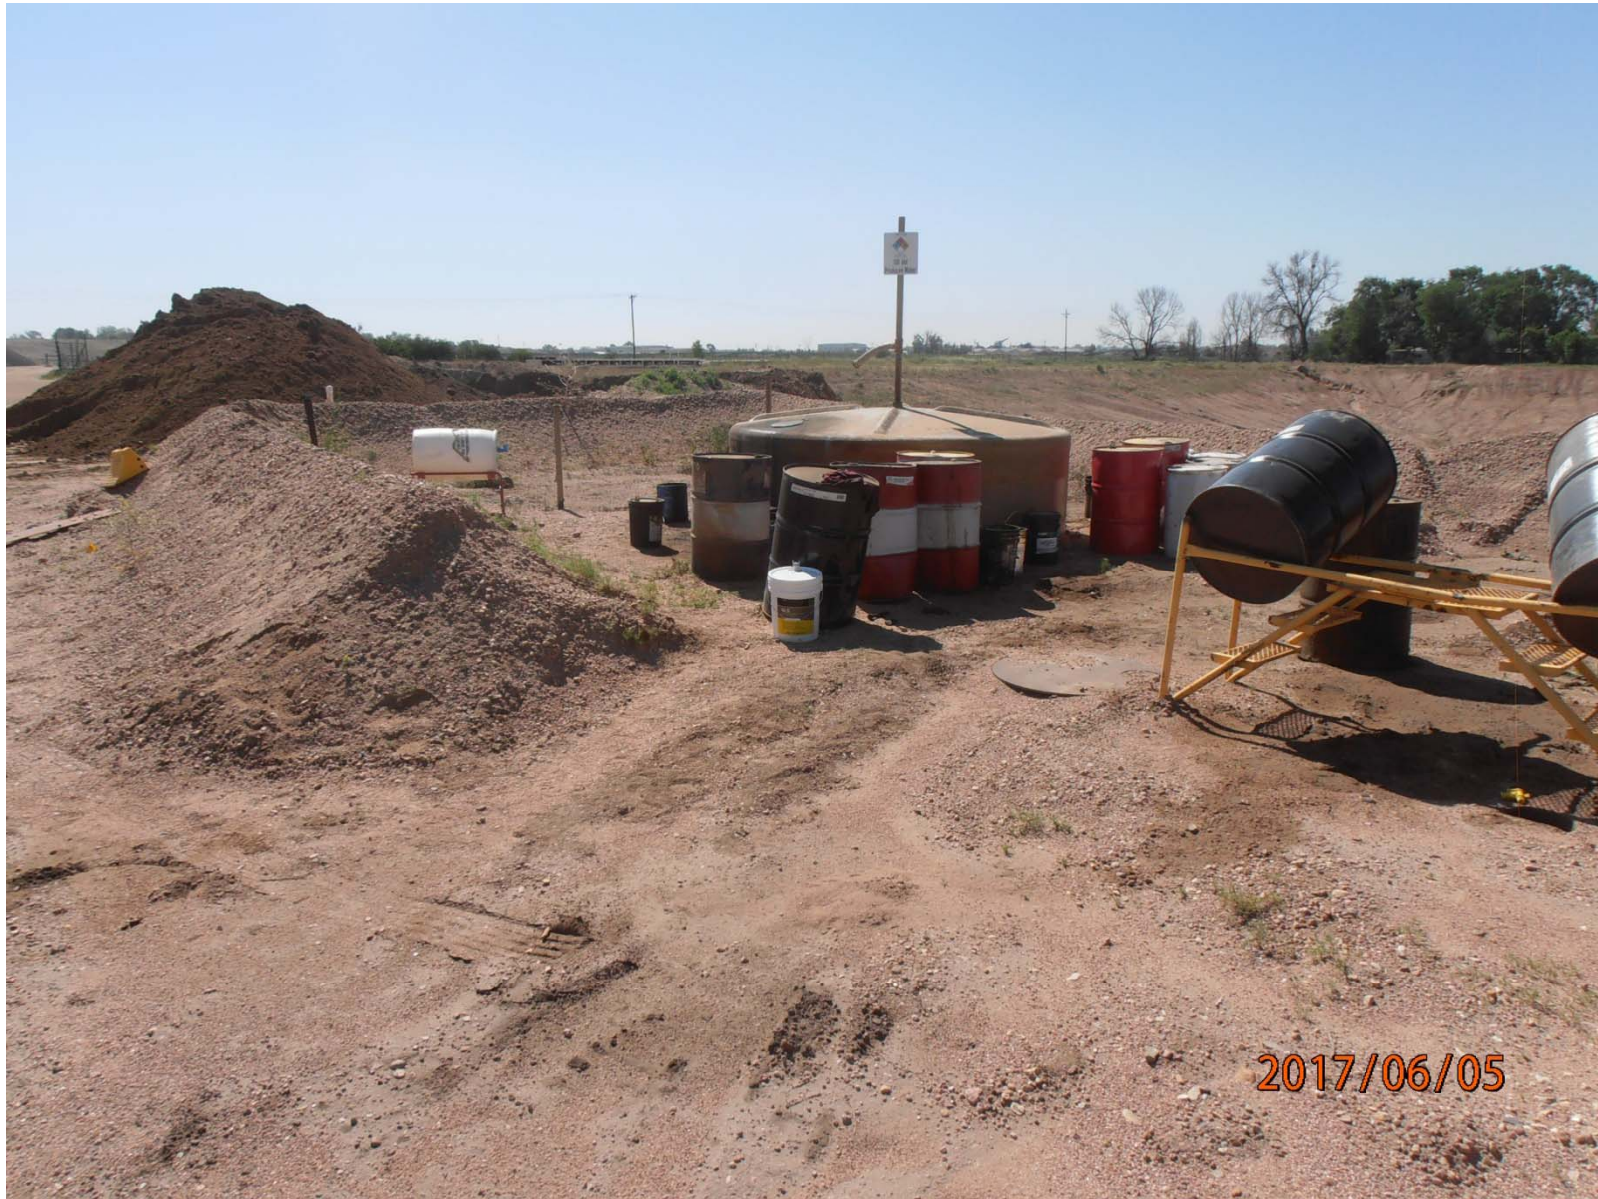
Former production facility showing risers for product piping and remaining partially buried fiberglass produced water vessel. Looking southeast.

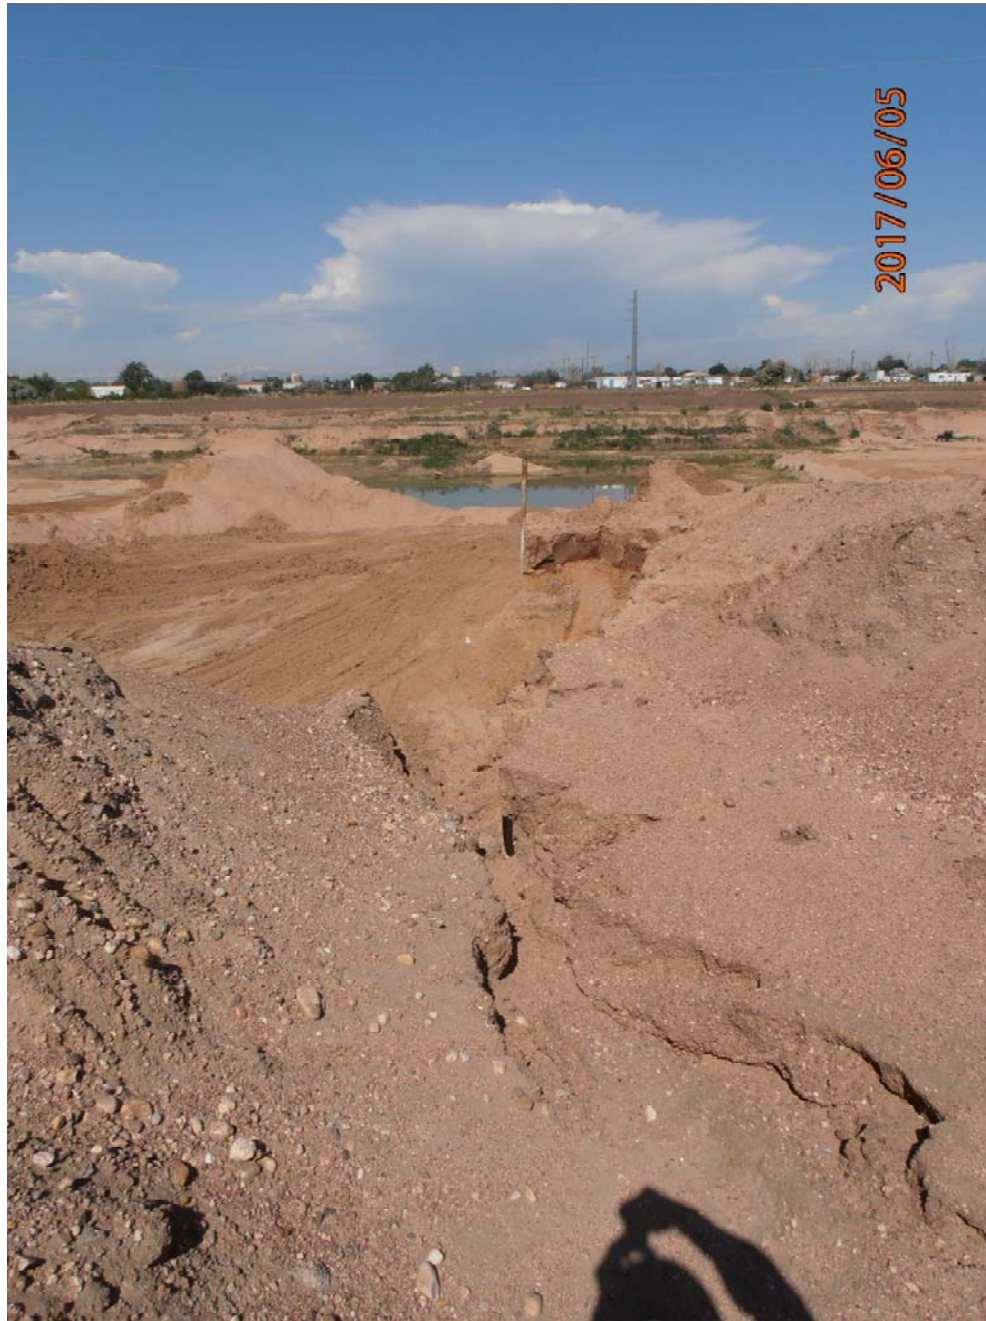
Standing near former separator, looking west at plugged and abandoned Loloff-Sand 1 well in distance.

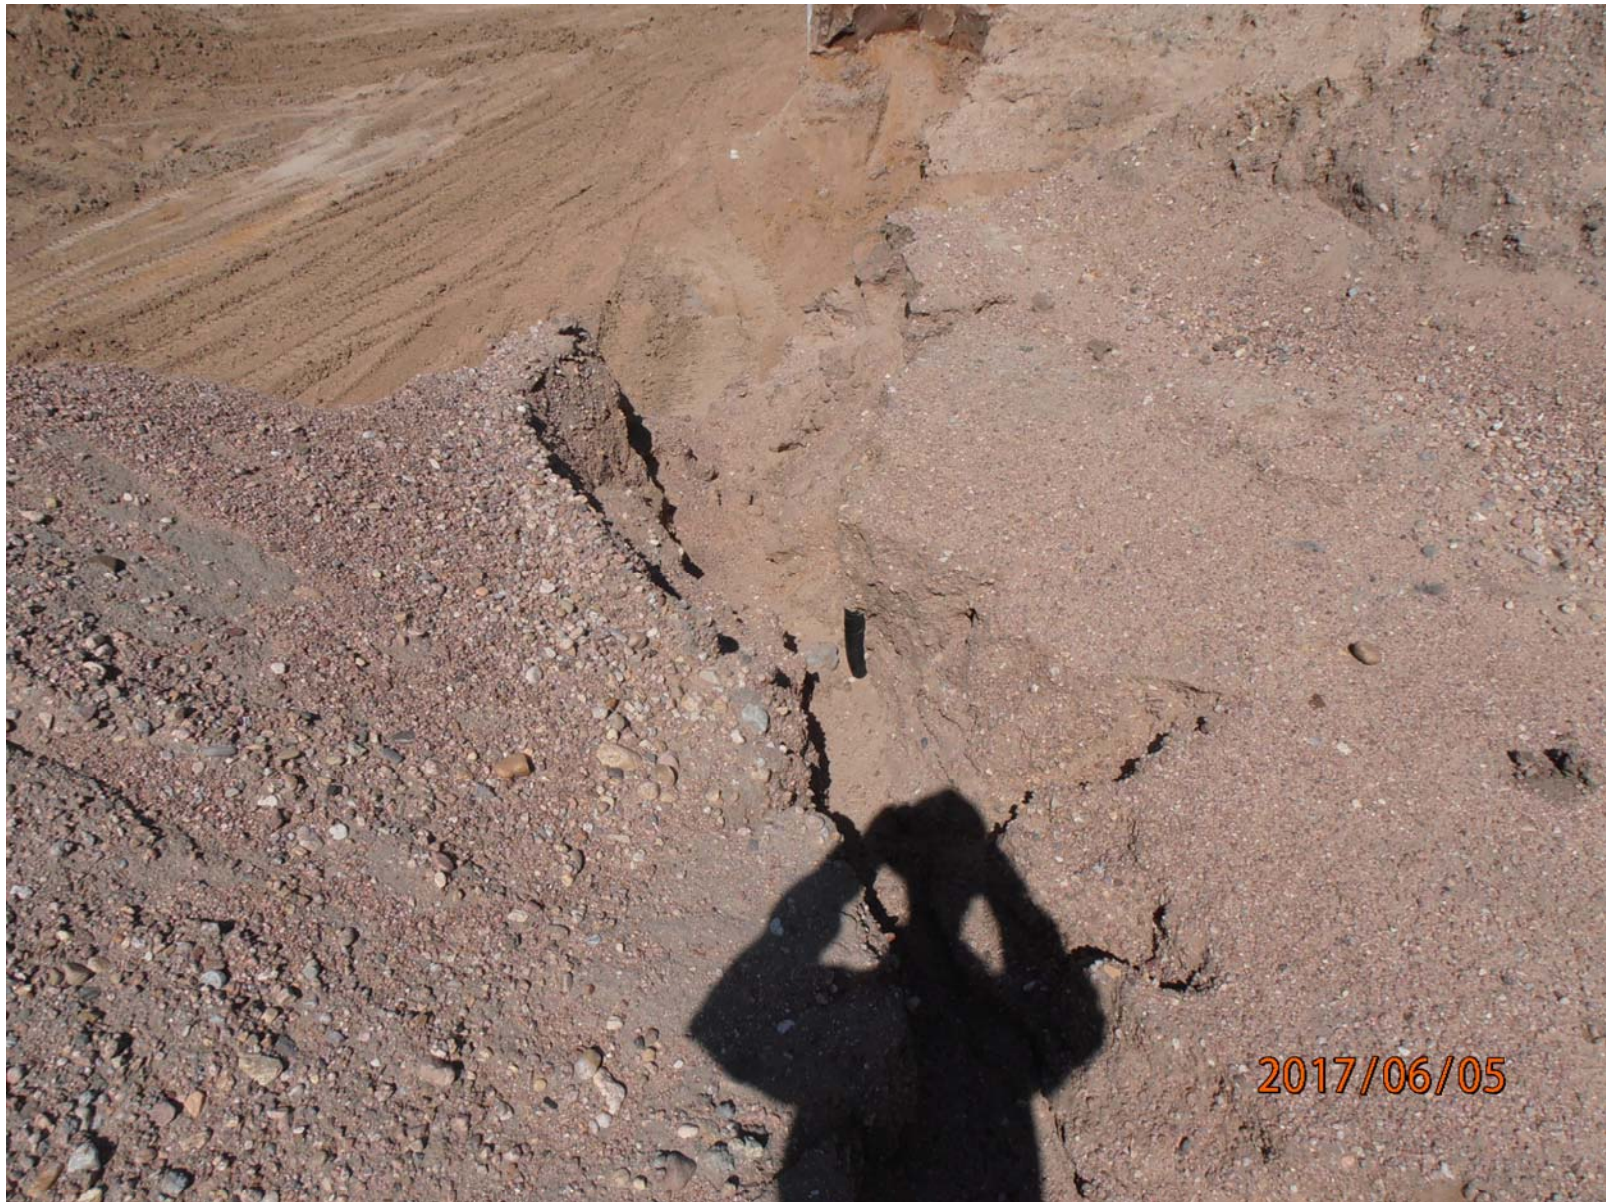
Former separator location with flowline riser visible.

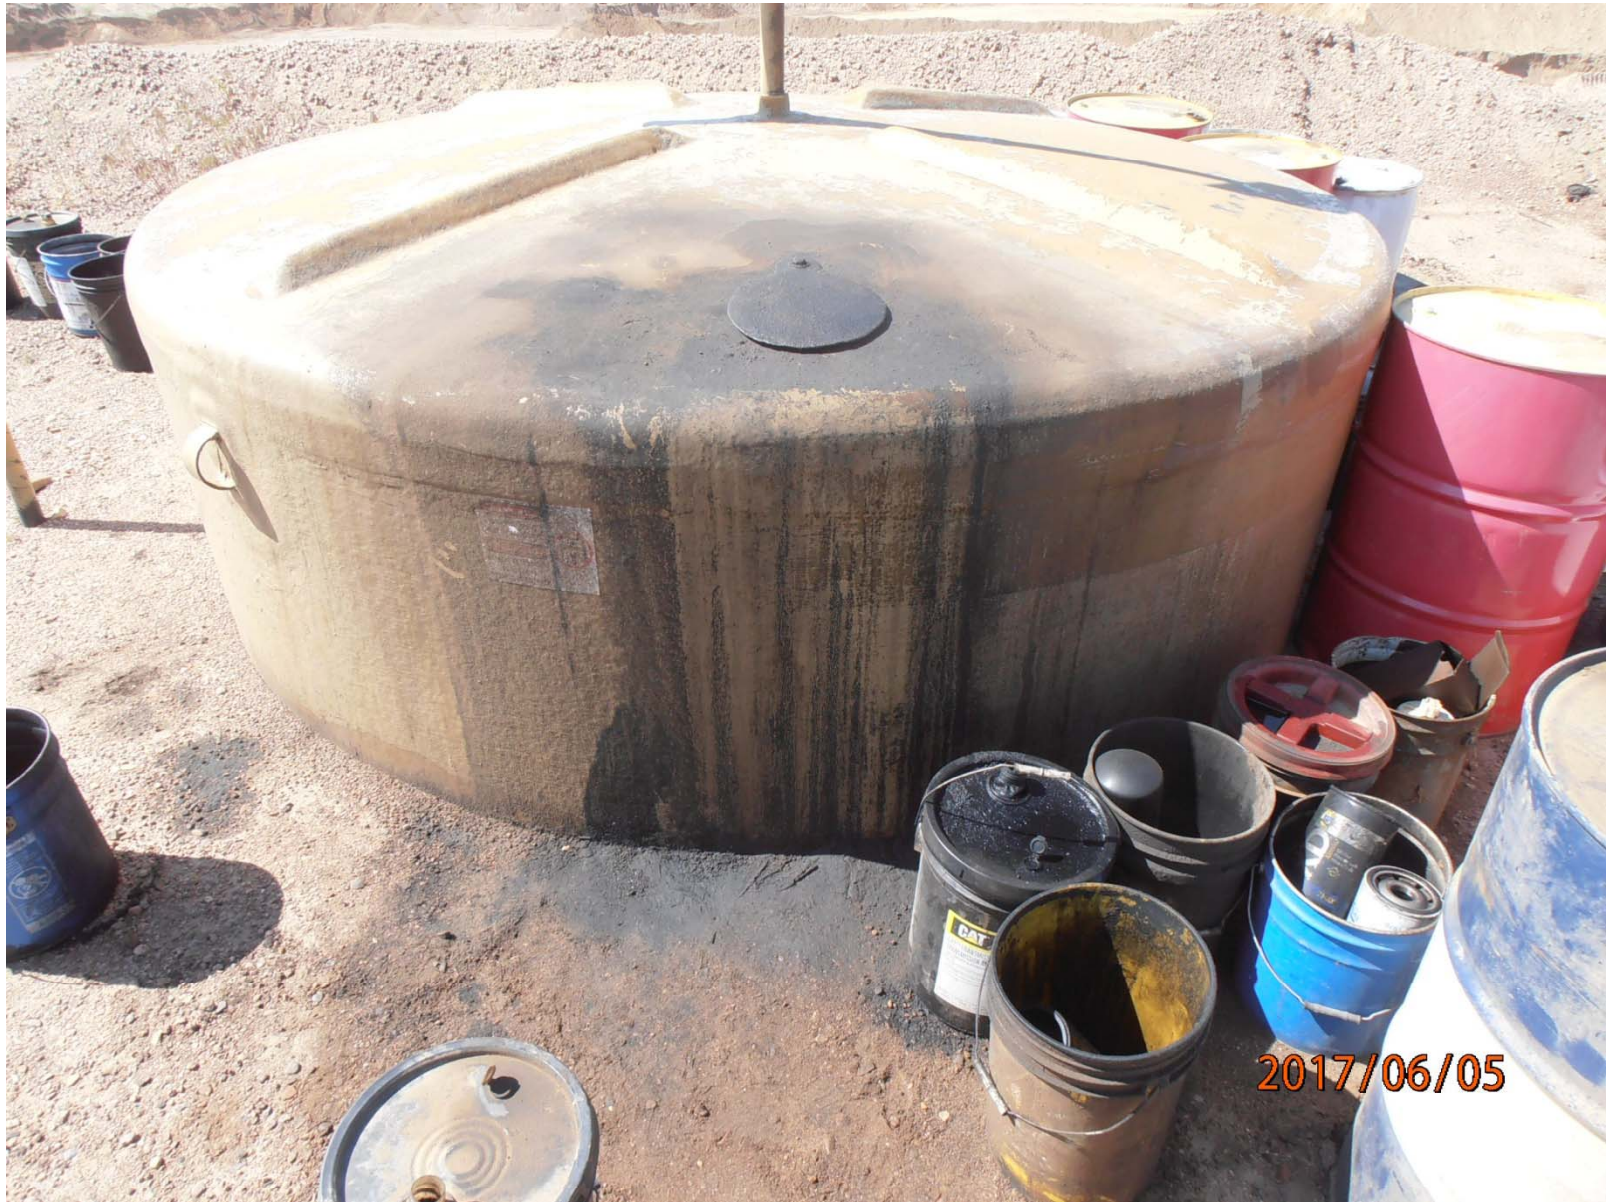
Former produced water vessel with spilled used oil.

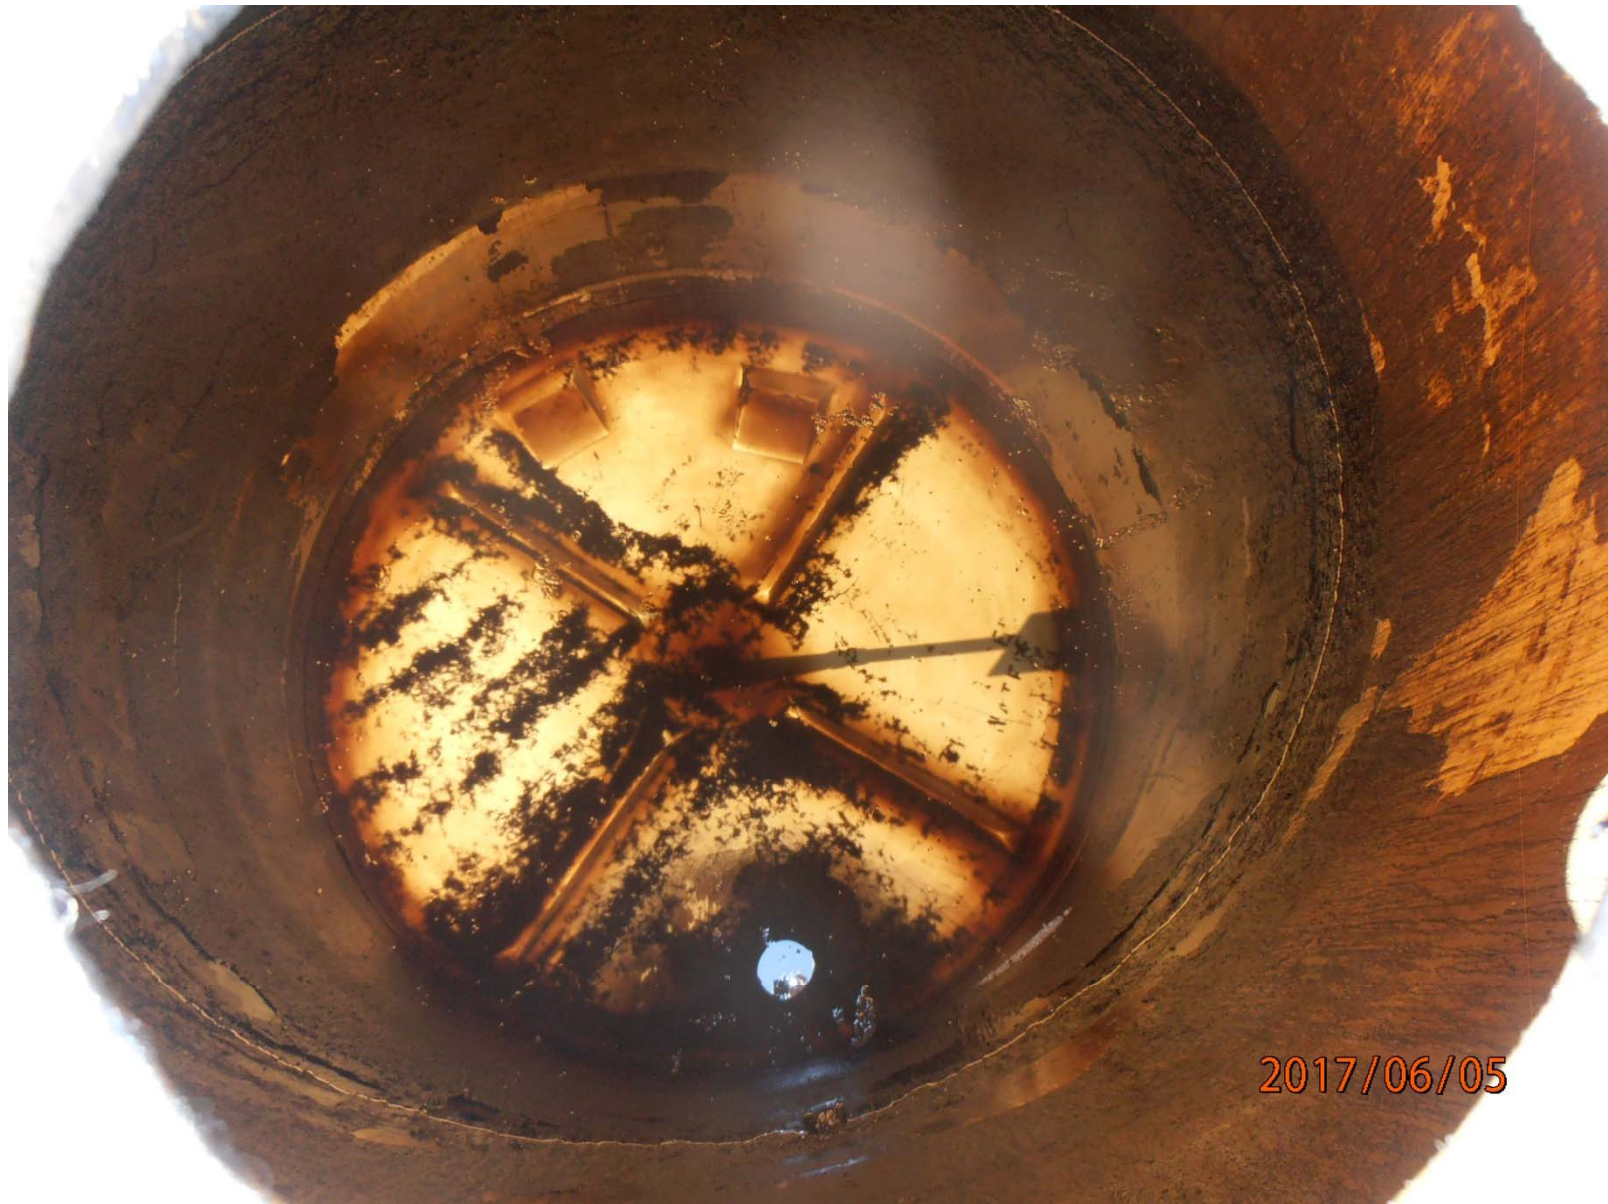
Water present in former produced water vessel.

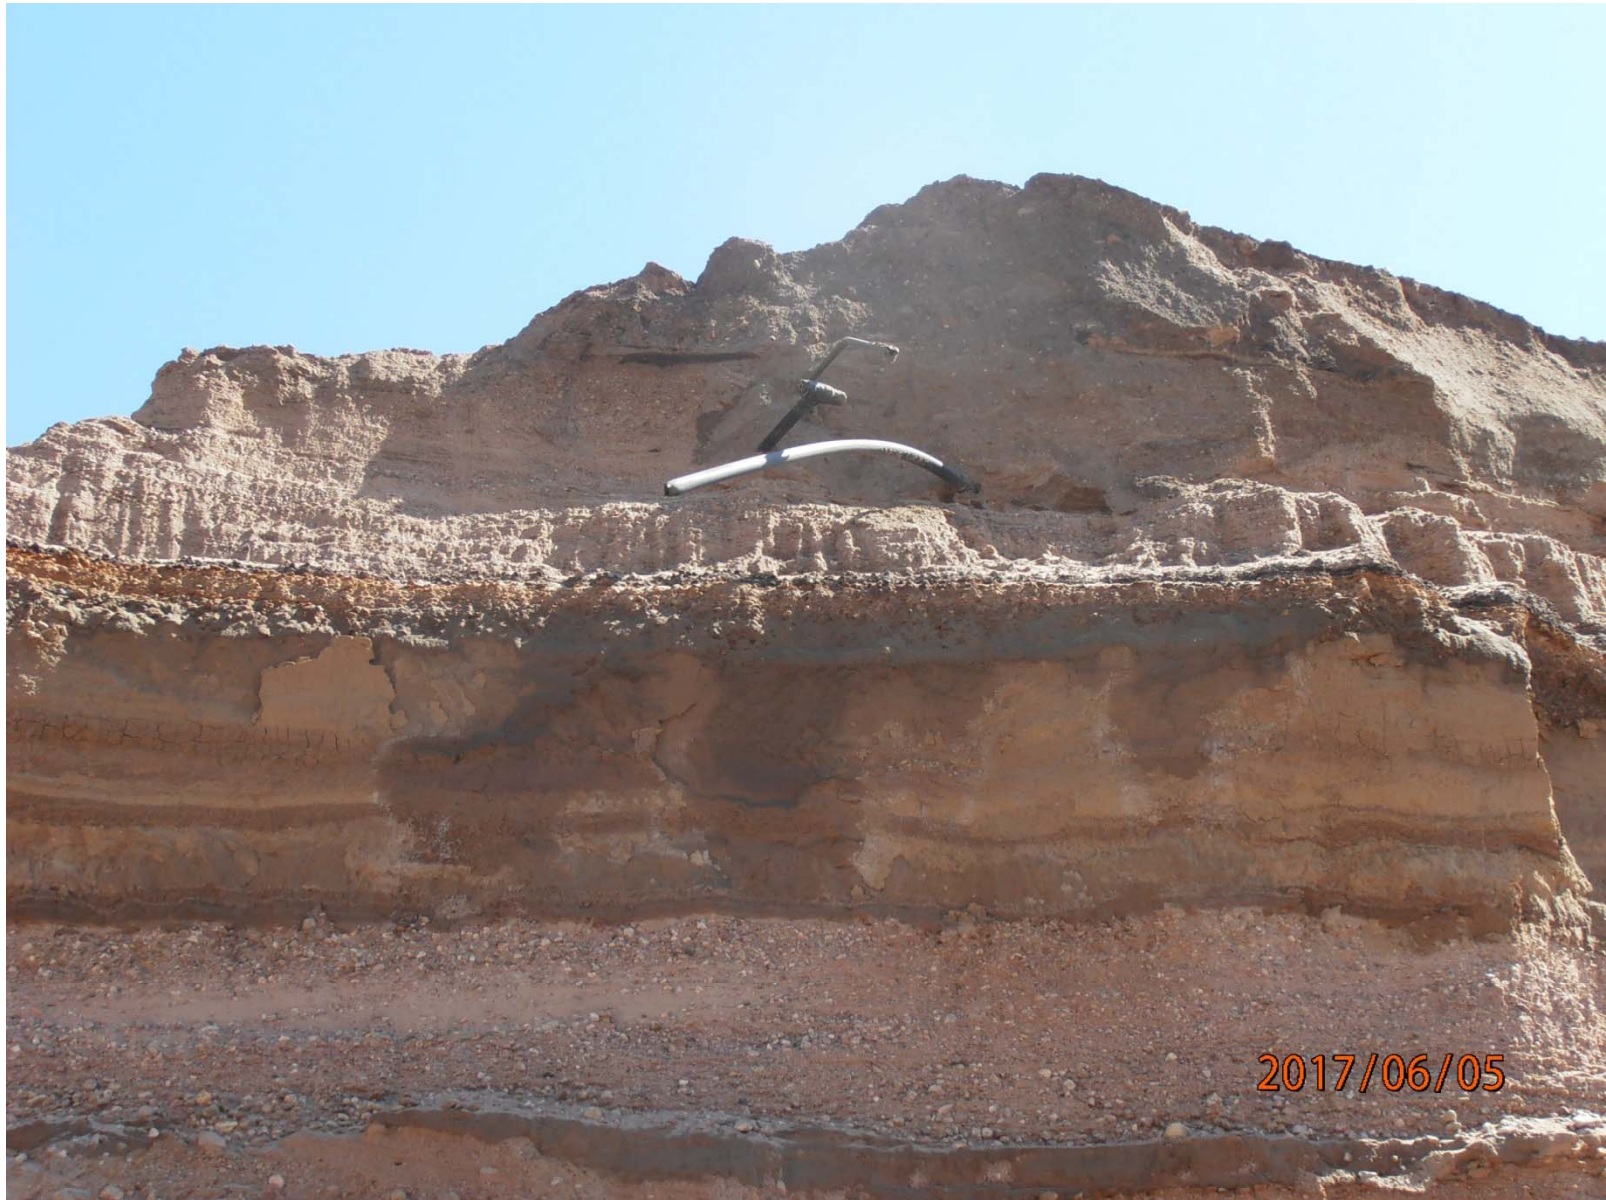
Flowlines protruding from gravel pit wall. COGCC unable to inspect sand near flowline due to safety hazard of steep excavation wall.

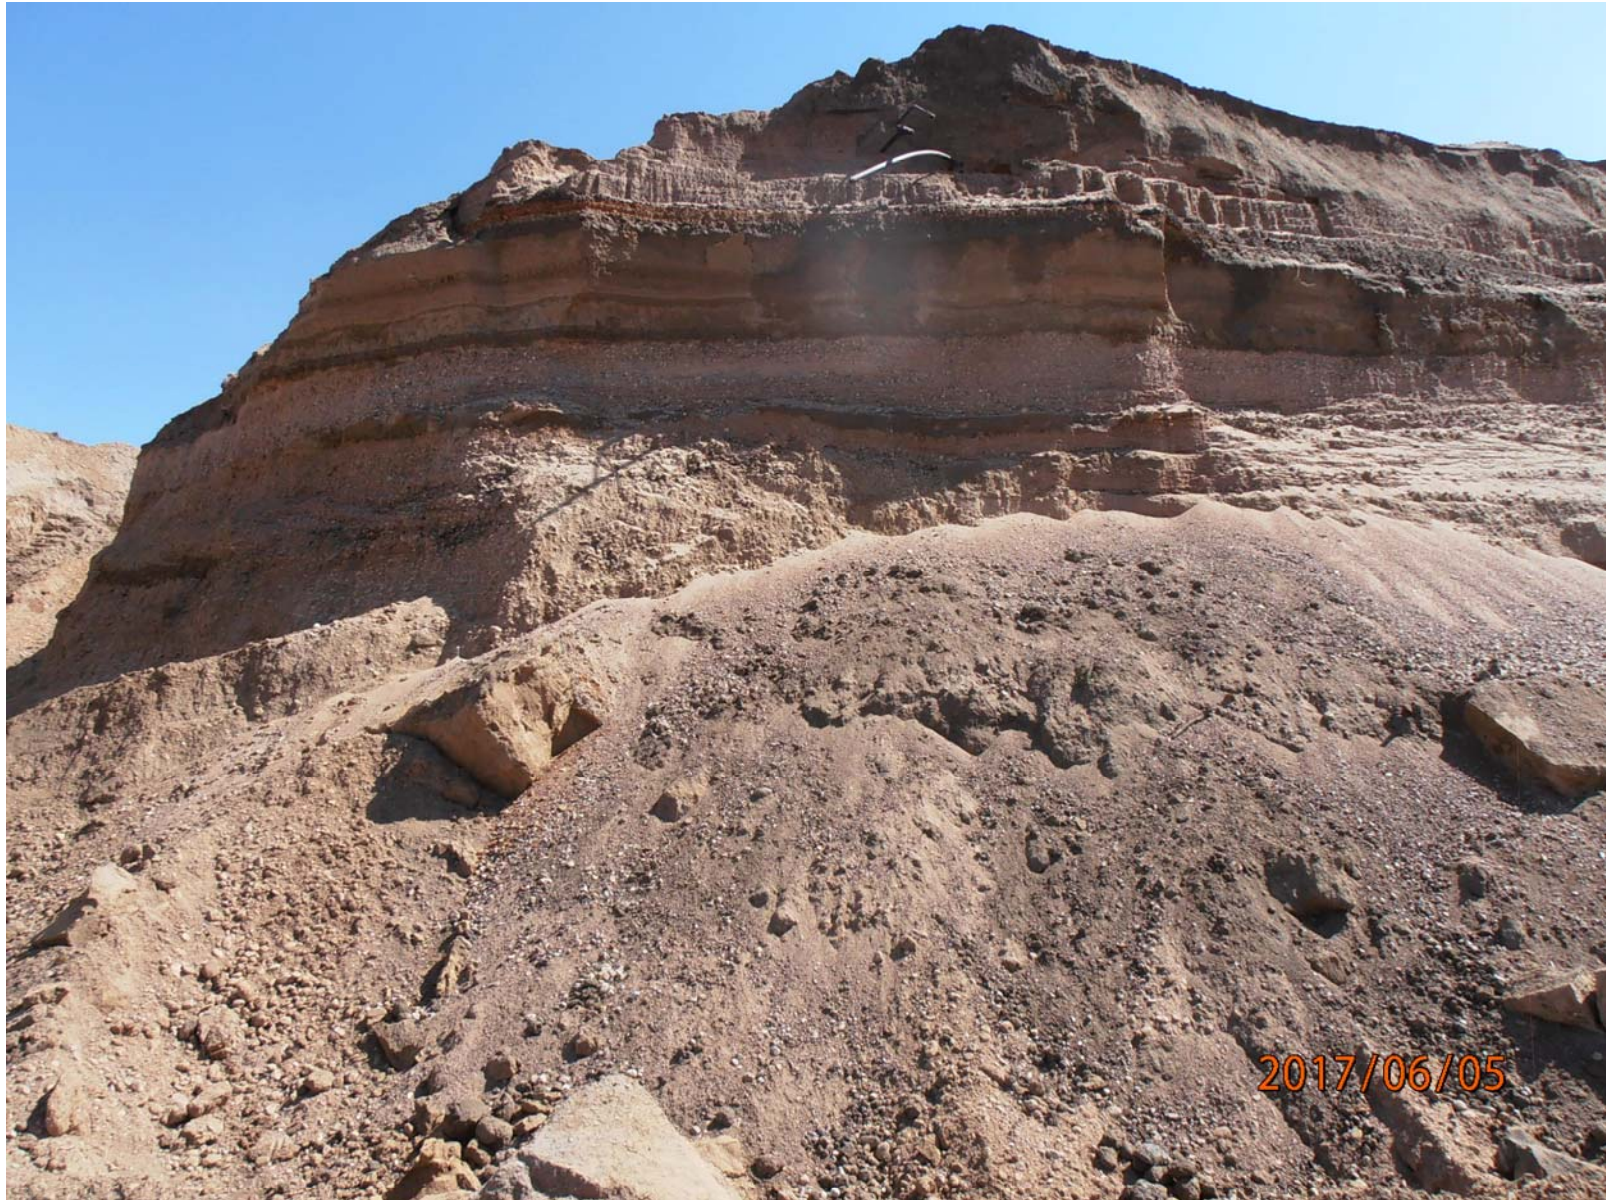
Flowlines protruding from gravel pit wall. COGCC unable to inspect sand near flowline due to safety hazard of steep excavation wall.

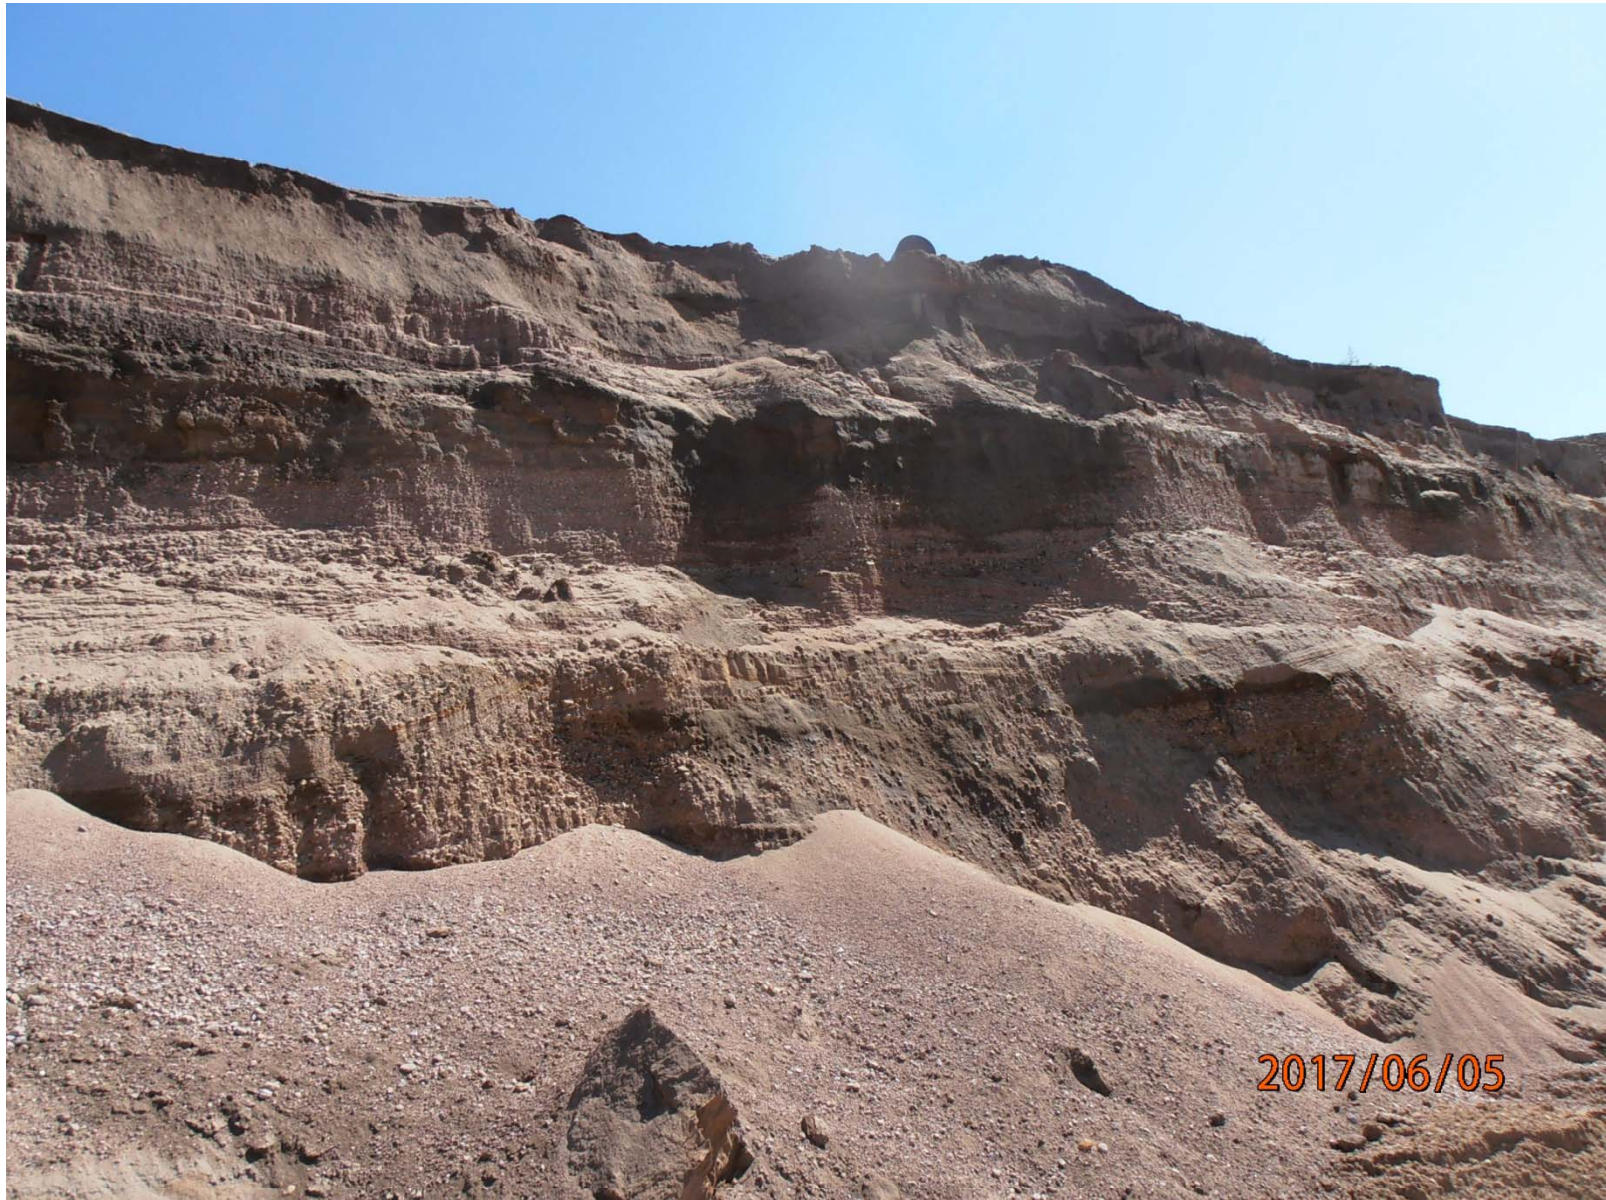
Viewing excavation wall beneath produced water vault and used oil storage area.

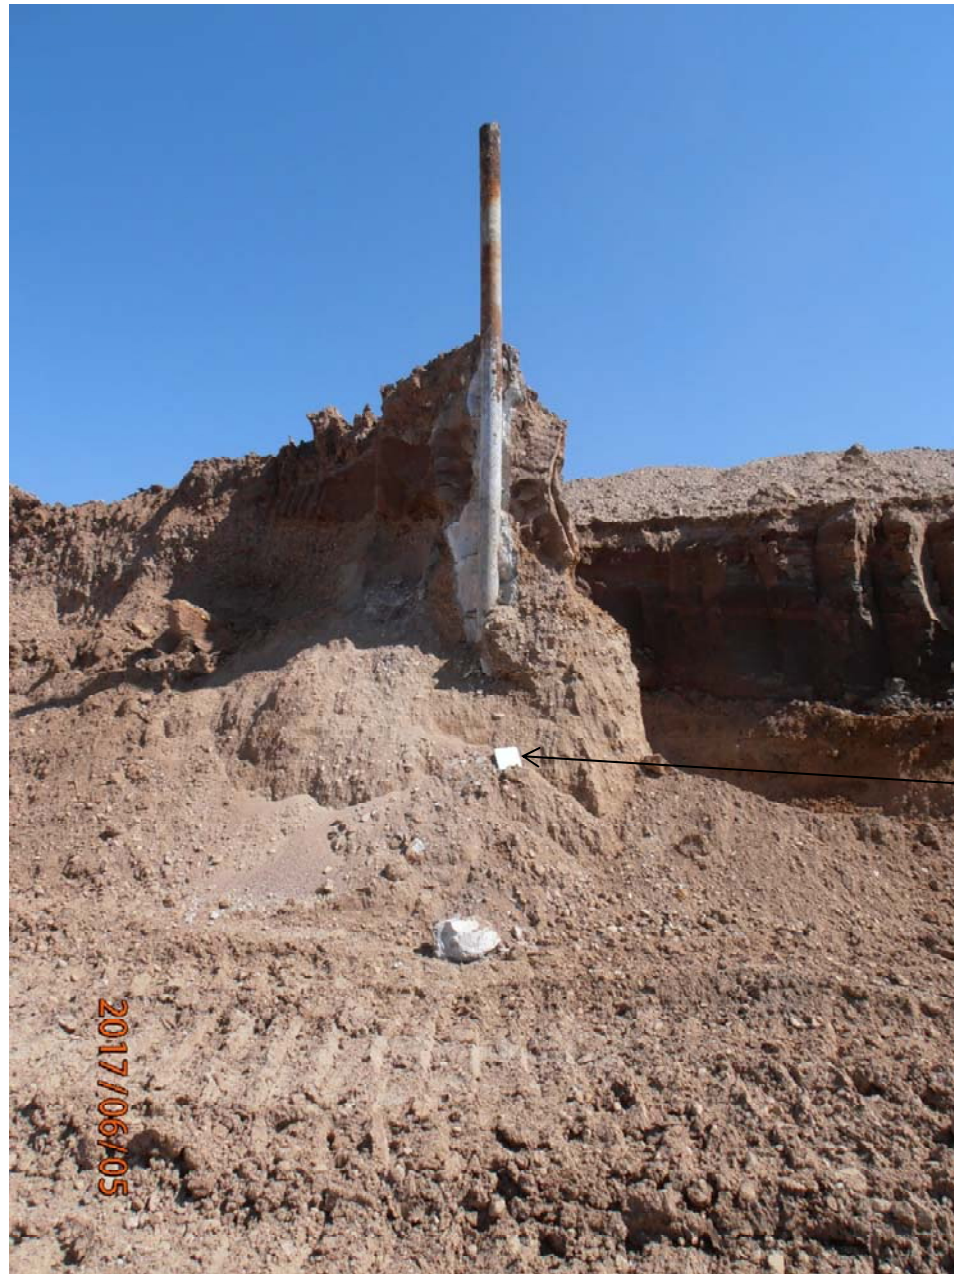
Casing of plugged and abandoned Loloff-Sand 1 in active gravel pit. 8 ½ x 11 notebook for scale.
