COGCC Environmental Field Inspection Report Photo Attachment

Inspection Date: June 6, 2017

Steven J. Arauza, P.G.

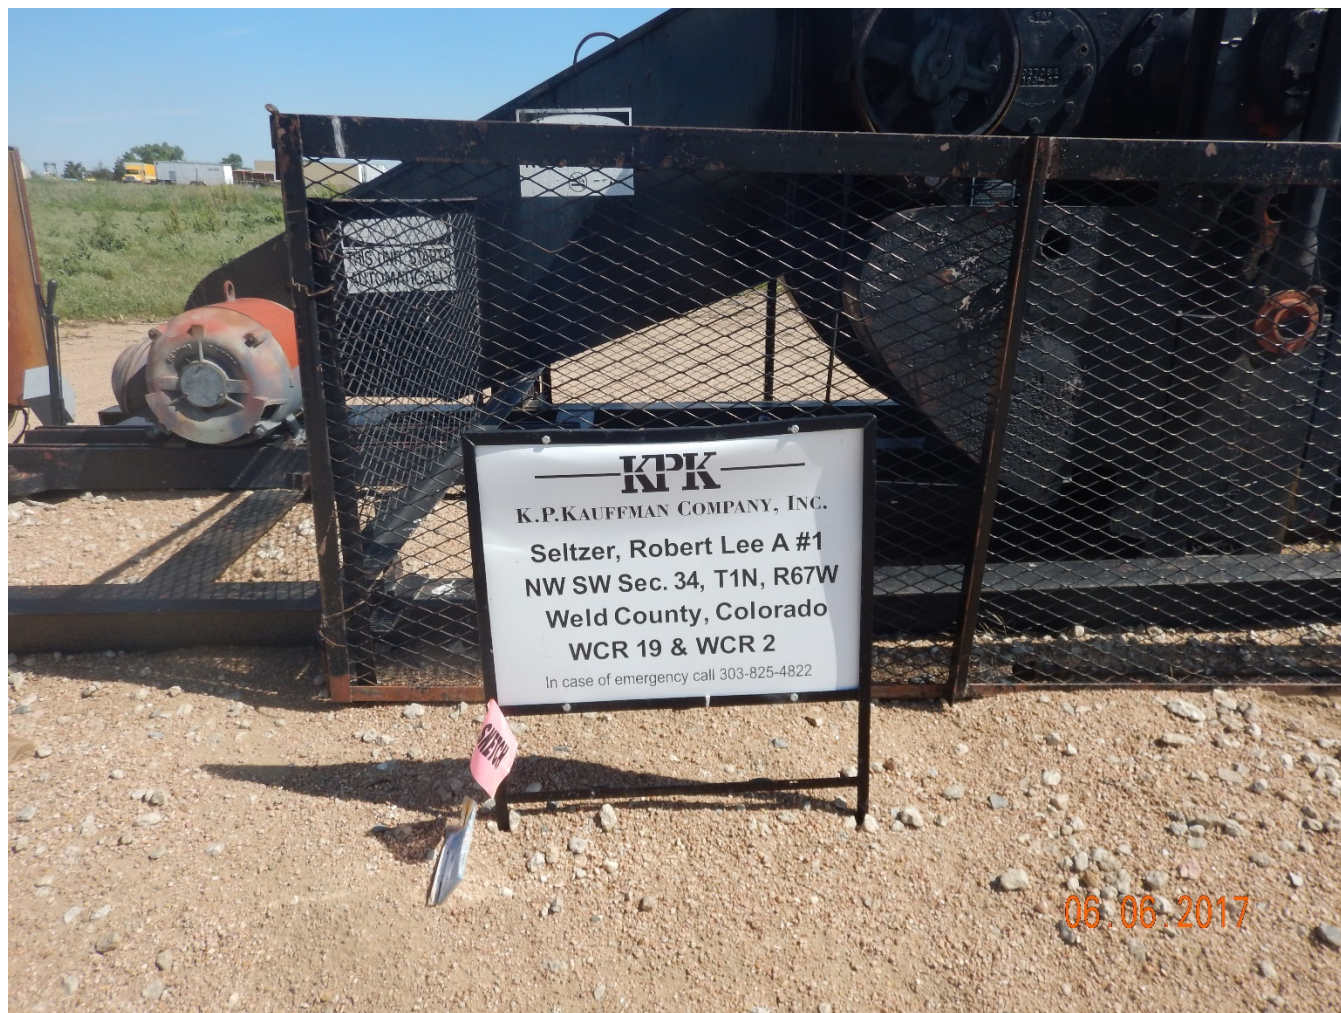
Photo 1 - Wellhead sign. Note that the well is identified as "Seltzer, Robert Lee A #1" rather than Seltzer #1-A, as indicated on COGCC filings.

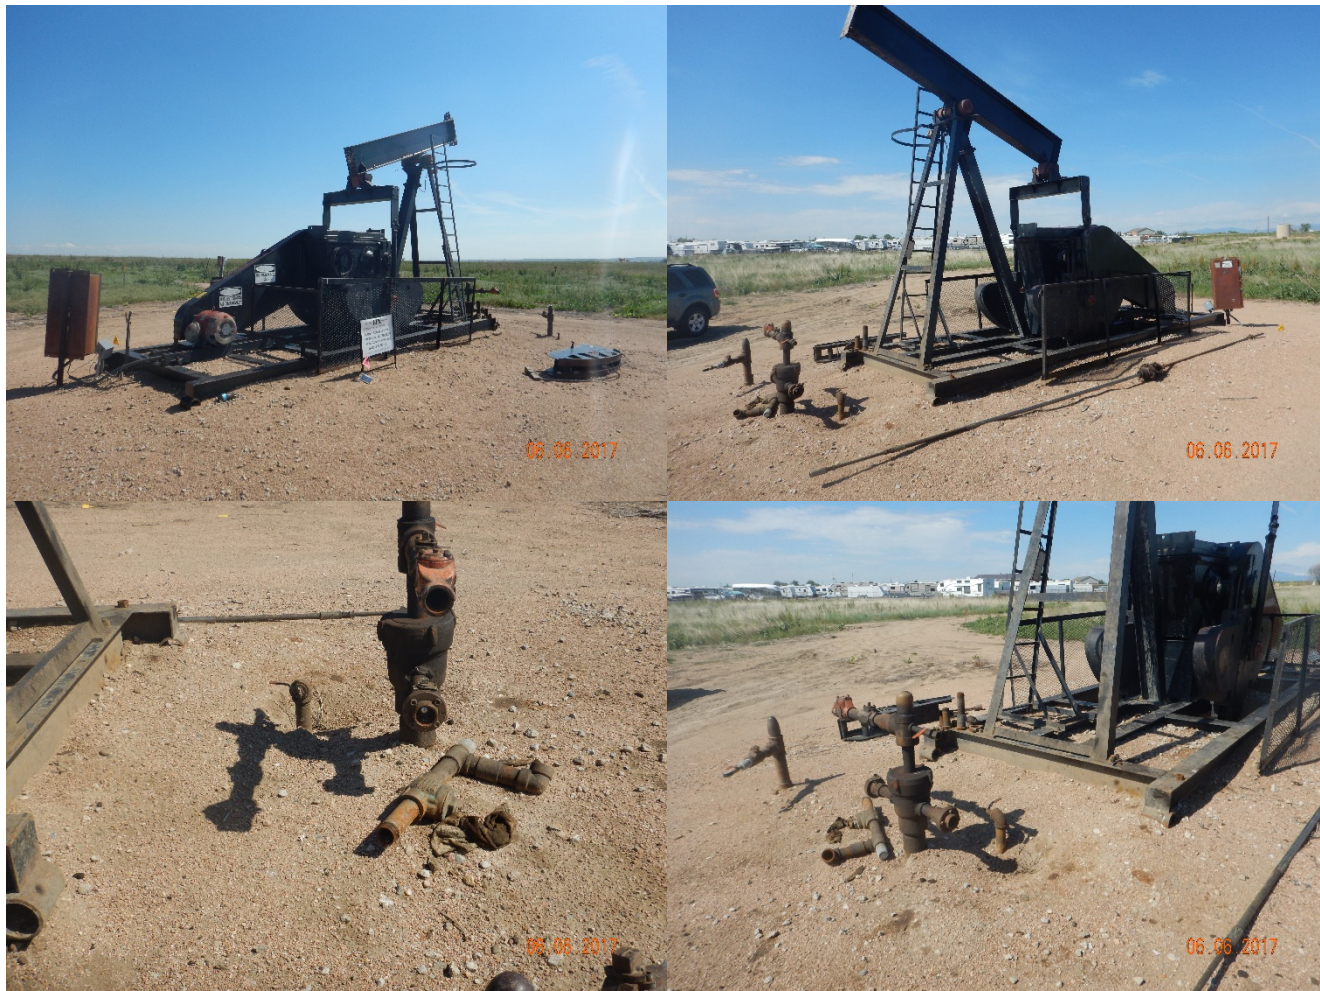
Photos 2, 3, 4, & 5 - Pumping unit and wellhead are currently disassembled, rendering well incapable of production. Note absence of bullplugs on wellhead and flowline risers. Flowline risers are out of compliance with 2017 Flowline NTO.

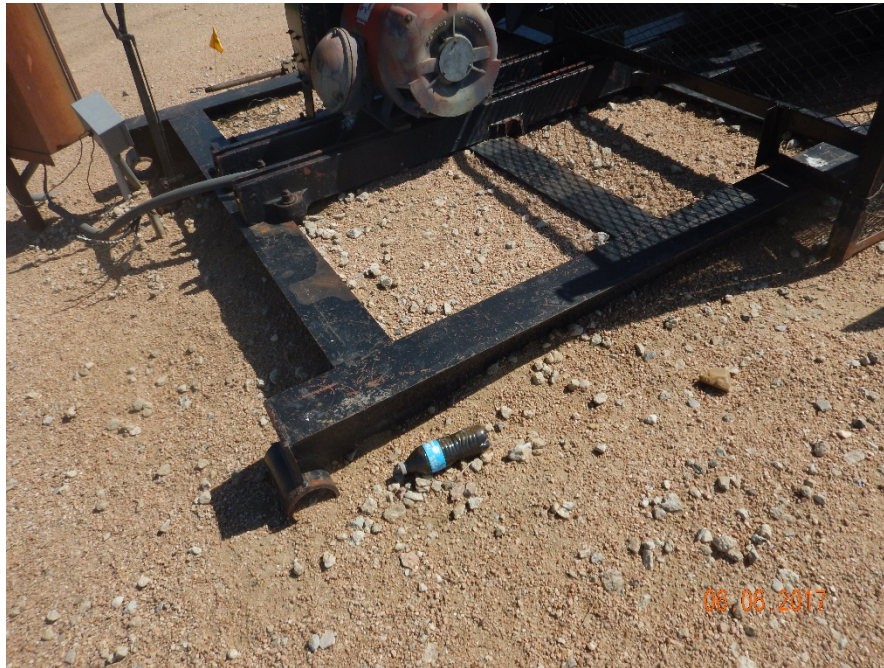
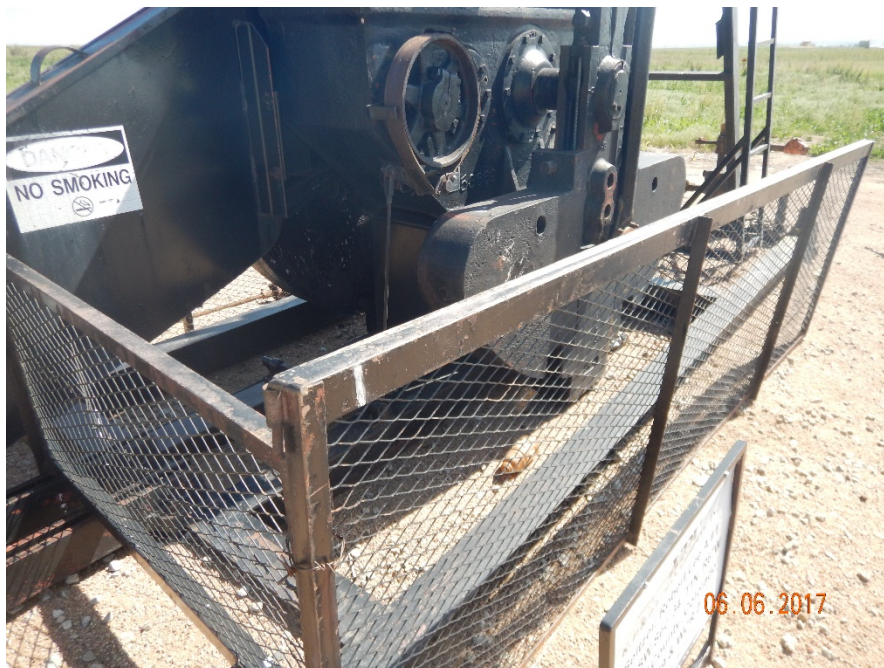
Photos 6 & 7 - Trash (bottles of unidentified liquids) at pumping unit.

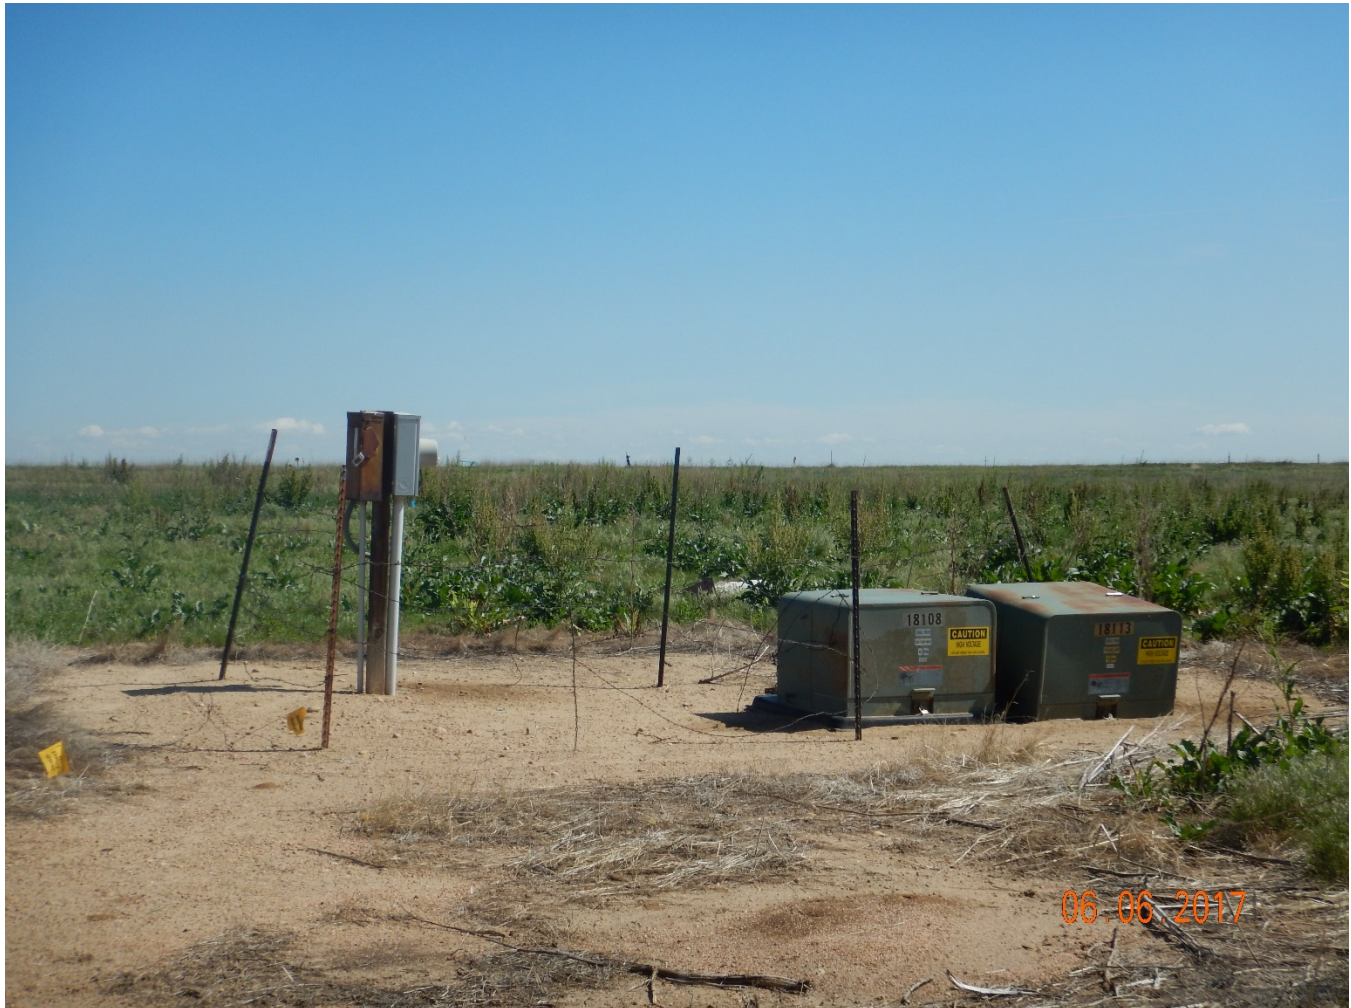
Photo 8 - Electrical control box and transformers NE of pumping unit. Note: barbed wire fence in need of repair.

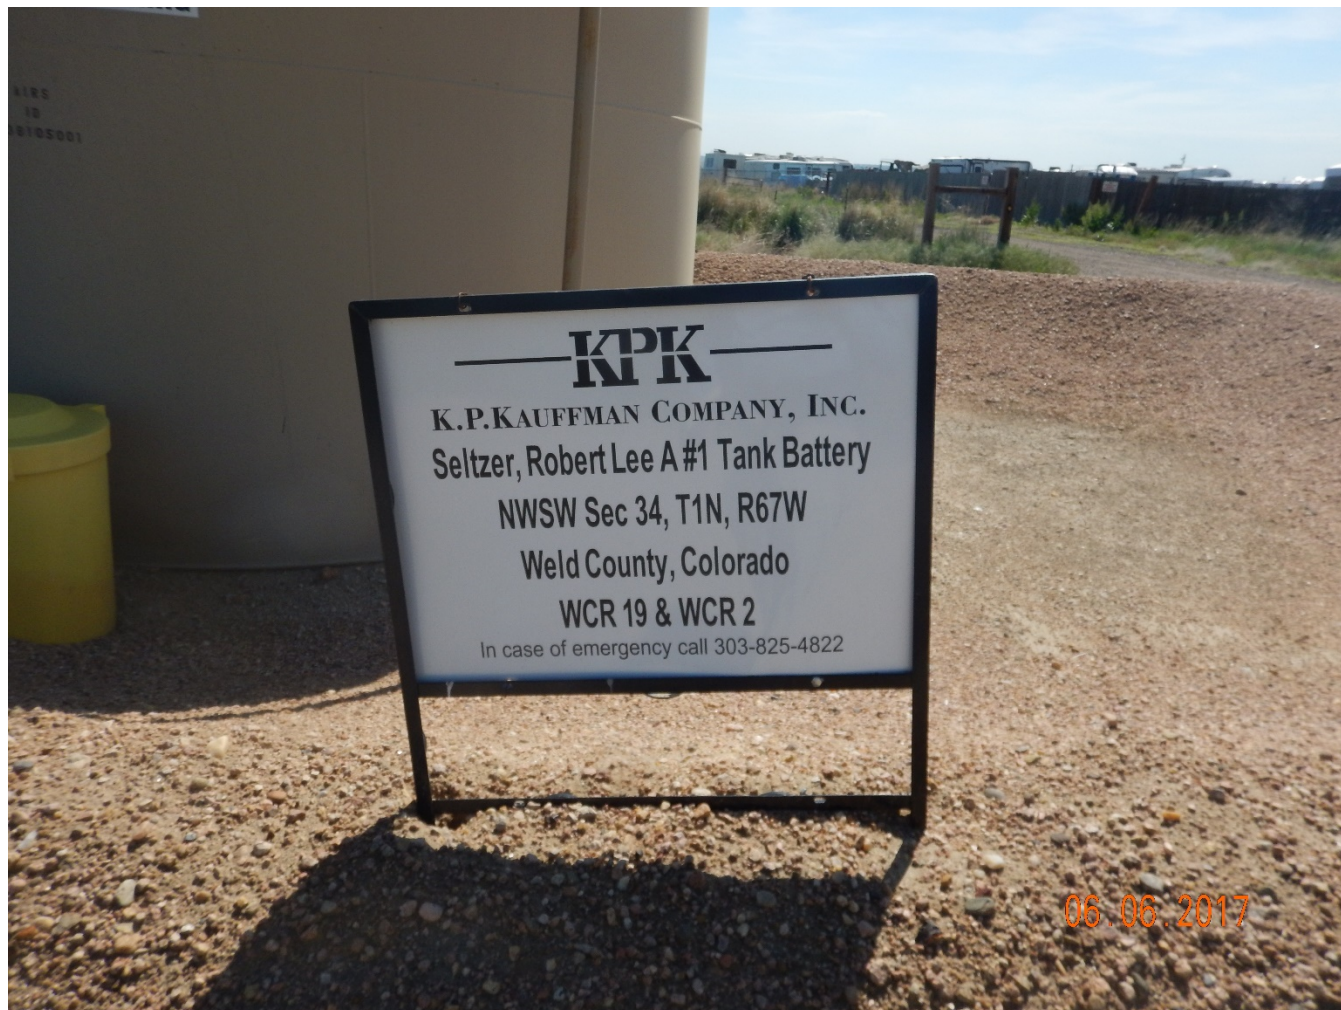
Photo 9 - Battery sign identifies facility as "Seltzer, Robert Lee A #1 Tank Battery"

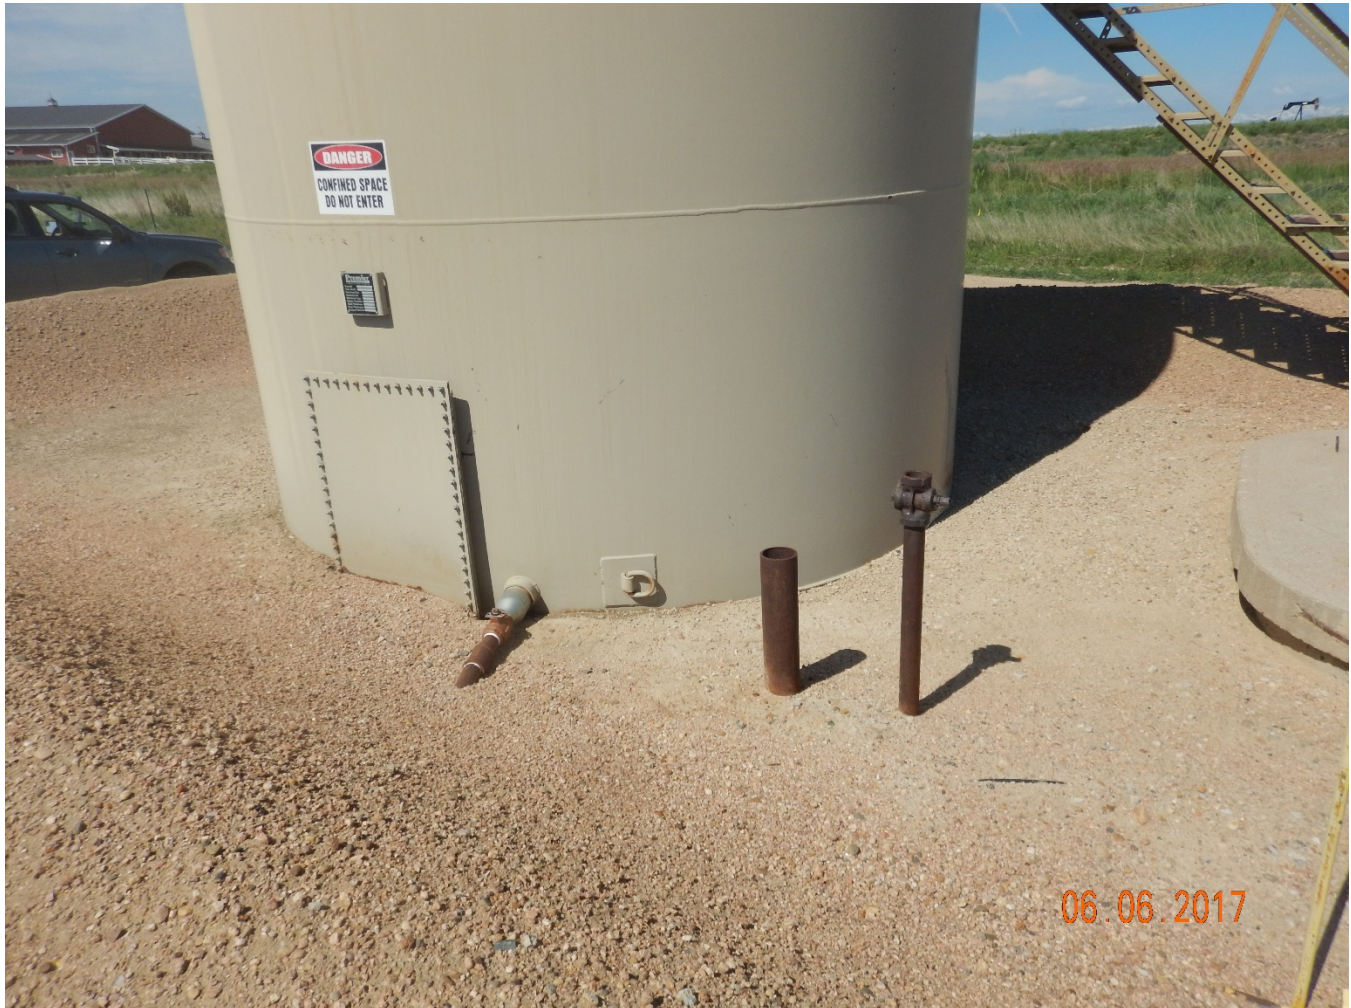
Photo 10 - Flowline risers NE of tank battery are out of compliance with 2017 Flowline NTO.

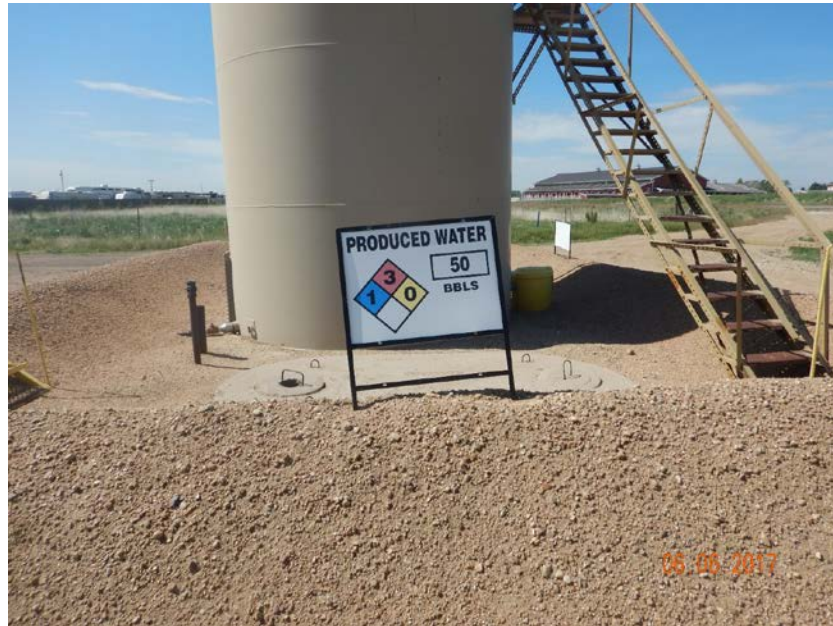
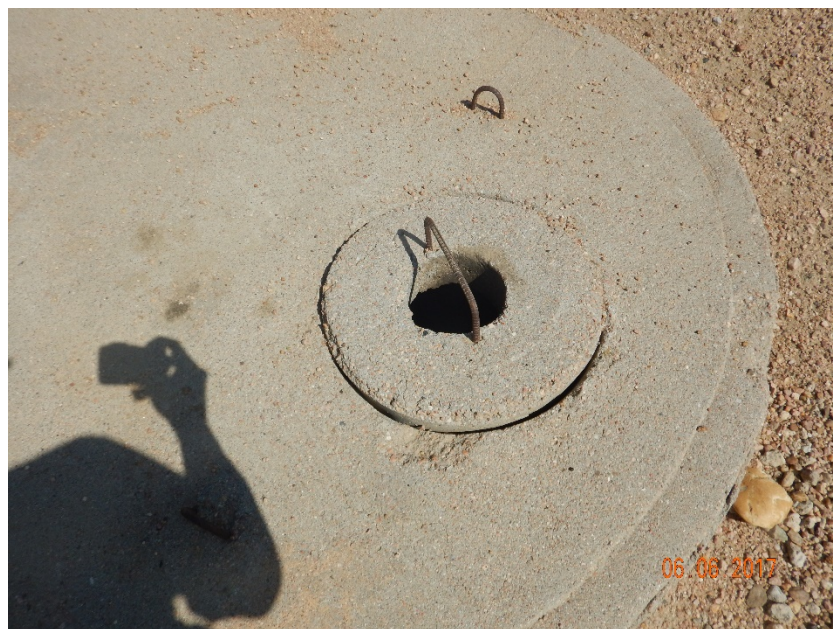
Photos 11 & 12 - Produced water vault is open to the atmosphere.

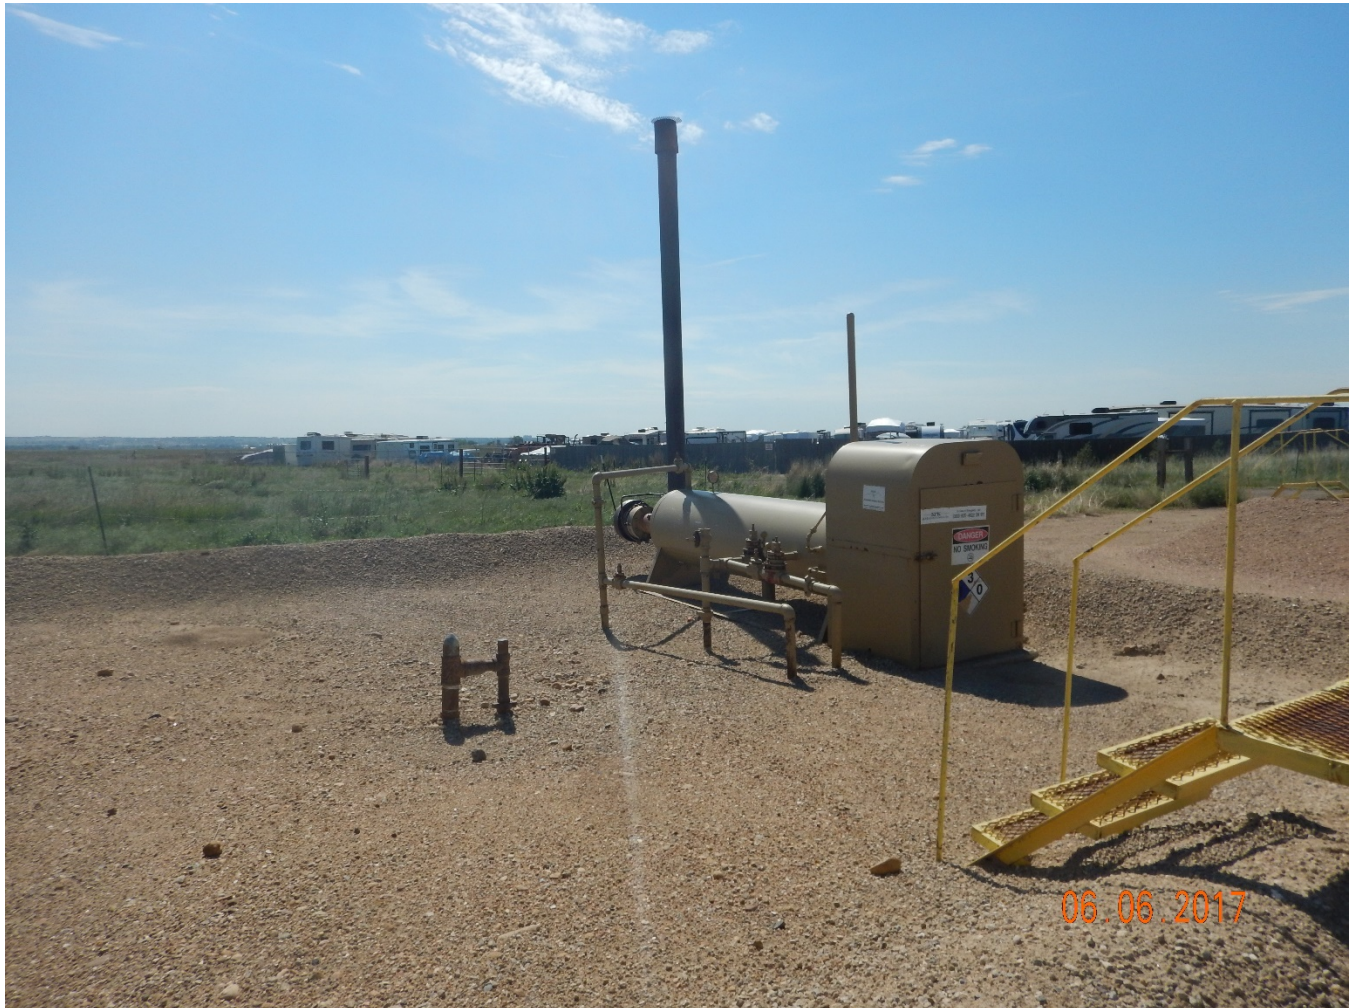
Photo 13 - Flowline risers at horizontal separators may be out of compliance with 2017 Flowline NTO.

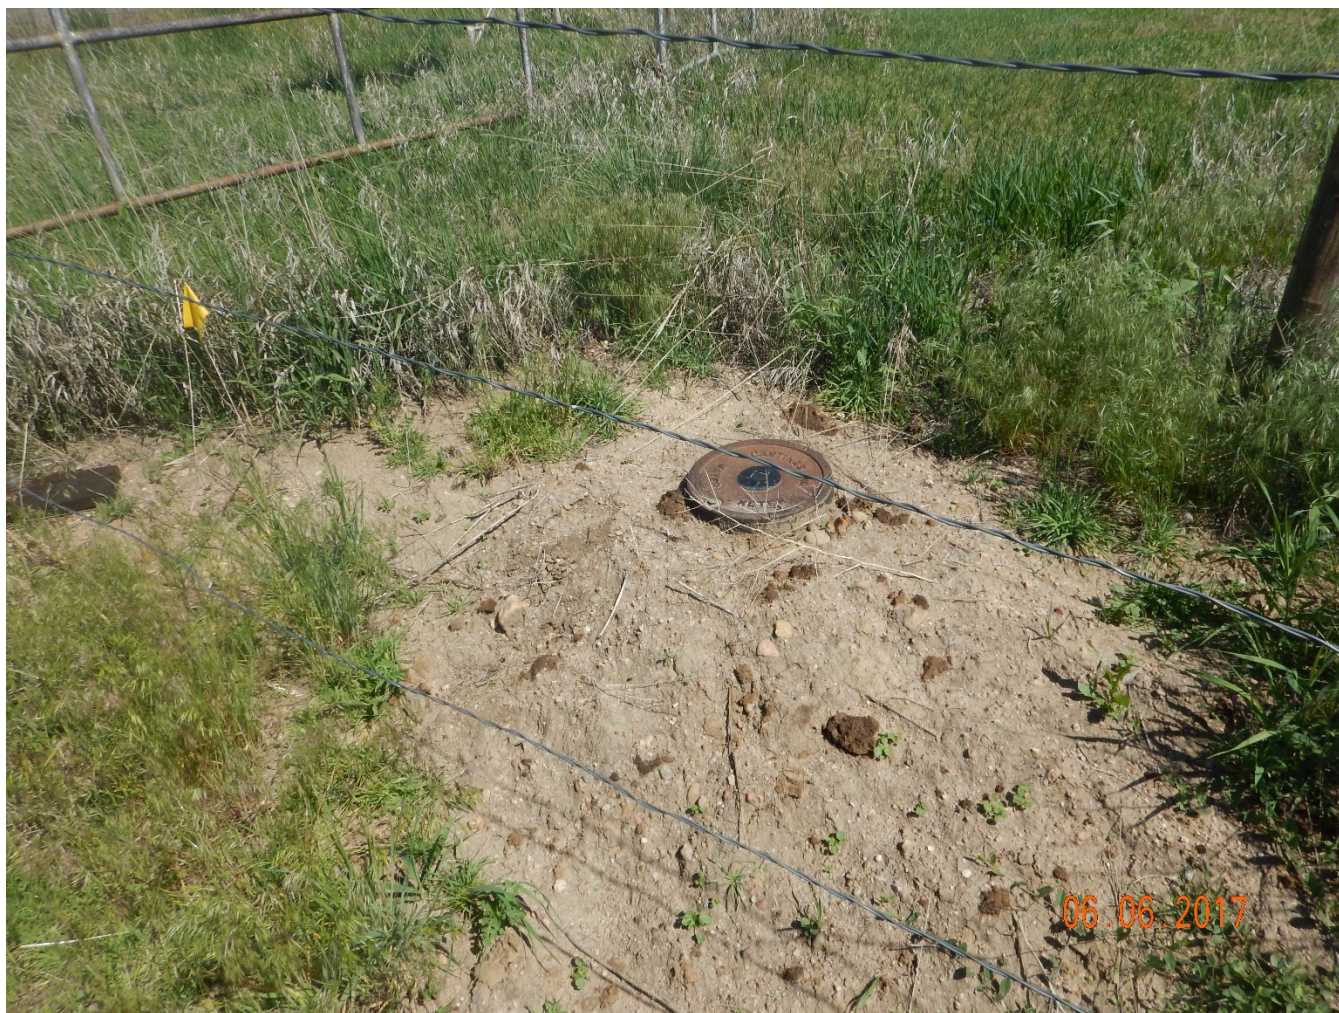
Photo 14 - Water Meter NW of horizontal separator was site of potential spill in March 22, 2017 FIR. The excavation observed in March has been backfilled, but stained soil and hydrocarbon odor remain.
