The Next Photo Set is of the Recent Disturbance Area

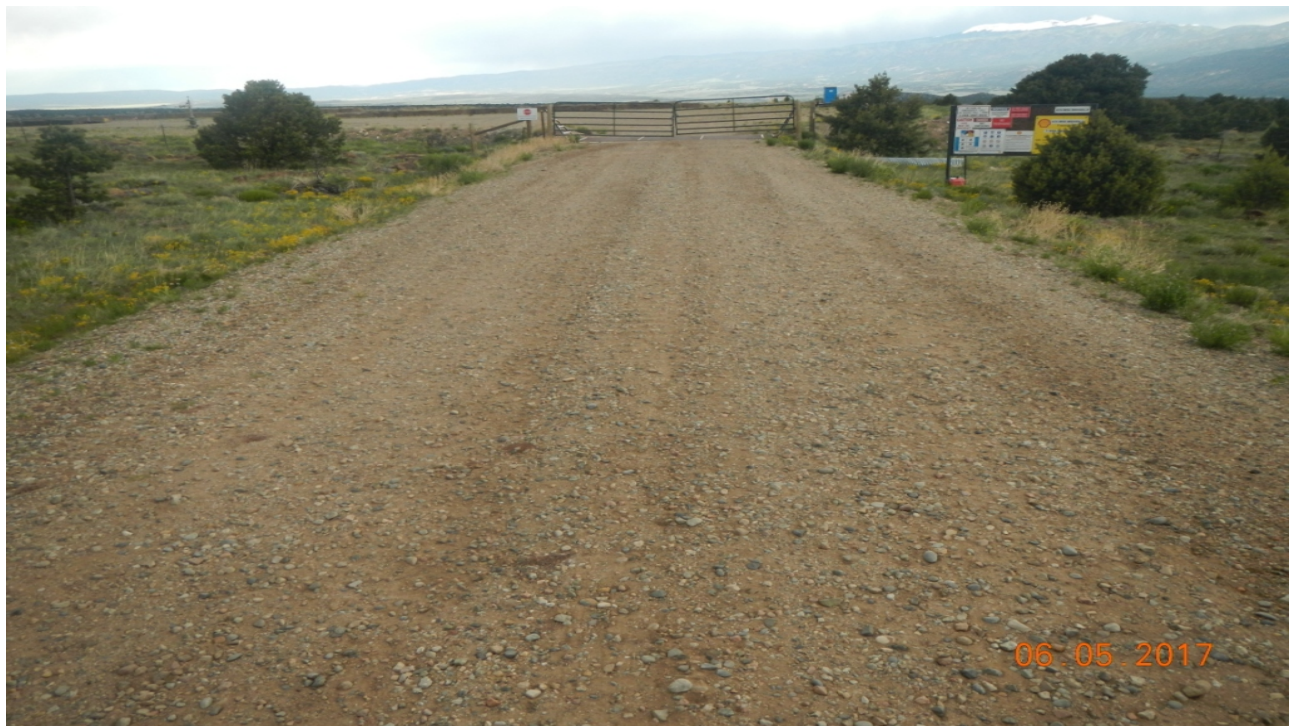
photo 1: Facing north toward the access road off of county road 530.

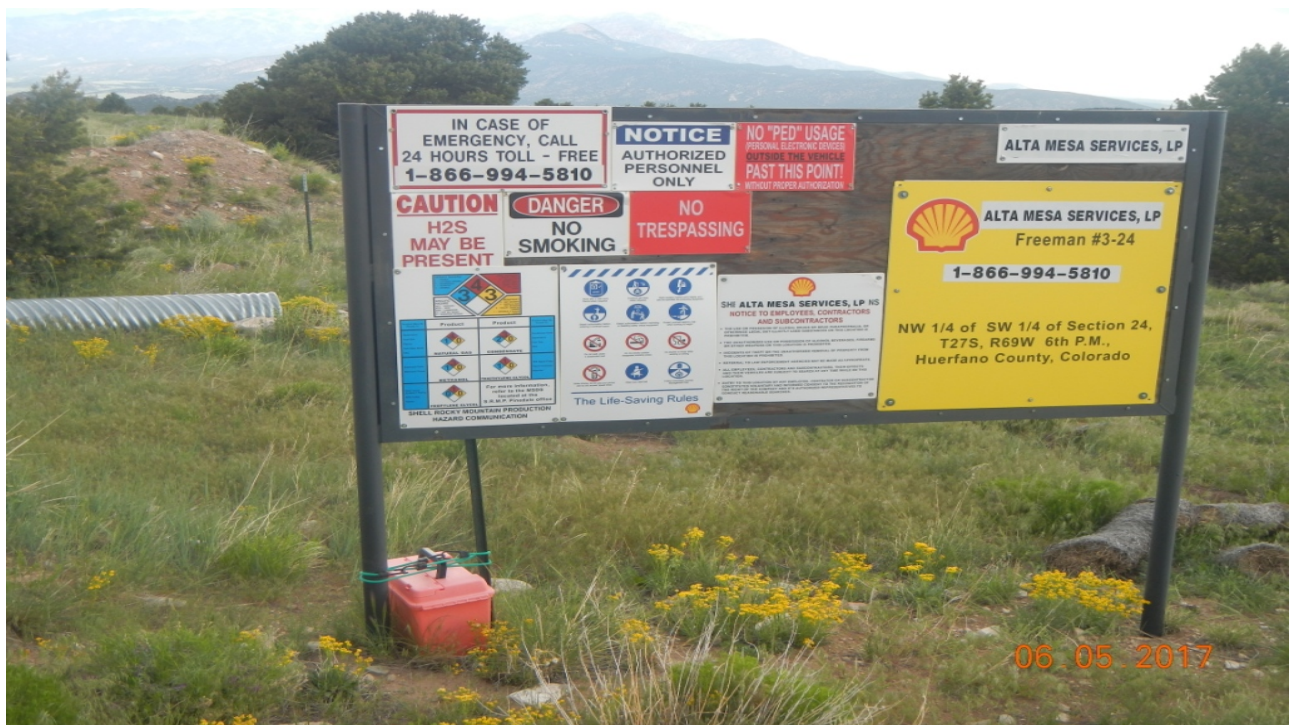
photo 2: The well sign is located at the entrance of the location.

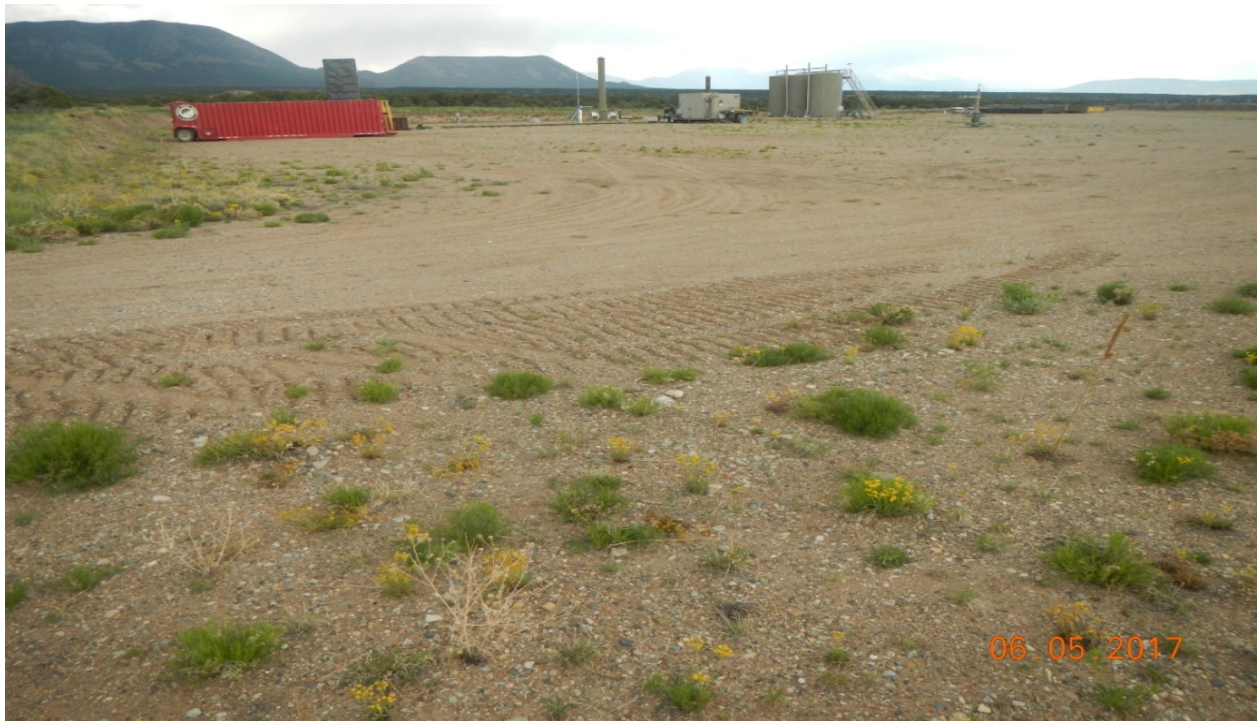
photo 3: Facing northwest toward the location. There is unused equipment (frac tanks) at the north side of the location.

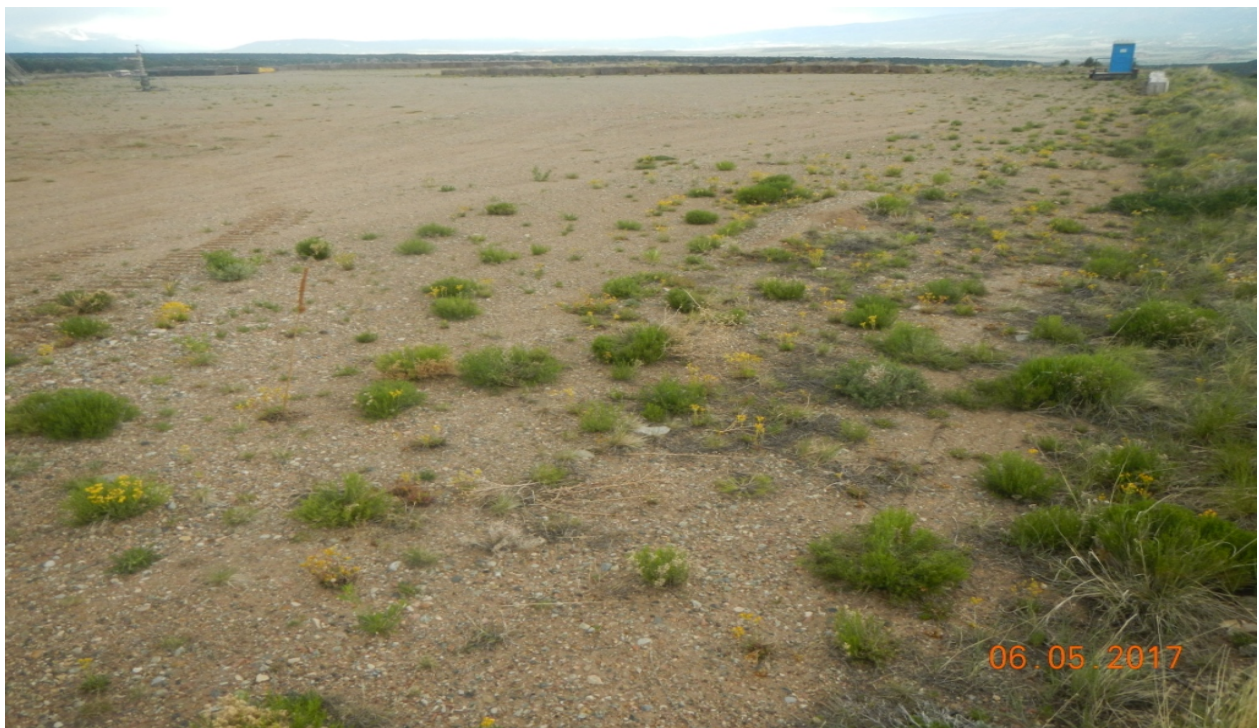
photo 4: Facing north toward the location. Unused areas of the location have not been reclaimed.

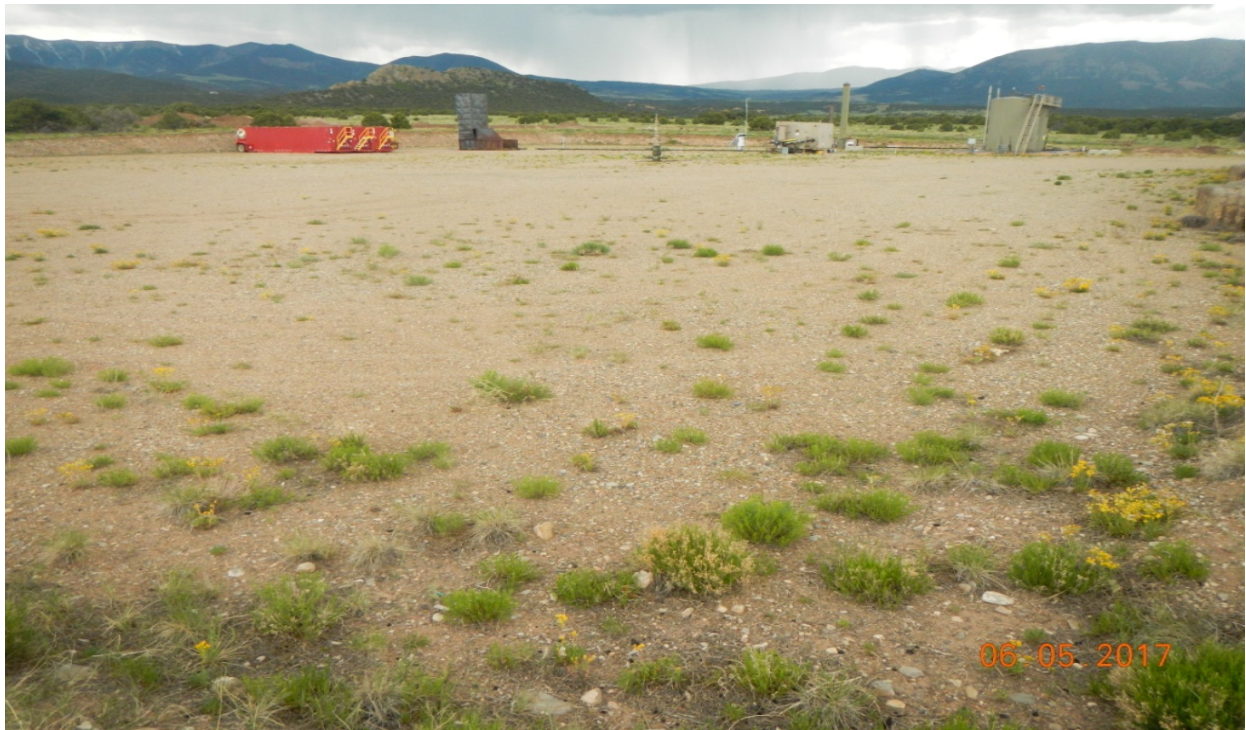
photo 5: East side of the location facing southwest.

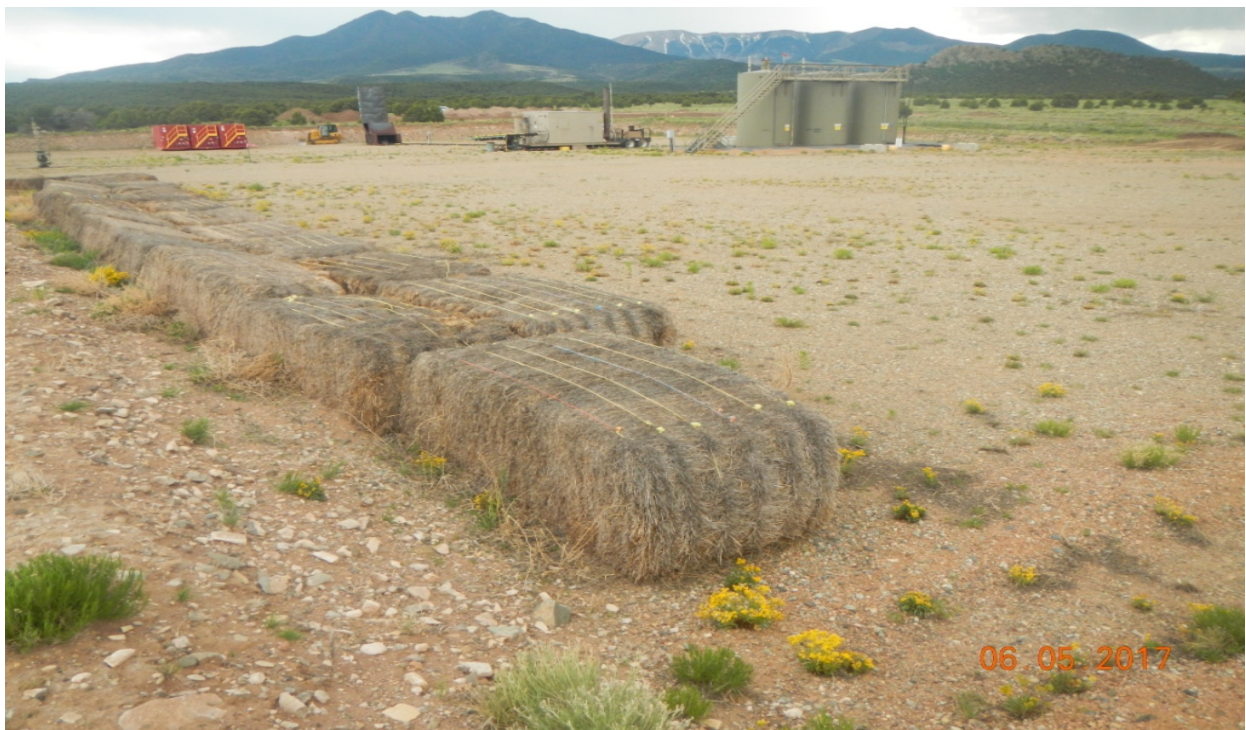
photo 6: Northeast side of the location facing southwest. There are degraded hay bales that remain around the north perimeter of the location that will need to be removed.

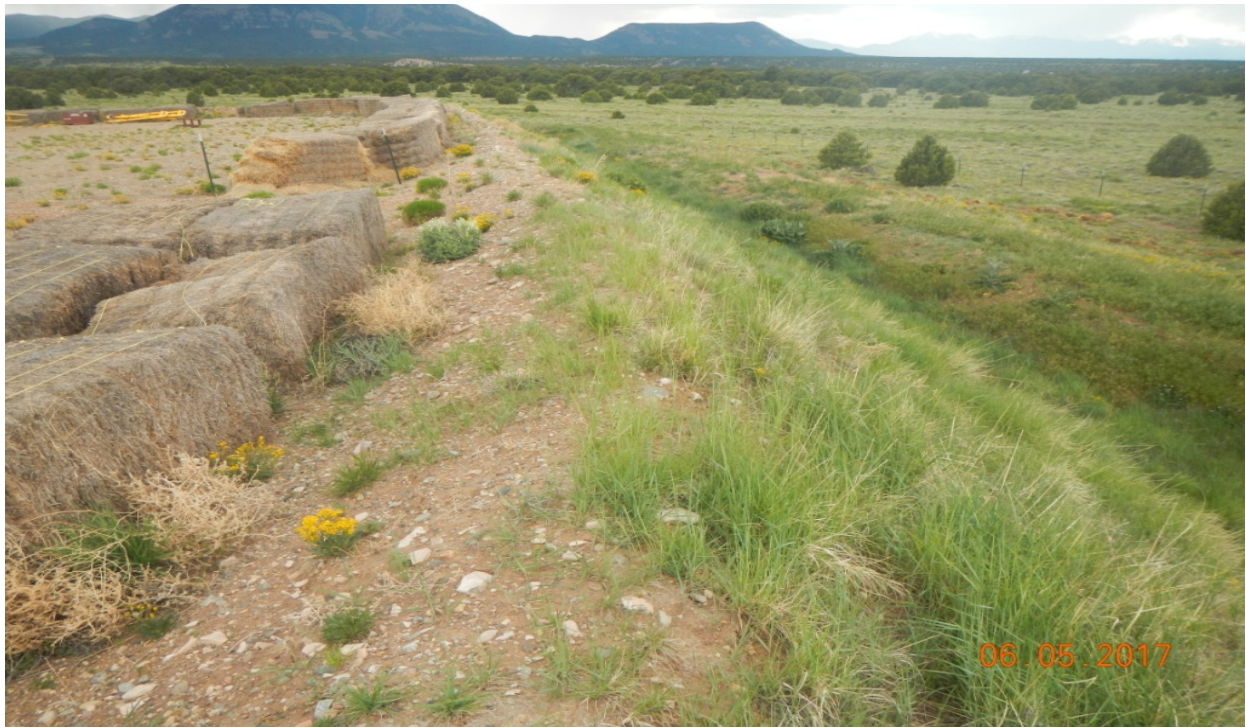
photo 7: North side of the location facing west. There is a stormwater berm around the northern perimeter of the location.

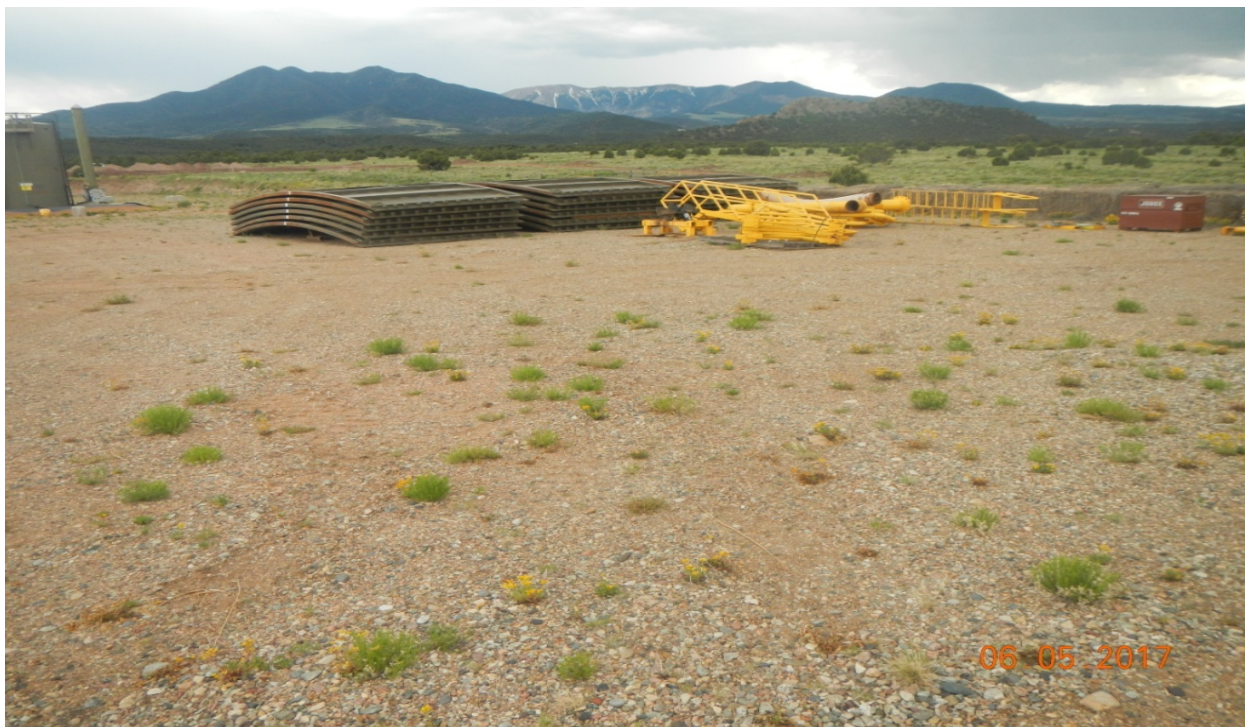
photo 8: There is unused equipment being stored at the west side of the location.

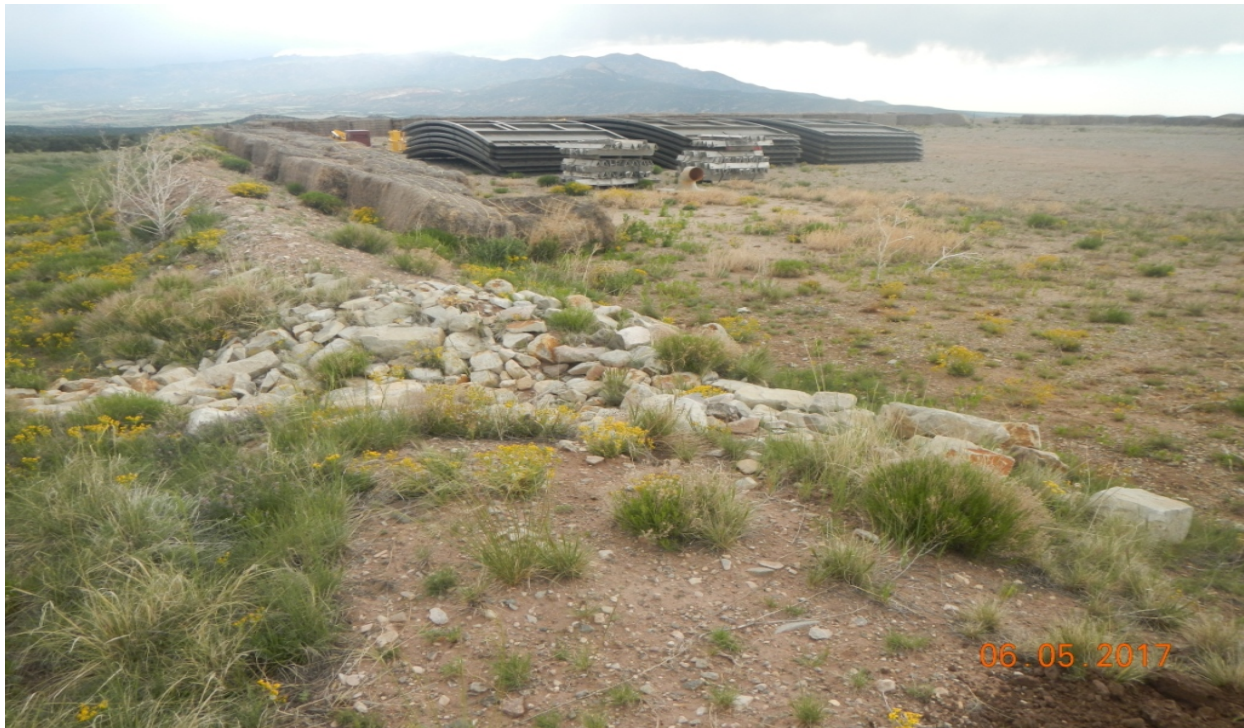
photo 9: West side of the location facing north toward unused equipment. There is rock rip/rap BMP in place for stormwater outlet.

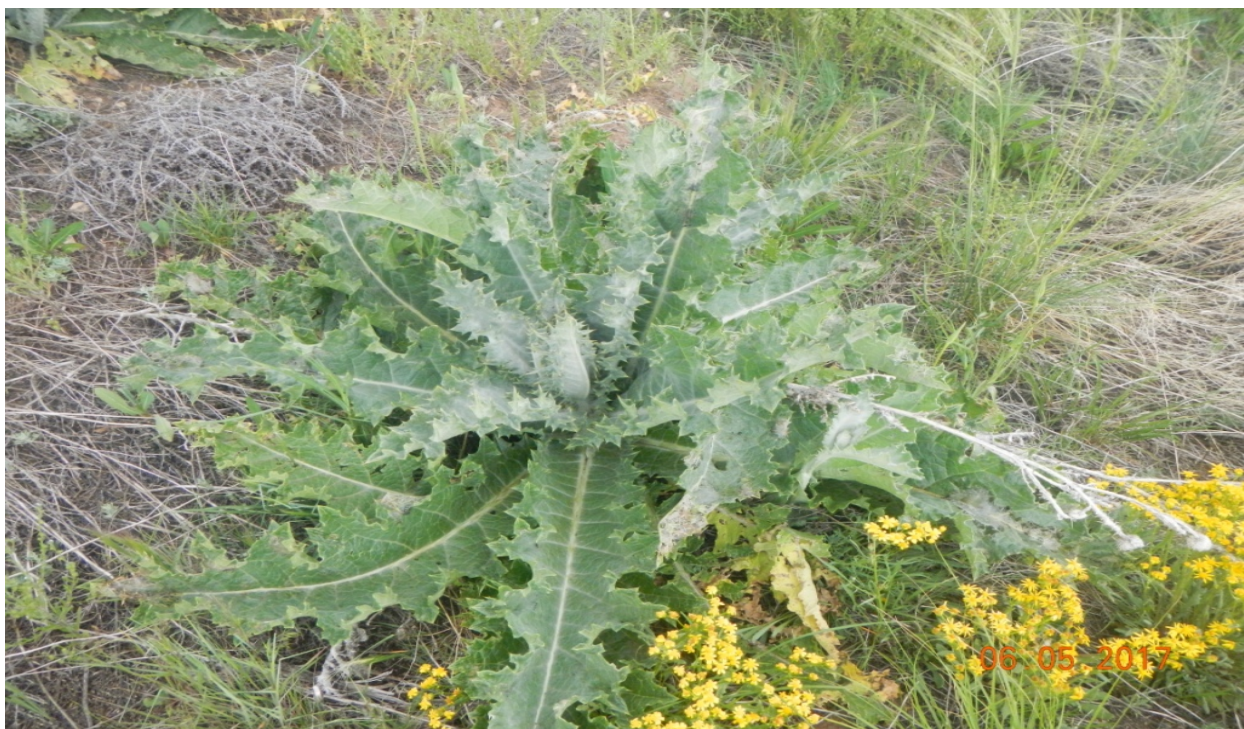
photo 10: There is List B noxious weeds (Scotch thistle) growing around the perimeter of the location.

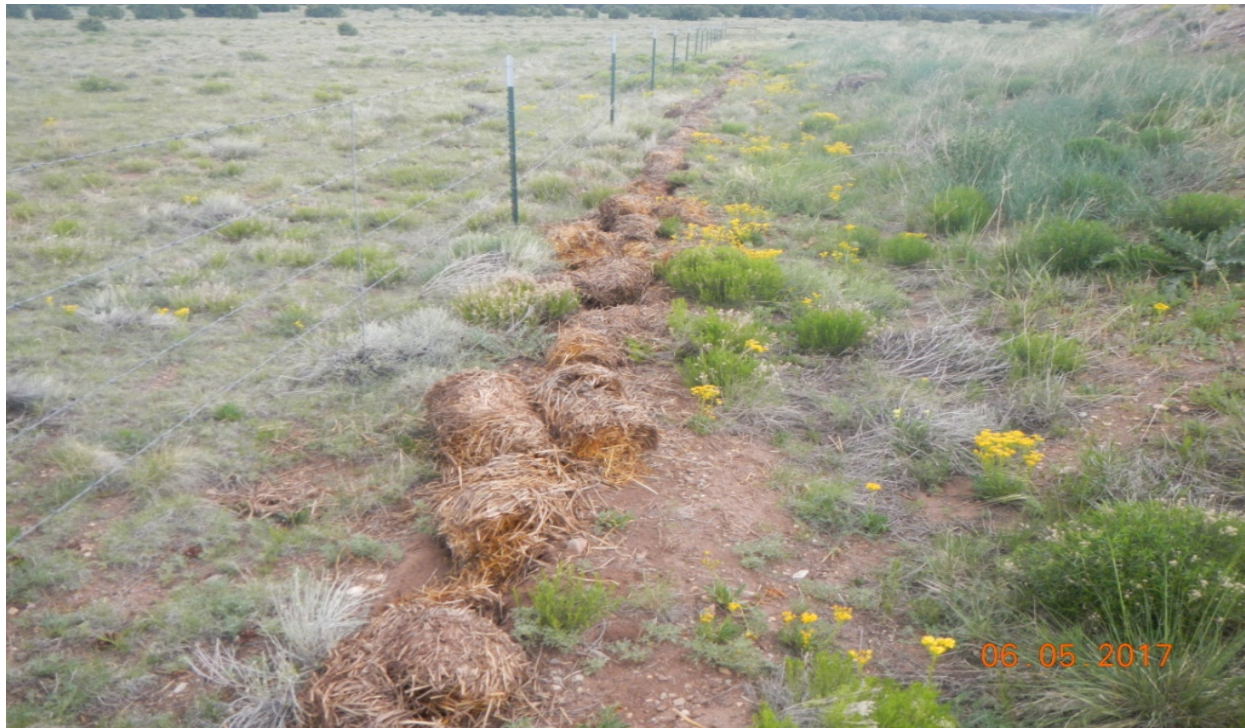
photo 11: There is debris remains from wattles around the perimeter of the location.

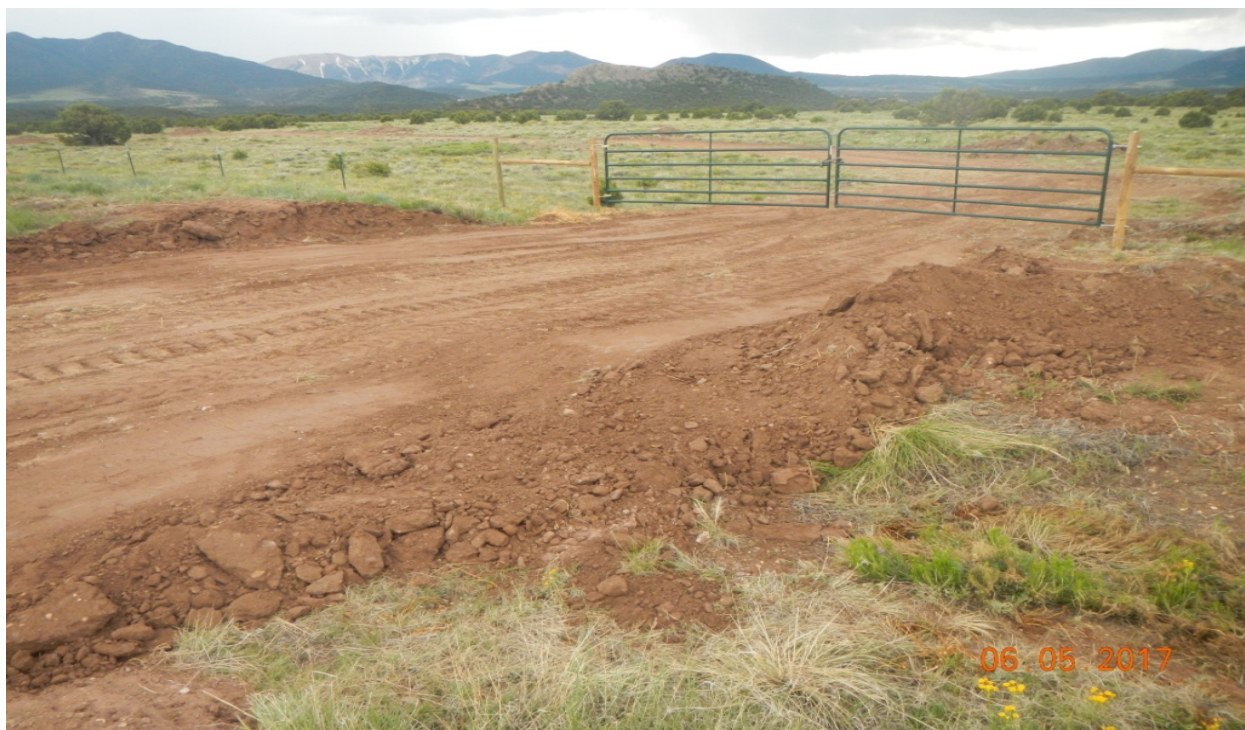
photo 12: East side of the location facing toward the recently constructed access road.

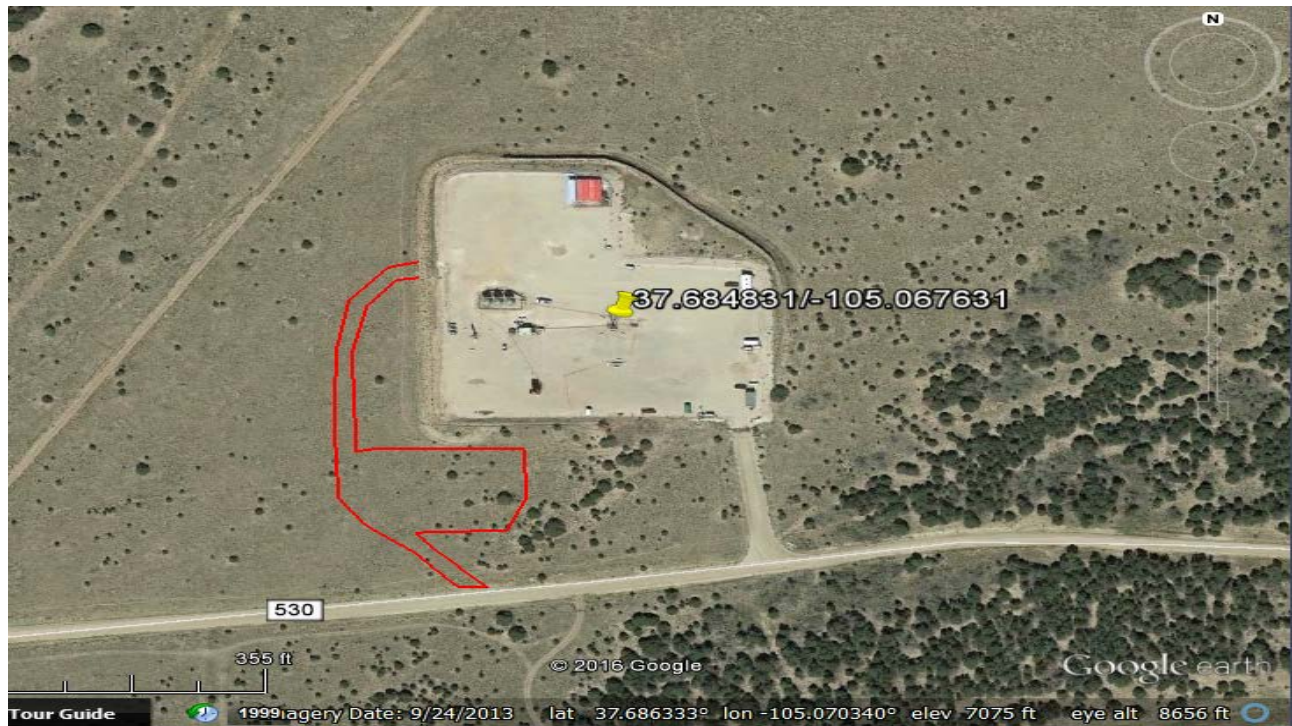
photo 1: Aerial photo 2013 of the Freeman 3-24 location. The red outline shows approximate area of new disturbance. There were no stormwater controls in place.

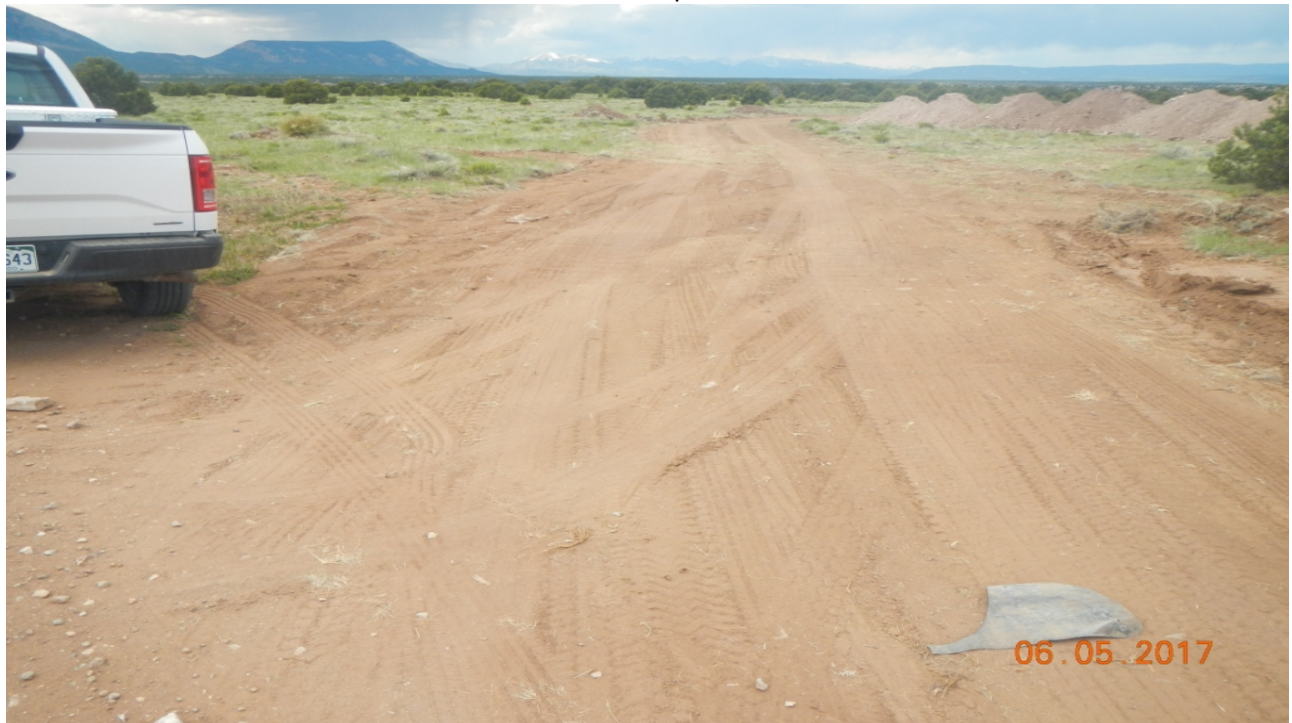
photo 2: Facing northwest toward recently constructed access road off of county road 530. There is no vehicle tracking controls in place.

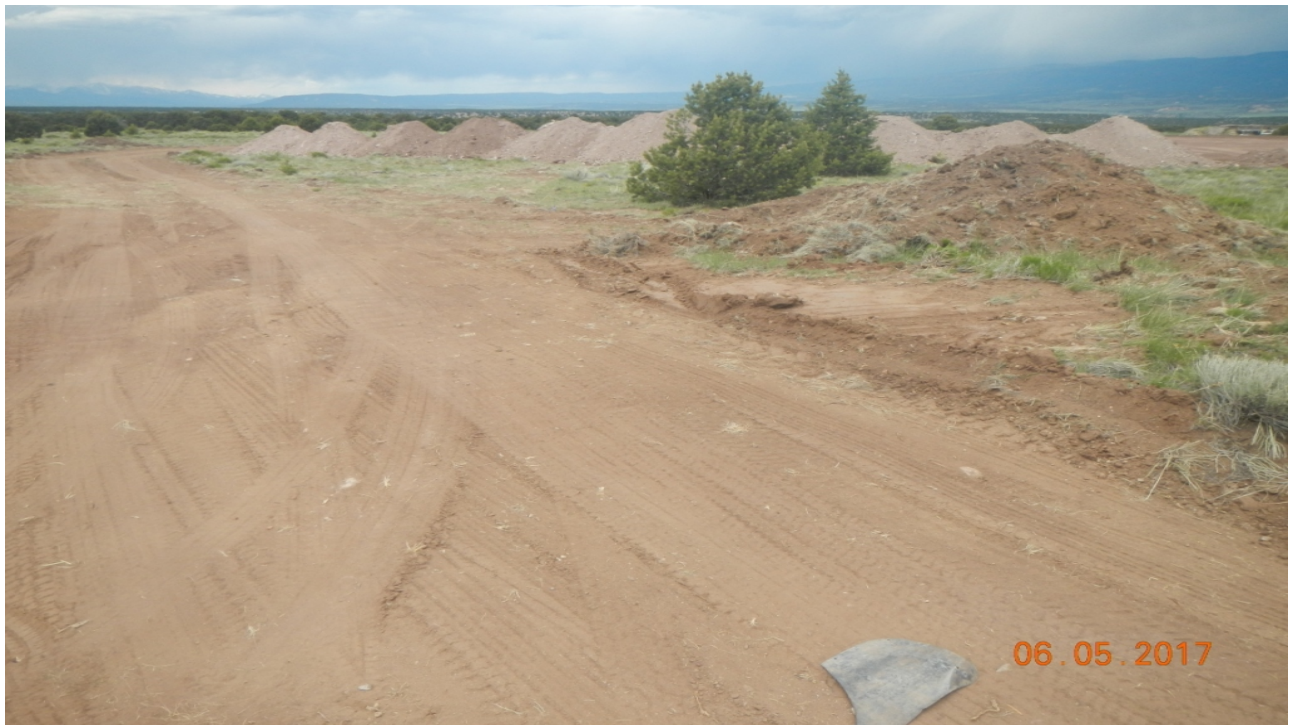
photo 3: Facing northwest along the access road.

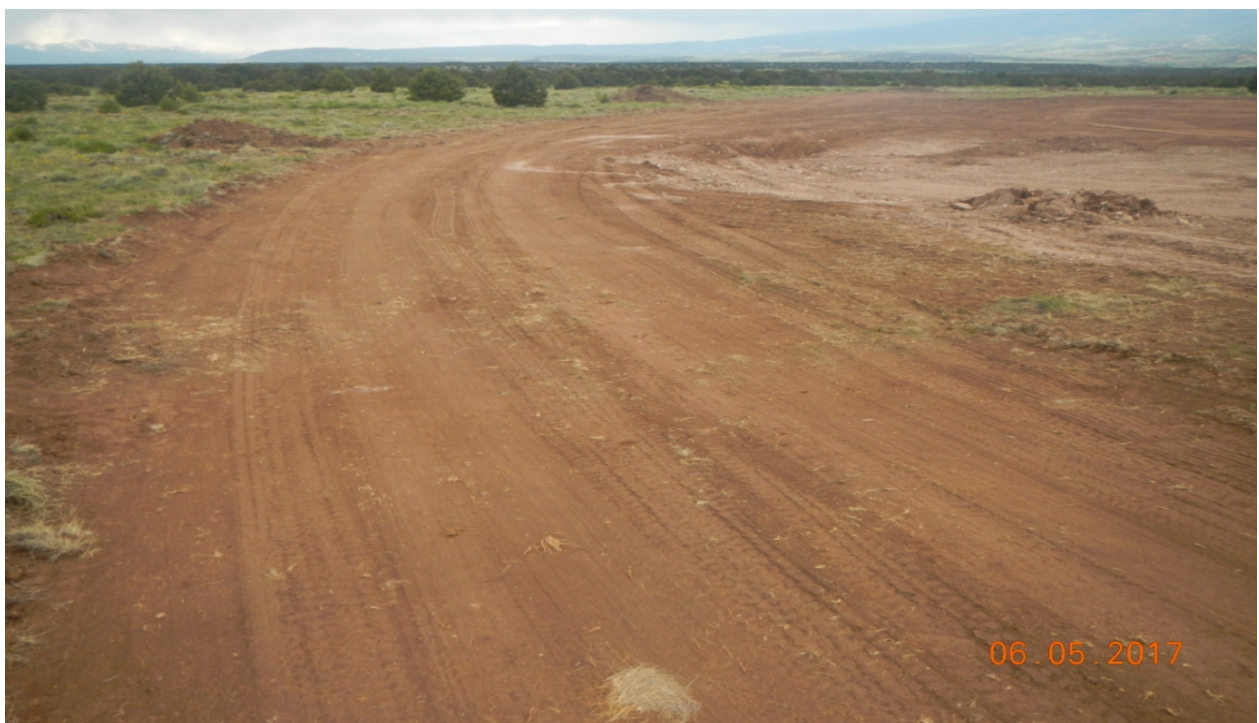
photo 4: Facing northwest along the access road. No stormwater perimeter controls are present.

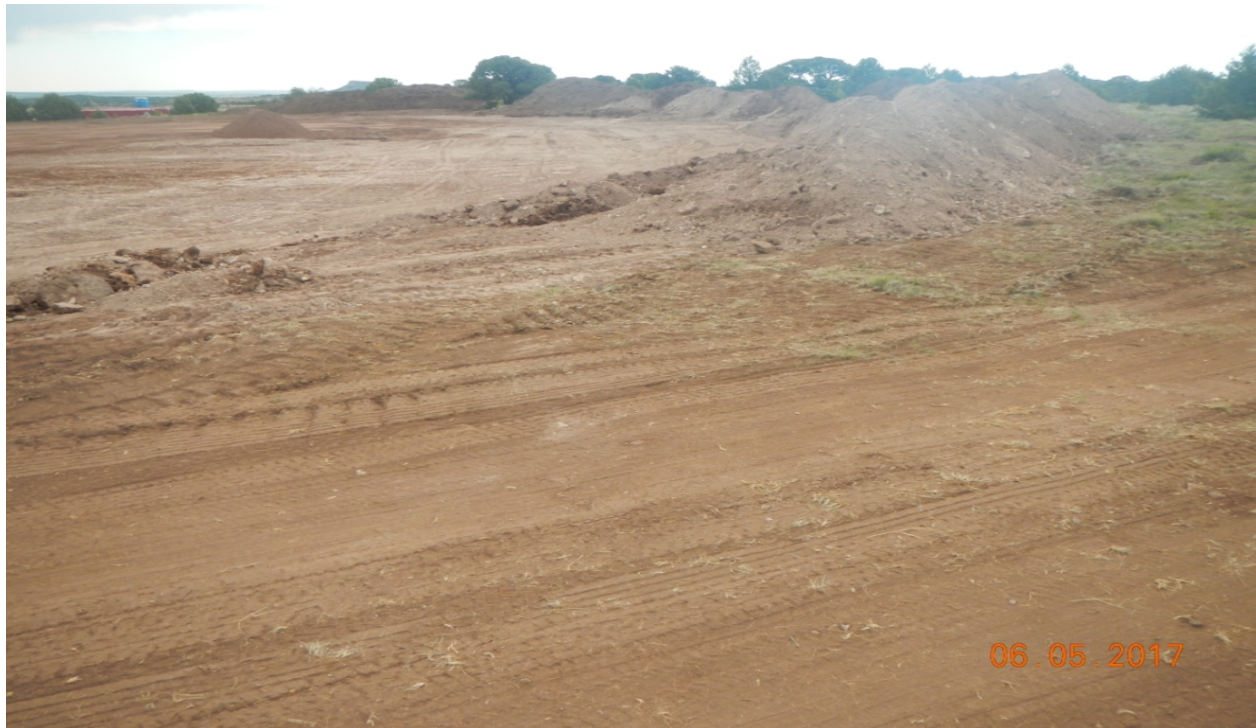
photo 5: Facing east toward the south side of the recently constructed location.

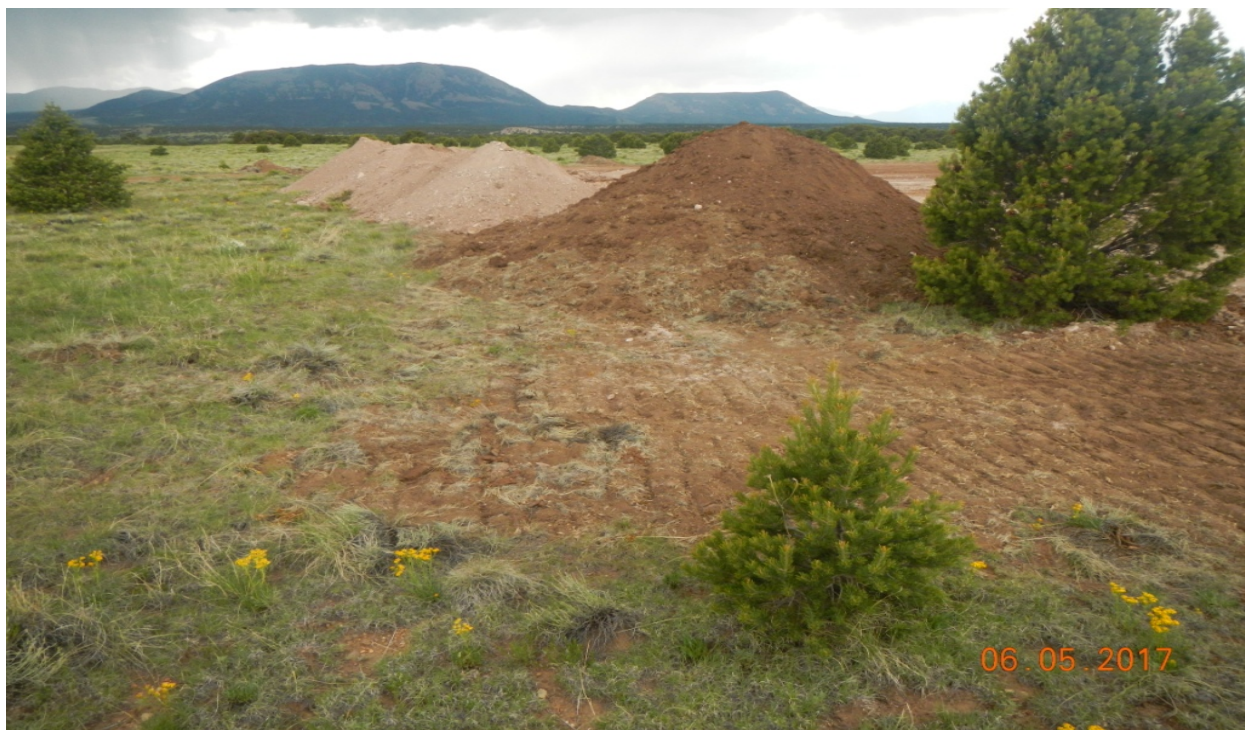
photo 6: Southeast side facing west toward soil piles. No stormwater perimeter controls are present and soil stockpiles are not stabilized.

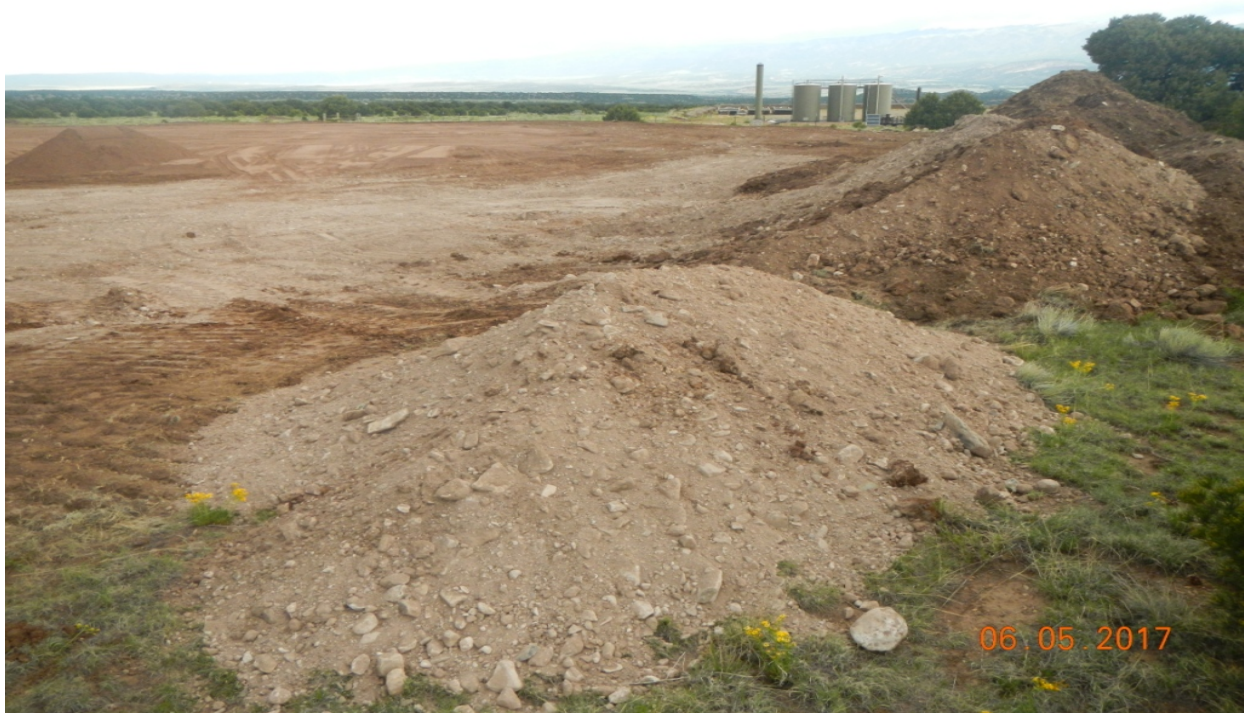
photo 7: Southeast side facing northwest. No stormwater perimeter controls are present and soil stockpiles are not stabilized.

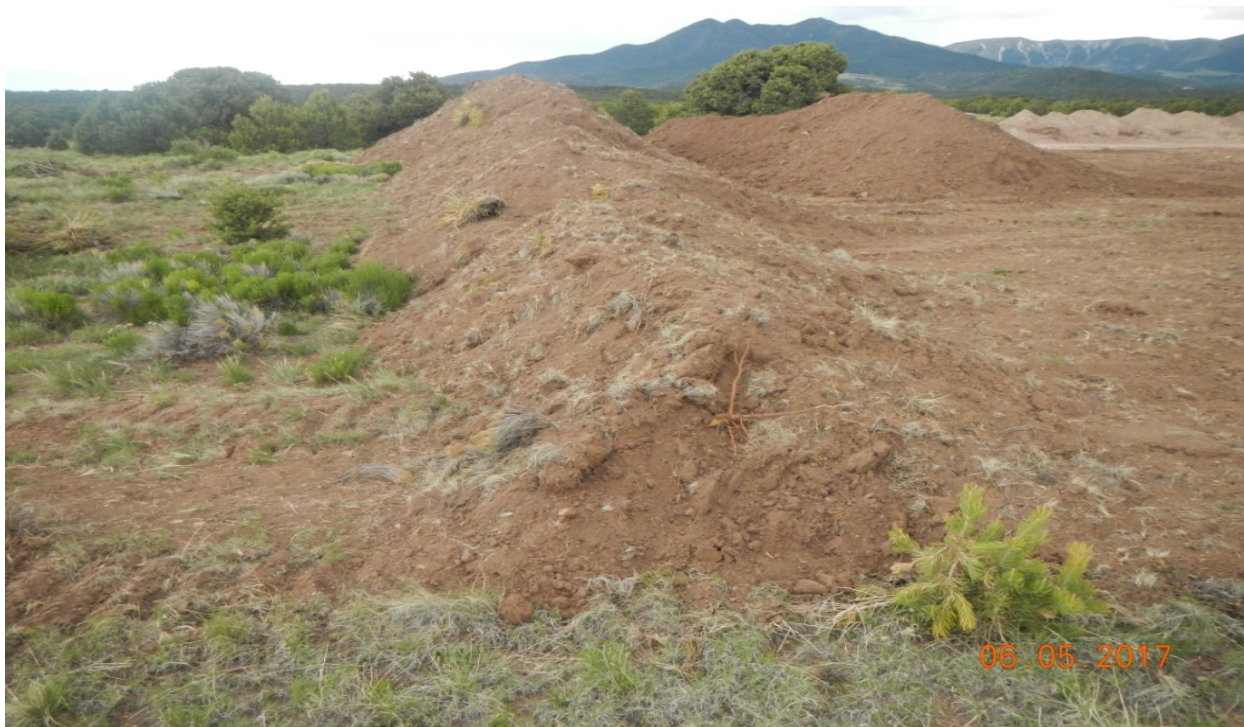
photo 8: Northeast side facing south toward the topsoil piles. No stormwater perimeter controls are present and soil stockpiles are not stabilized.

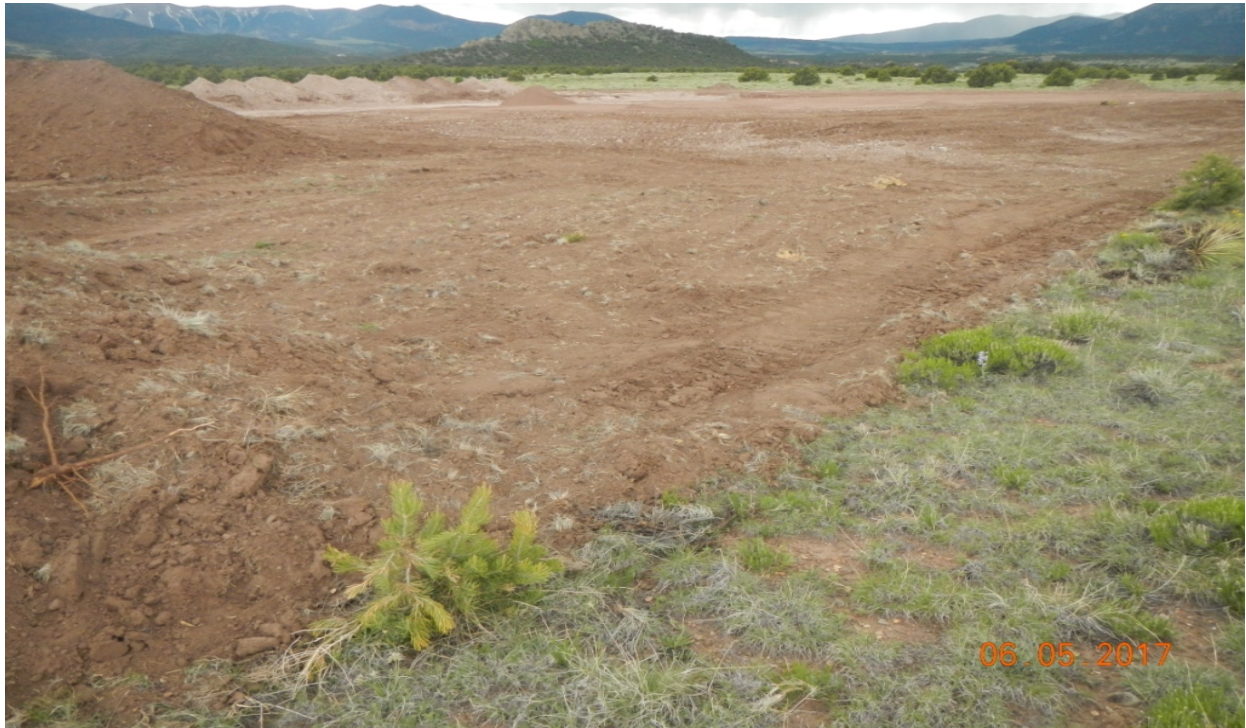
photo 9: Northeast side facing southwest.

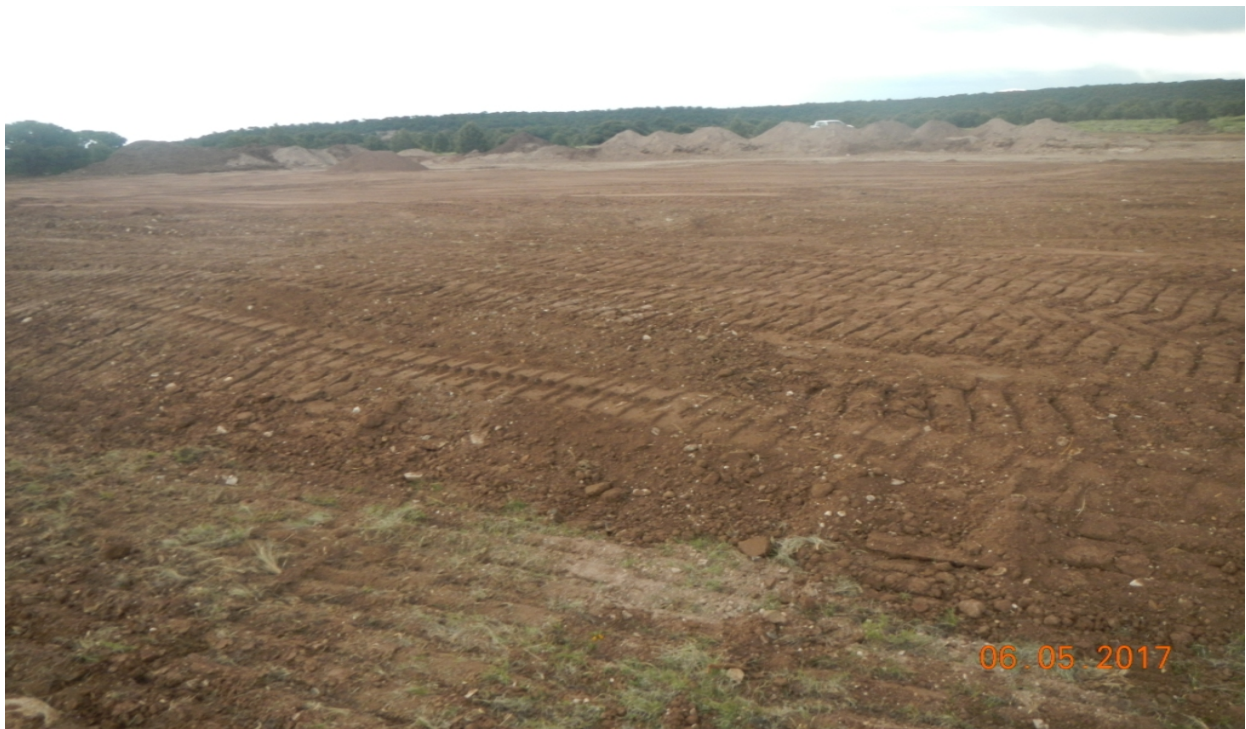
photo 10: Northwest side of the recently constructed location facing southeast.

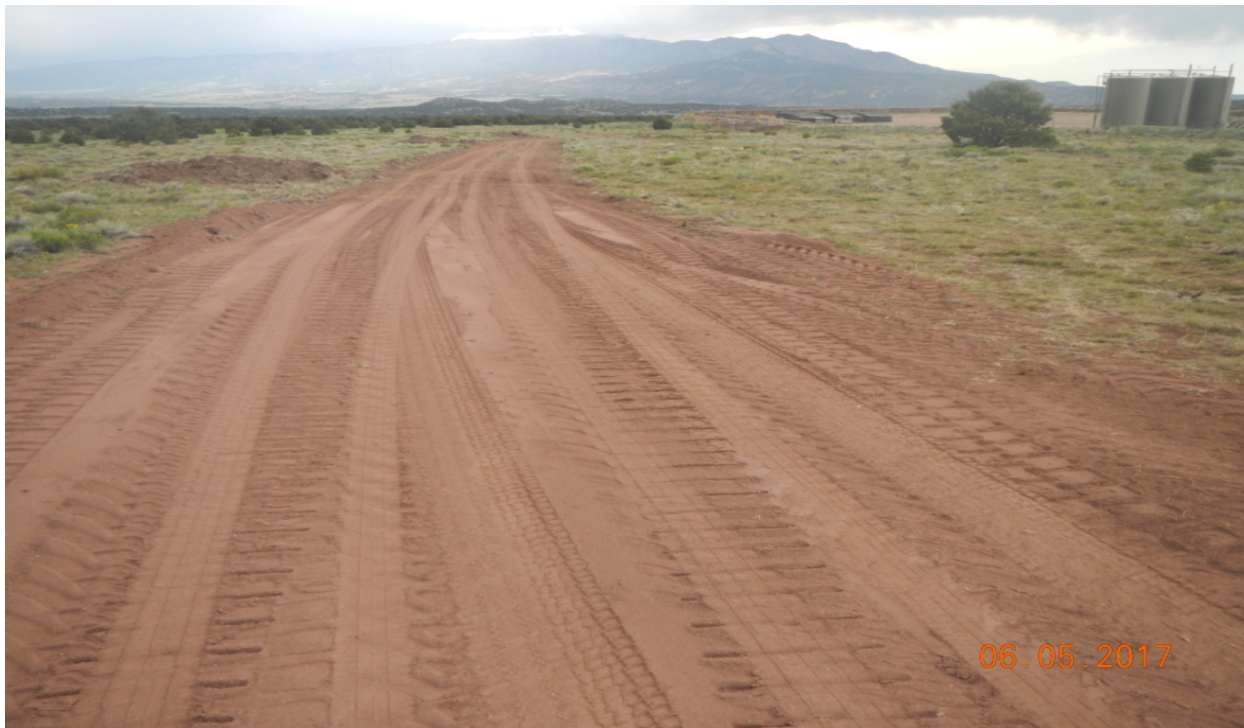
photo 11: The new access road continues toward the Freeman 3-24 location.

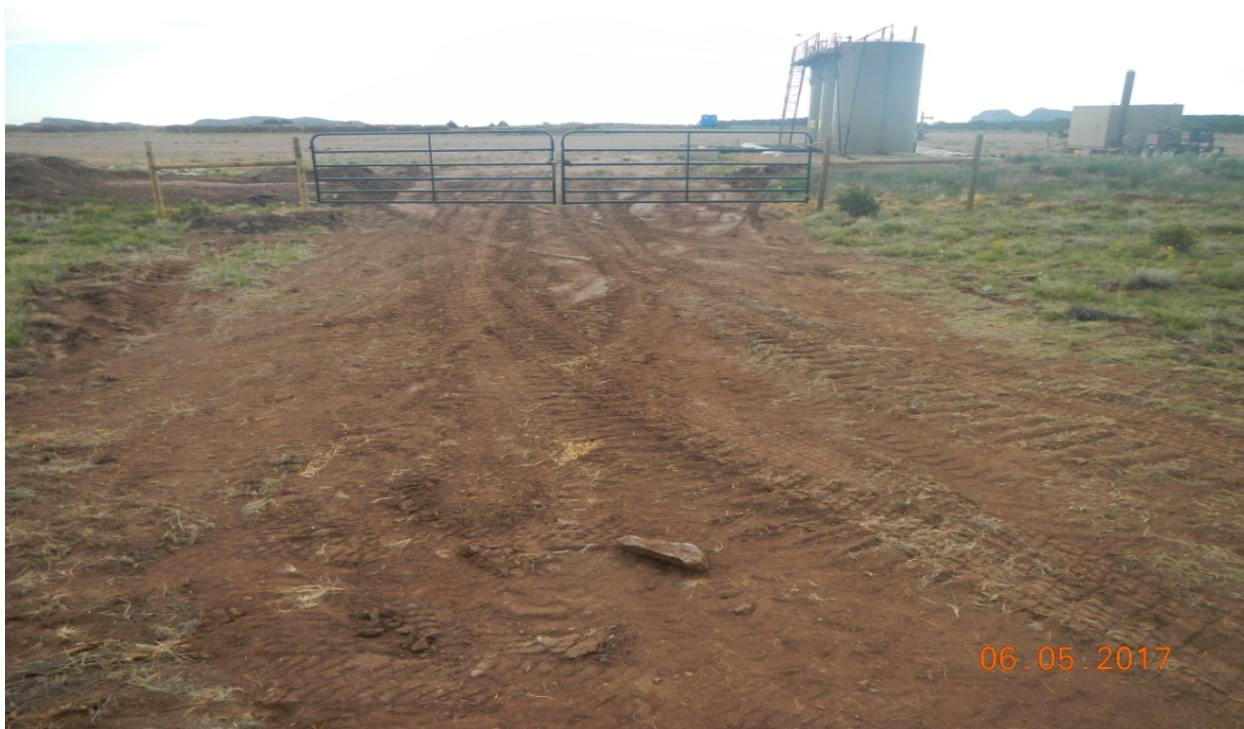
photo 12: Facing east, the new access road enters the west side of the Freeman 3-24 location.
