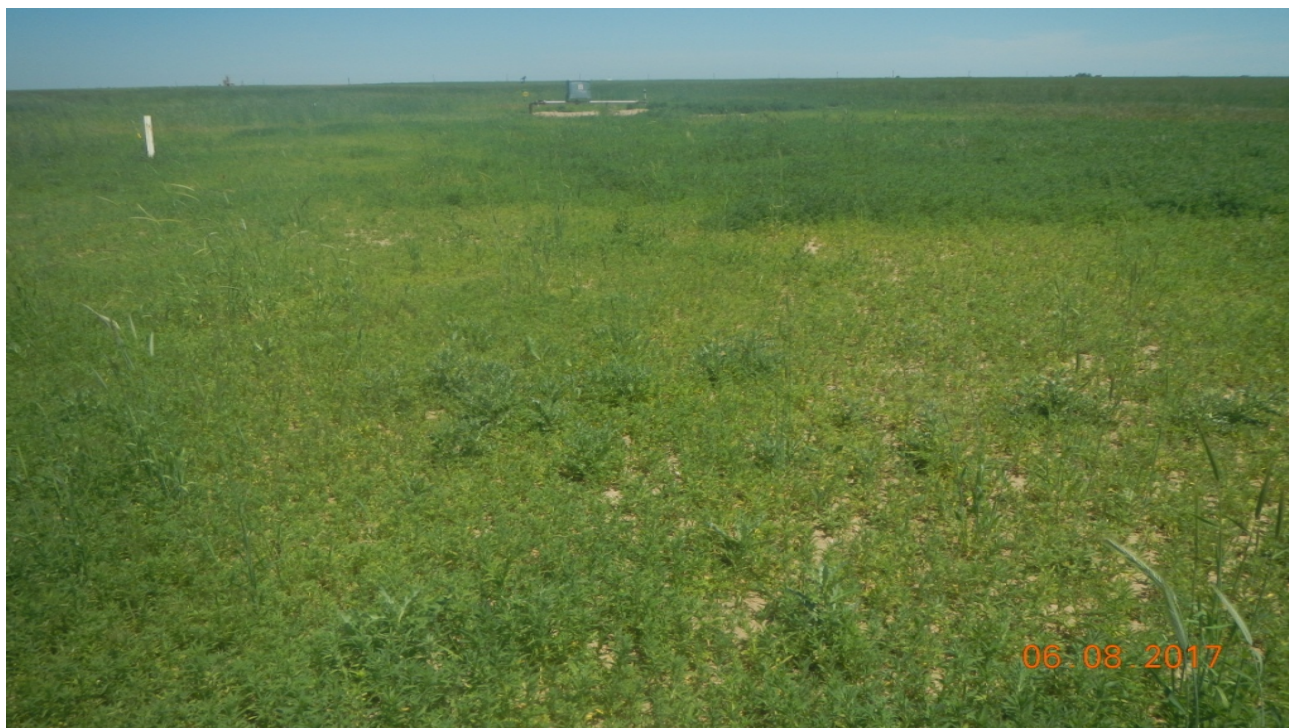
**photo 1:** Facing northeast toward the former tank battery area. This area does not have adequate crop growth and contains predominately undesirable vegetation.

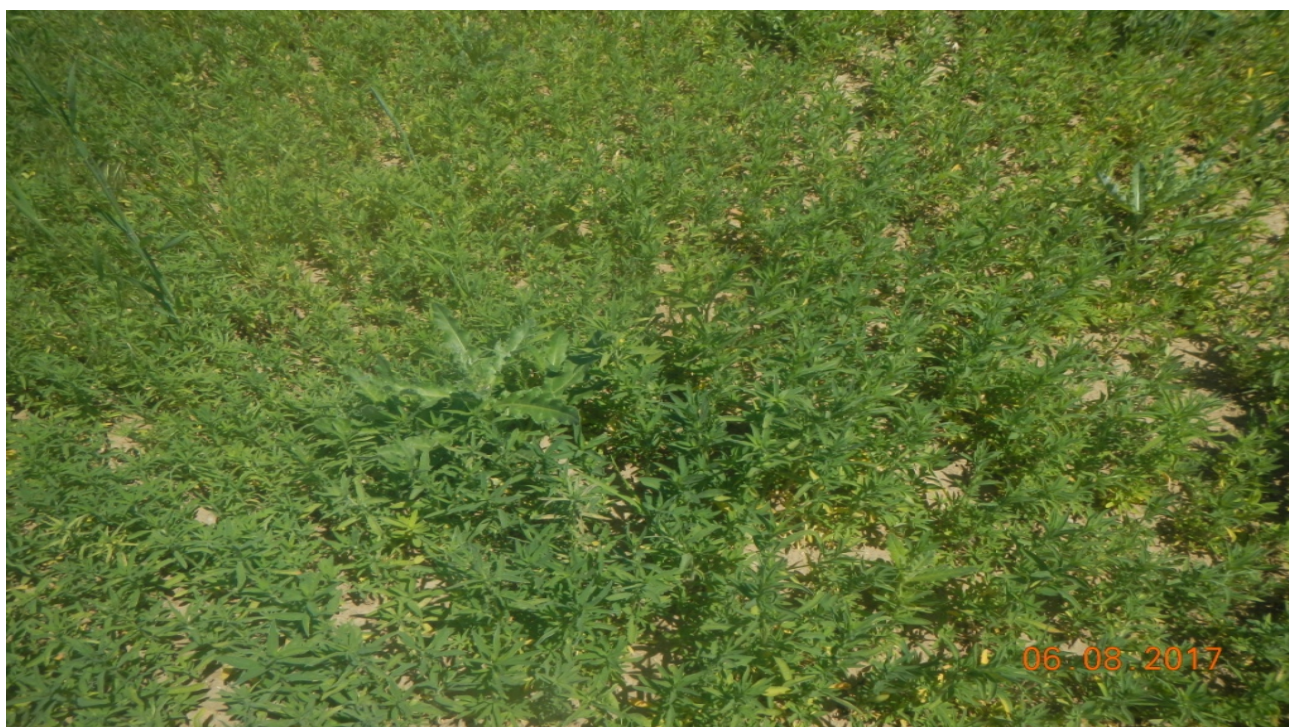
**photo 2:** View of undesirable vegetation and noxious weed growth (Kochia sp., Canada thistle) at the tank battery site.

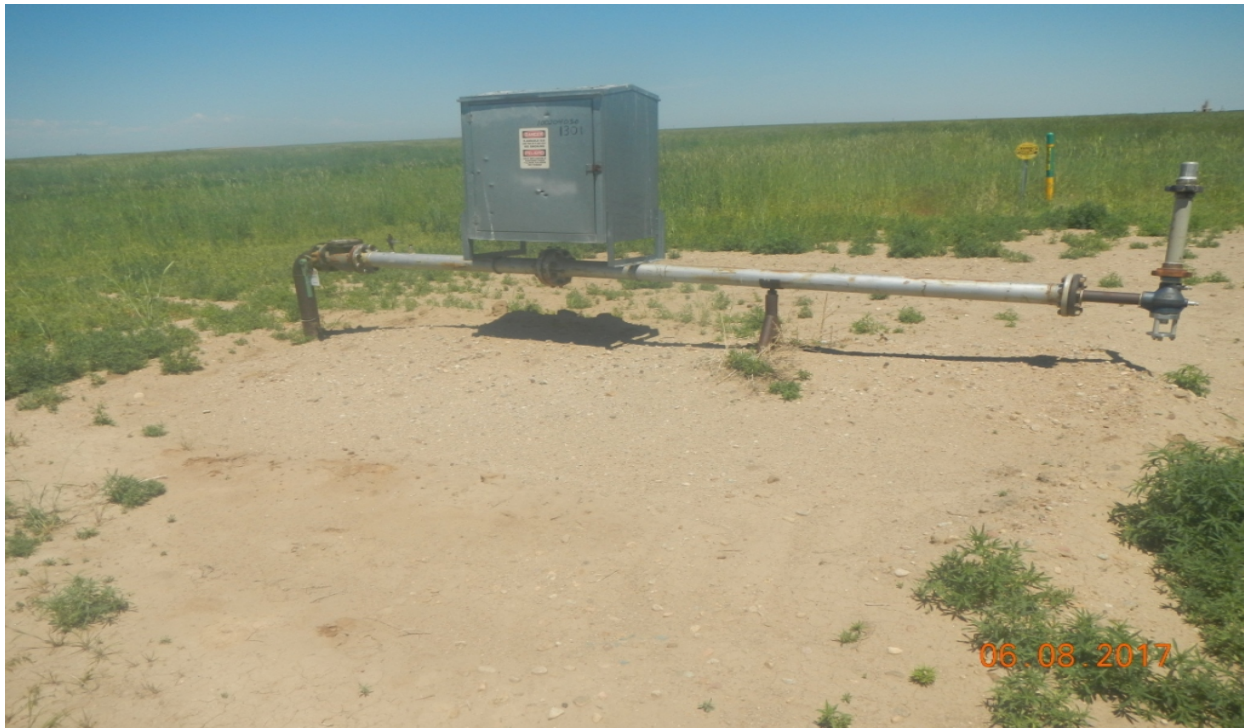
**photo 3:** There is a pipe riser that remains at the former battery site Lat/Long:39.84499,-104.45152.

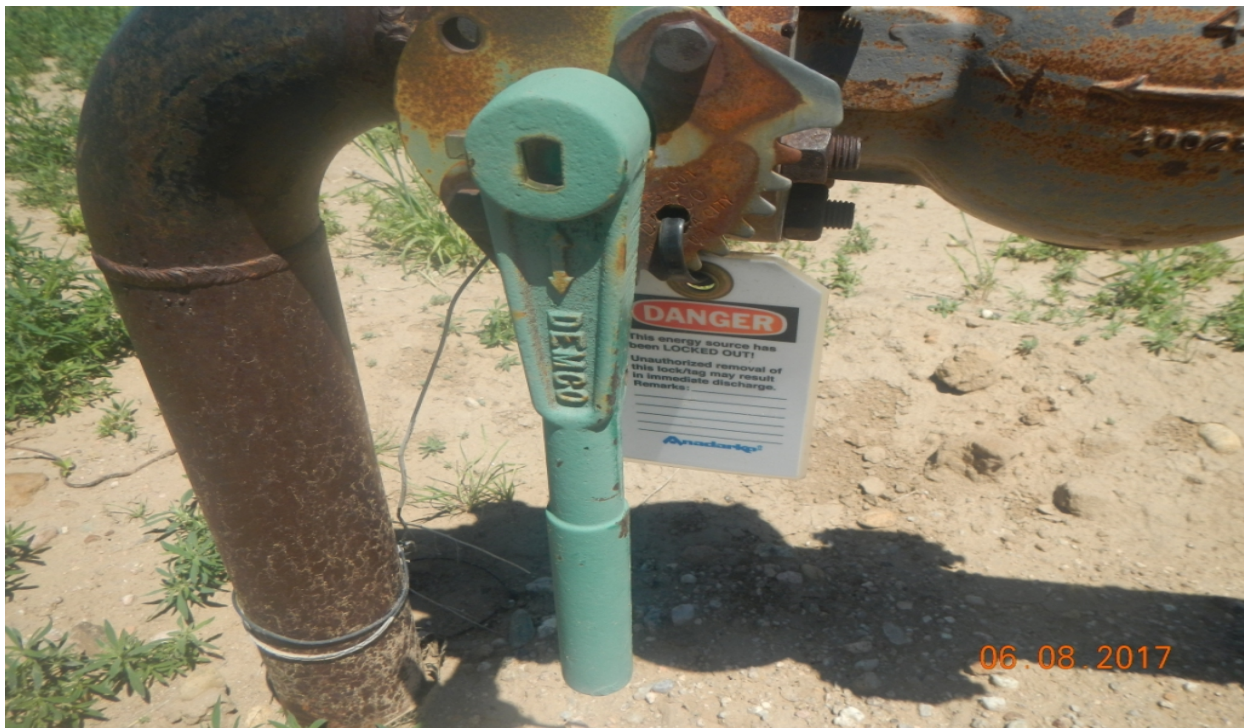
**photo 4:** Tag out has been applied to this valve at the pipe riser.

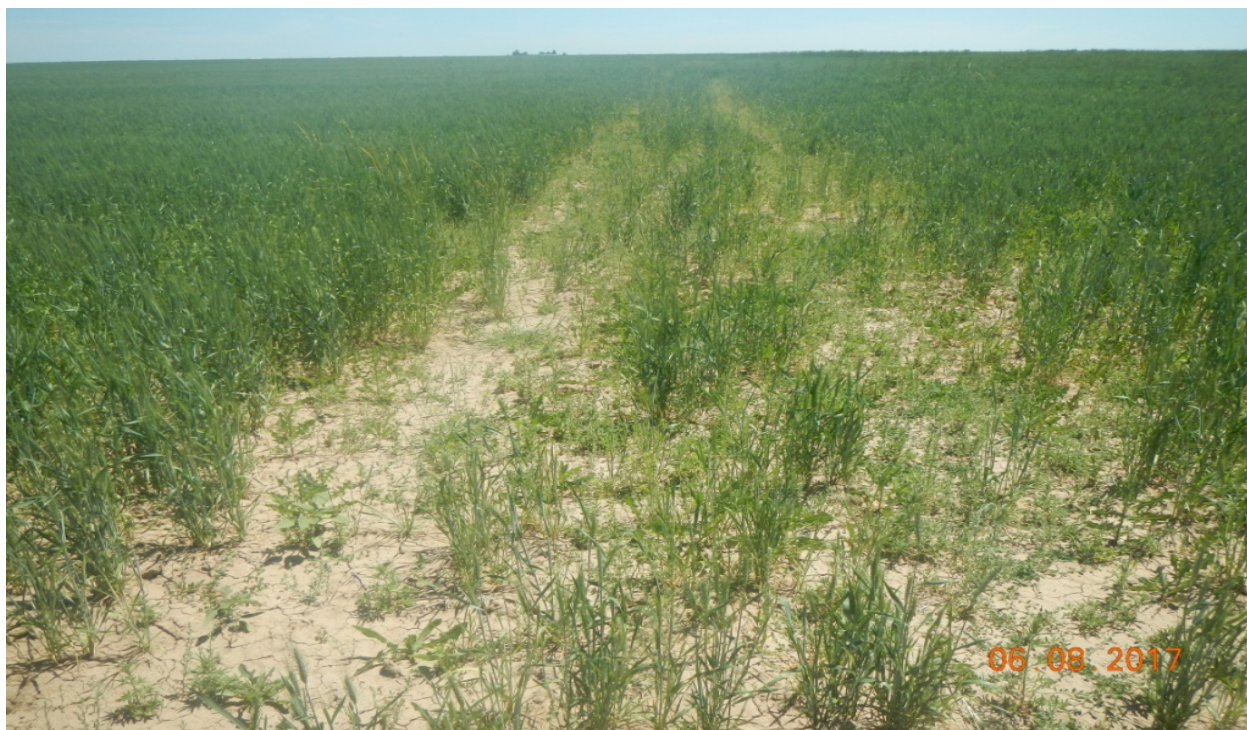
**photo 5:** Facing east toward the former access road. The crop growth has not adequately established along this area.

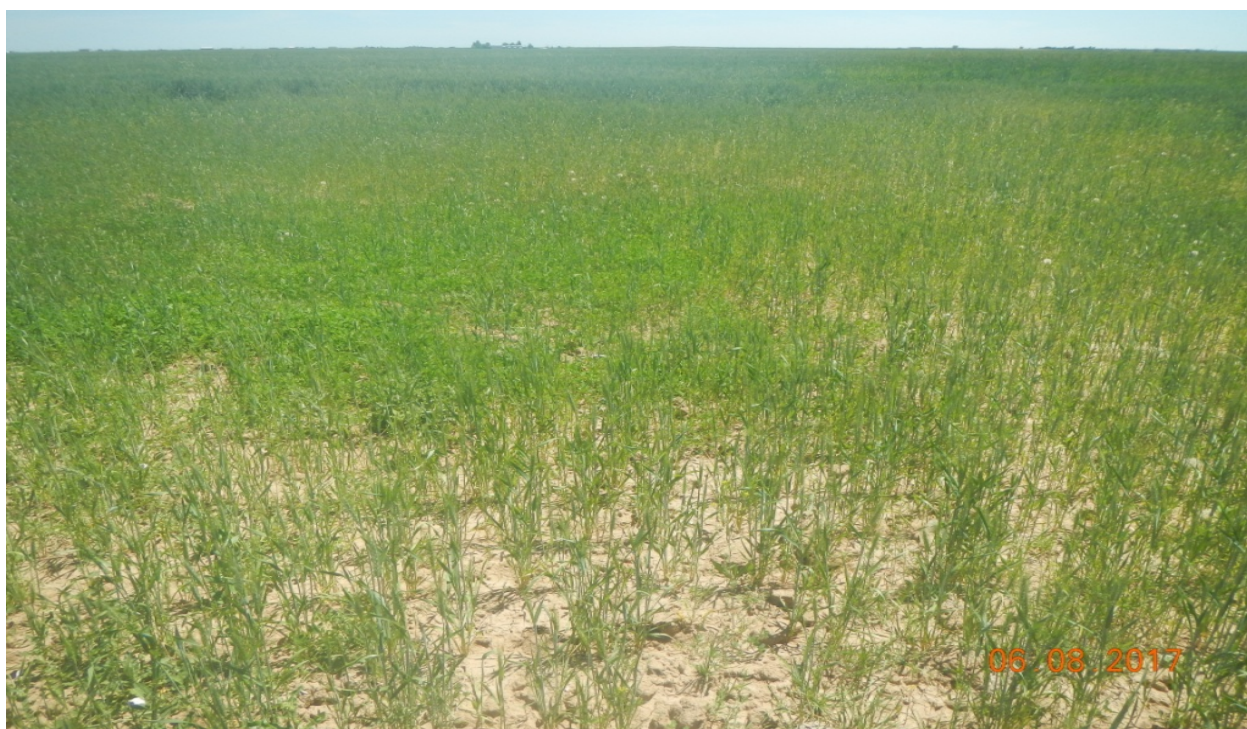
**photo 6:** Facing east toward the location. The crop growth has not adequately established along this area.

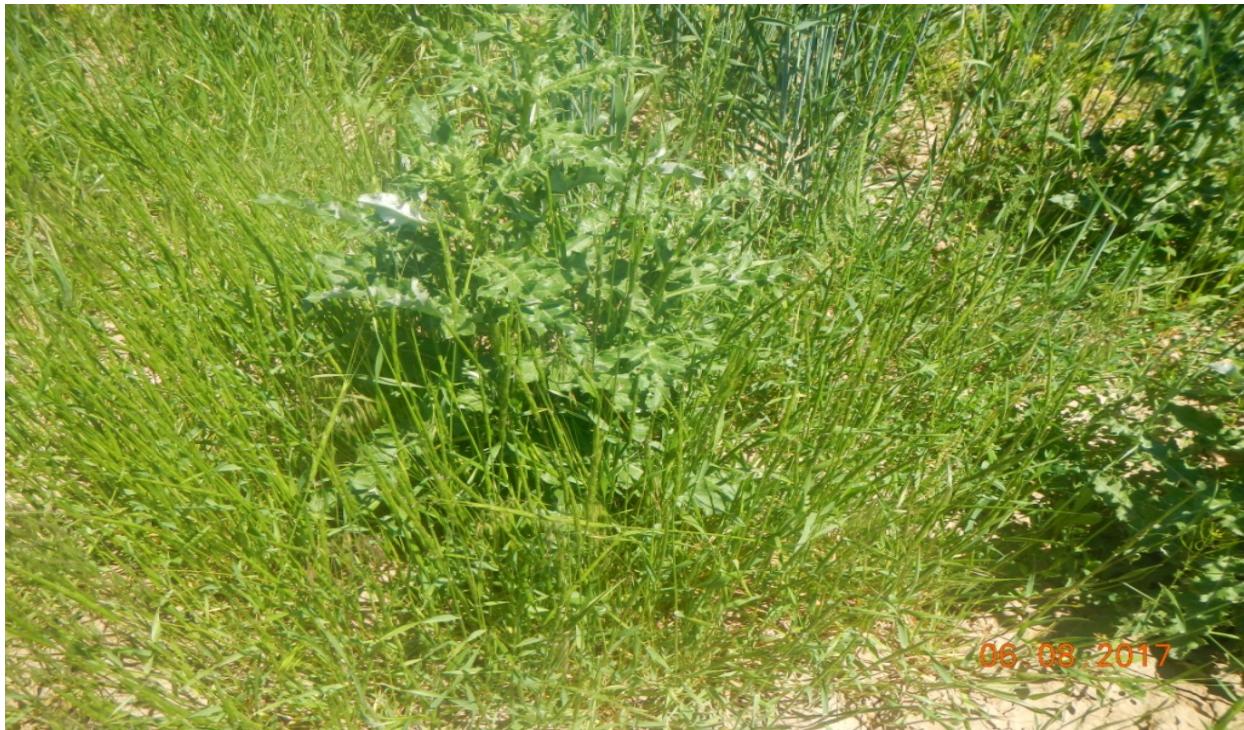
**photo 7:** There are noxious weeds growing at the location. (Canada thistle, Jointed goatgrass)
