GE 21-15X API# 05-071-08063

Date: June 06, 2017

COGCC FIR Document # 673504278 (1) Corrective Action is complete.

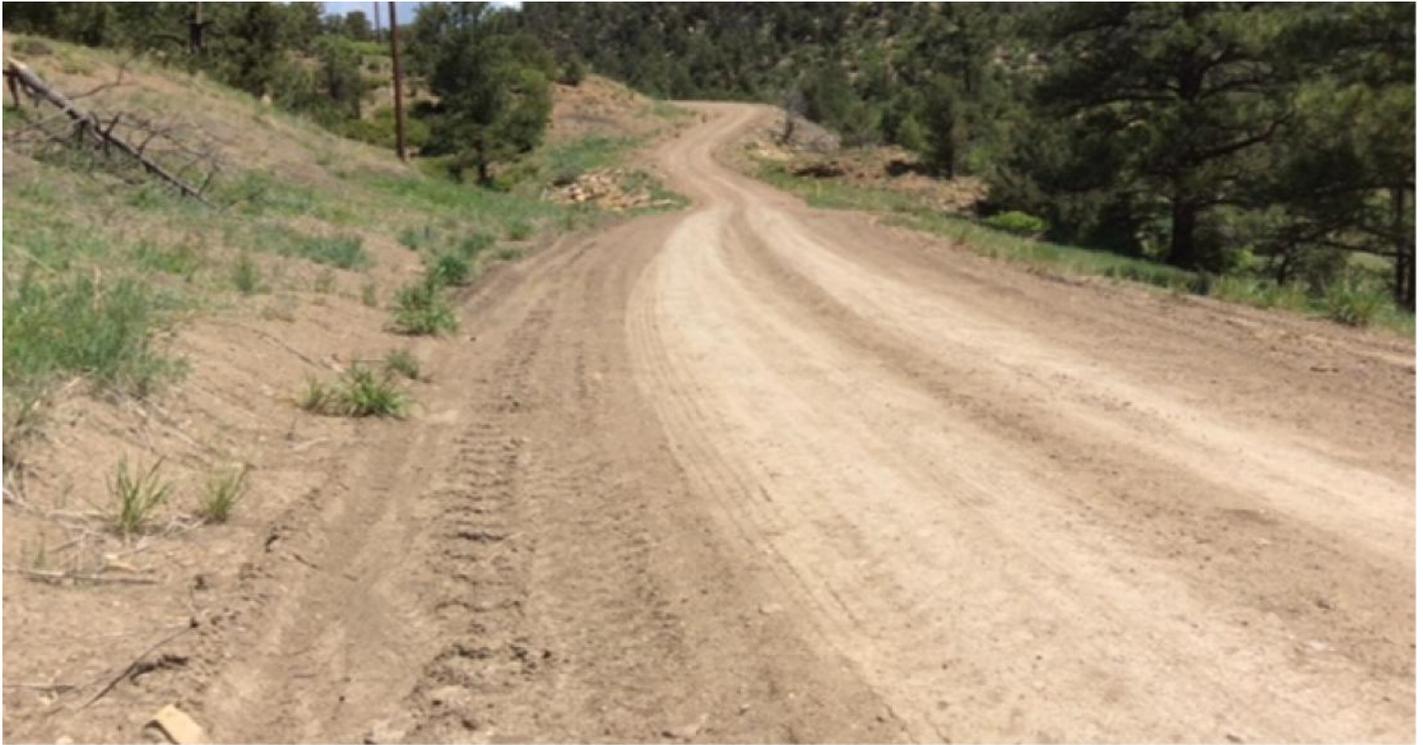
Photo 1: Facing northeast along the main access road. Bladed the roadway and crowned the driving surface to establish sheet flow.

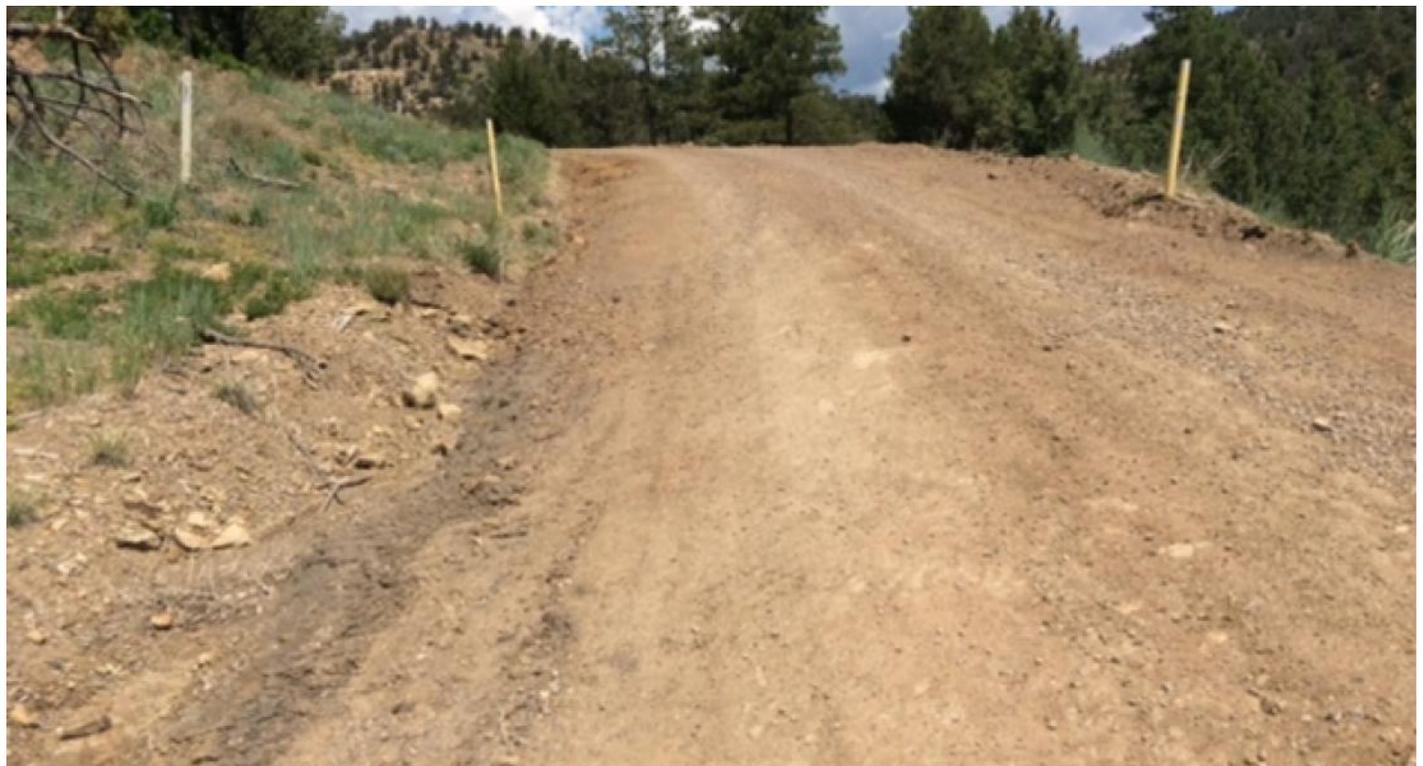
Photo 2: The main road surface has been bladed and crowned to correct the erosion issues.

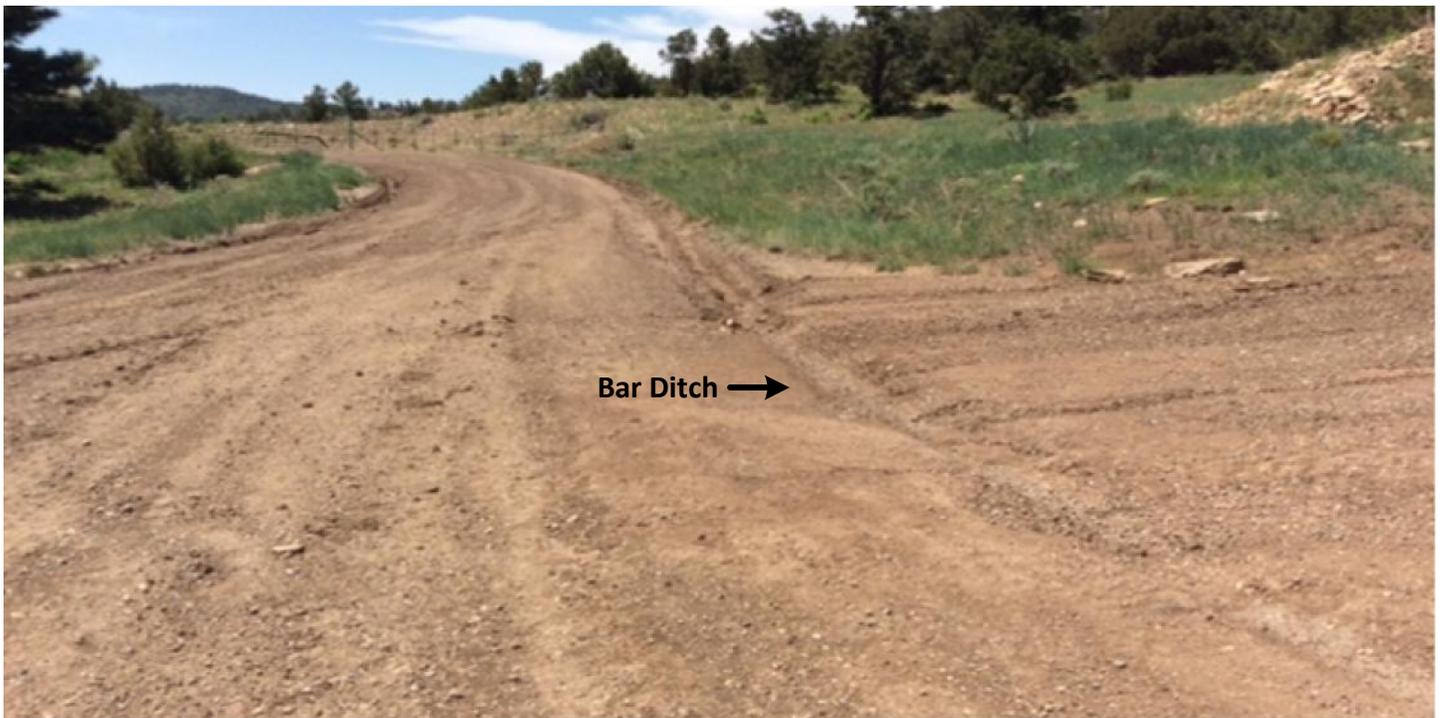
Photo 3: Facing south toward the well pad access road. Gravel was pulled into the access road and surface crowned to create sheet flow. The bar ditch was dominated to direct run off to the down gradient culvert inlet, to control erosion of the main access road.

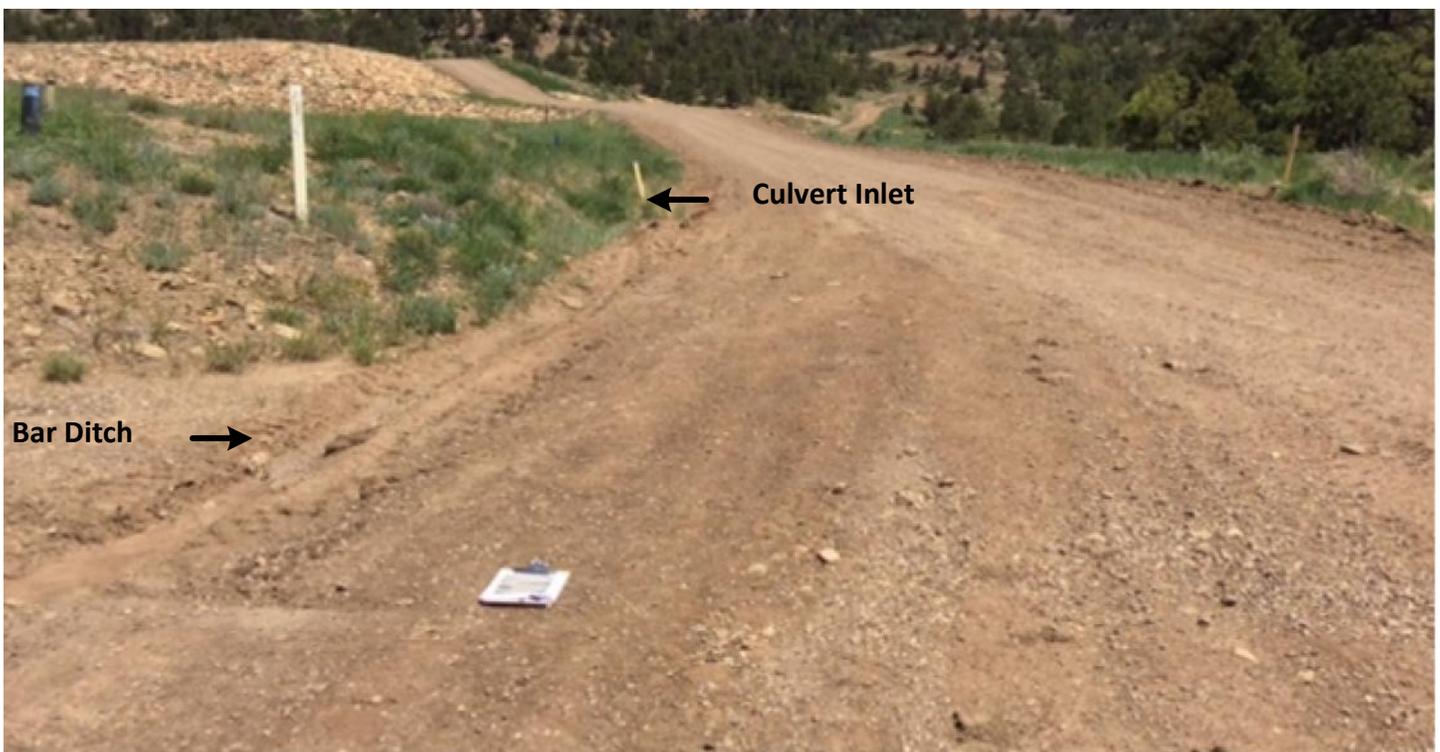
Photo 4: The bar ditch was dominated to direct run off to the down gradient culvert inlet.

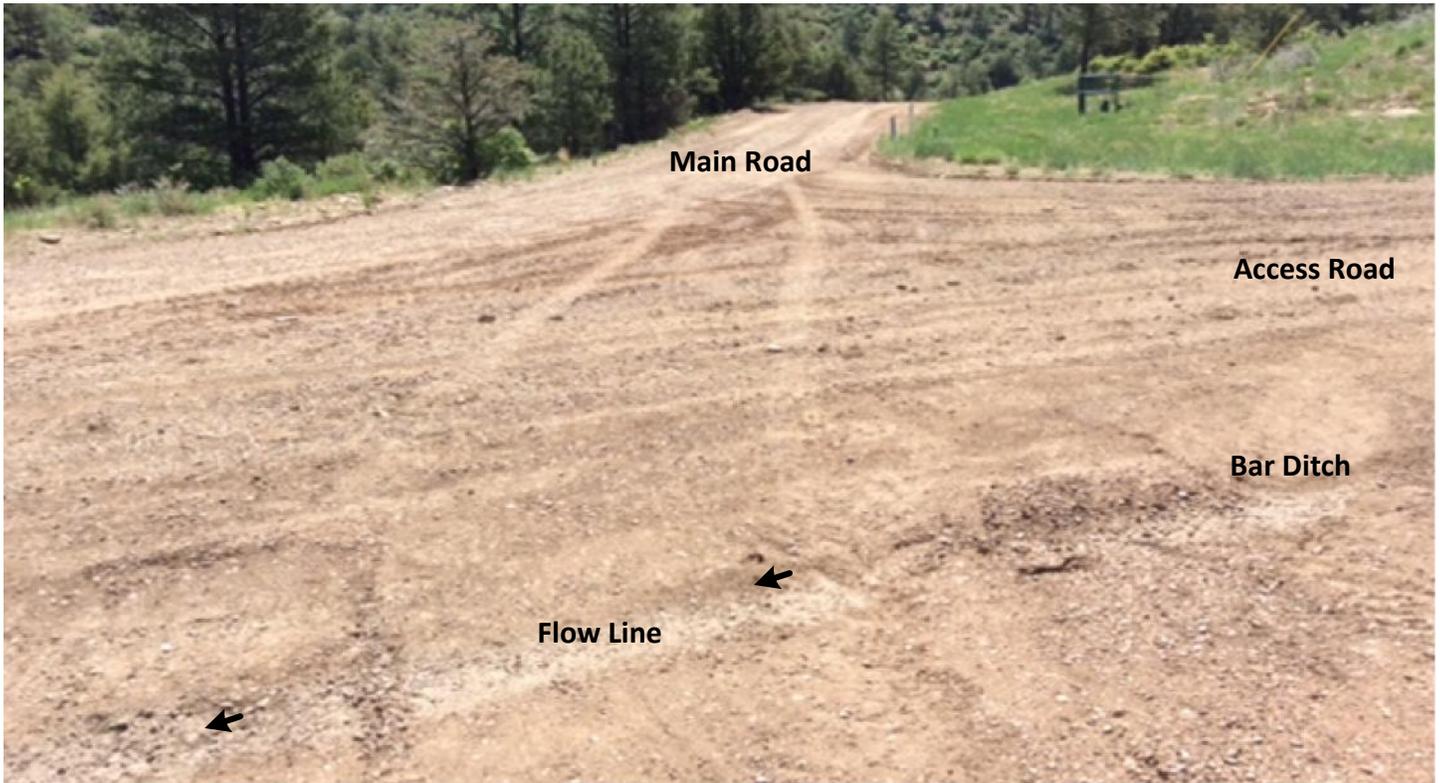
Photo 5: Intersection of main Lopez road and GE 21-15X access road. Pulled gravel onto the driving surface and re-established the bar ditch.

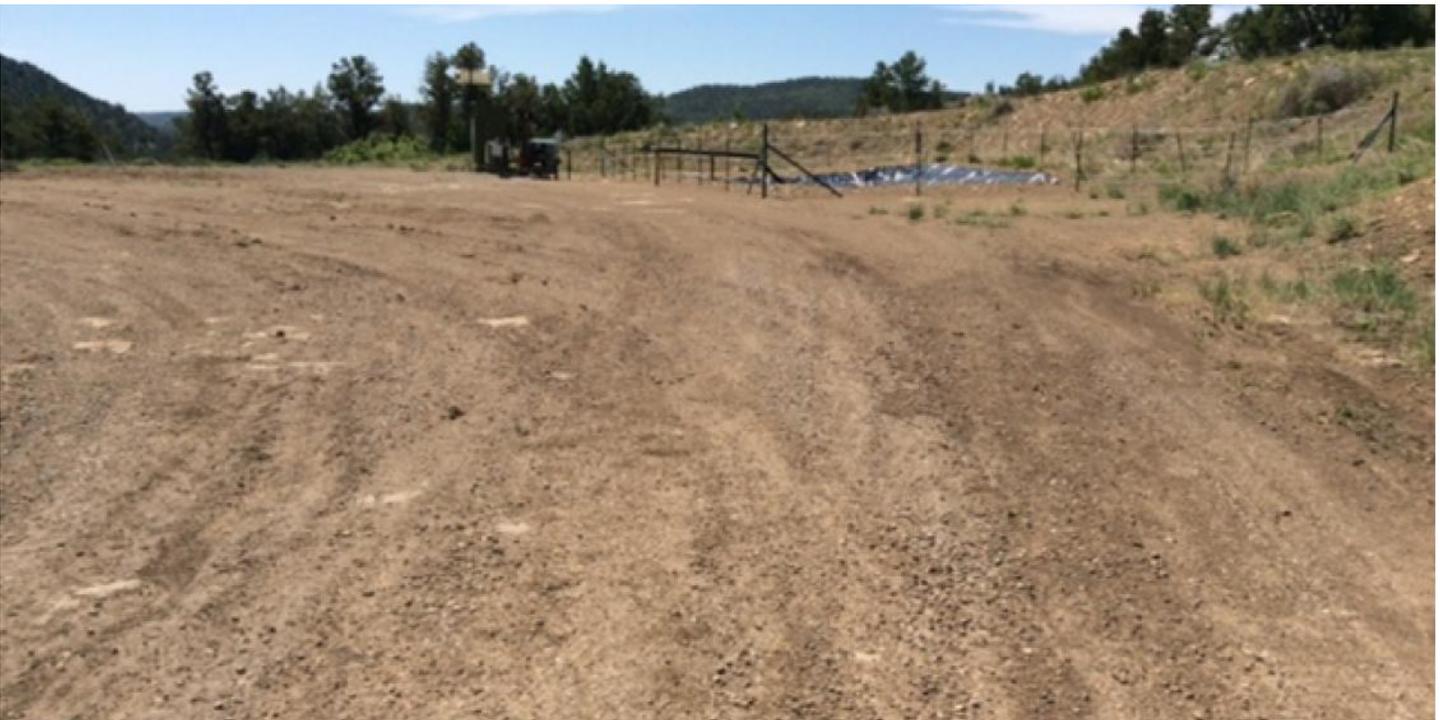
Photo 6: Facing south toward location. Pulled gravel onto the driving surface and bladed tire ruts.
