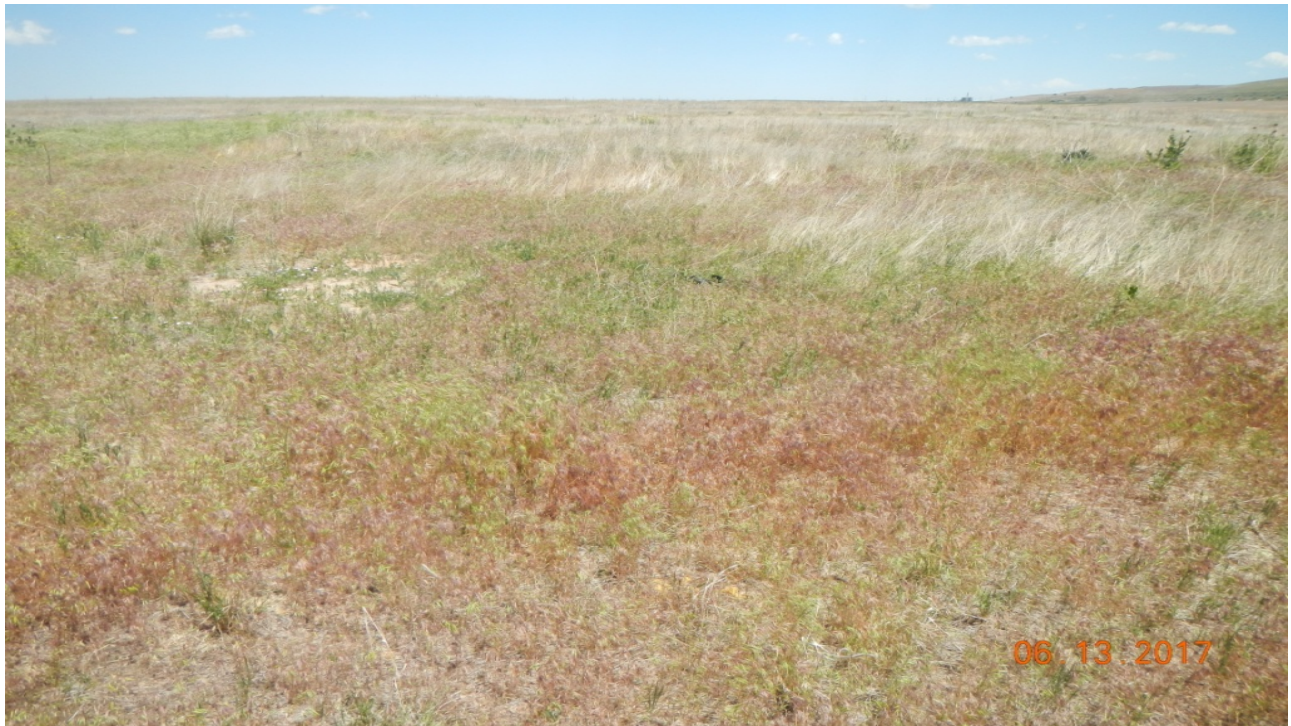
**photo 1:** Facing west toward the location. There is predominately undesirable vegetation (Cheat grass) at the location.

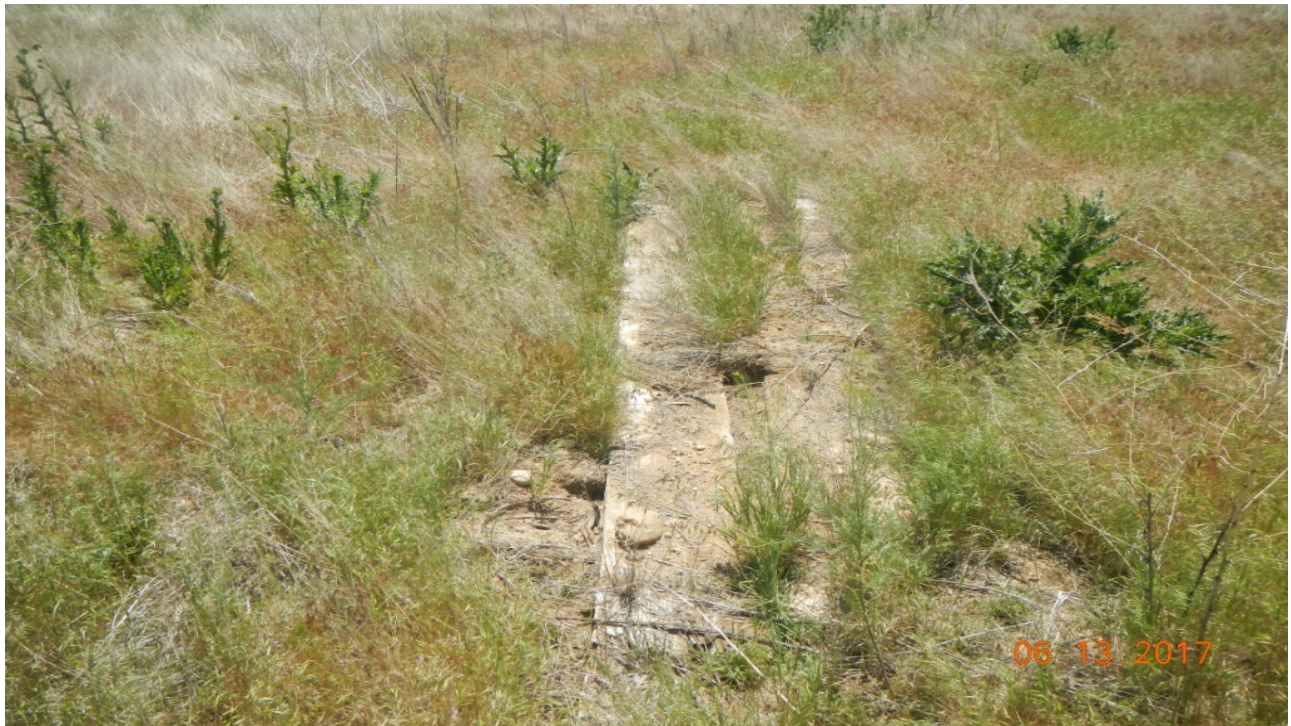
**photo 3:** There are two boards found on location.

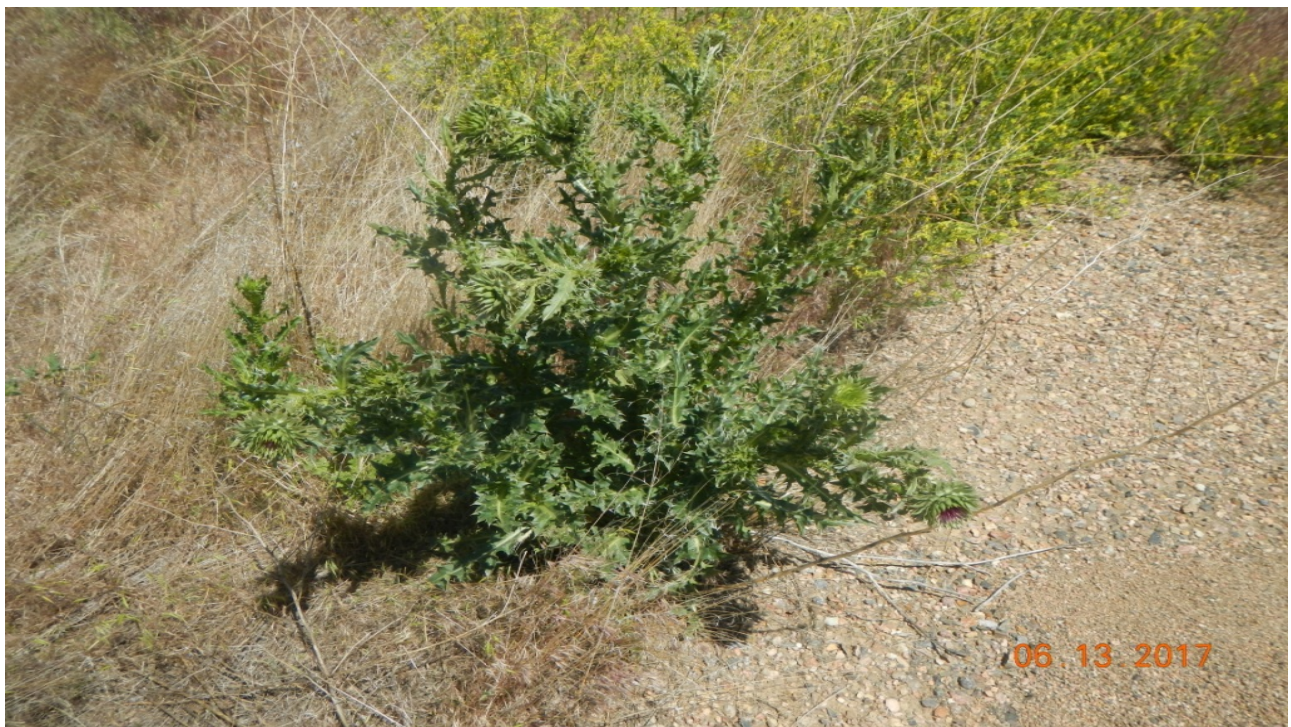
**photo 4:** There are noxious weeds (Musk thistle) growing at the location.

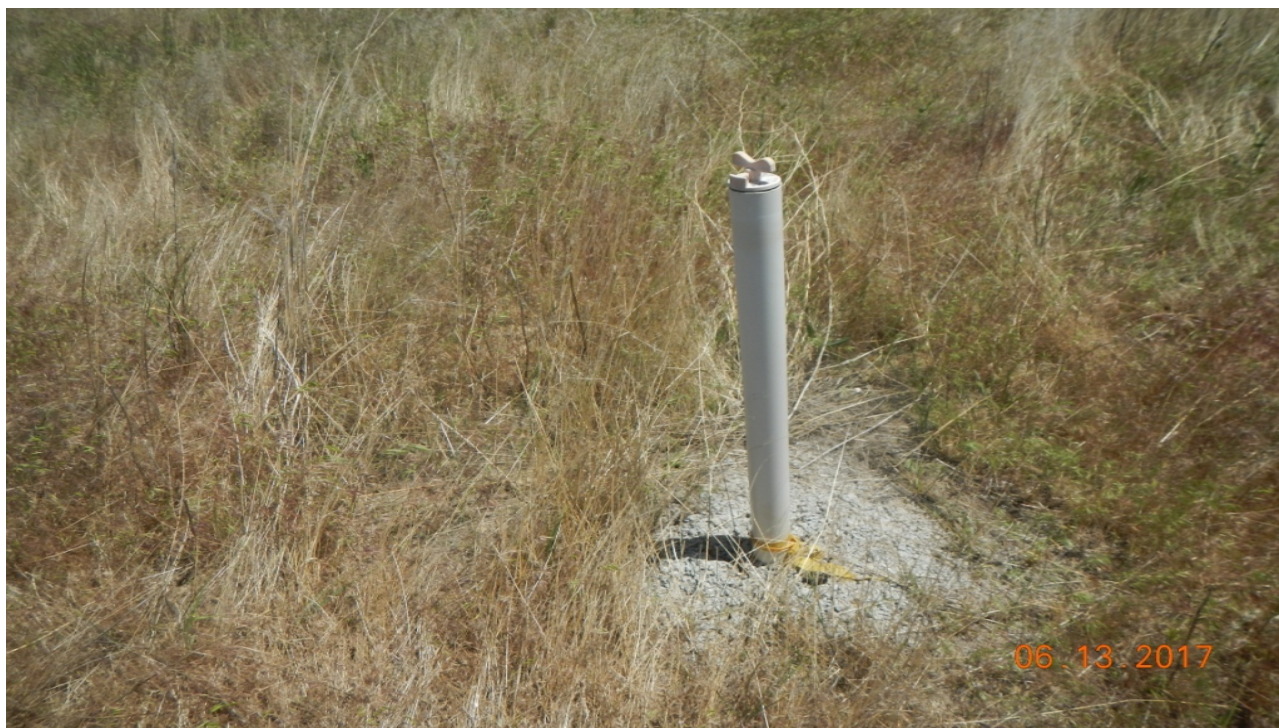
**photo 5:** There are pvc pipes at the location, presumably groundwater monitoring for remediation project.

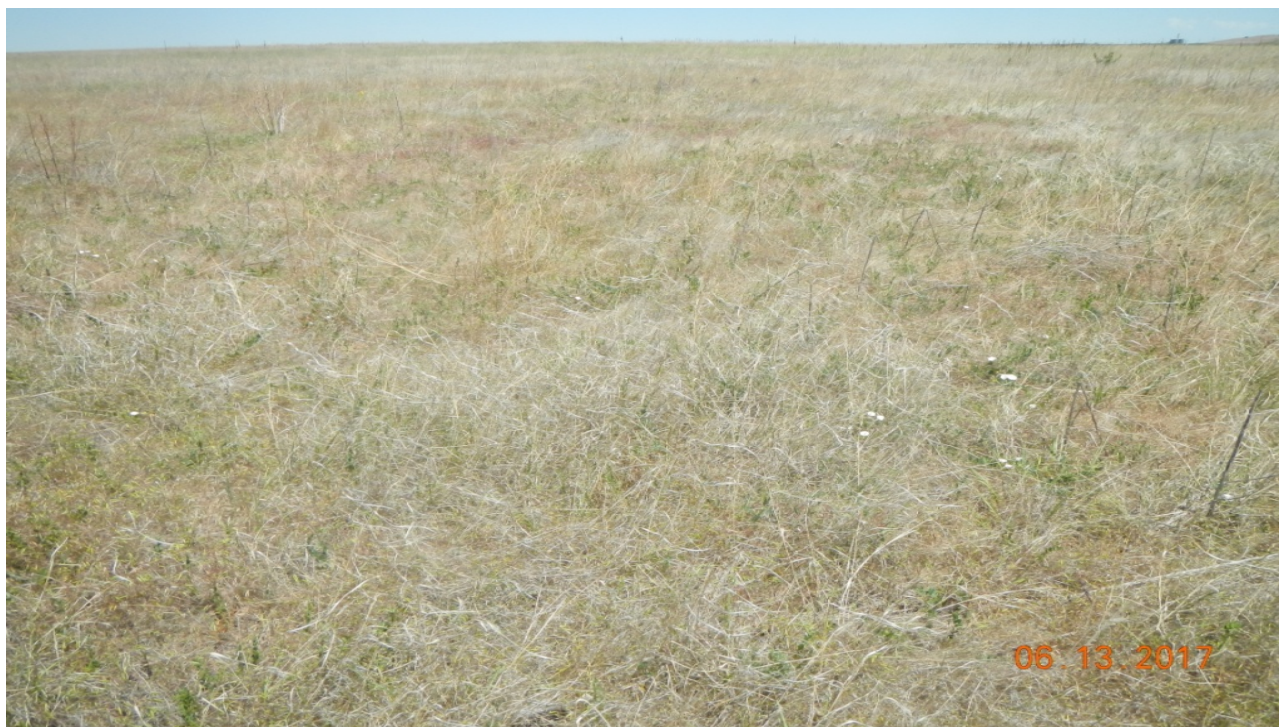
**photo 6:** Facing east toward the surrounding undisturbed area. There are more desirable species found outside of the disturbance area.
