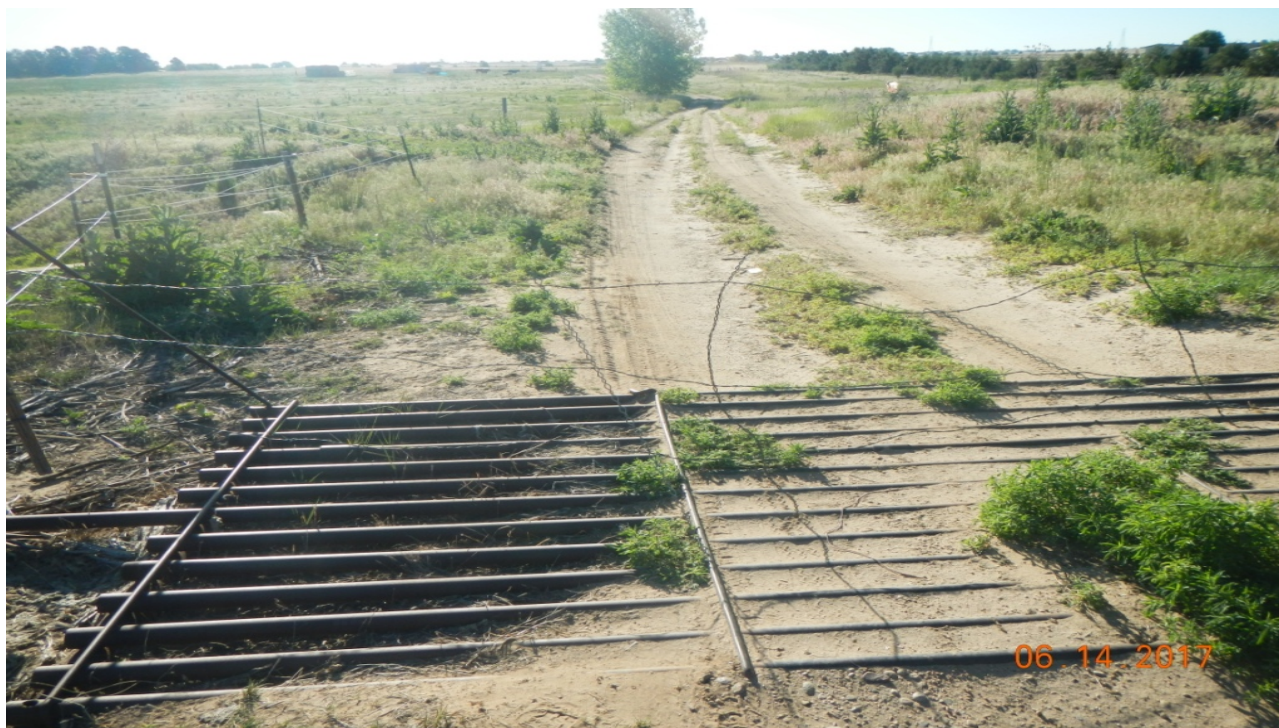
**photo 1:** Facing east toward the access road which has not been reclaimed and the cattle guard remains.

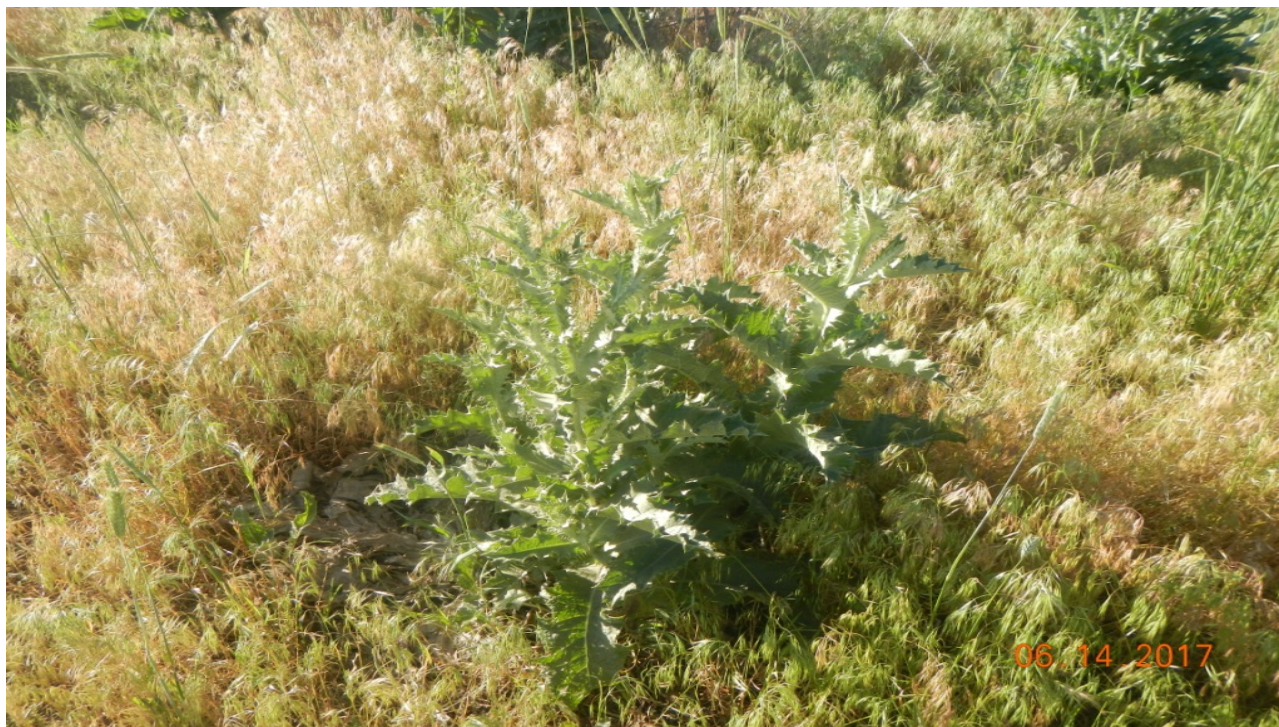
**photo 2:** There are noxious weeds along the access road. (Scotch thistle)

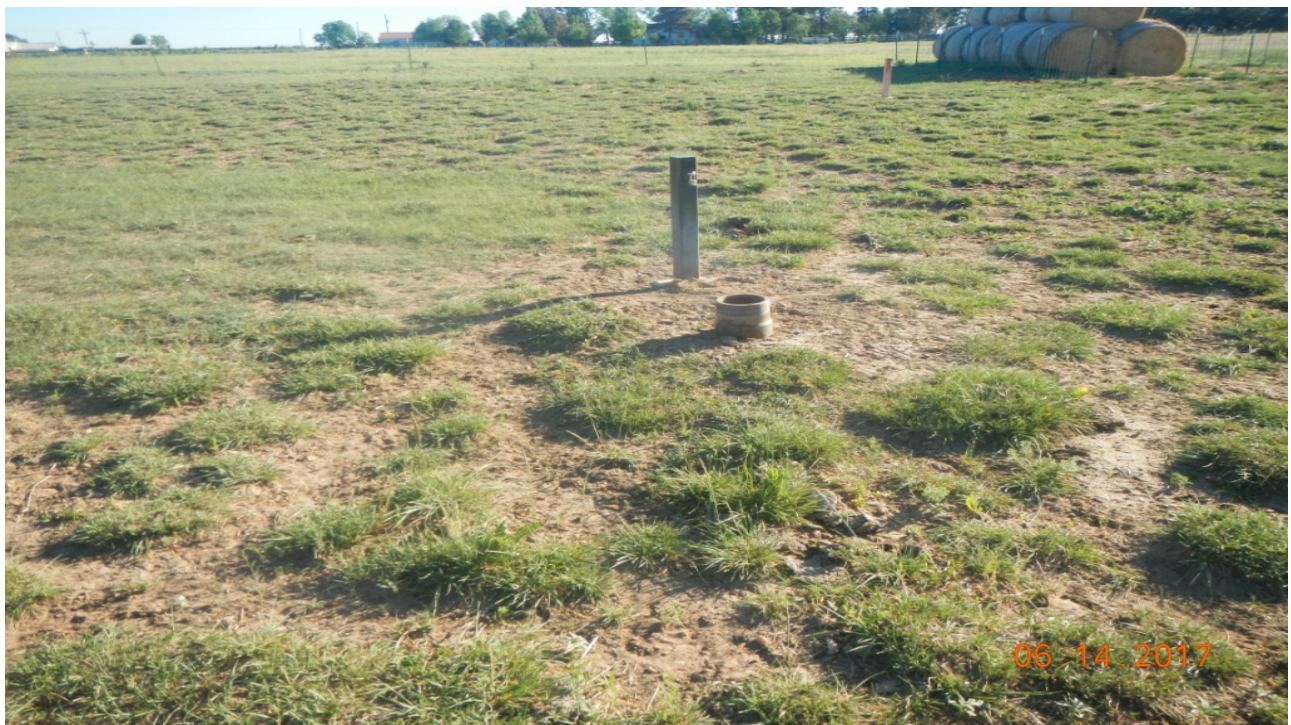
**photo 4:** There are numerous square pipe in the ground at the location which appears to be for groundwater monitoring.

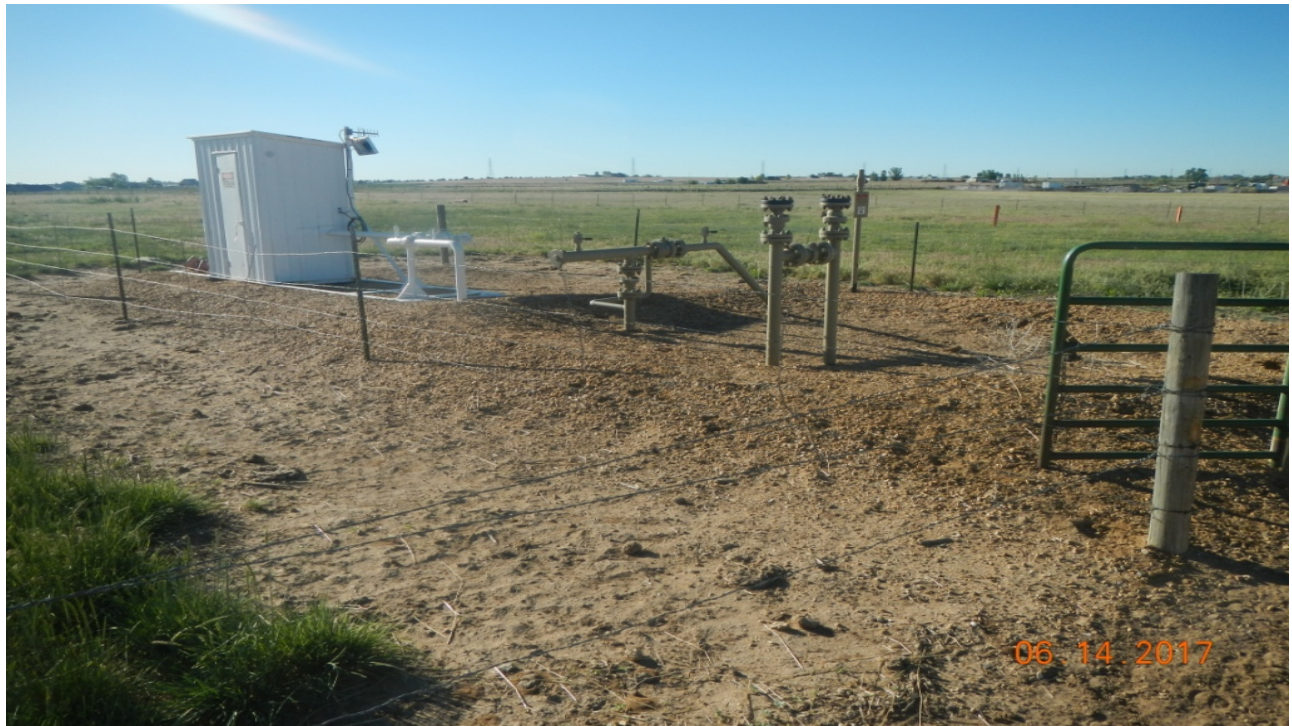
**photo 5:** There is equipment that remains at the east side of the location.

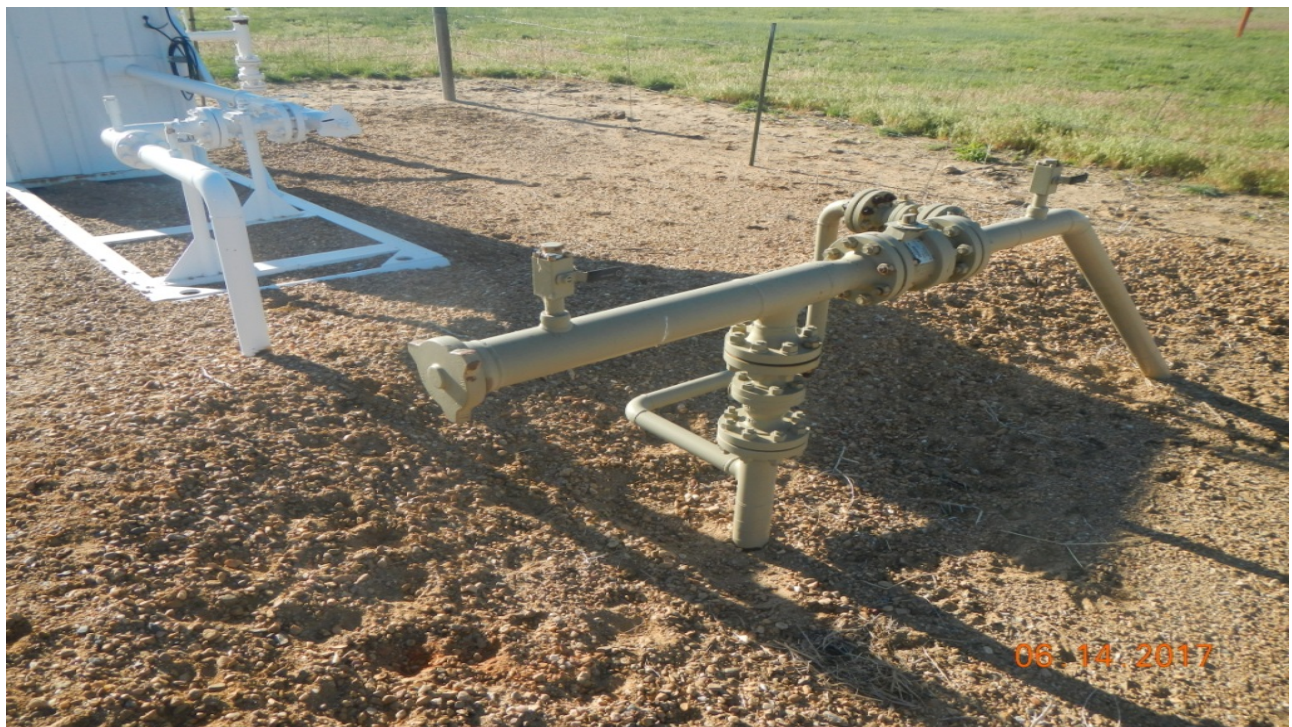
**photo 6:** There is no lock out/tag out that has been applied to the pipe infrastructure.

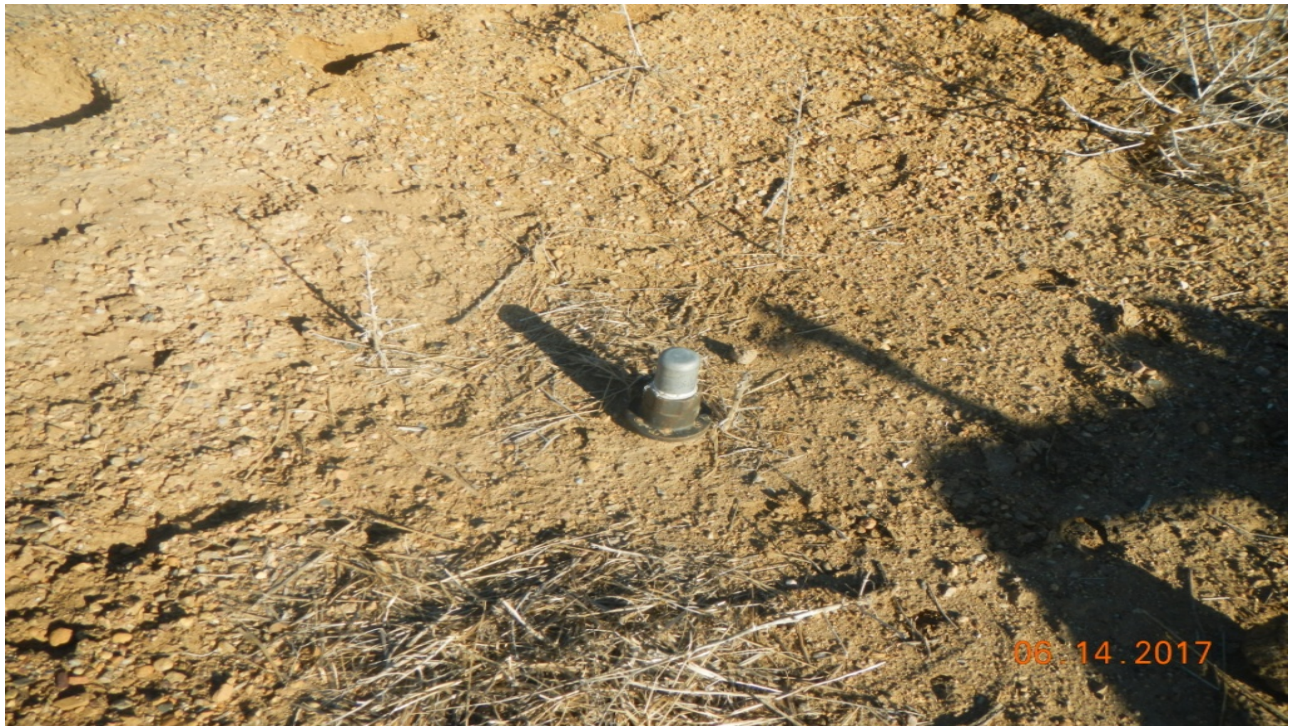
**photo 7:** There is an unknown capped pipe at Lat/Long:39.99704,-104.69336.

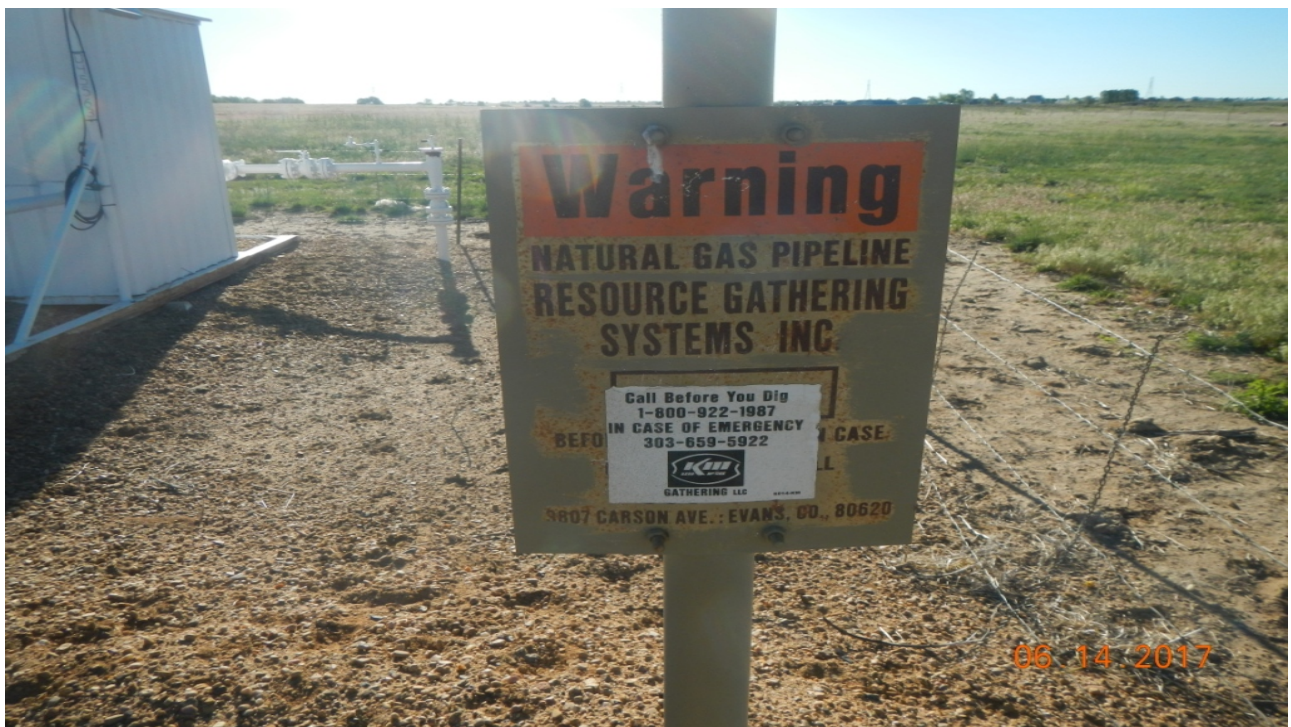
**photo 8:** Sign indicates Kerr McGee Gathering line.

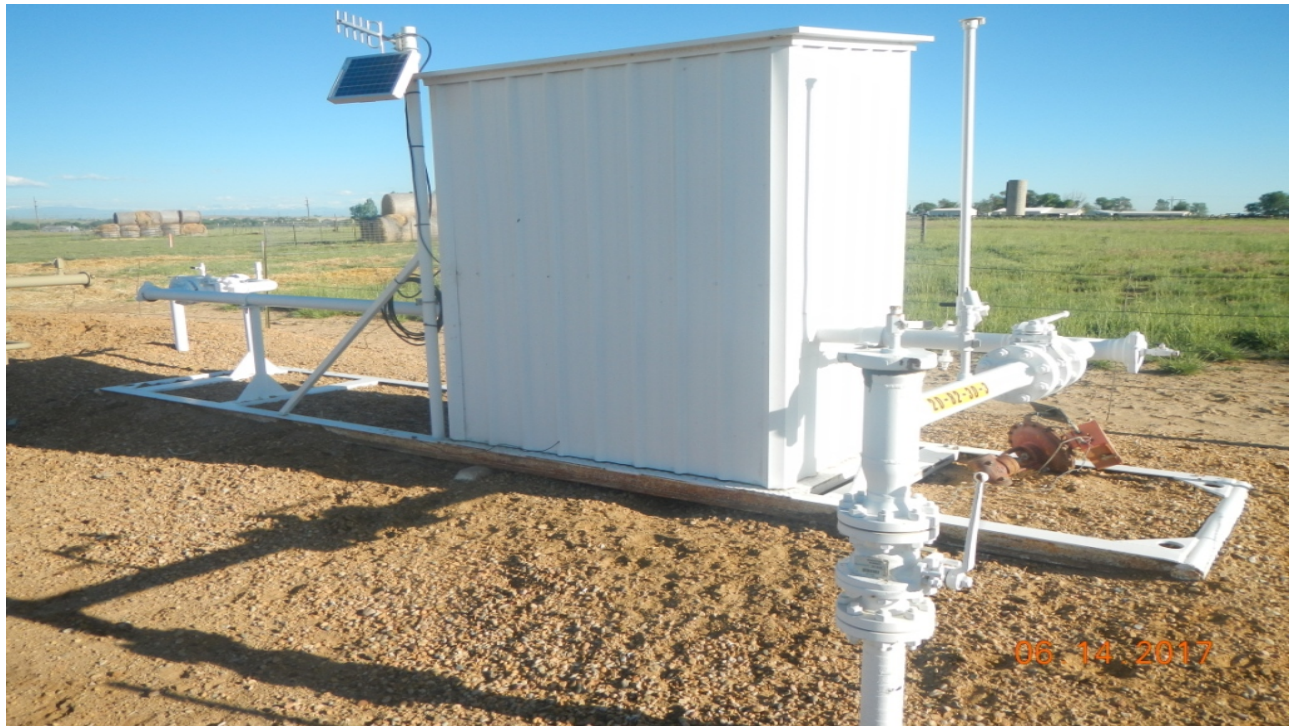
**photo 9:** Facing toward backside of equipment that remains at the location.
