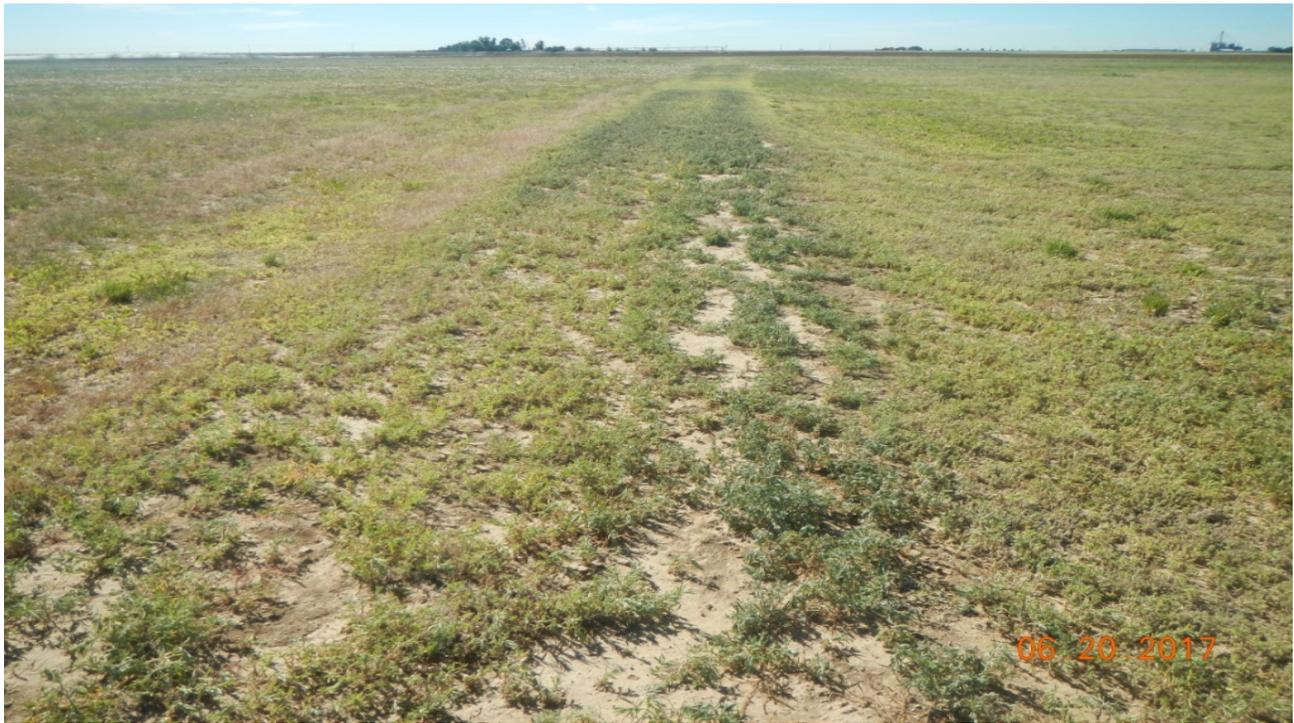
**photo 1:** Facing southeast along the former access road. The former road is still visible and there is predominately undesirable vegetation along the road.

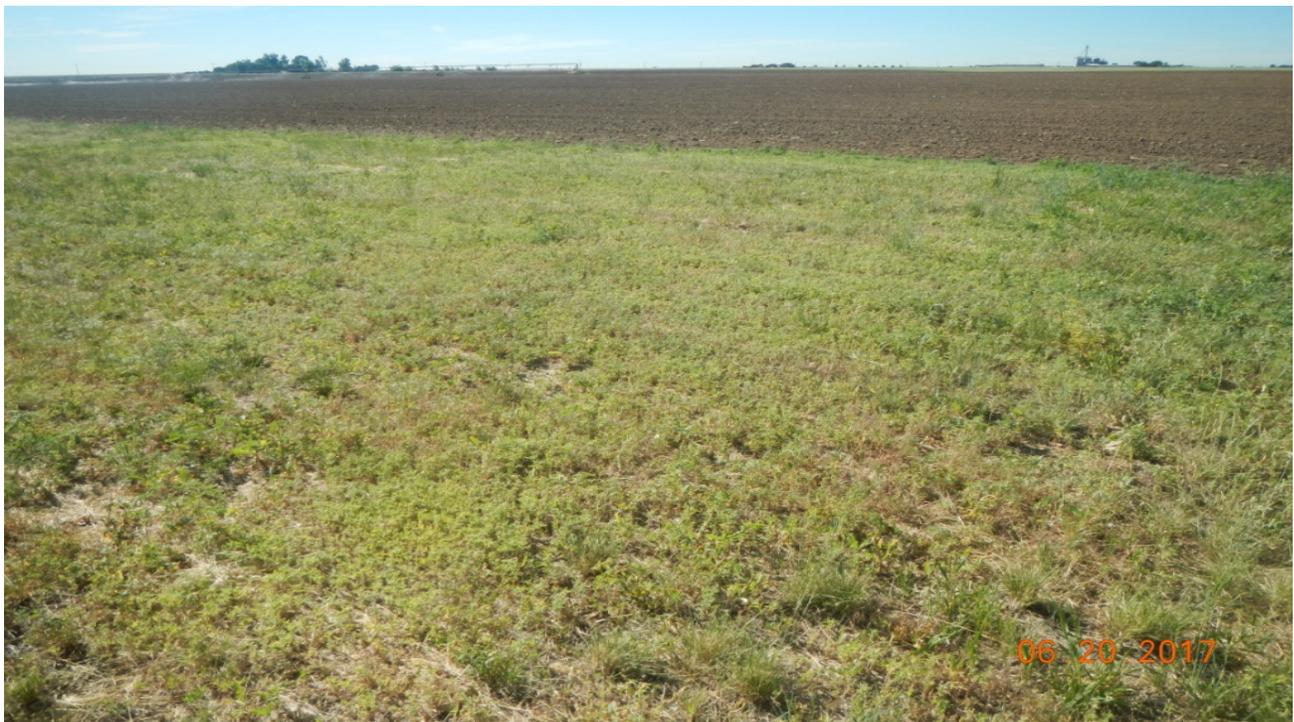
**photo 2:** Facing southeast toward the location. There is no equipment that remains and the southern portion is cultivated.

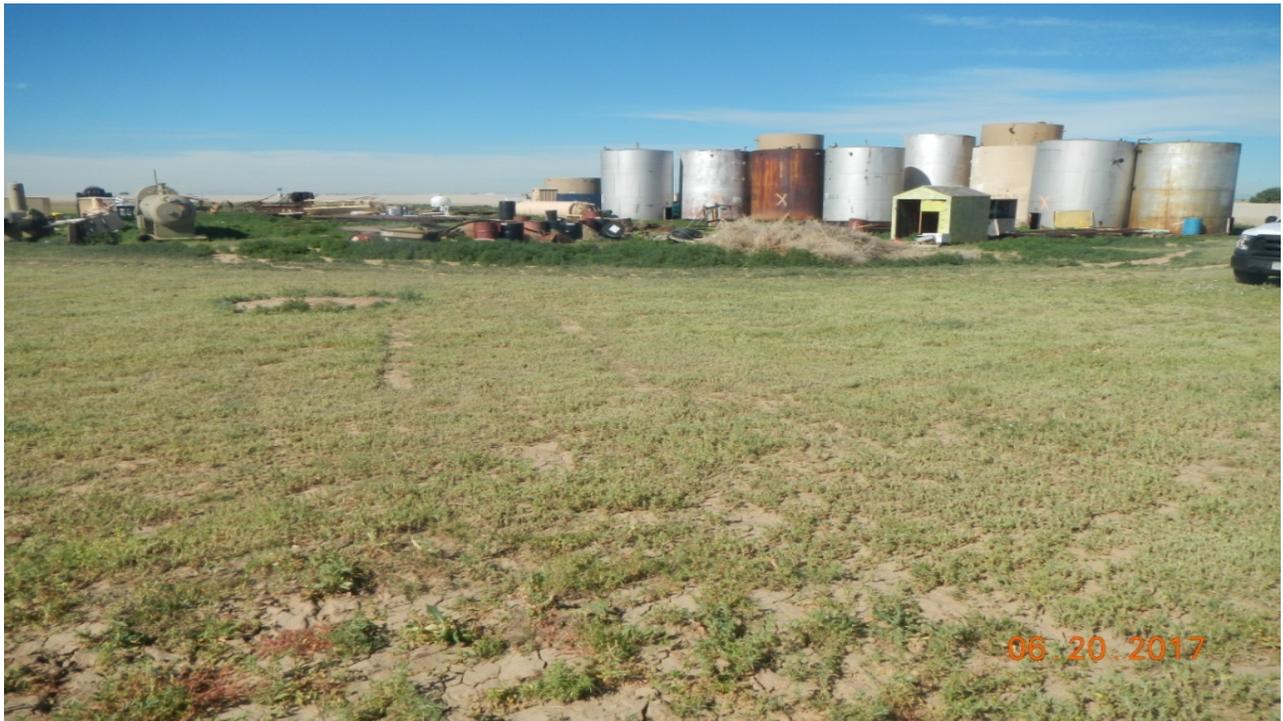
**photo 3:** Facing southeast toward the former tank battery site near the location. Unused equipment is being stored in this area.

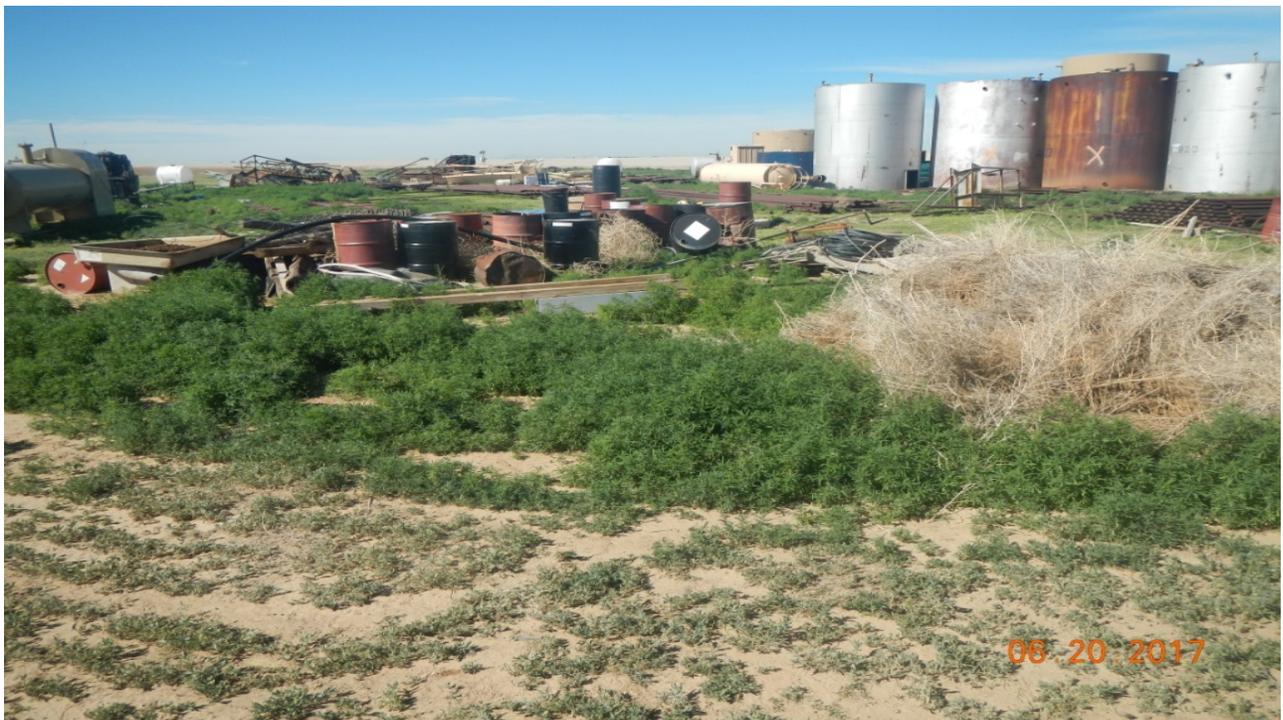
**photo 4:** Facing north towards unused equipment that remains at the former tank battery site.

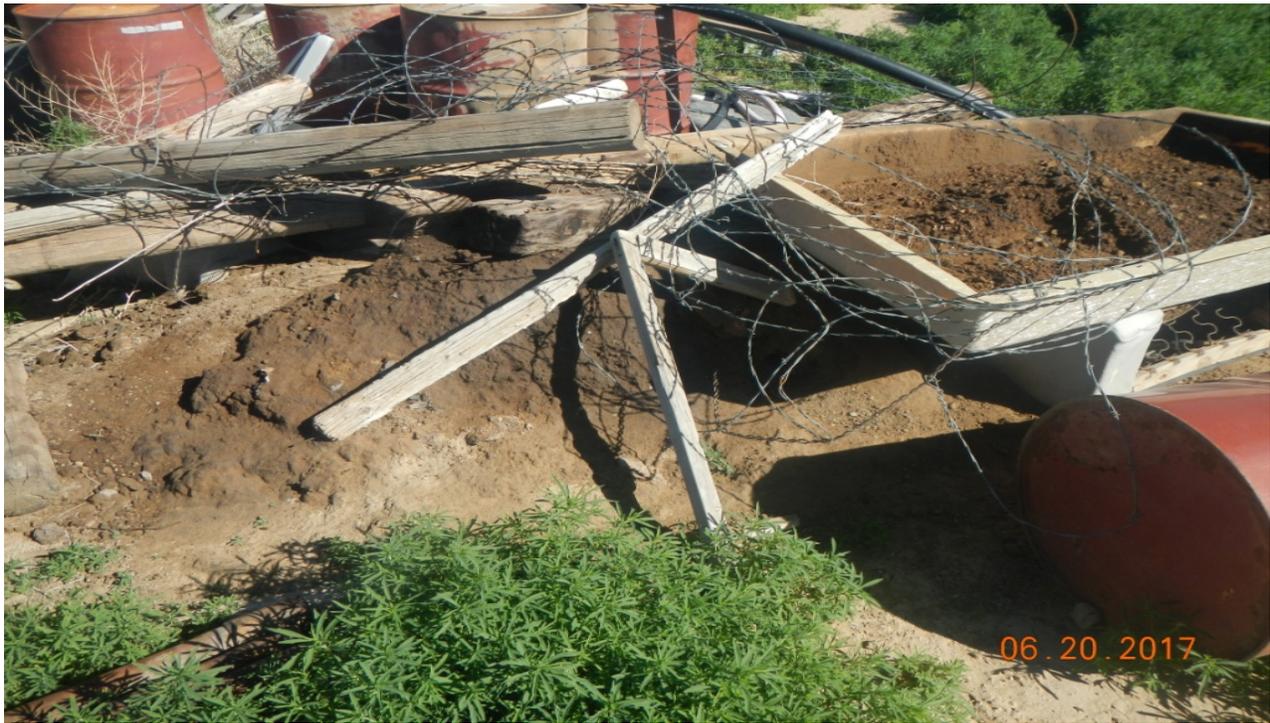
**photo 5:** There is oily soil waste noticed where unused equipment is stored.

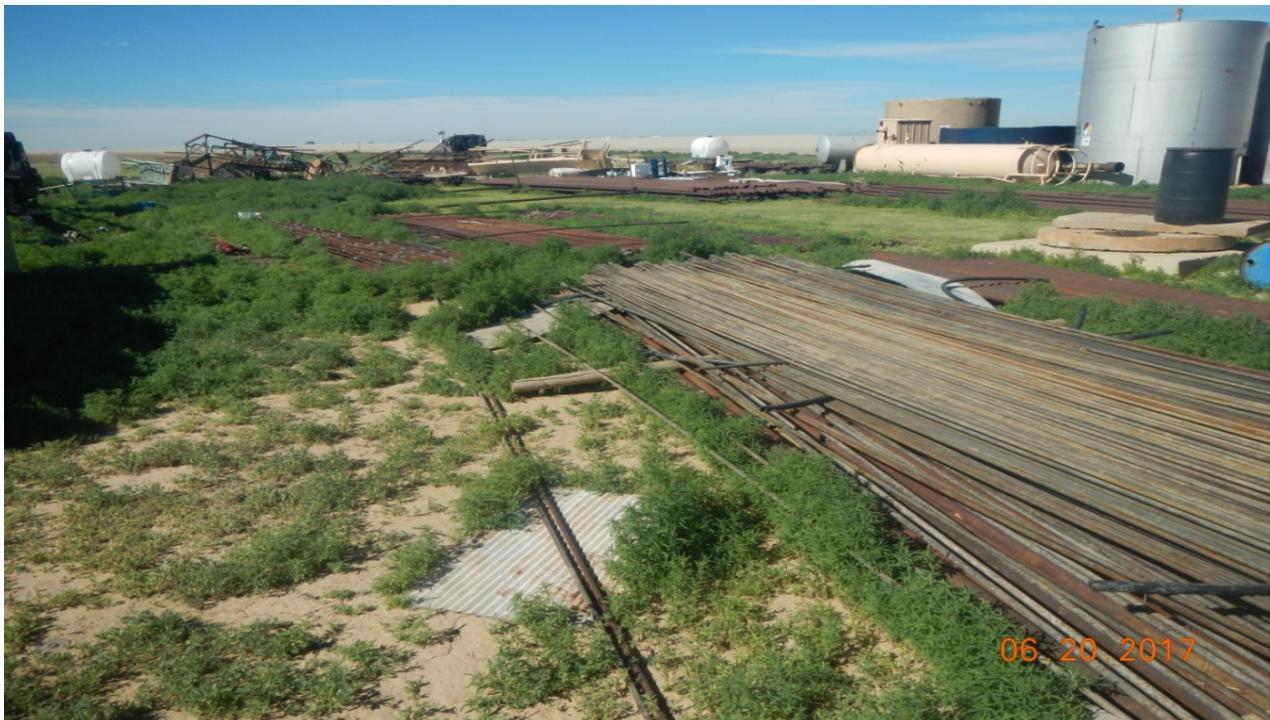
**photo 6:** Facing south toward the former tank battery site where unused equipment is being stored.

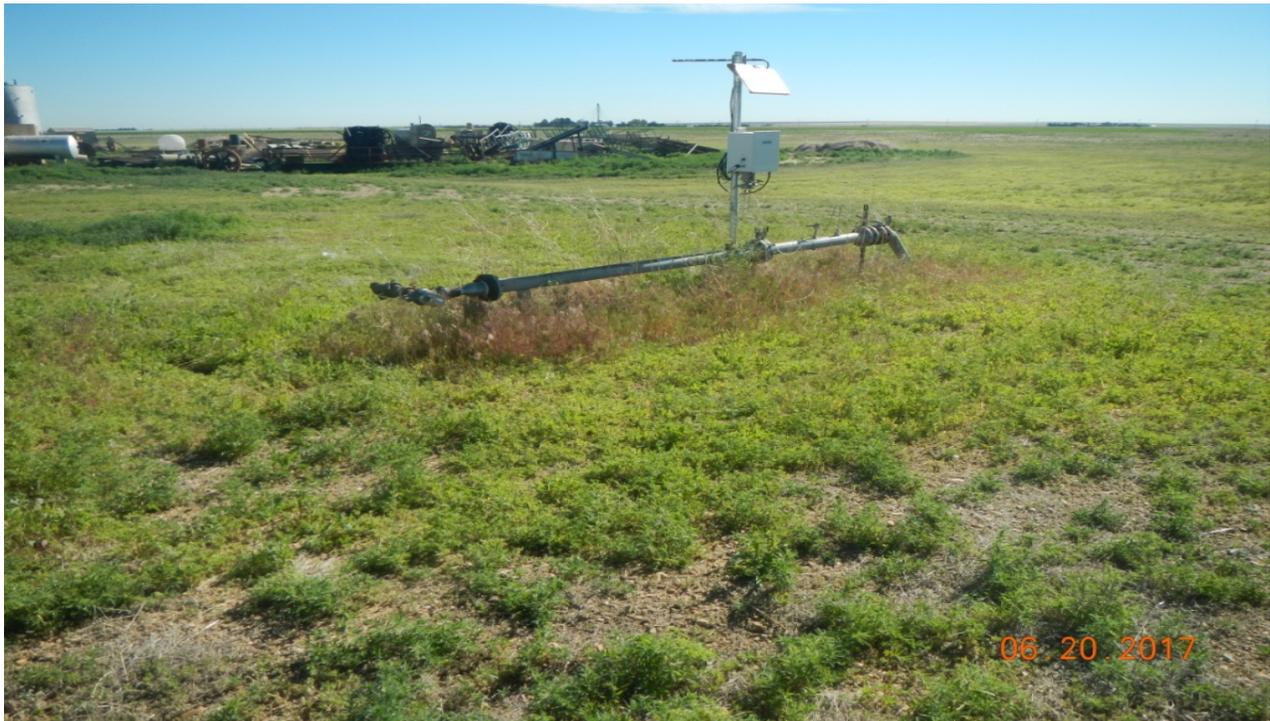
**photo 7:** There is a pipe riser that remains at the former tank battery site.  
Lat/Long:39.94706,-104.42354

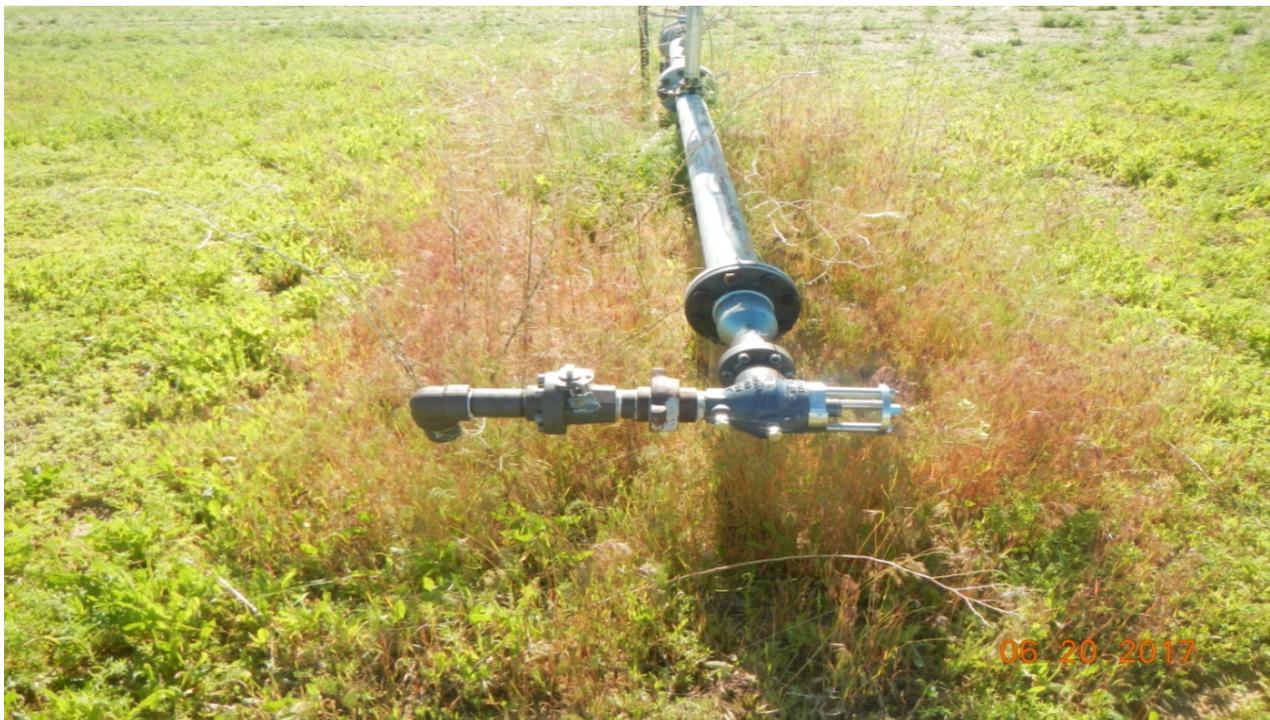
**photo 8:** One end of the pipe riser has been disconnected, capped and locked out.  
Lat/Long:39.94706,-104.42354
