**Inspection Photos**  
**Location Name: Moyer Unit 13-29**  
**API: 05-123-07029**

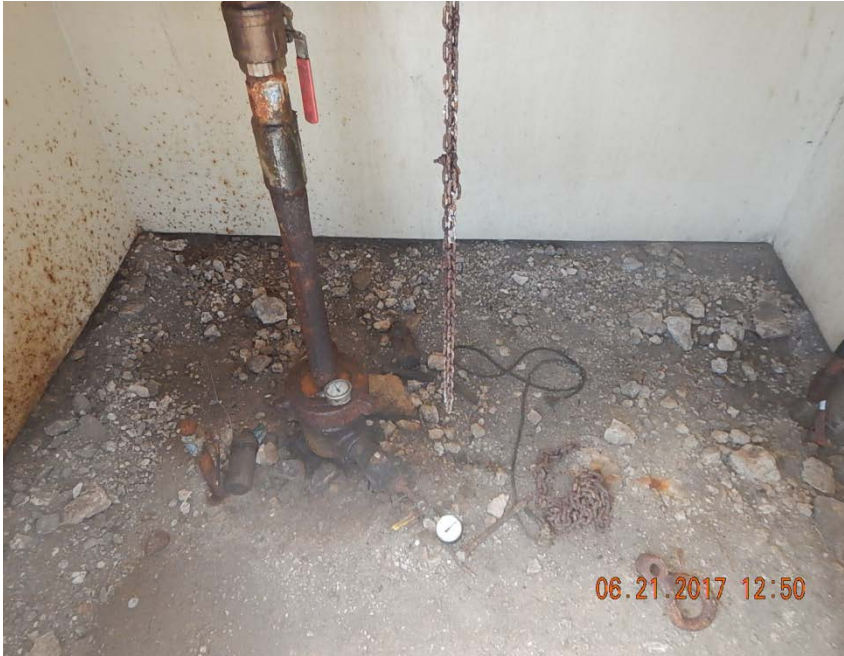
**Photo 1: Stained soil at wellhead**
