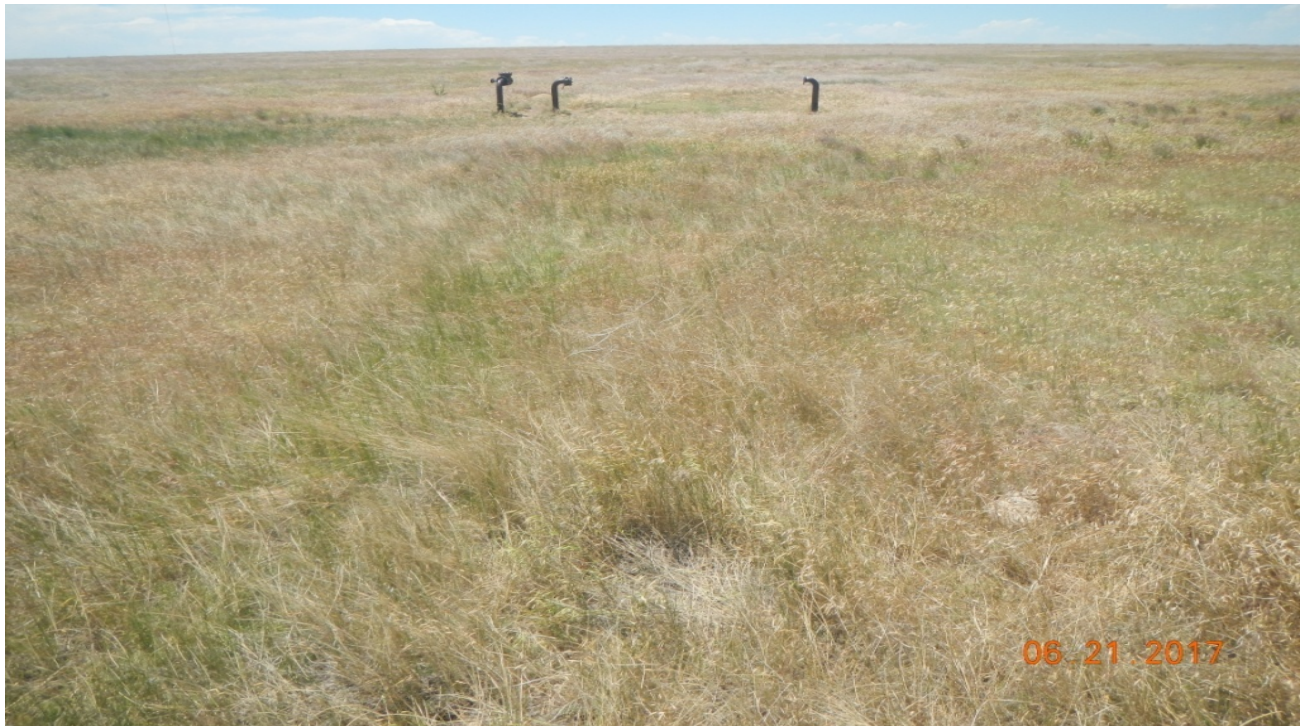
photo 1: Facing west toward the location. The native vegetation has fully re-established however, pipe risers remain at the location.
