COGCC Environmental Field Inspection Report Photo Attachment

Inspection Date: **June 22, 2017**

COLORADO
Oil & Gas Conservation
Commission

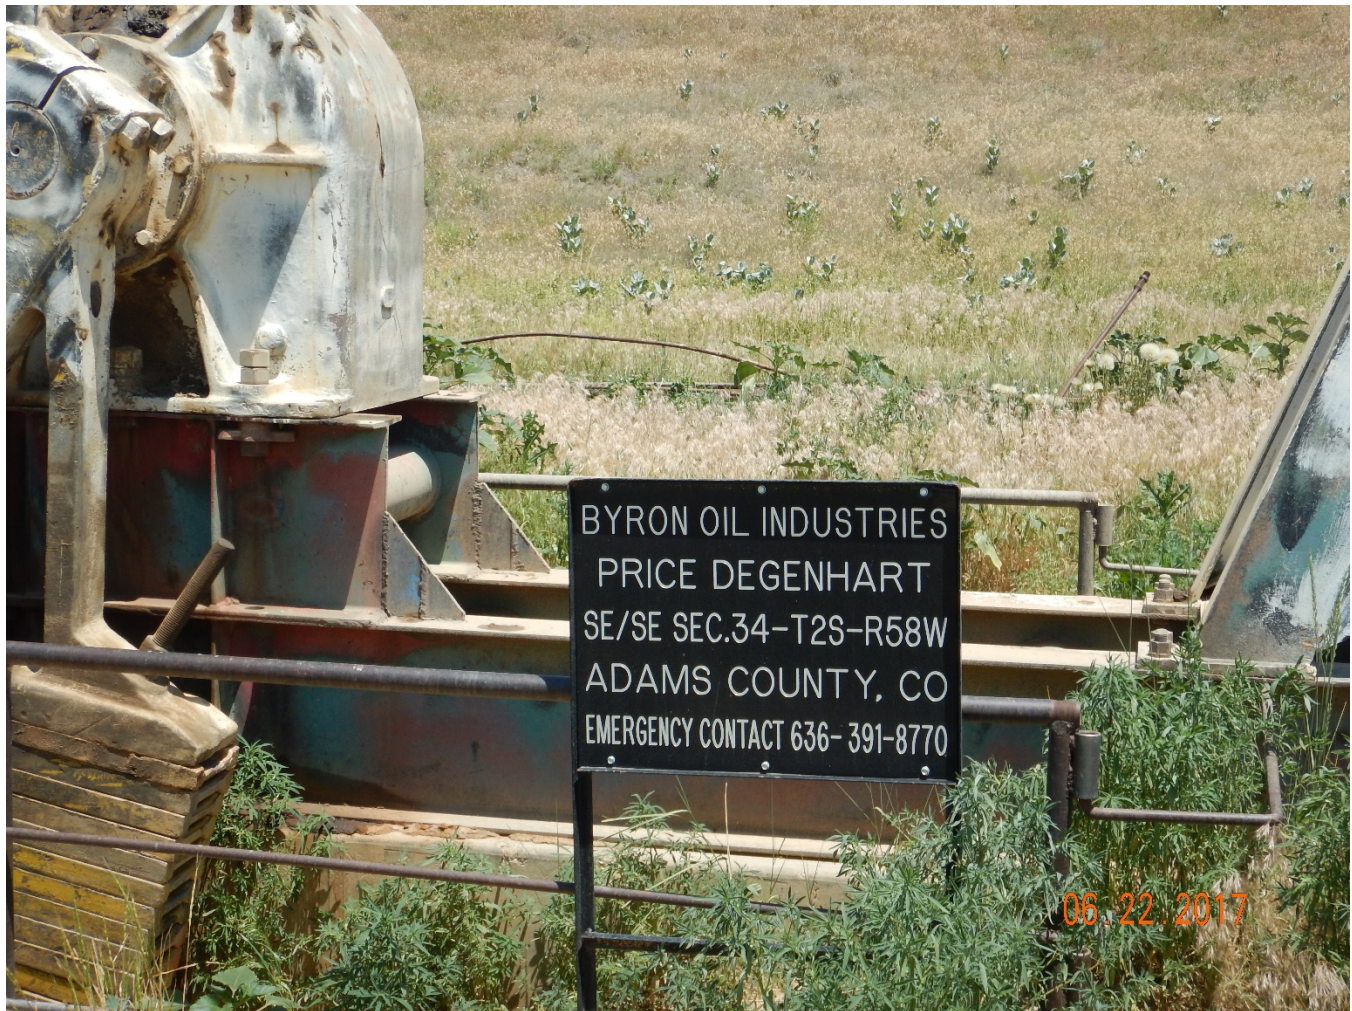
Figure 1 - Well sign.

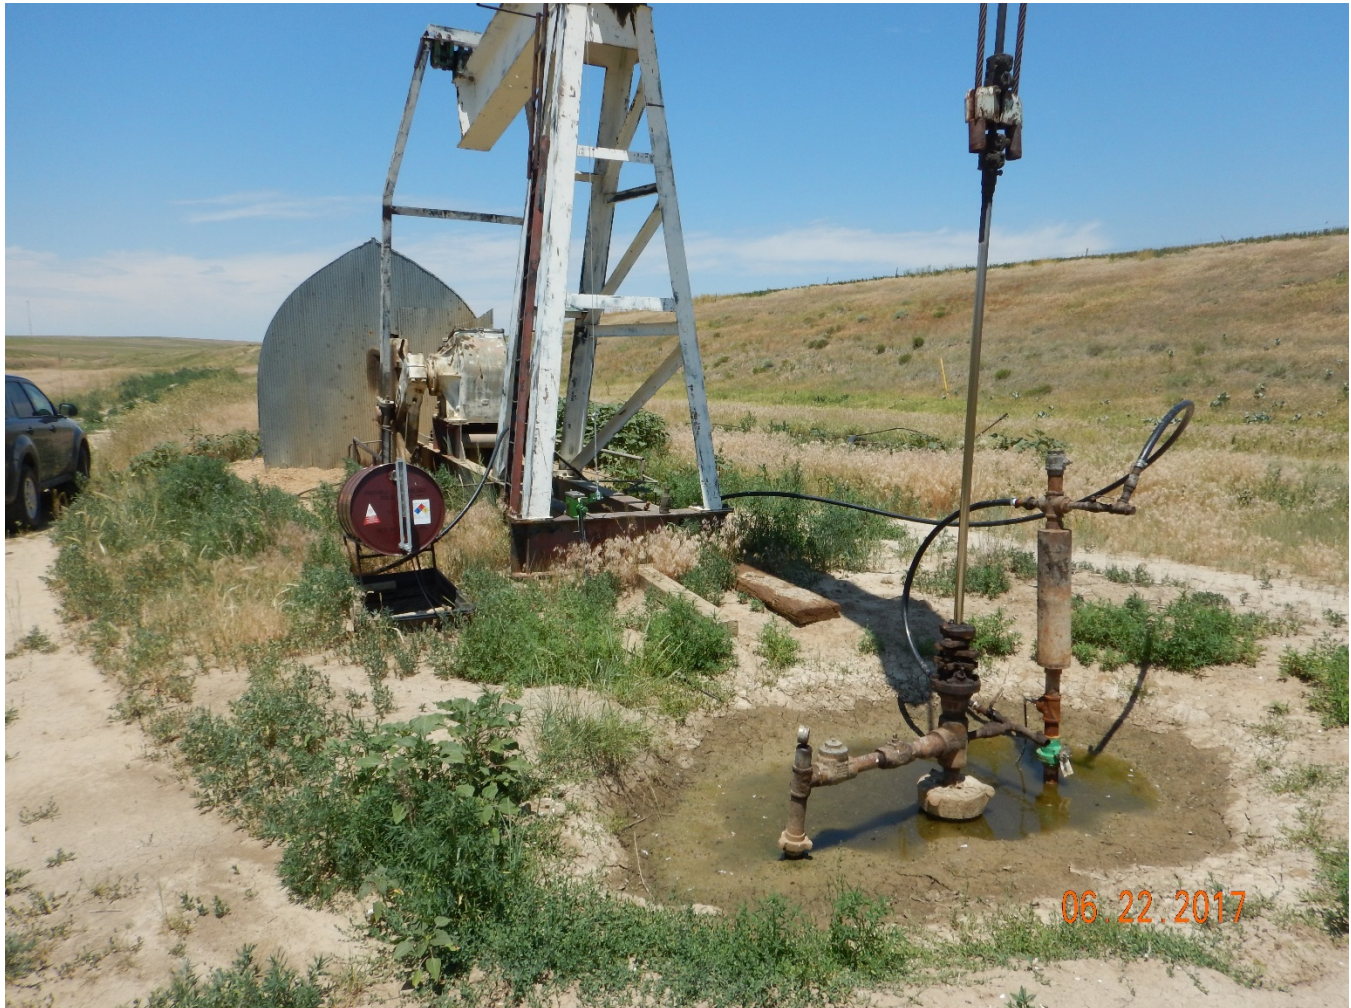
Figure 2 - Price-Degenhart 1 Wellhead. Note: puddle/depression around wellhead, uncontrolled weeds, and chemical storage tank.

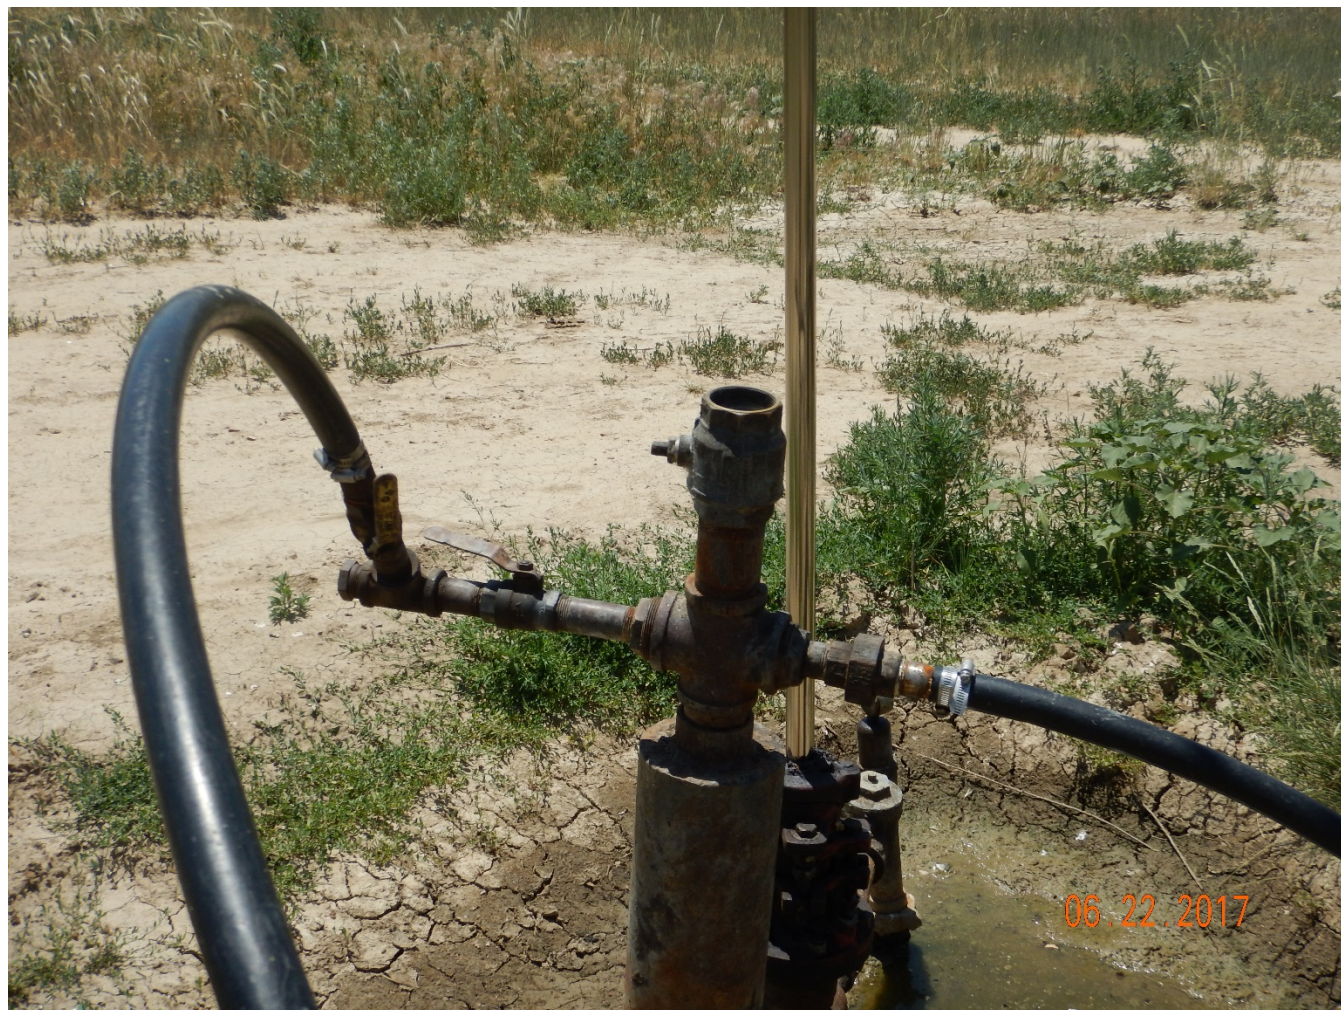
Figure 3 - Wellhead equipment is open to atmosphere (no bullplug installed).

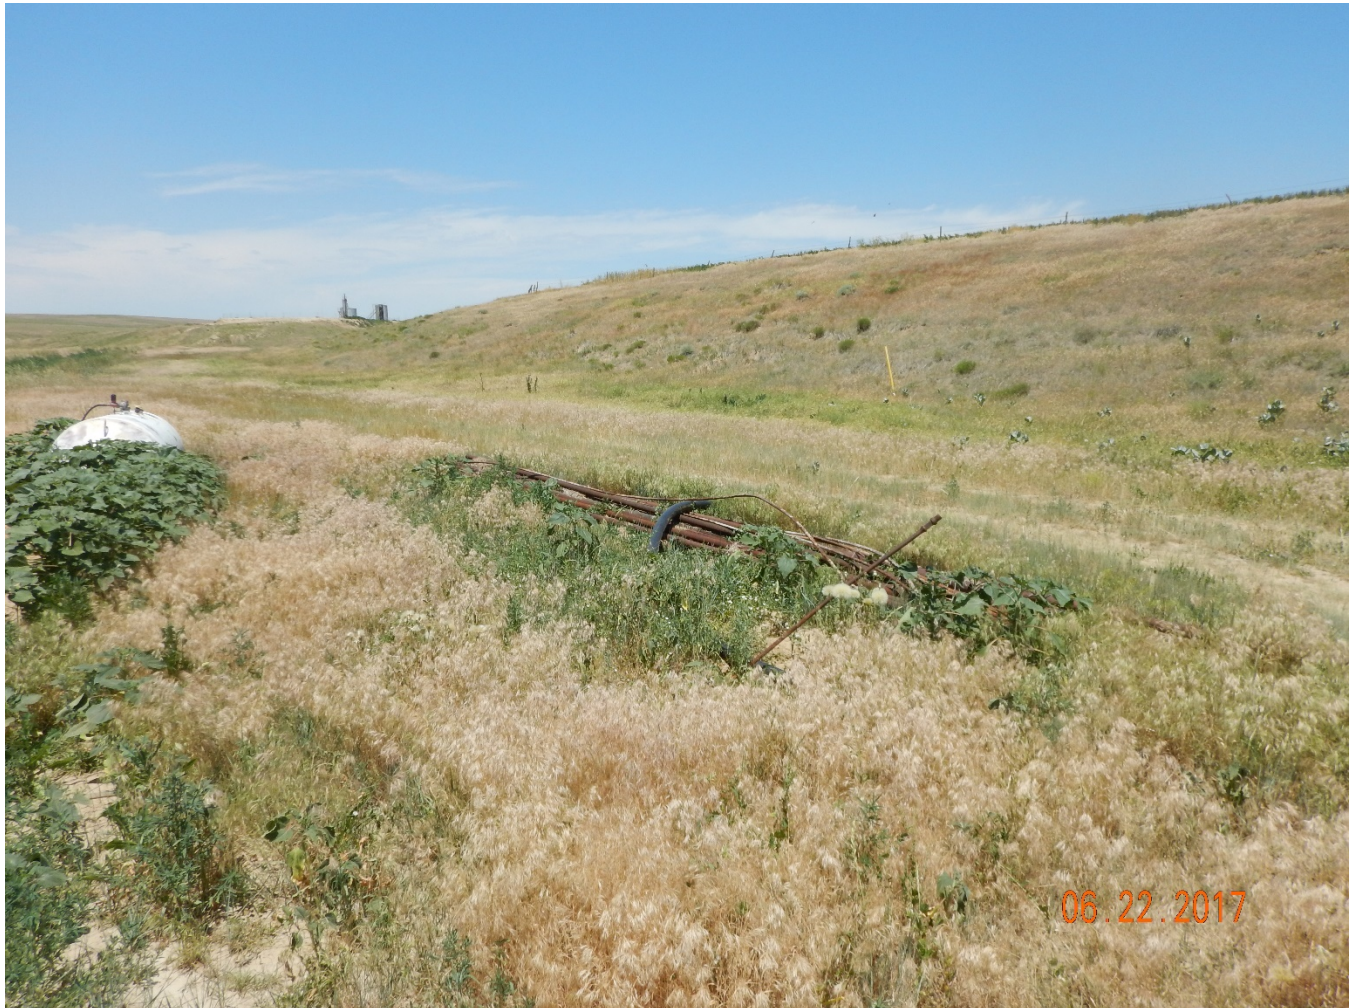
Figure 4 - Unused equipment and propane tank at pumping unit.

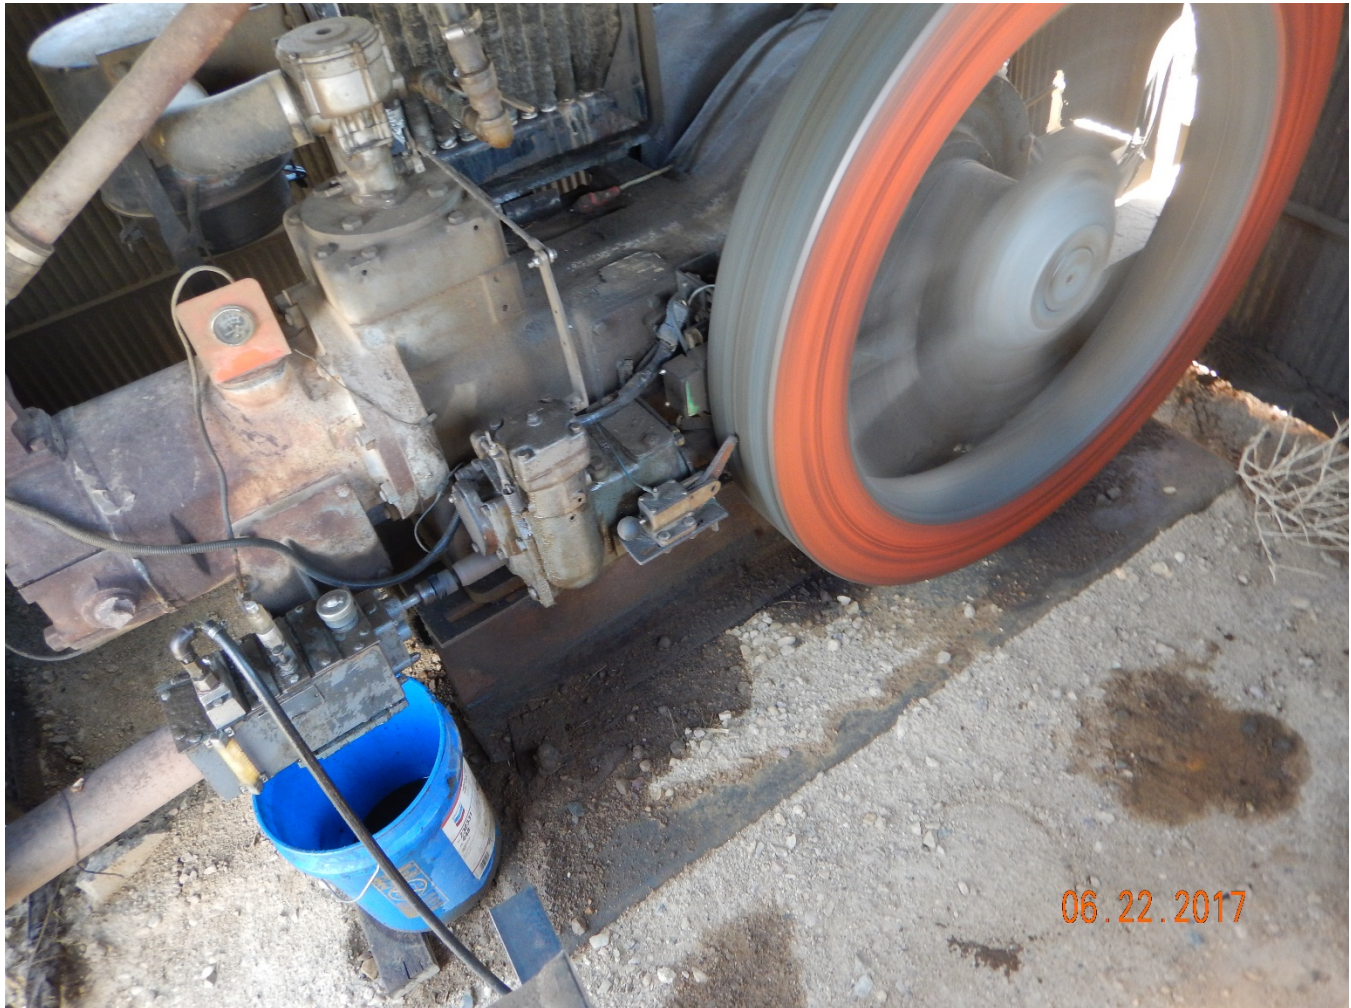
Figure 5 - Localized, oil-stained soil beneath prime mover (inside of shed).

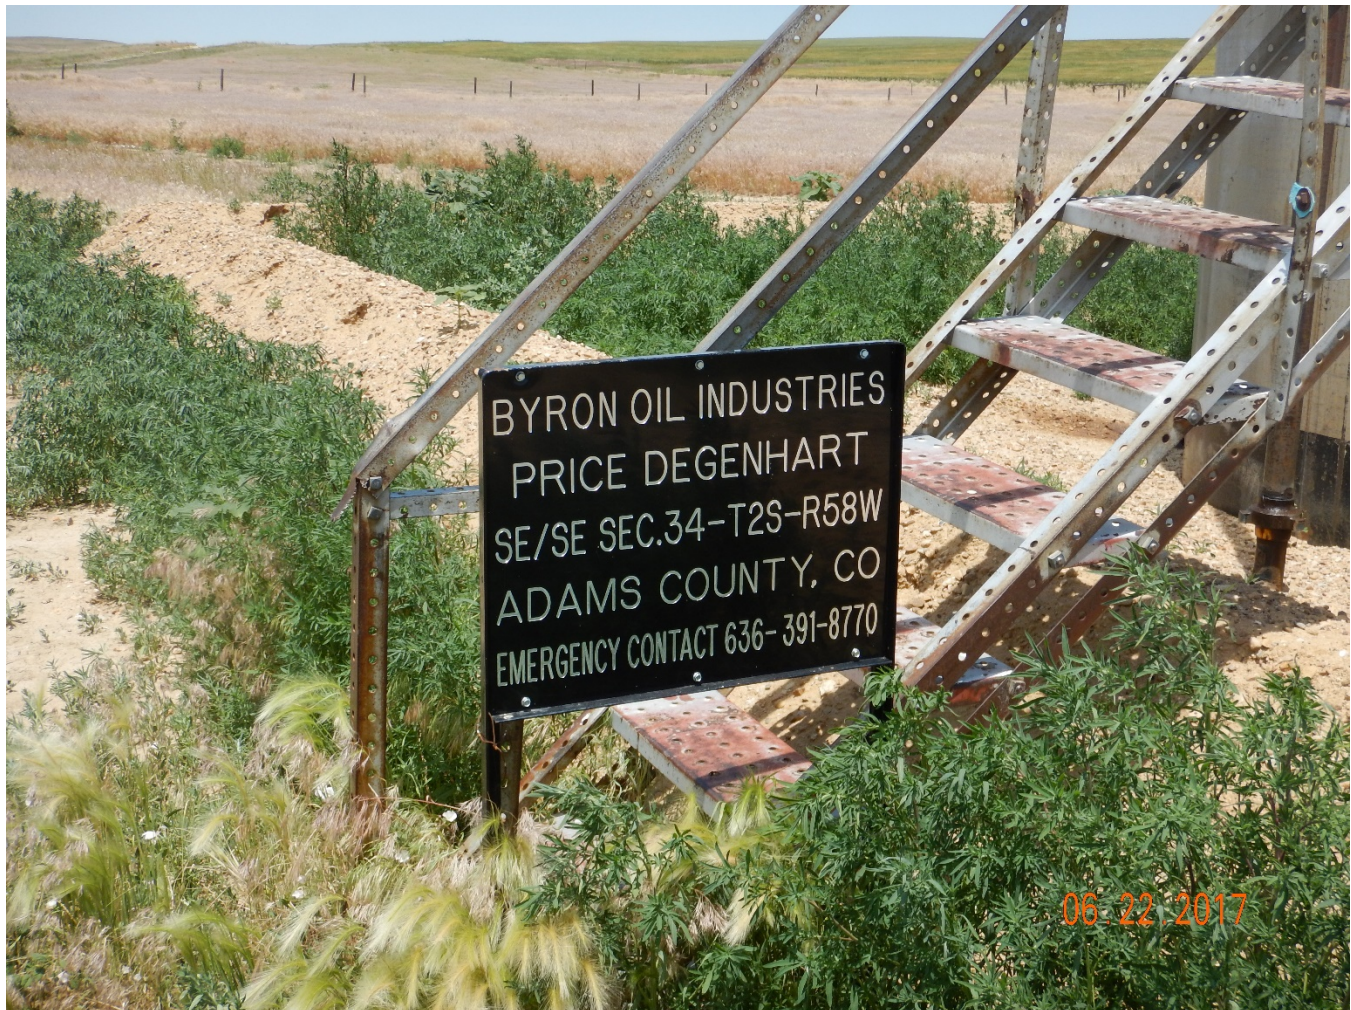
Figure 6 - Battery sign is located at bermed crude oil AST.

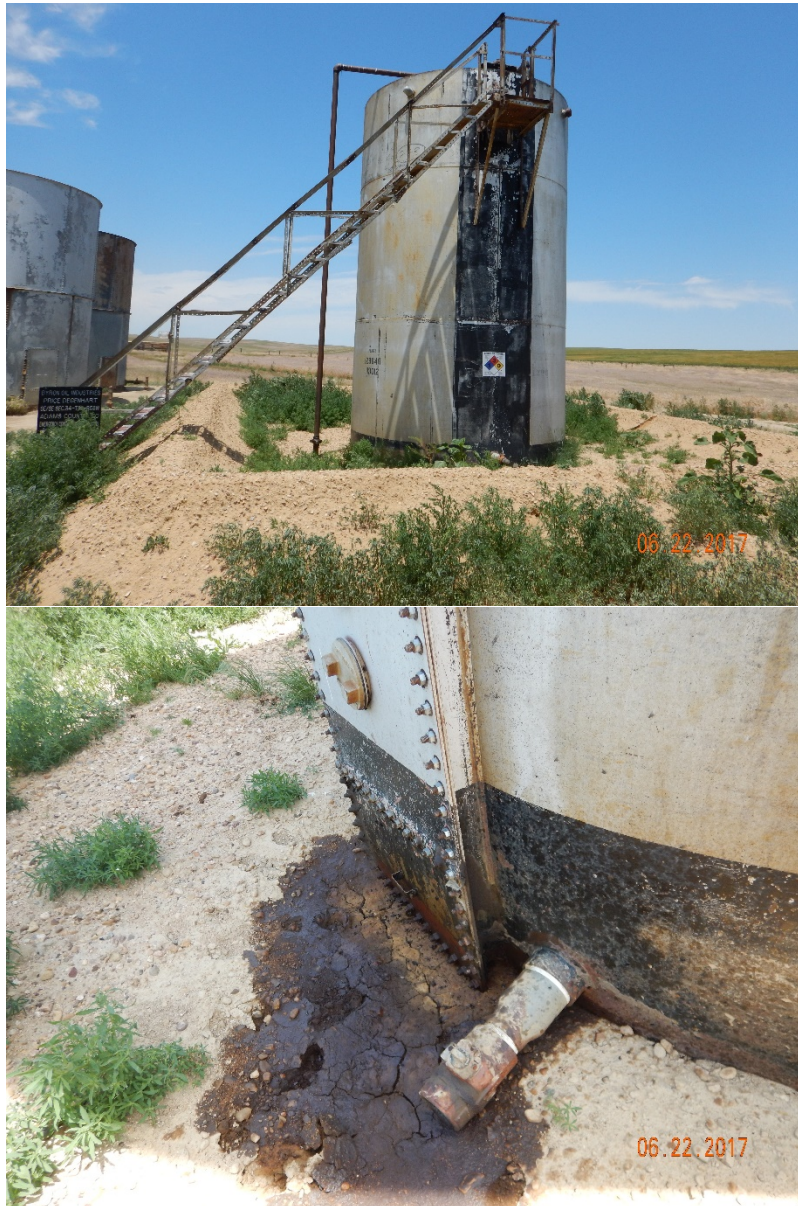
Figure 7 - Bermed, crude-oil AST (top) and close-up on exposed valve with oil-stained soil on NW side of tank. Note: uncontrolled weeds growing into berm.

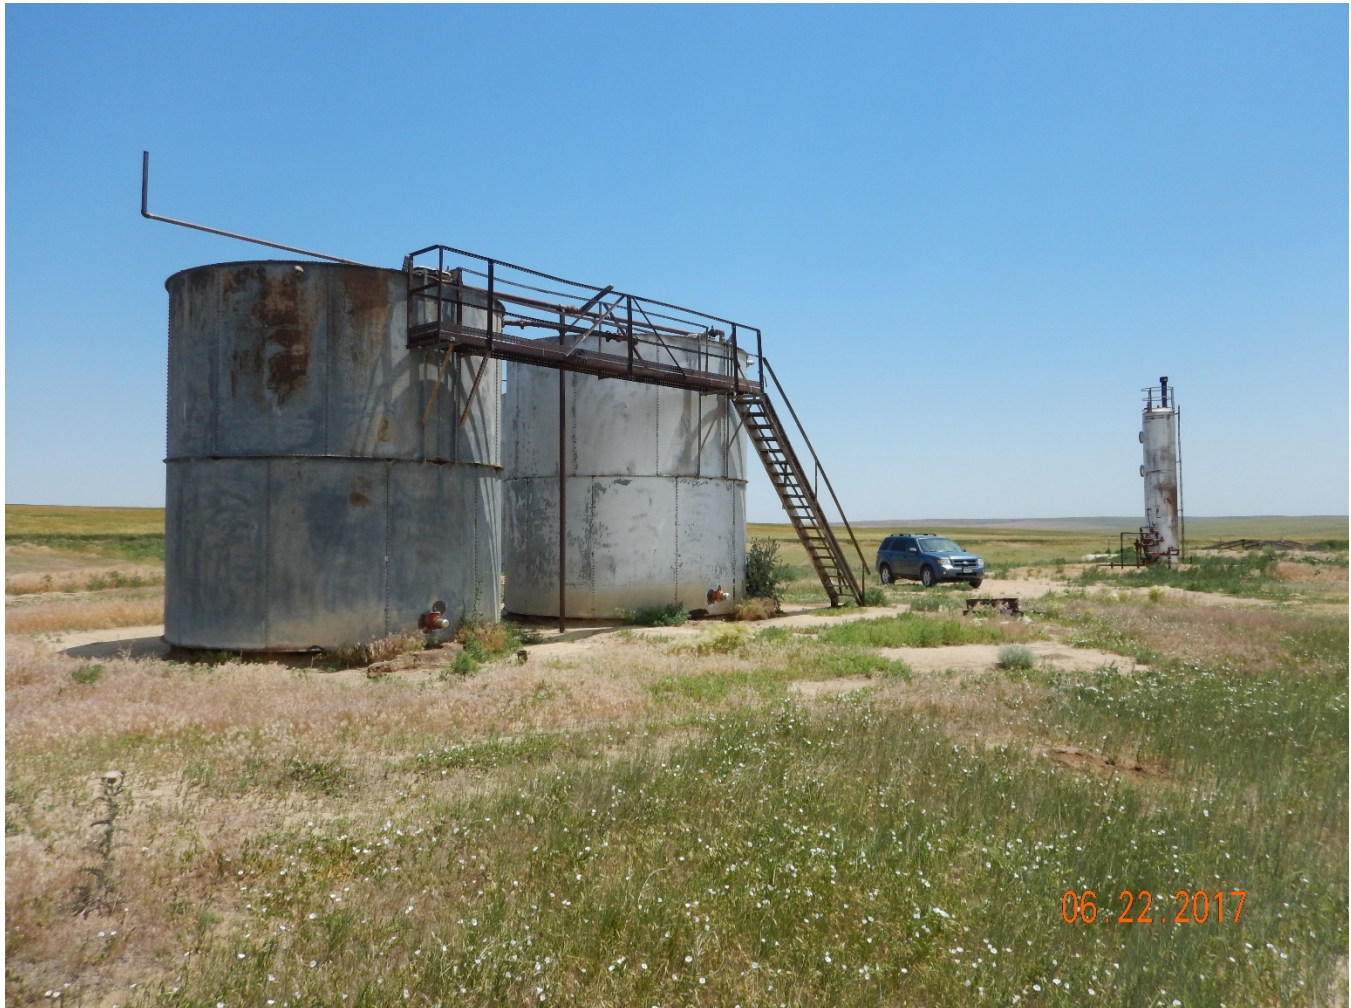
Figure 8 - Unidentified steel panel ASTs at NW corner of location lack volume and NFPA labels. Note complete absence of secondary containment.

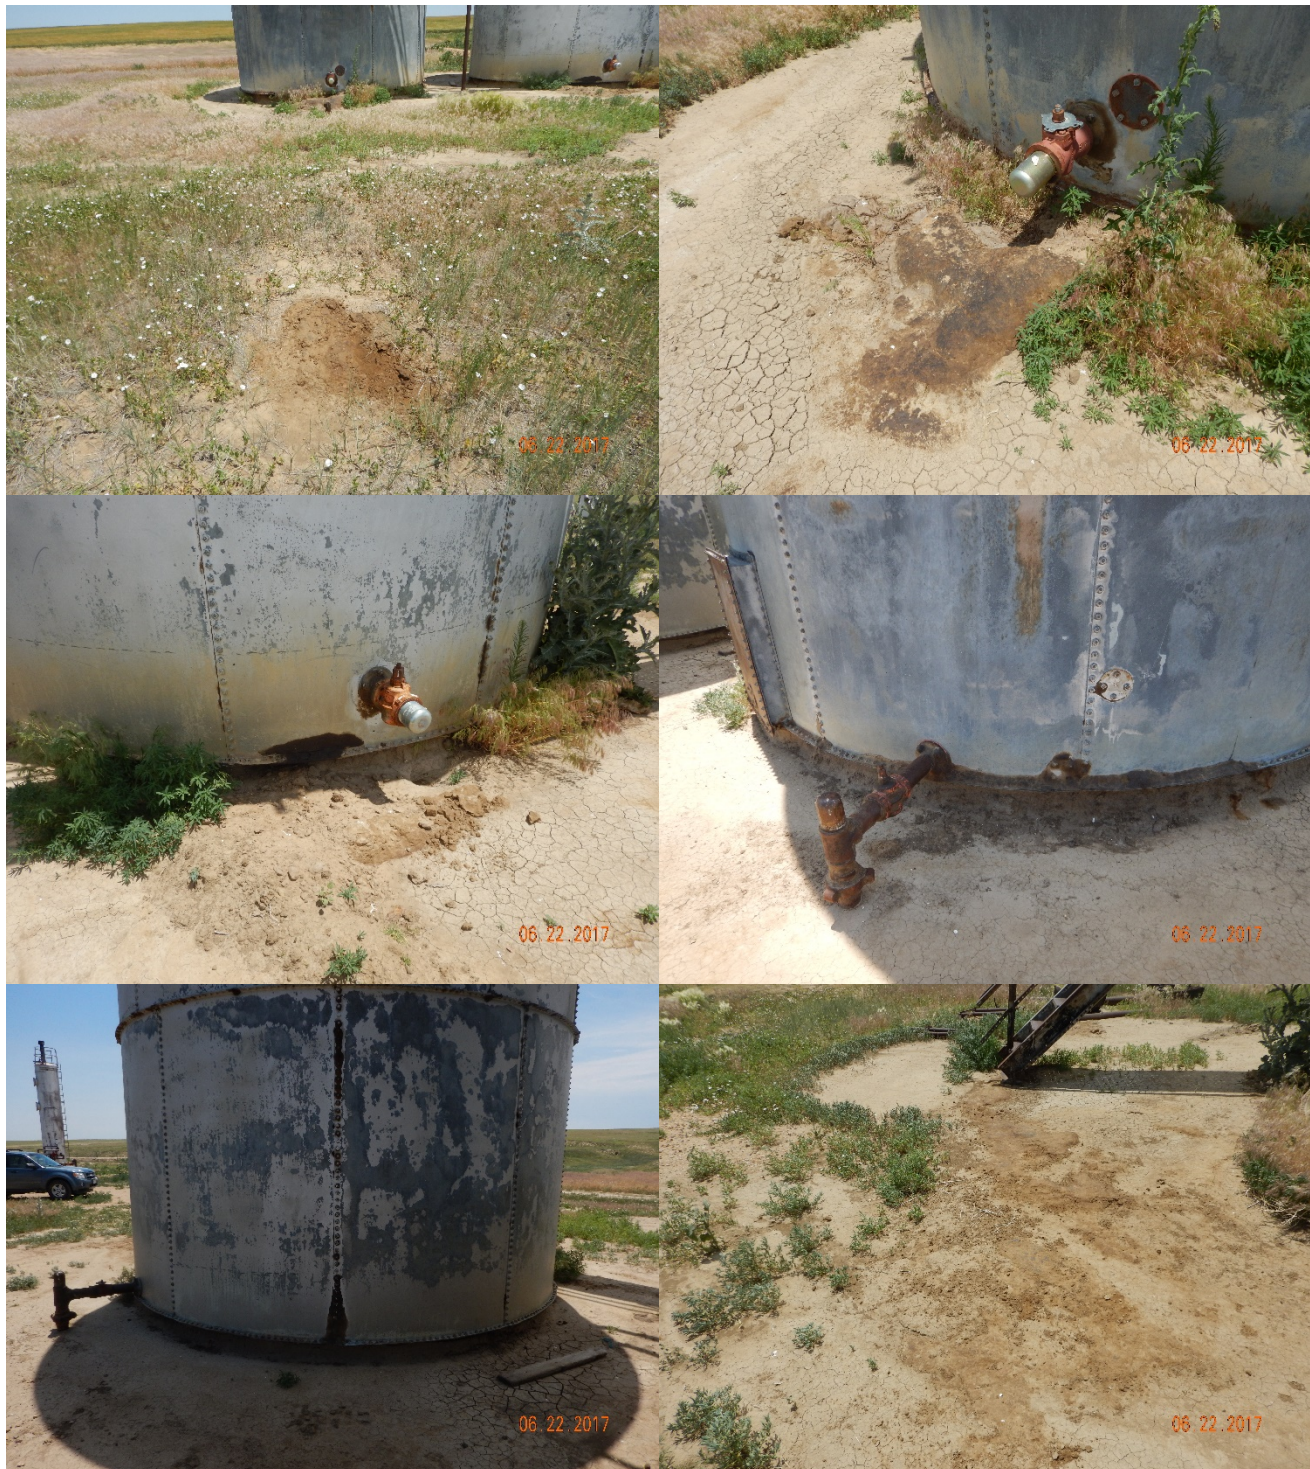
Figure 9 - Assorted shots of localized, oil-stained soil associated with unidentified tanks at former loadout west of tanks (top left), beneath valves on either side of tanks (top right, middle left & right), weeping from bolts (bottom left) and east of stairs (bottom right).

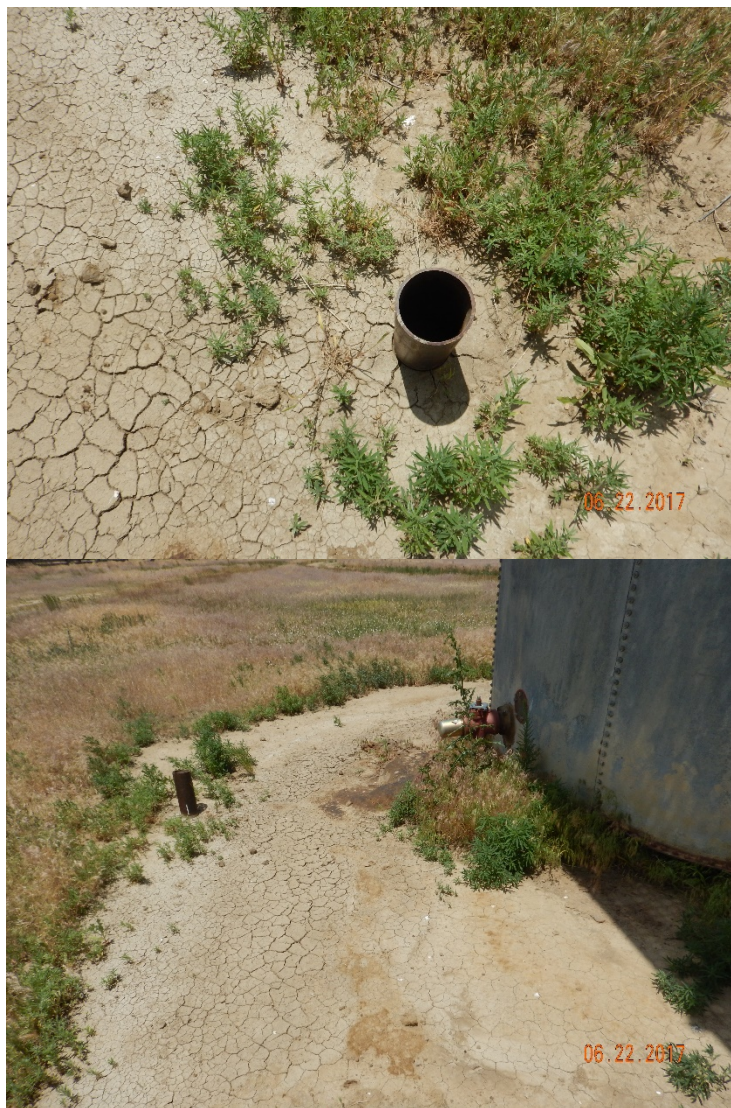
Figure 10 - Photos of unidentified riser on west side of northern panel tank.

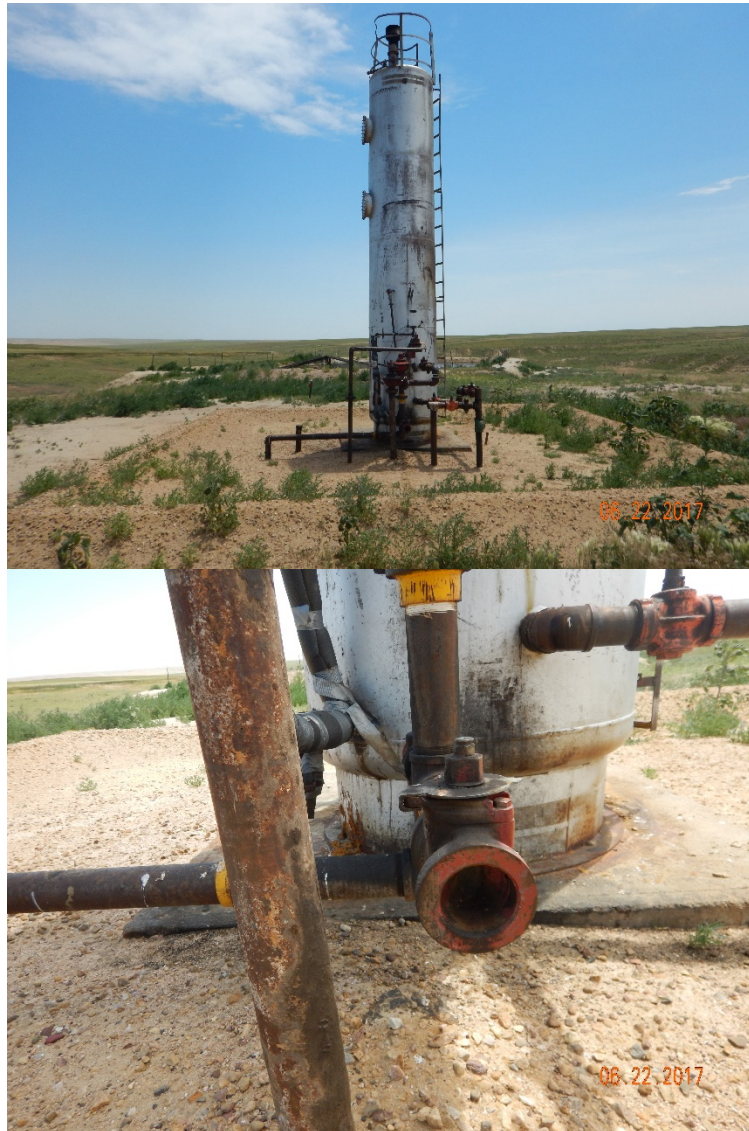
Figure 11 - Vertical heater treater with earthen berm (top) and close-up on exposed valve located on north side of treater (bottom). Note: uncontrolled weeds.

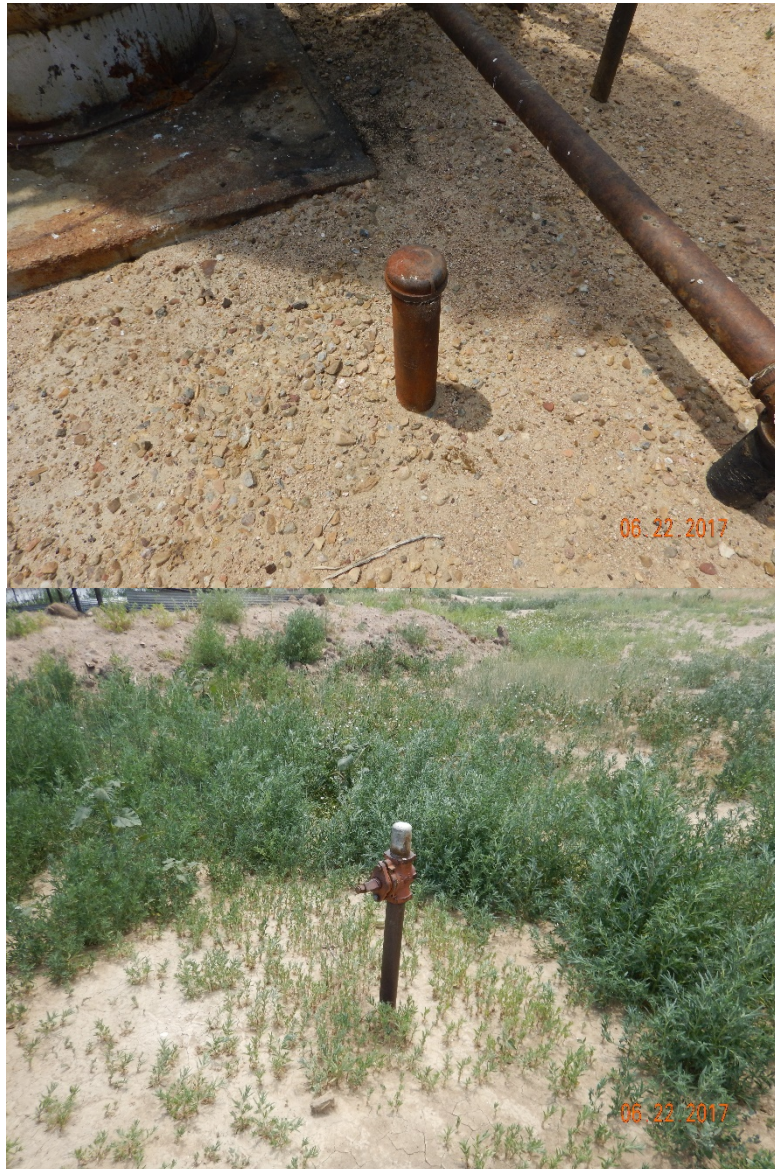
Figure 12 - Capped flowline risers located east and south of treater.

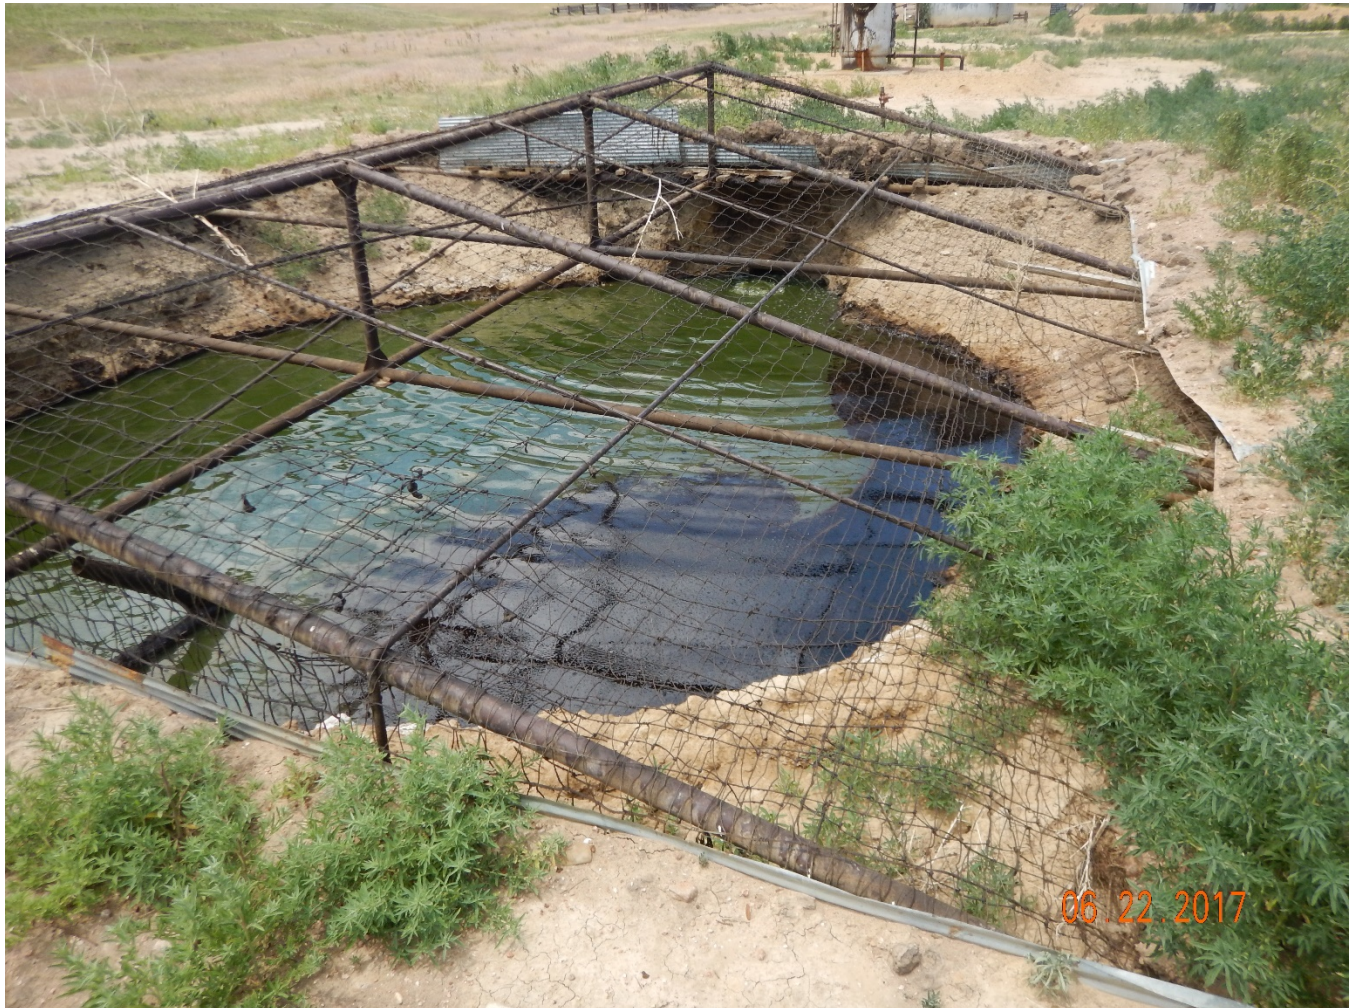
Figure 13 - Skim pit (COGCC Facility ID #104647). Wildlife mesh was in good shape on inspection date. Note: oil on pit, uncontrolled weeds in/out of berm, erosion of pit berm.

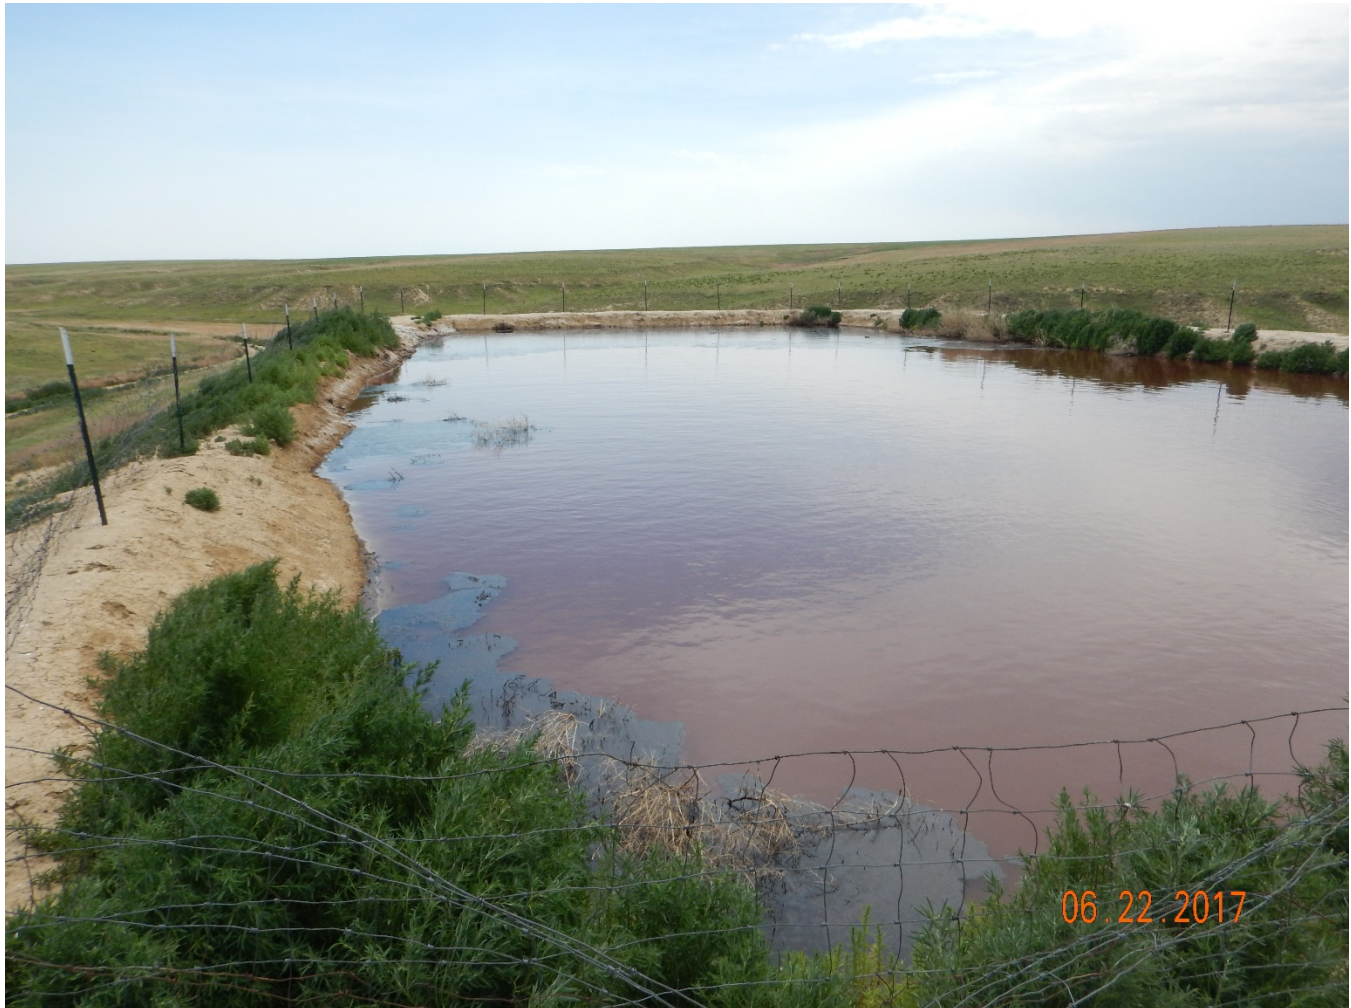
Figure 14 - Produced water pit (COGCC Facility ID #114378). Note: uncontrolled weeds and erosion of pit berm. Oil is present around perimeter of pit.

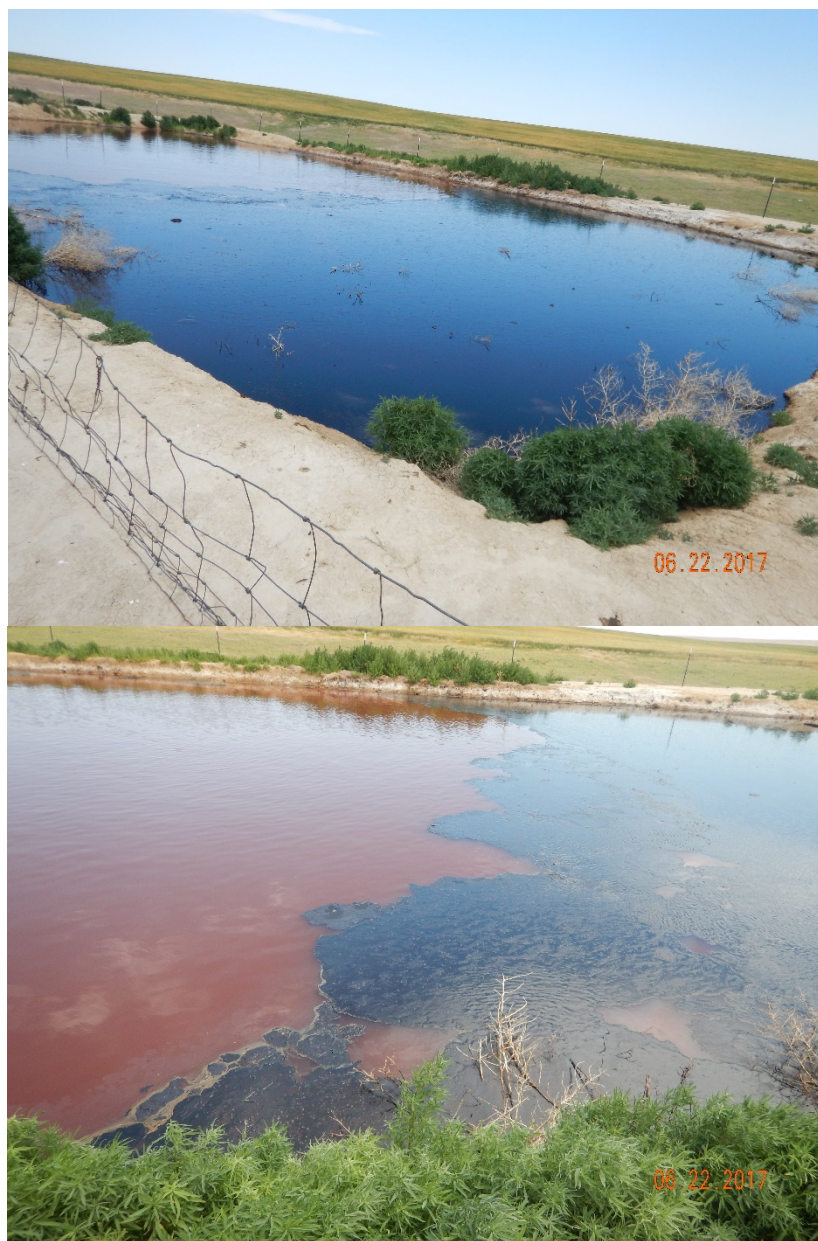
Figure 15 - Oil covers south end of produced water pit (top) and close-up of water/oil contact (bottom).
