June 28, 2017 COGCC Inspection of TEP Rocky Mountain LLC (TEP) Facility ID: 451109

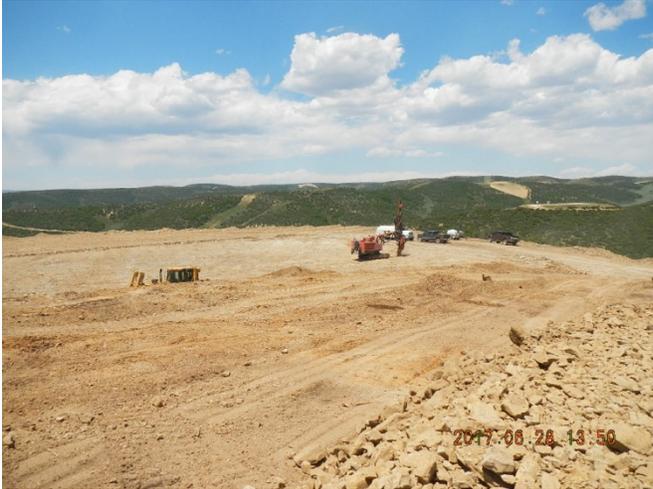
Dozer and coring rig.

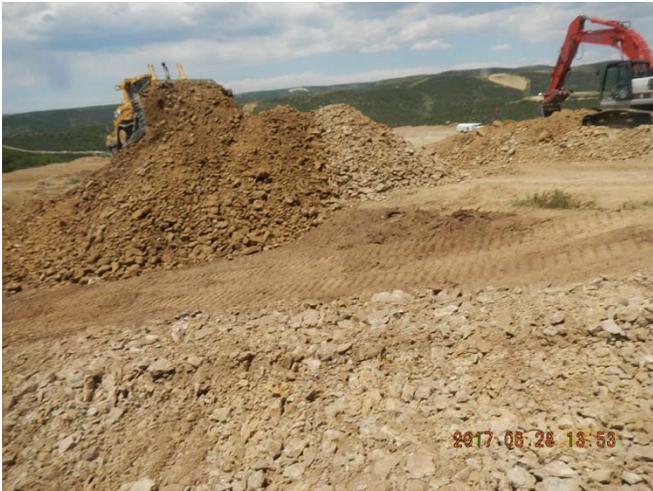
Overburden material being pushed with dozer.

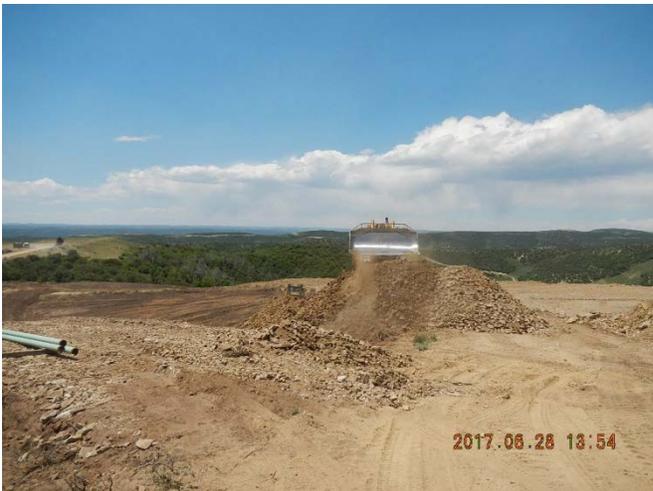
Overburden material being pushed with dozer.

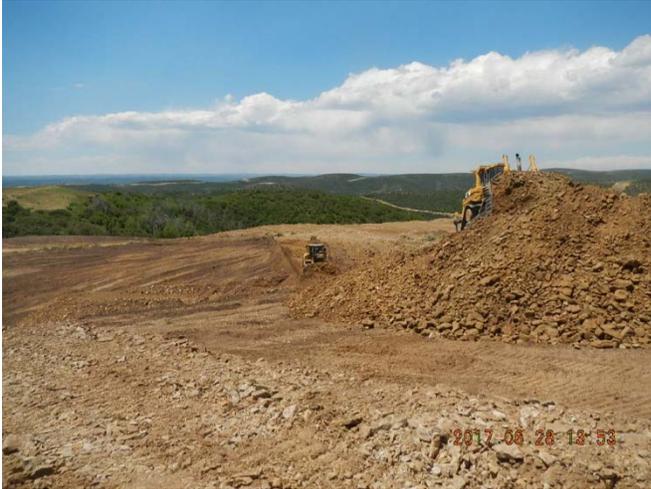
Overburden material being pushed with dozers.

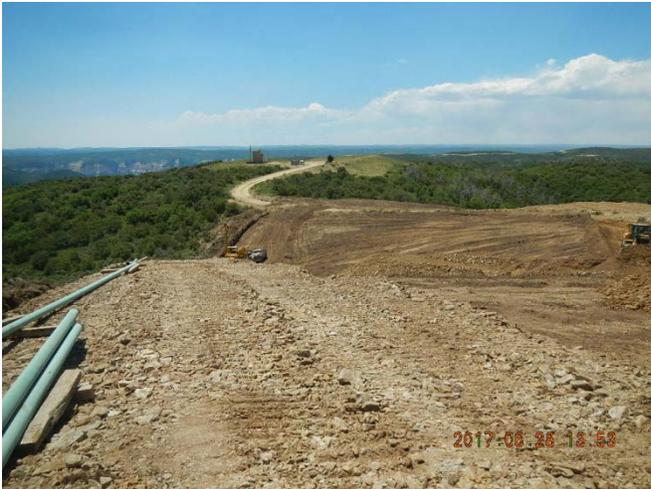
Pipe and fractured rock.

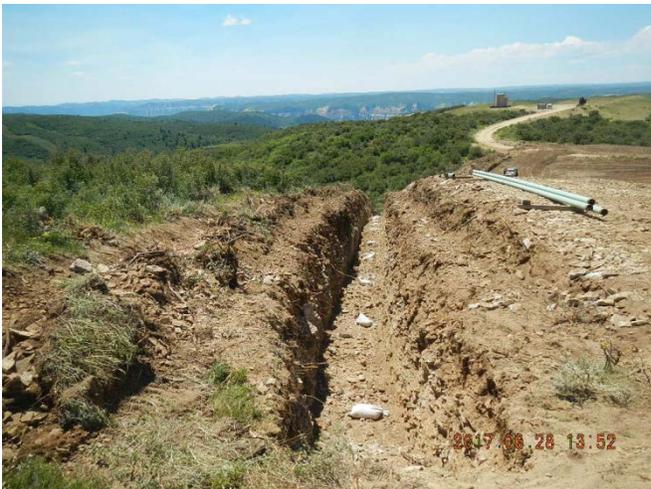
Trench, sandbags, pipe, fractured rock.
