Inspection Photos

Operator: ALLISON DRILLING COMPANY INC -
1350

Location ID: 402112

Inspection Doc. Number: 682502322

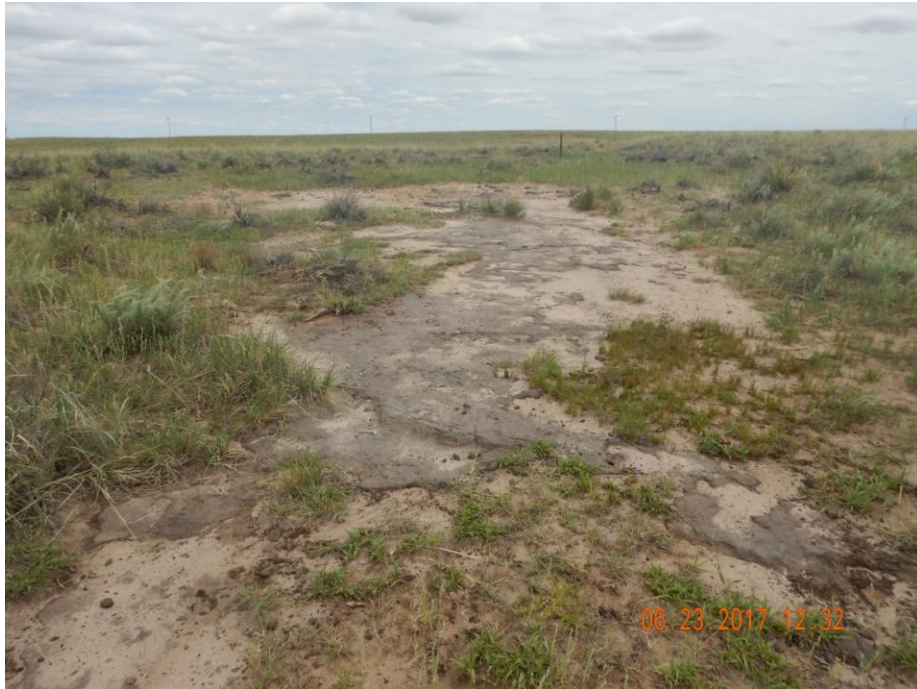
Photo 1: Photo taken from the west end of the well location, facing east. Photo shows a black, hard material staining the soil throughout the well location, pits and access road.

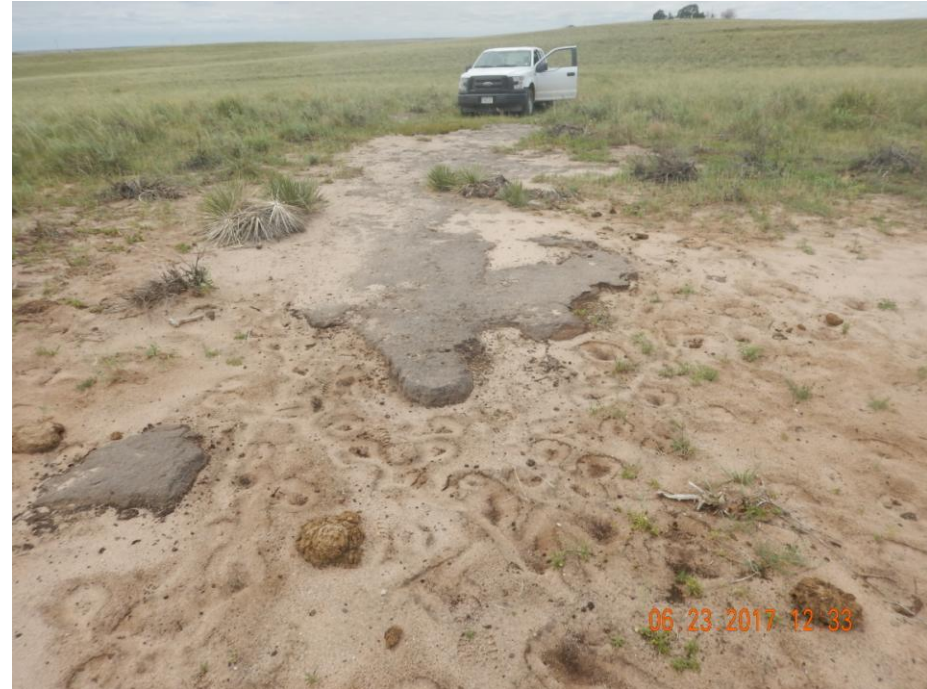
Photo 2: Photo taken from the west end of the well location, facing west. Photo shows a black, hard material staining the soil throughout the well location, pits and access road.

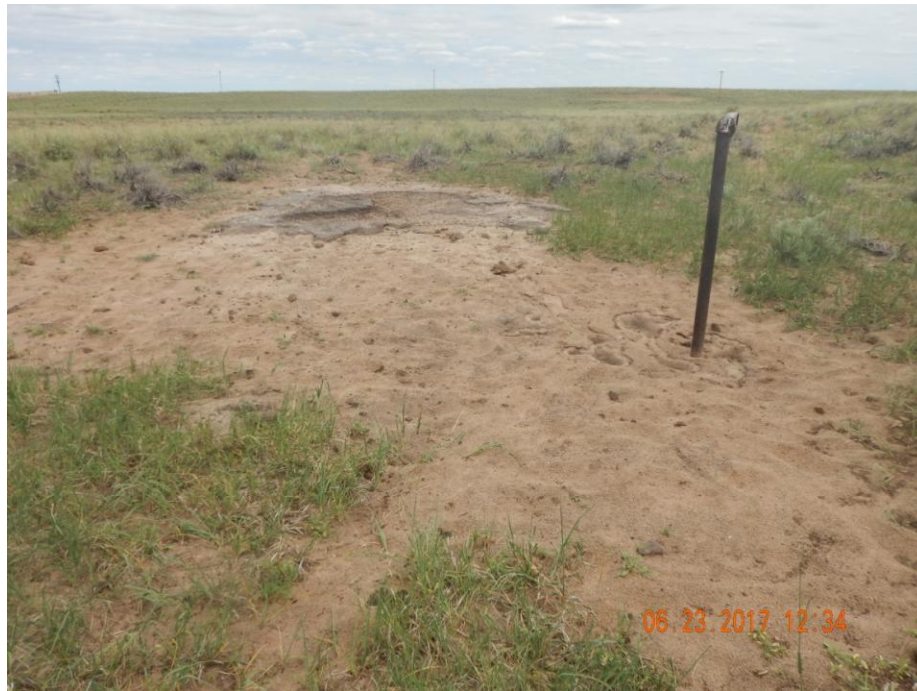
Photo 3: Photo taken from the north east end of the location, facing east. Photo shows pipe riser on location. Photo also shows a black, hard material staining the soil throughout the well location, pits and access road.

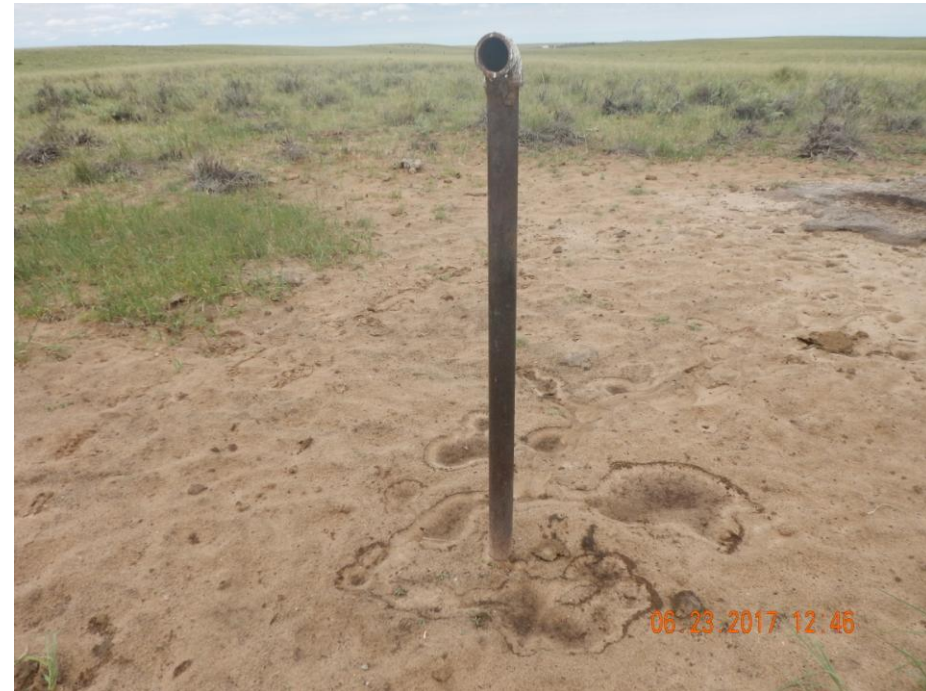
Photo 4: Photo taken from the north east end of the location, facing south. Photo shows pipe riser on location.

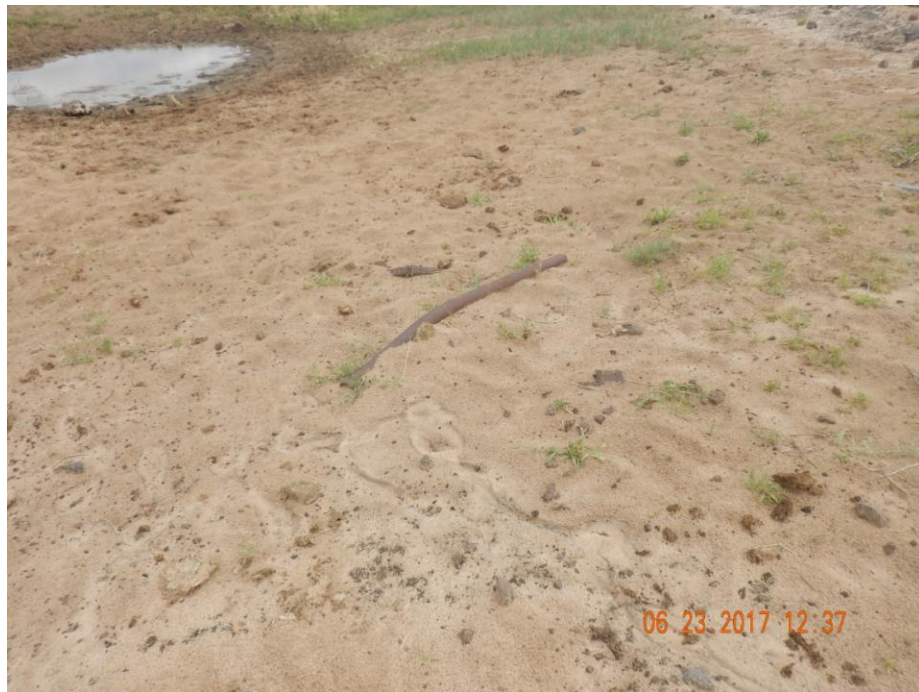
Photo 5: Photo of pipe debris found at the pit.

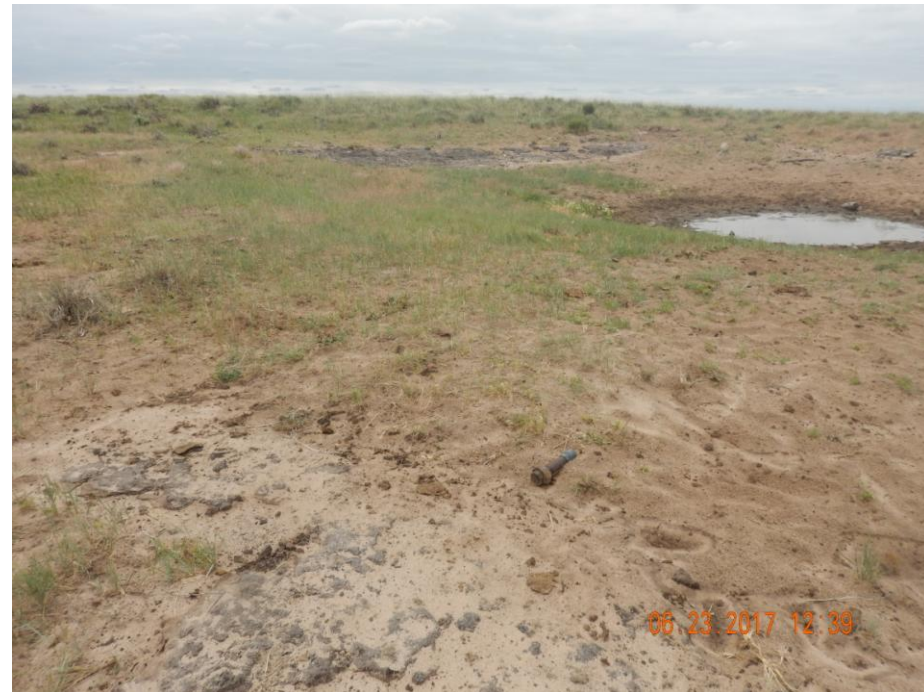
Photo 6: Photo taken from the northeast corner of the southern pit, facing south. Photo shows a black, hard material staining the soil throughout the well location, pits and access road.

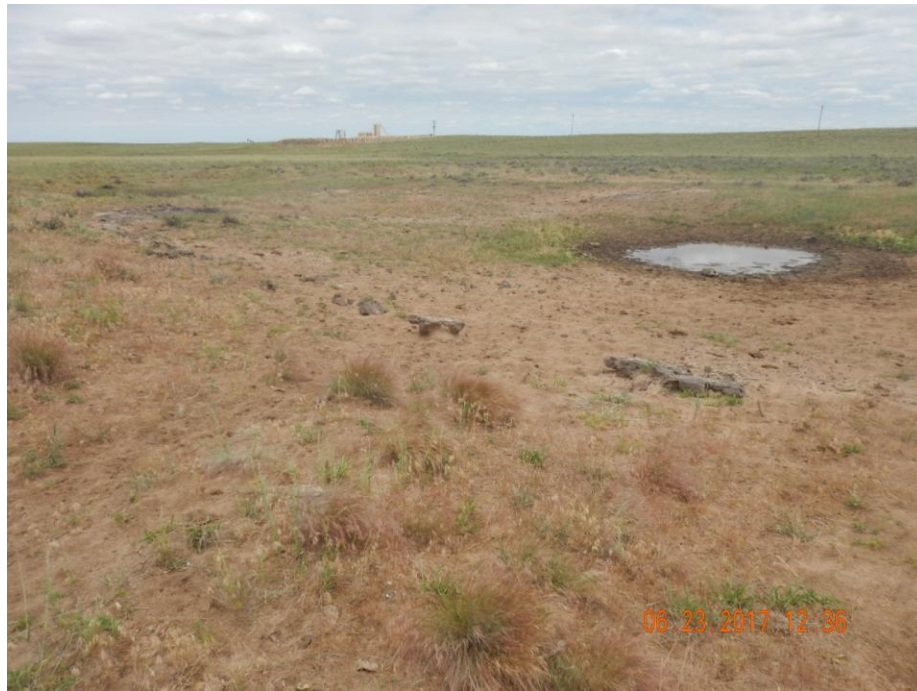
Photo 7: Photo taken from the southwest corner of the southern pit, facing northeast. Photo shows a black, hard material staining the soil throughout the well location, pits and access road.

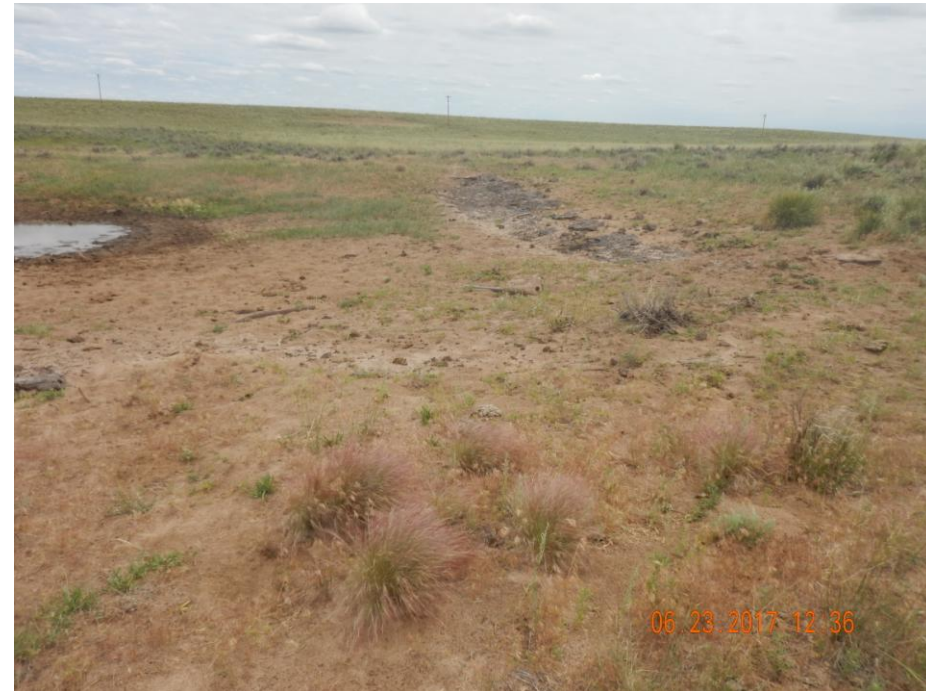
Photo 8: Photo taken from the southwest corner of the southern pit, facing east. Photo shows a black, hard material staining the soil throughout the well location, pits and access road.

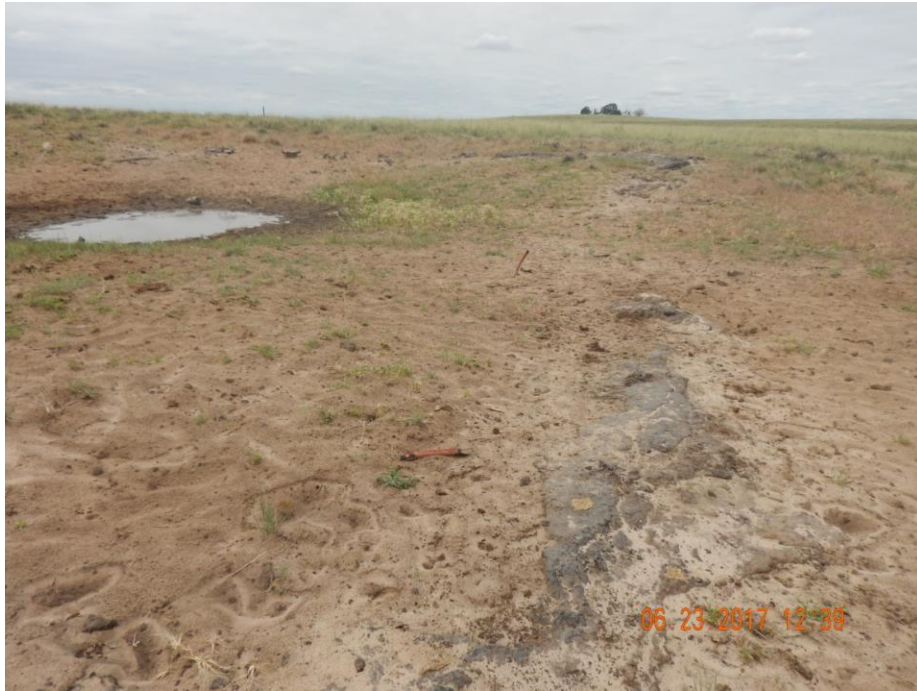
Photo 9: Photo taken from the northeast corner of the southern pit, facing west. Photo shows a black, hard material staining the soil throughout the well location, pits and access road.

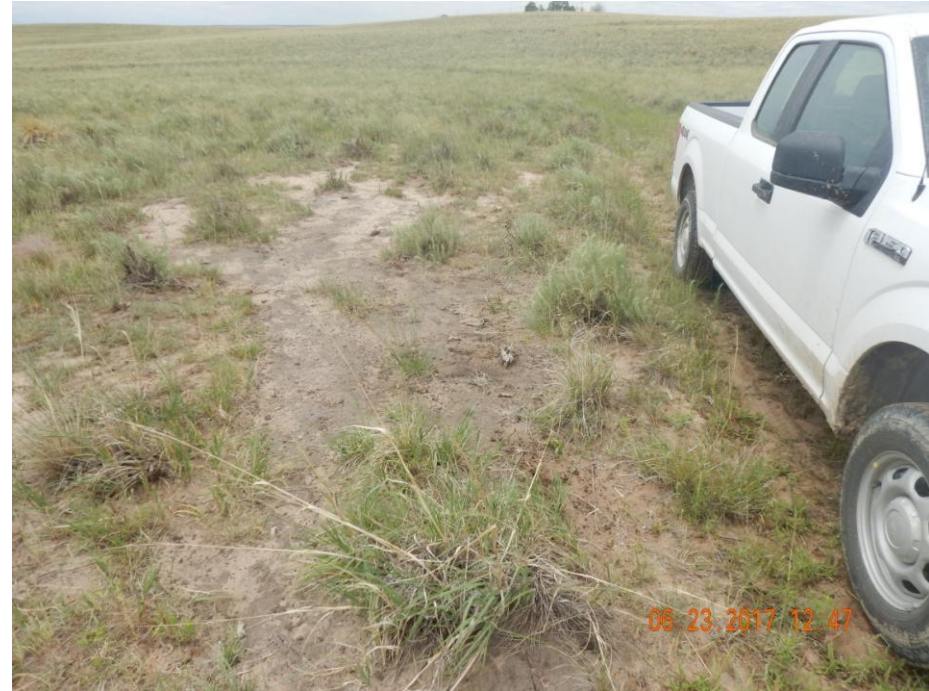
Photo 10: Photo taken from the access road on the west end of the location. Photo taken from the northeast corner of the southern pit, facing south. Photo shows a black, hard material staining the soil on the access road.

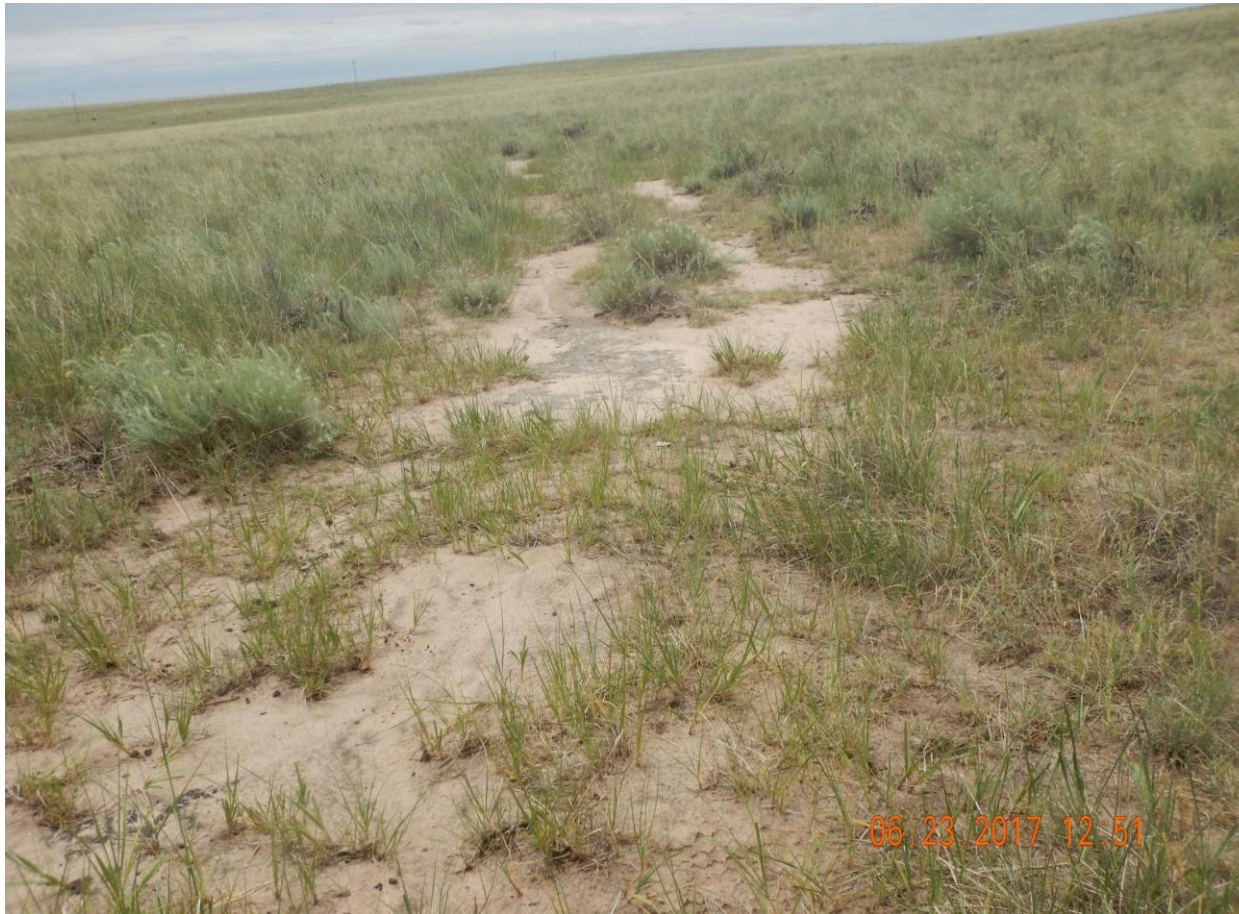
Photo 11: Photo taken from the access road on the west end of the location. Photo taken from the northeast corner of the southern pit, facing south. Photo shows a black, hard material staining the soil on the access road.
