Inspection Photos
Location Name: Kuipers 1
API: 05-057-06090

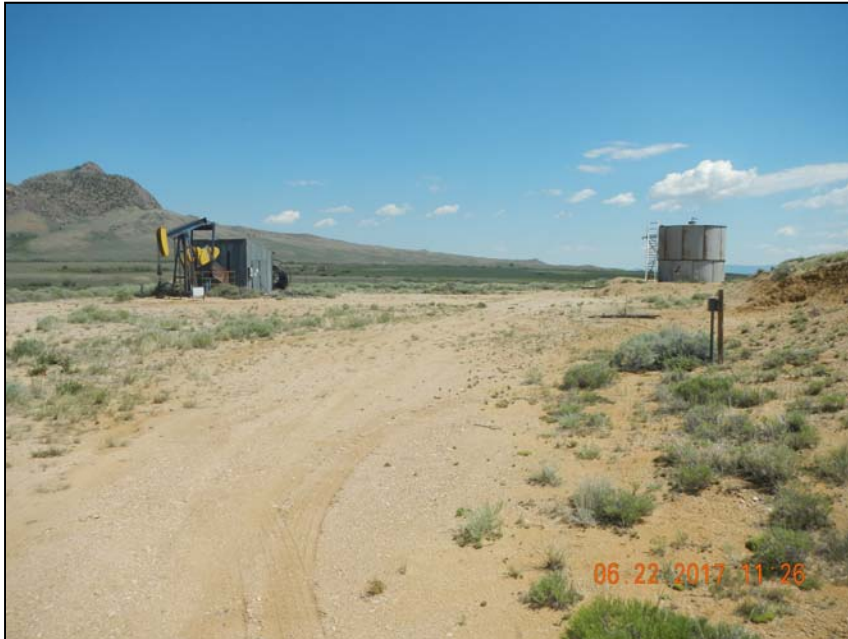
Photo 1. Overview of location taken at entrance facing north.

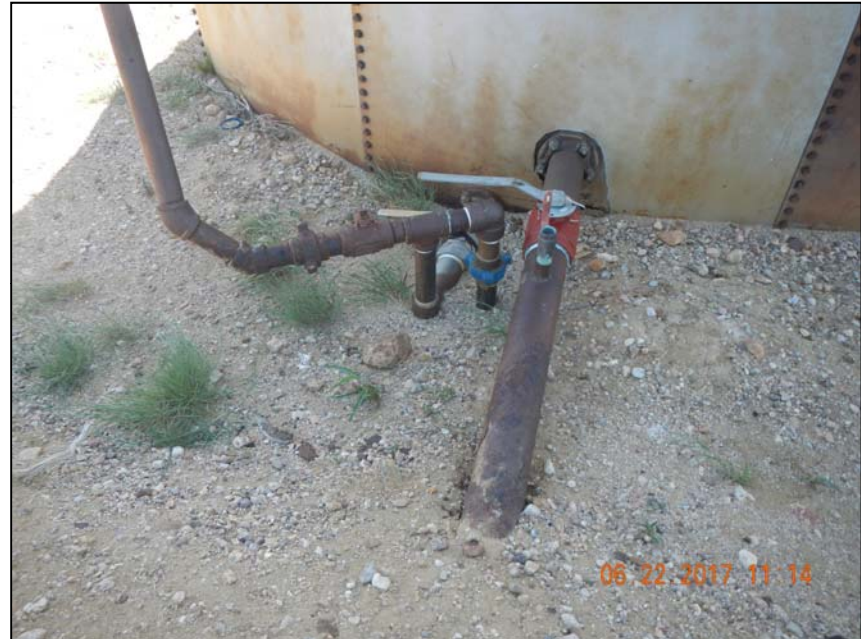
Photo 2. In Use riser at tank.

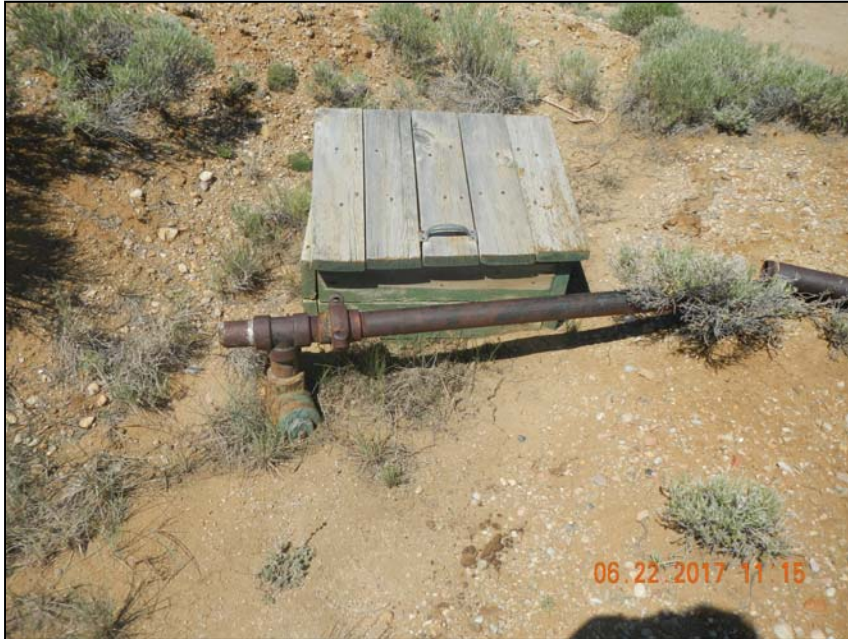
Photo 3. Not in use flowline.

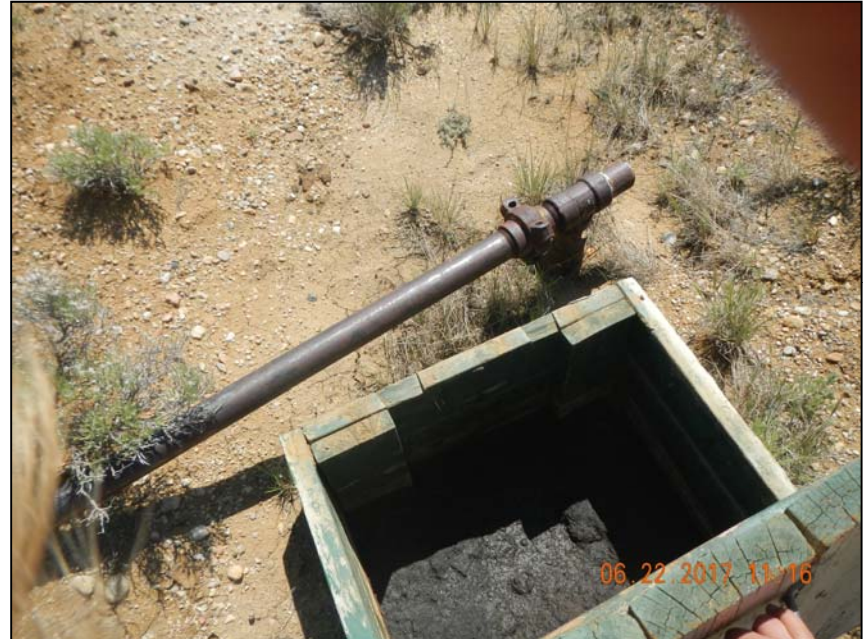
Photo 4. Oily waste.

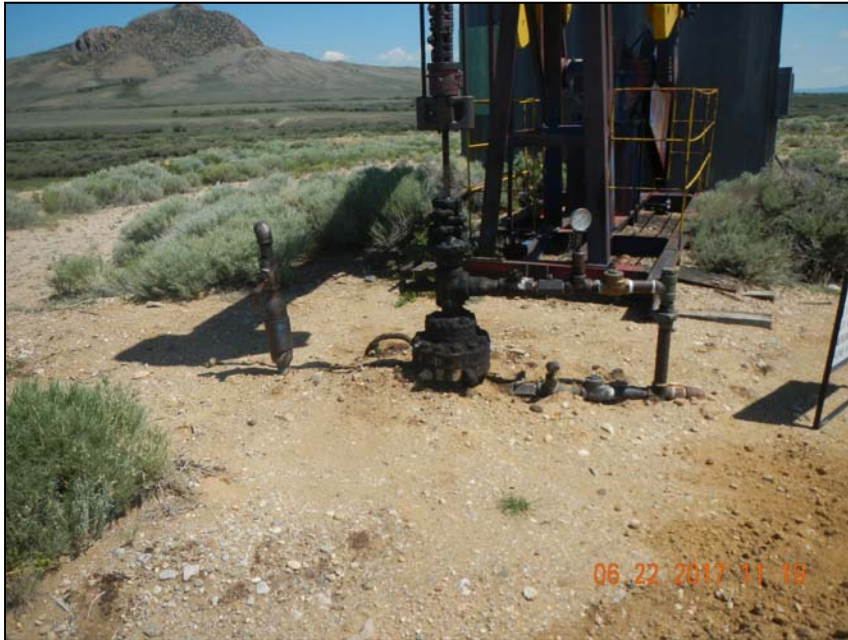
Photo 5. In use and not in use risers at wellhead.

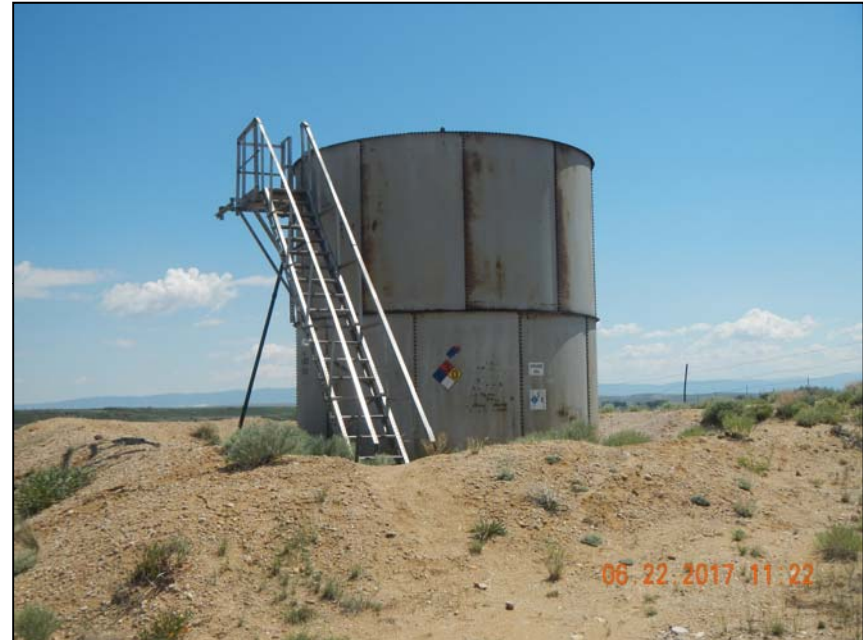
Photo 6. Tank label missing capacity.
