Inspection Photos
Location Name: Dowdell 1
API: 05-057-06252

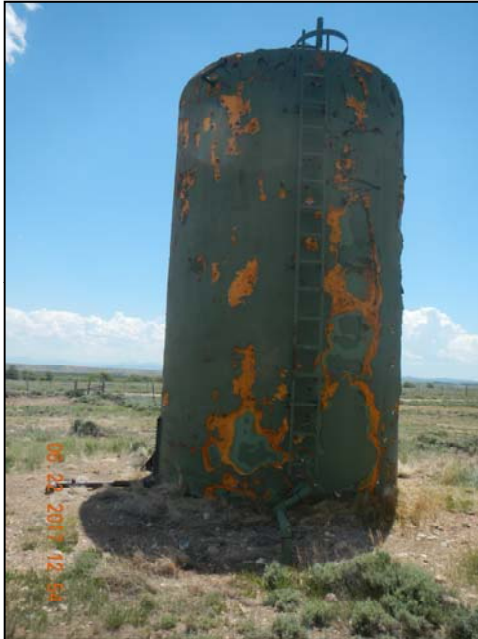
Photo 1. Insulated tank, no berm or labels.

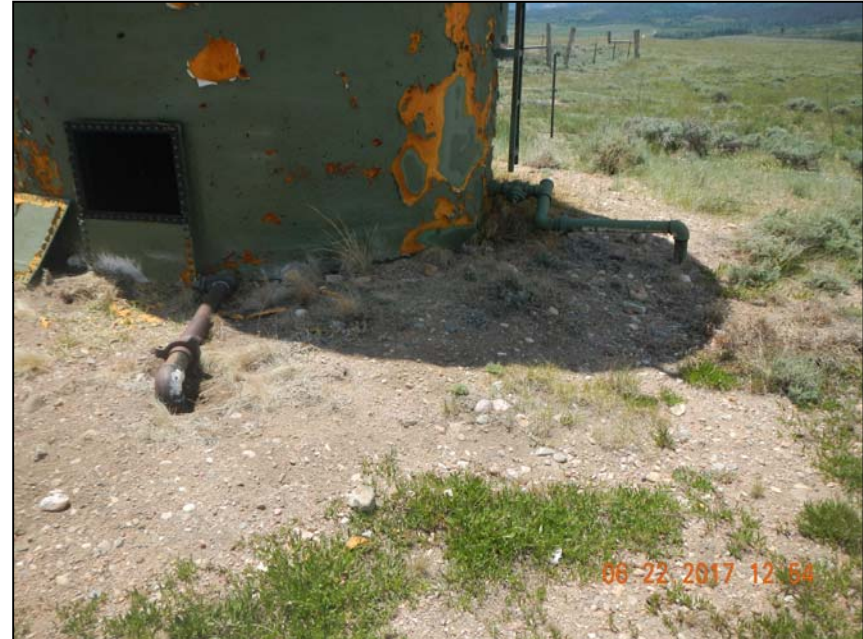
Photo 2. Risers at tank not in use, not locked out tagged out.

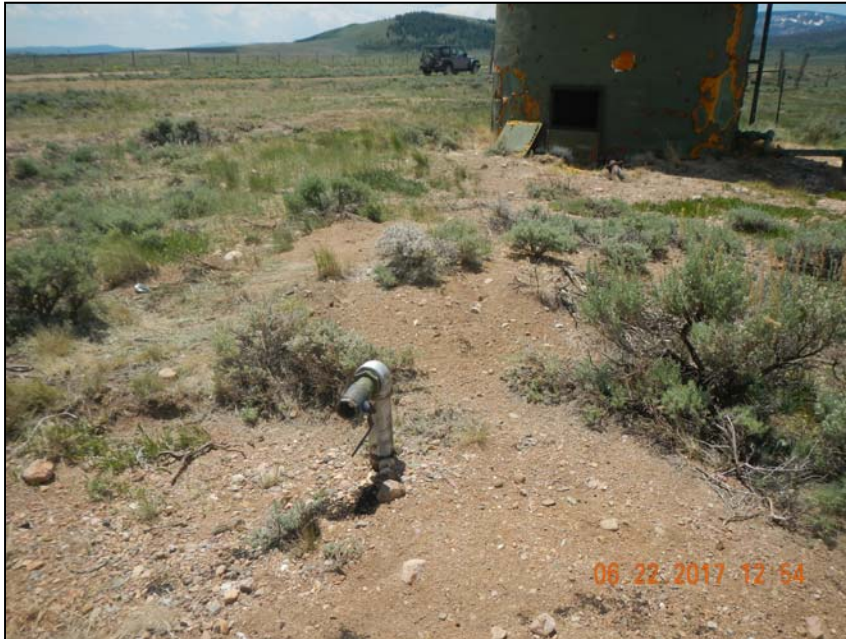
Photo 3. Steel riser not in use, not locked out tagged out.

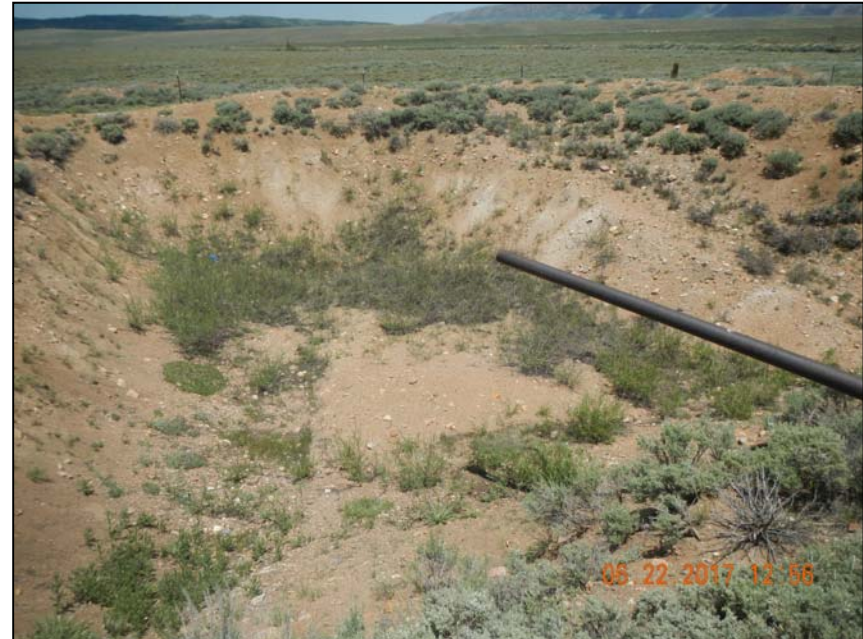
Photo 4. Steel riser going into northern pit.

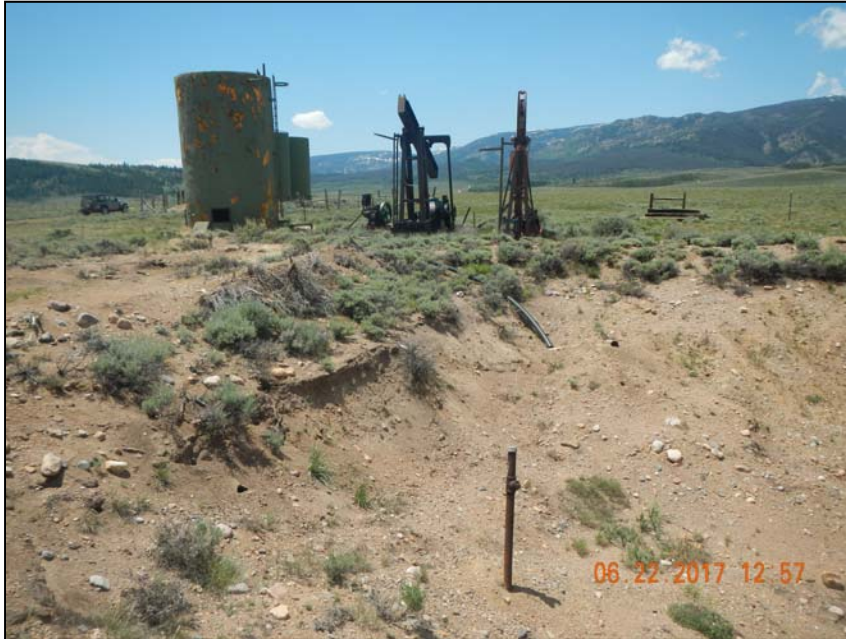
Photo 5. Steel riser not in use, not locked out tagged out in southern pit.

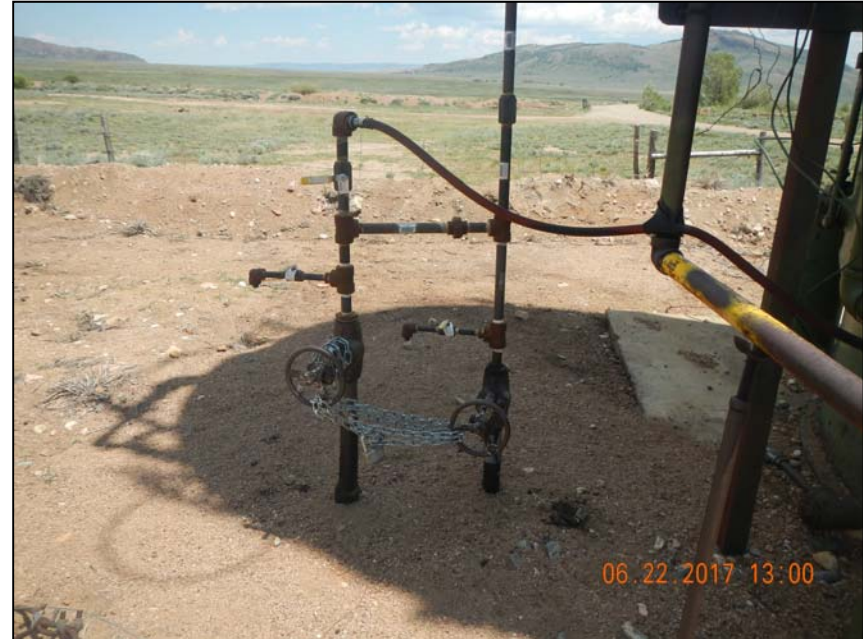
Photo 6. Steel risers at separators locked out tagged out.

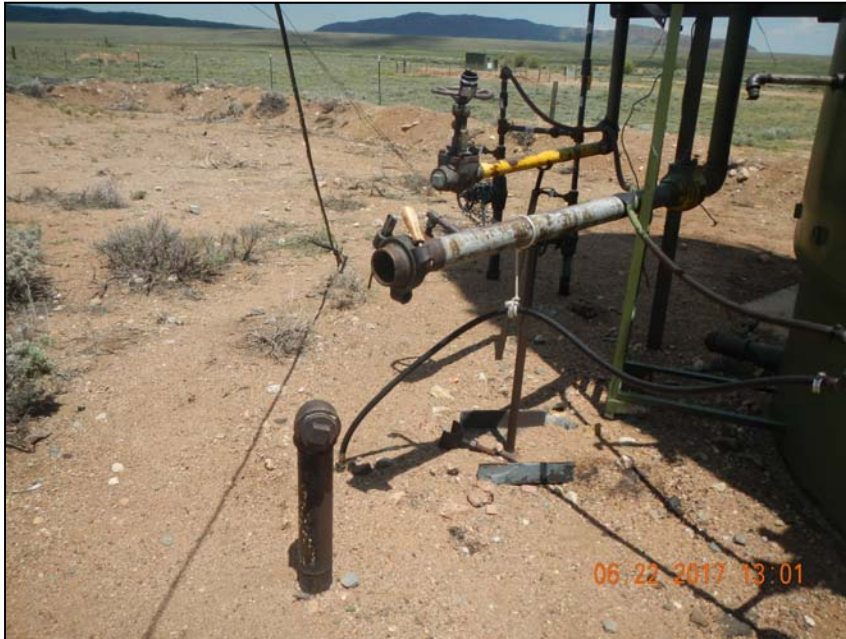
Photo 7. Steel riser not in use, not locked out tagged out in southern pit.

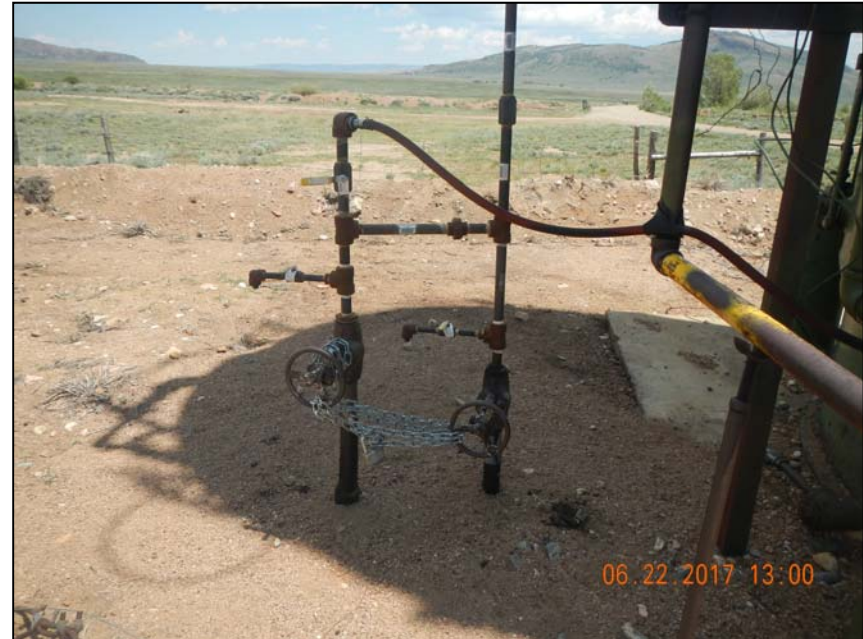
Photo 8. Steel risers not in use at separator not locked out tagged out.

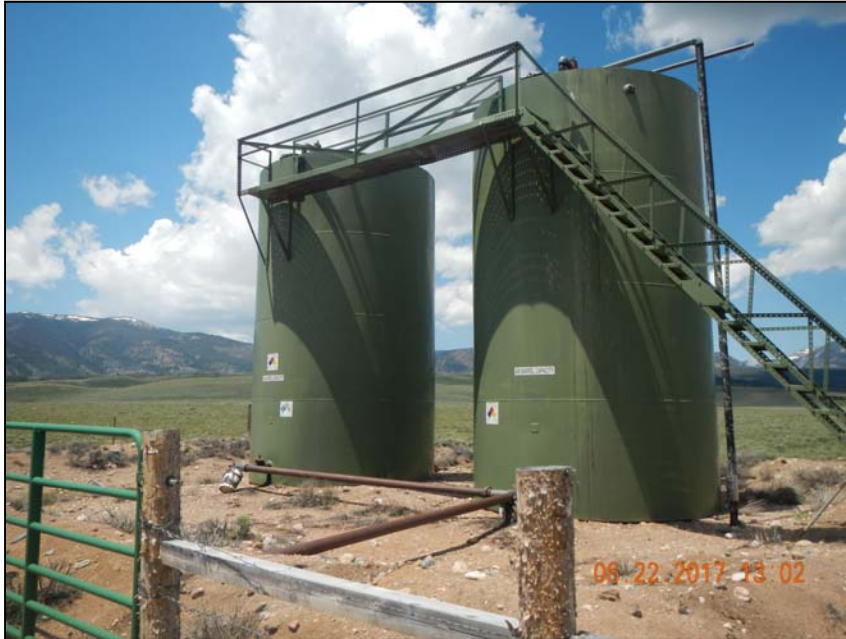
Photo 9. Tank battery.

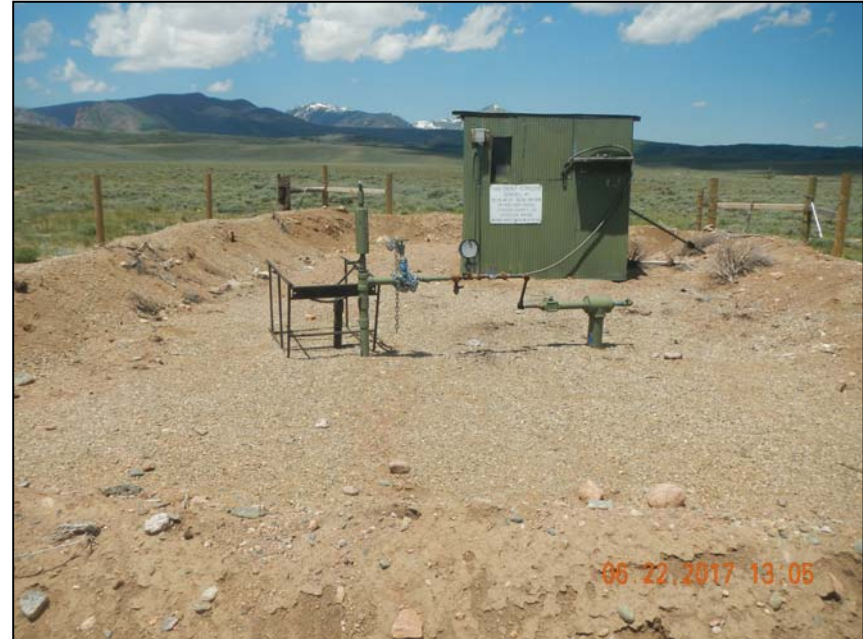
Photo 10. Steel risers not in use at wellhead not locked out tagged out.
