# Flowline and Final Reclamation Inspection

June 29, 2017

Operator: PDC ENERGY INC - 69175

API: 05-123-11129

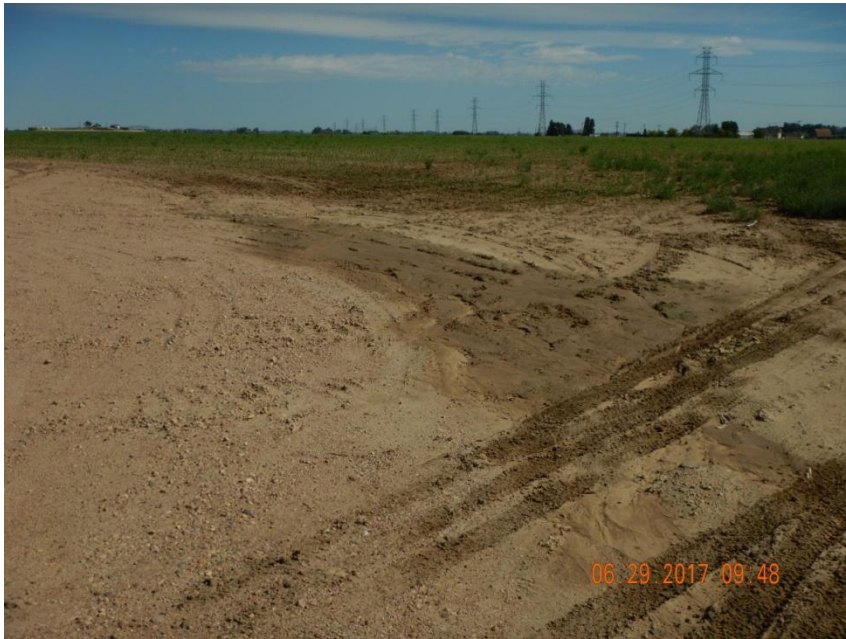
**Photo 1.** Photo taken from the northeast location, facing North. Appears stormwater and/or irrigation water run-on is flowing onto location which then travels across the eastern location through the wells. Gully erosion is occurring along the eastern location and off location.

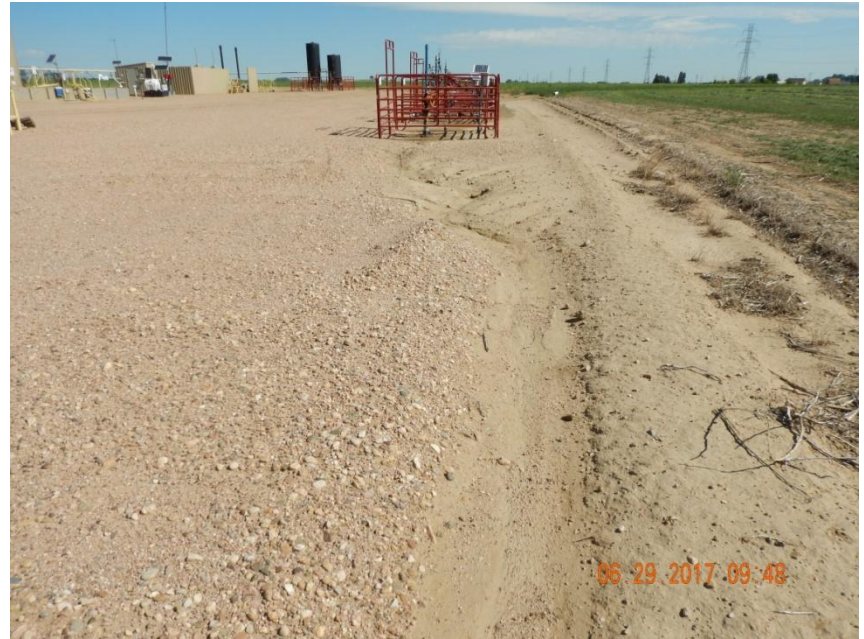
**Photo 2.** Photo taken from the eastern location, facing North. Gully erosion evident from stormwater and/or irrigation water run-on onto location.

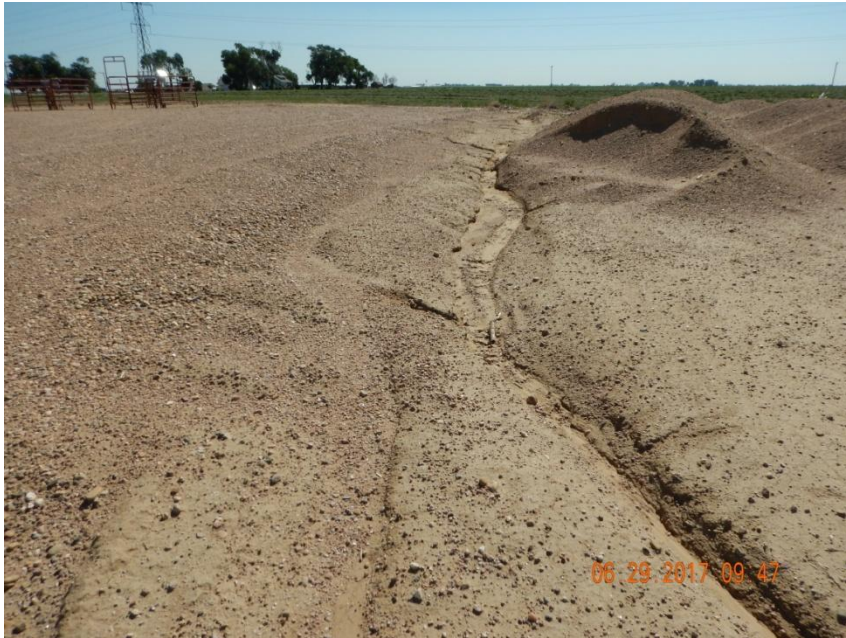
**Photo 3.** Photo taken from the southern location, facing East. Gully erosion is occurring adjacent to the location from stormwater and/or irrigation water run-on onto location.

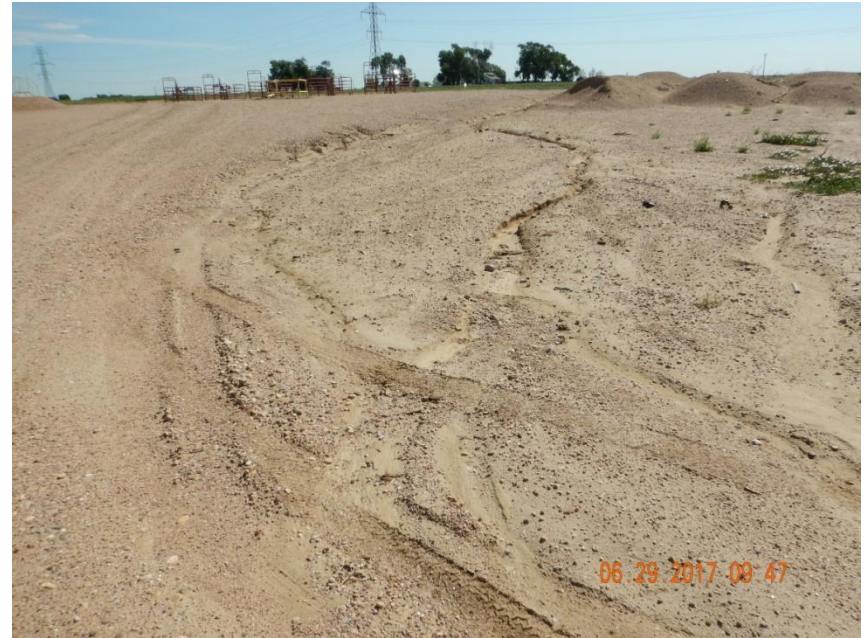
**Photo 4.** Photo taken from the area that would likely be the inlet of the culvert, facing East. Appears sediment has accumulated overtime blocking the inlet of a culvert-see following photo.

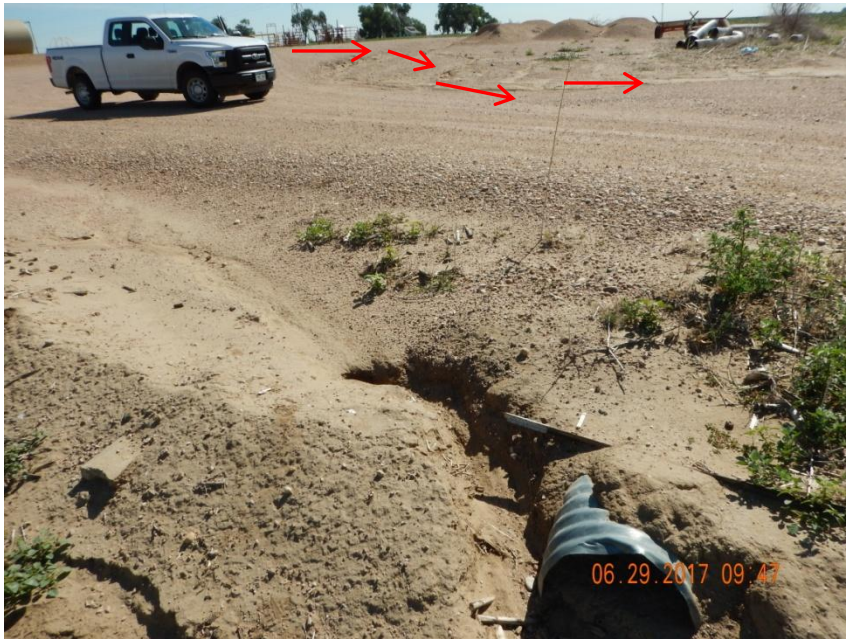
**Photo 5.** Photo taken from the outlet of the culvert along a portion of the access road, facing Northeast. Did not observe the inlet of the culvert due to sediment build up overtime. Red arrows indicate the likely direction of current water flow.
