COGCC Environmental Field Inspection Report Photo Attachment

Inspection Date: **June 30, 2017**

**Oil & Gas Conservation
Commission**

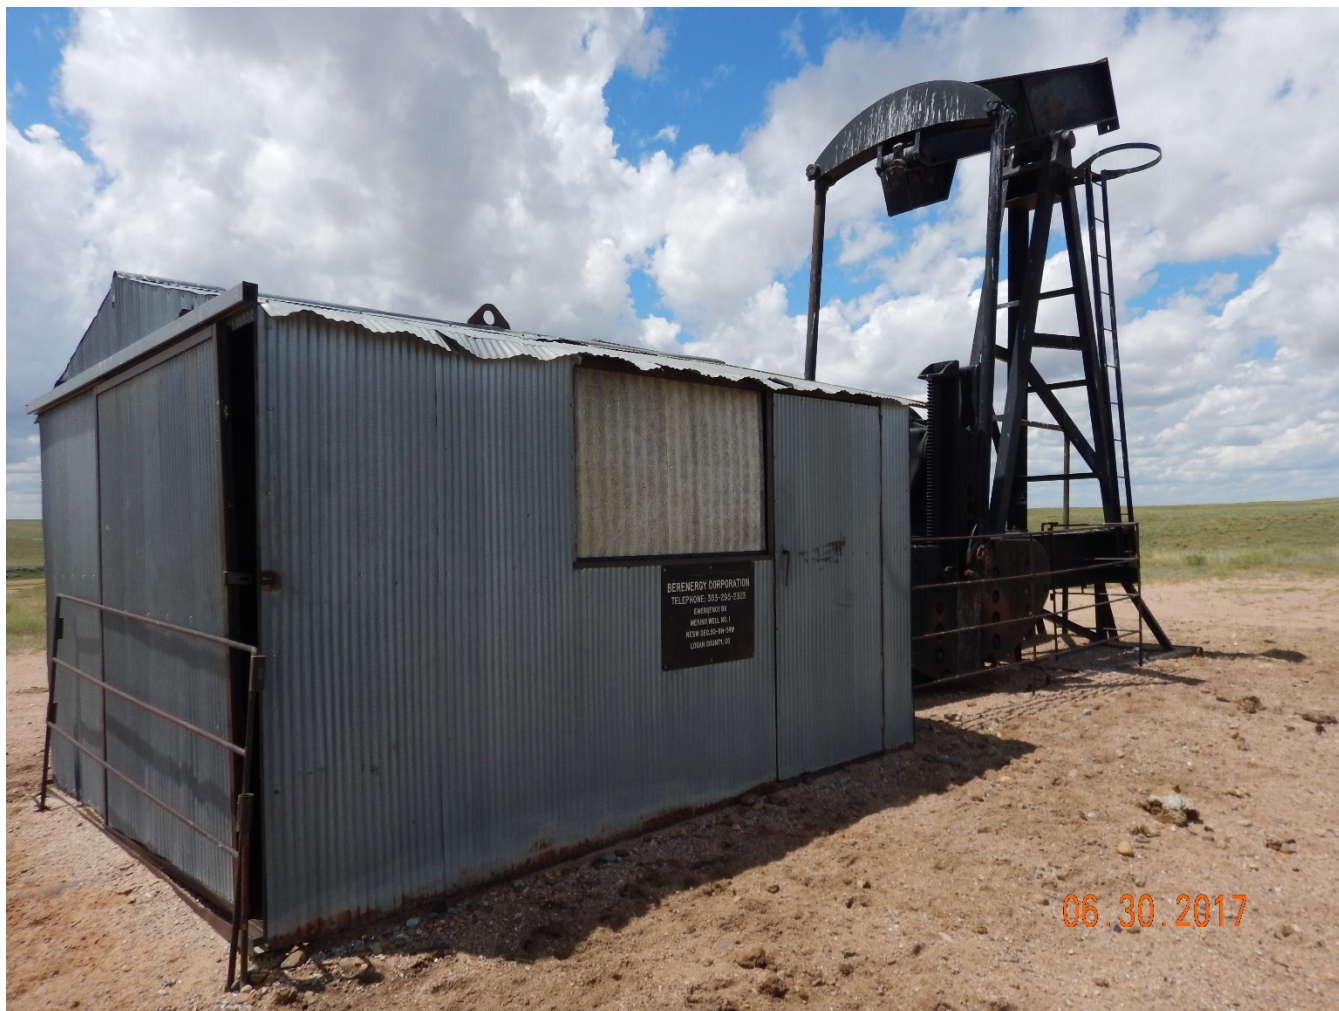
Figure 1 - Pump jack and shed remain at abandoned well pad location.

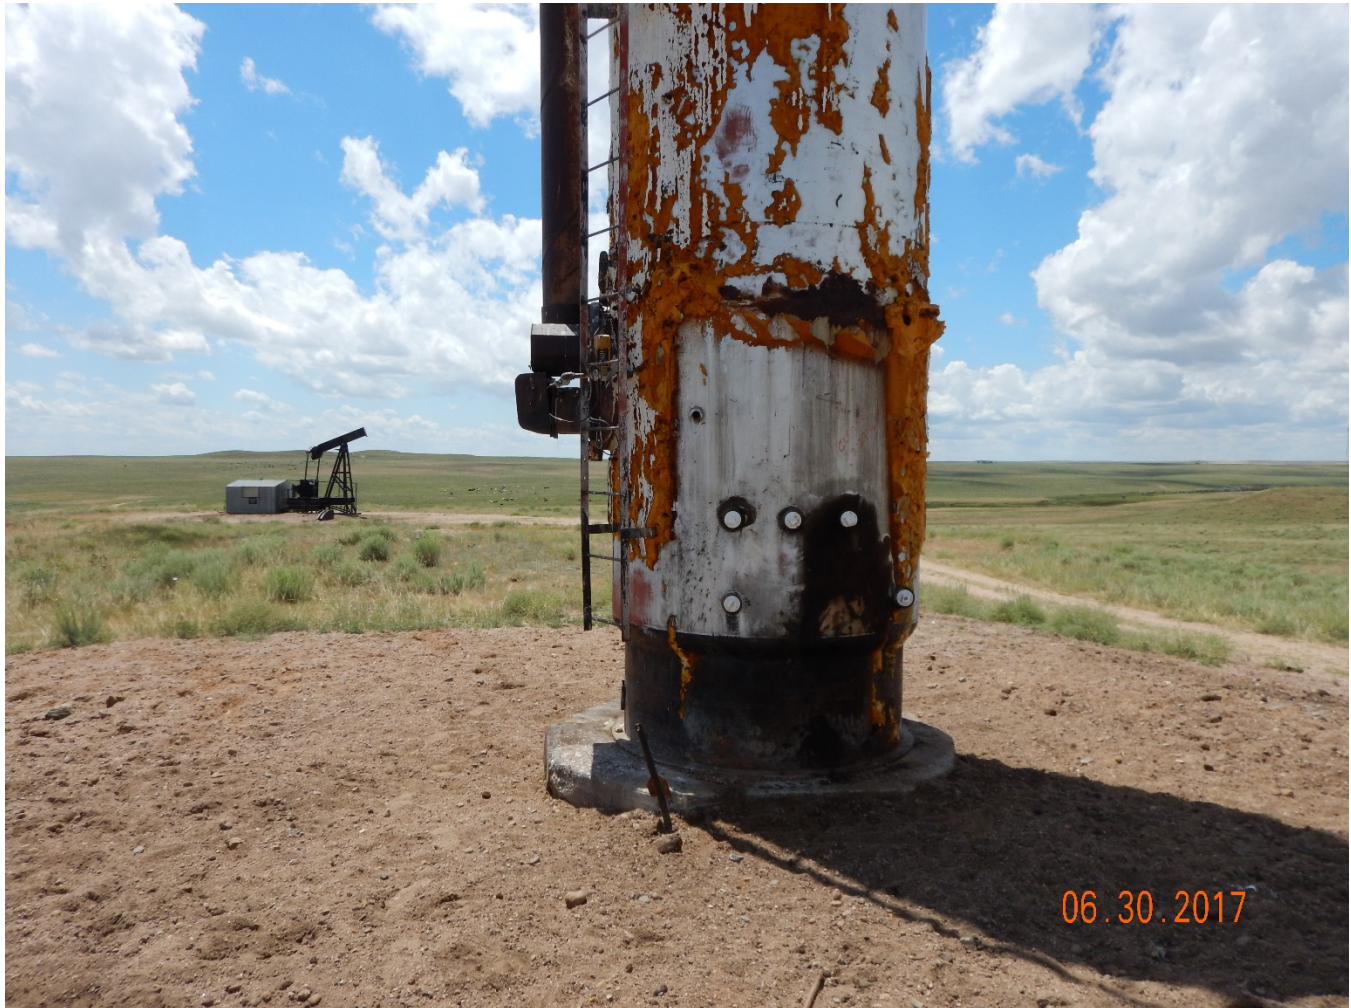
Figure 2 - Vertical heated separator remains on location.

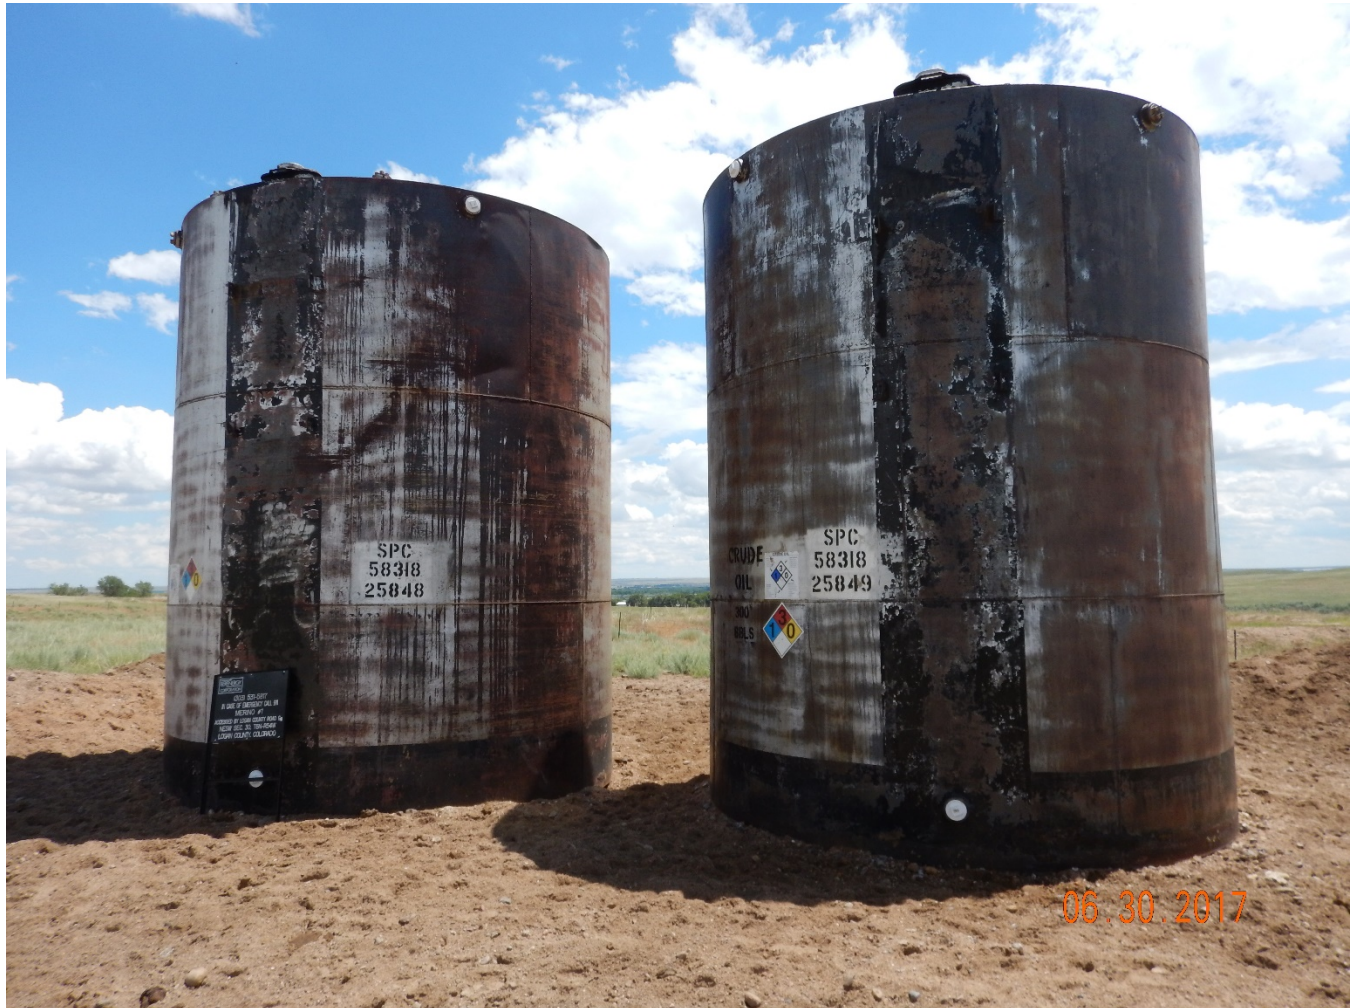
Figure 3 - Crude oil ASTs remain on location. Tanks appear to be empty.

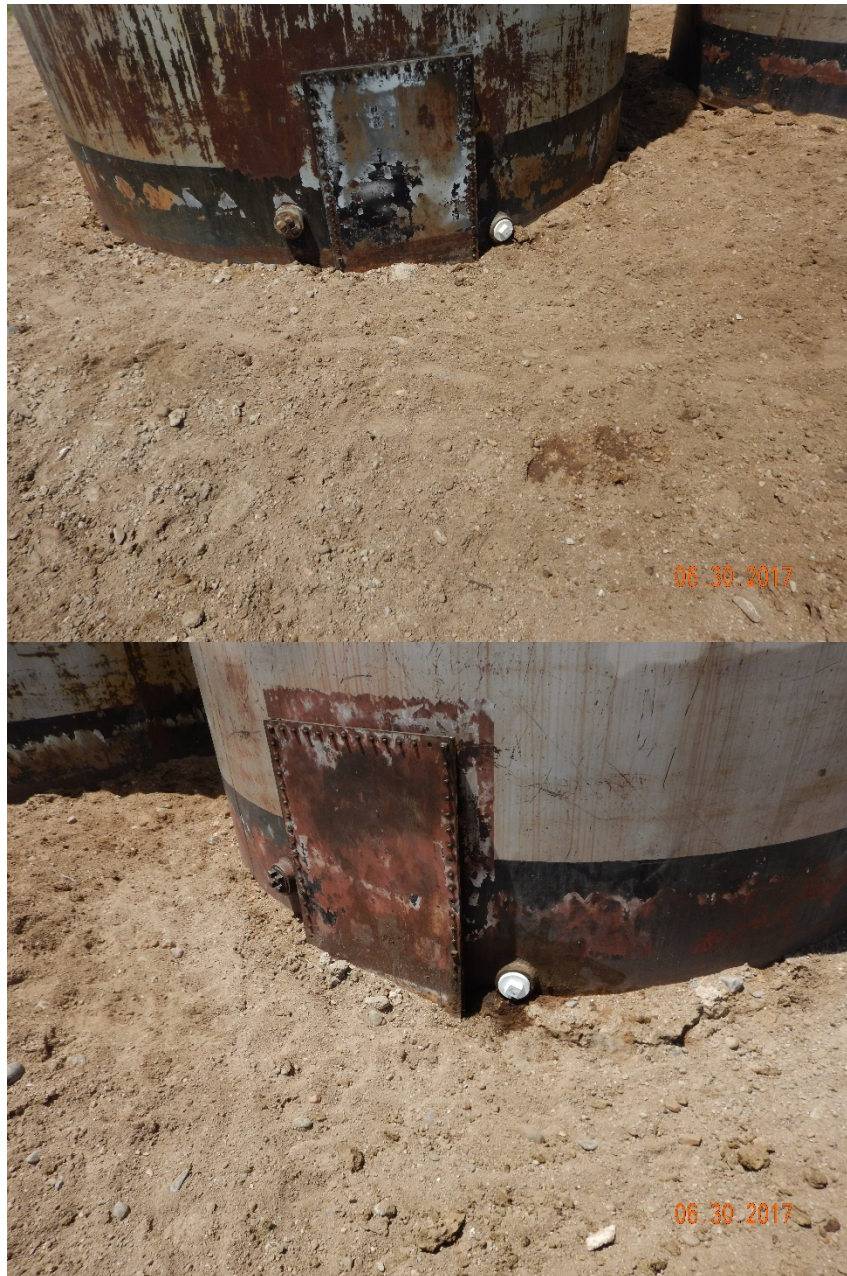
Figure 4 - Localized, stained soil at tank battery.

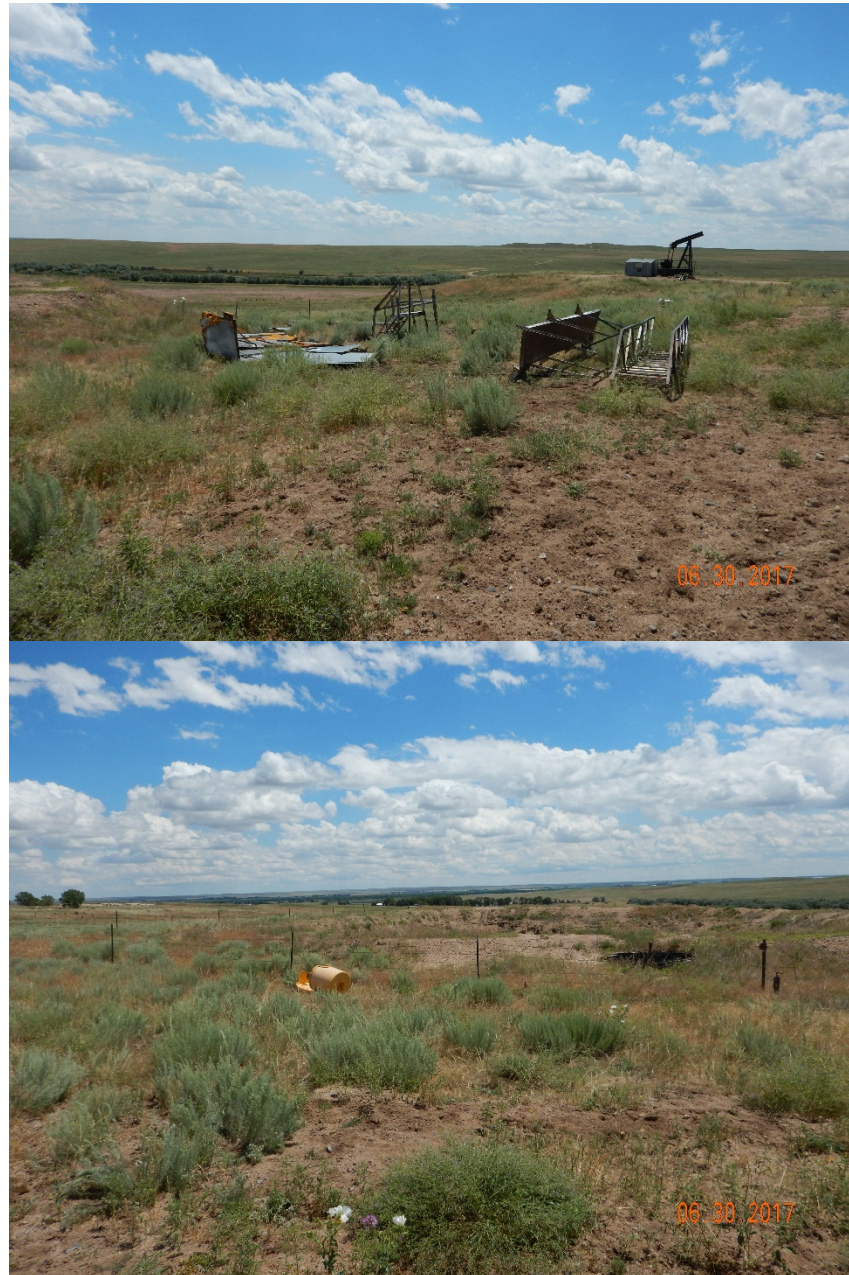
Figure 5 – Assorted debris (top photo - former shed and stairs; bottom photo – truck loadout containment device) located north of produced water pit.

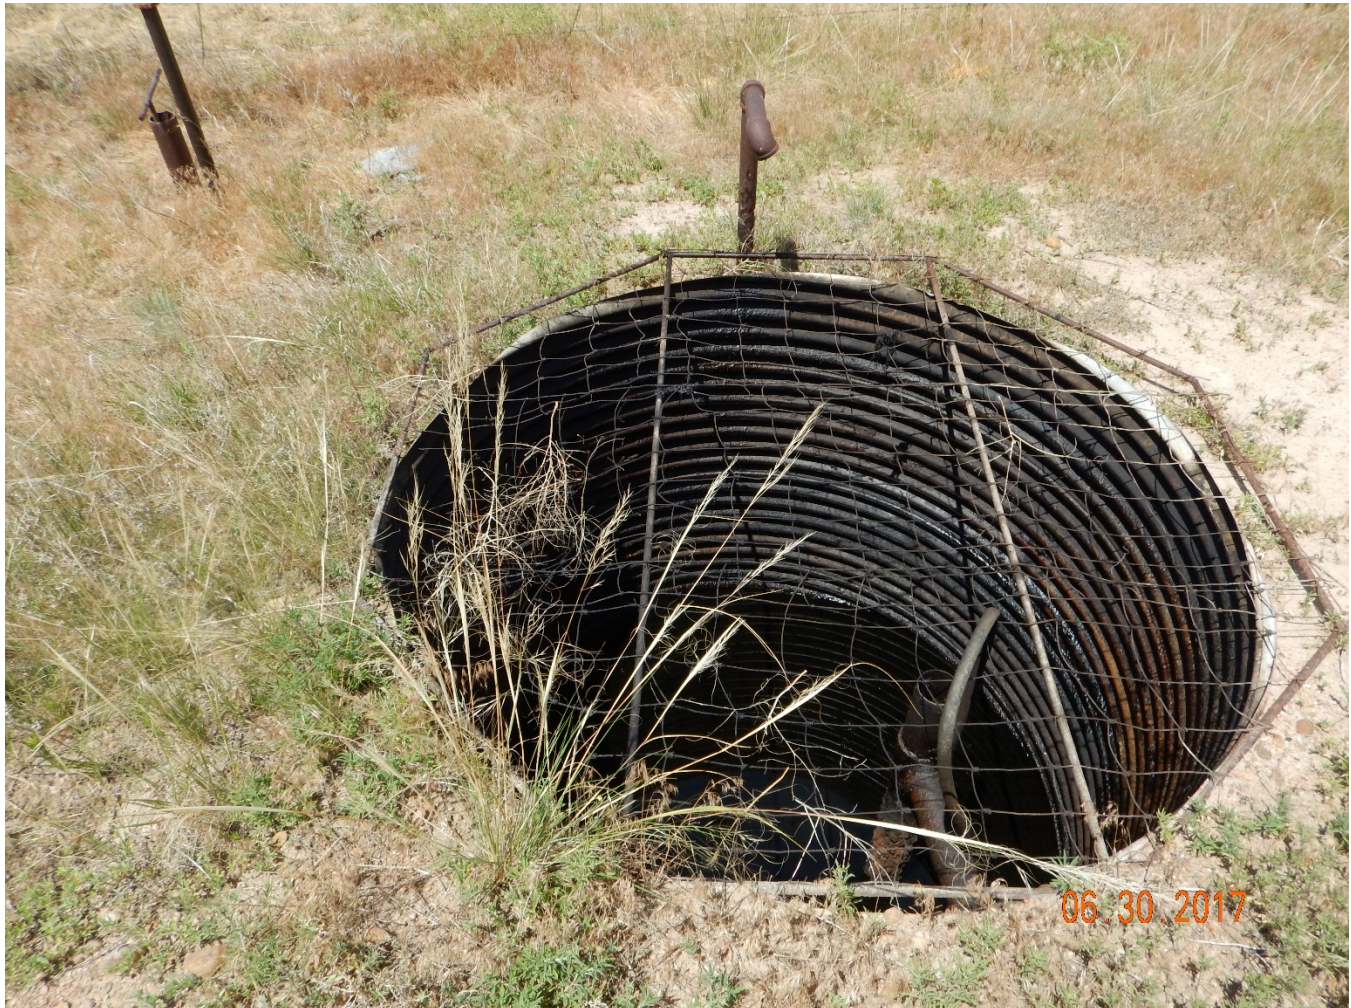
Figure 6 - Oil skim tinhorn remains on location. Operator indicated that both pits would be remediated by 6/15/2017.

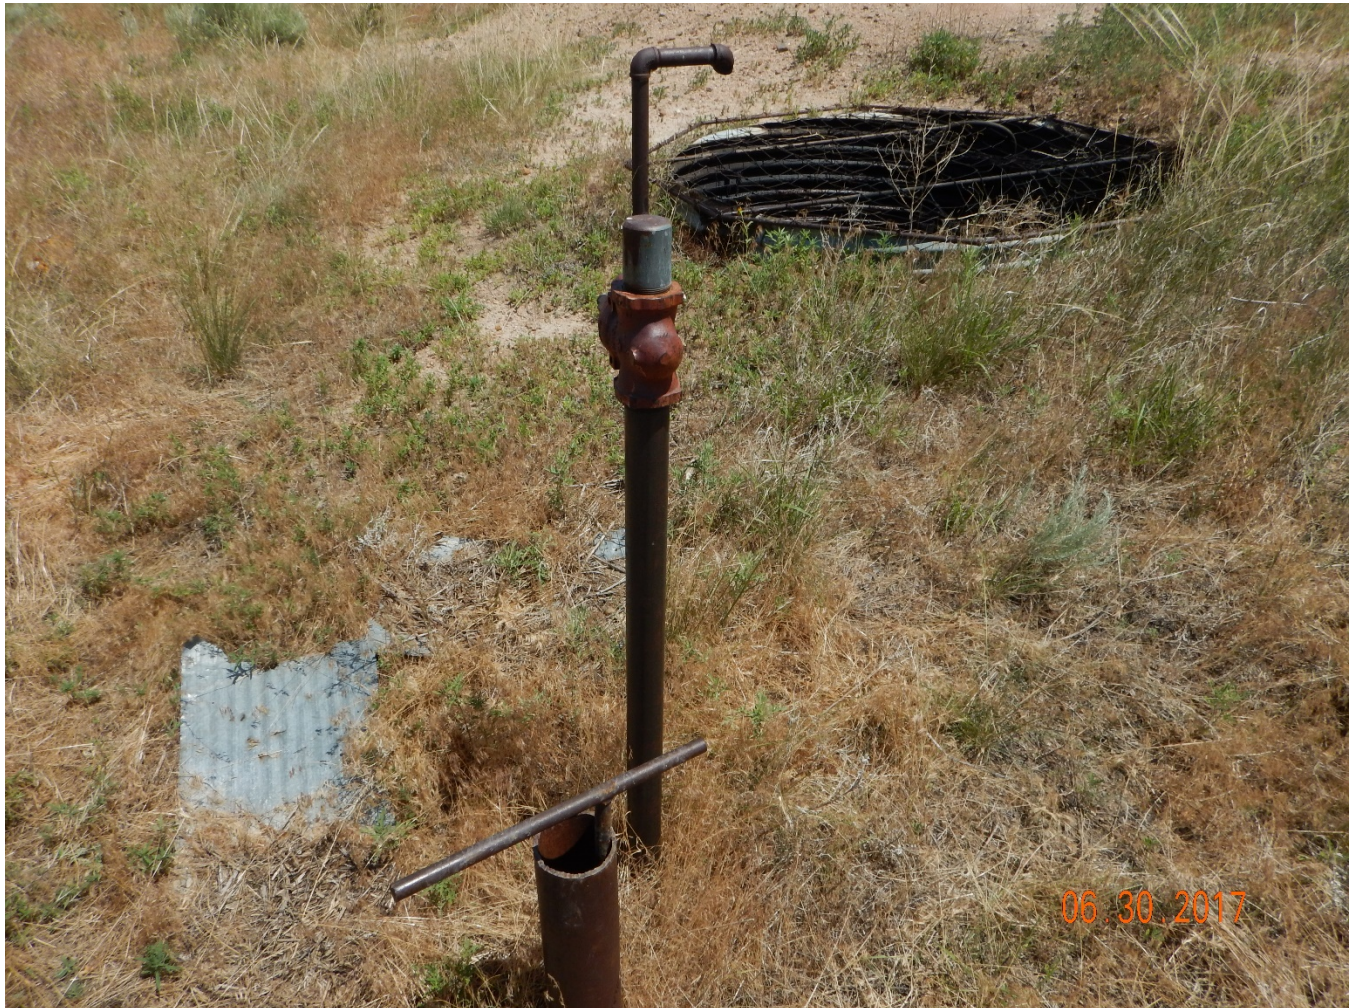
Figure 7 - Abandoned flowline risers N and NW of tinhorn.

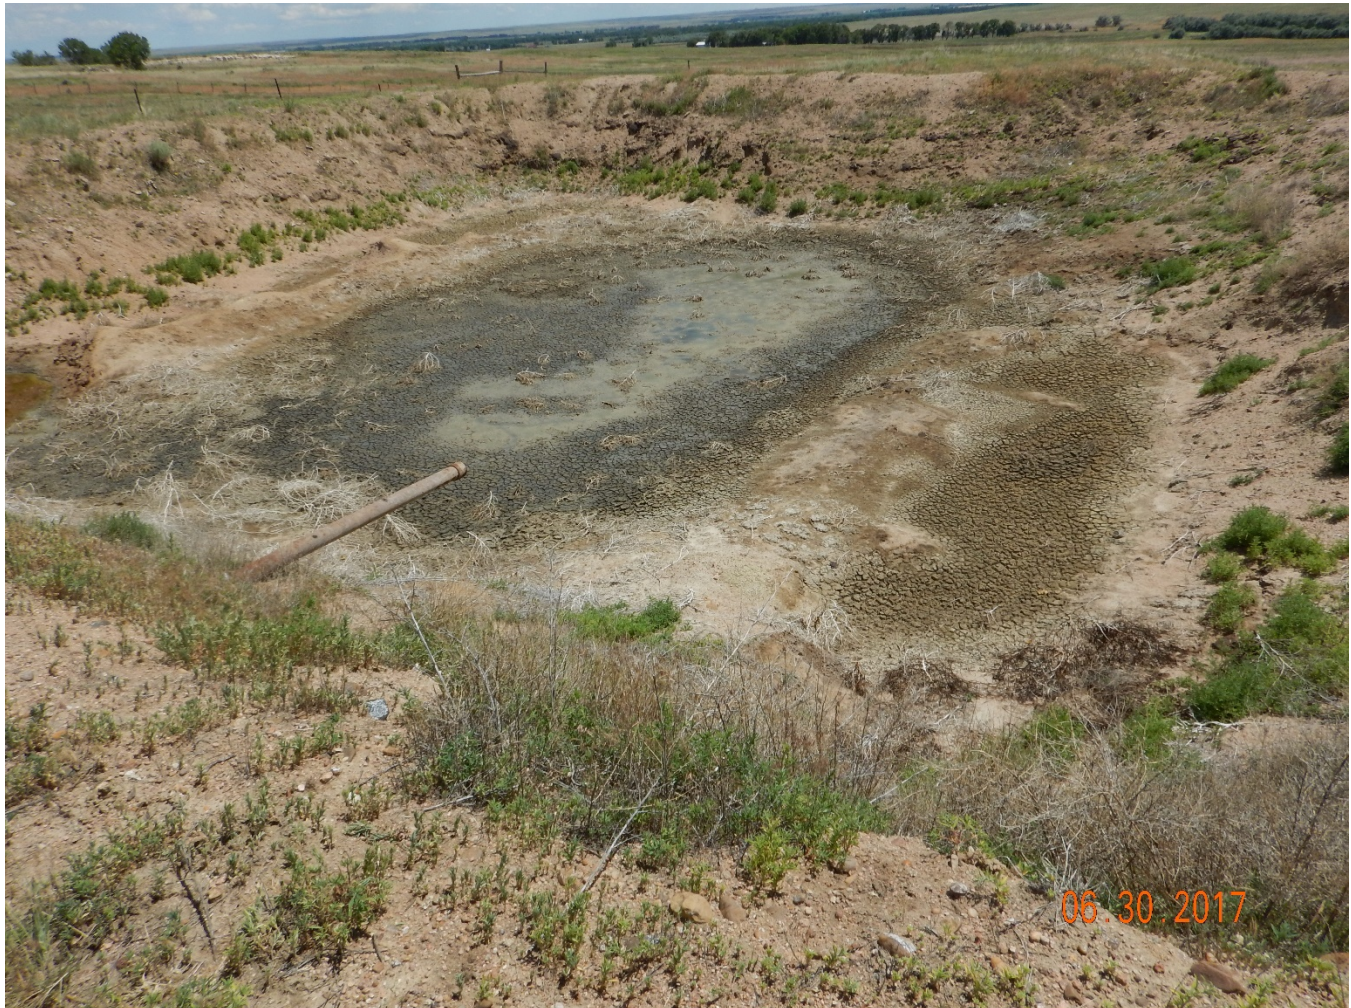
Figure 8 - Produced water pit remains on location. Operator indicated that both pits would be remediated by 6/15/2017.
