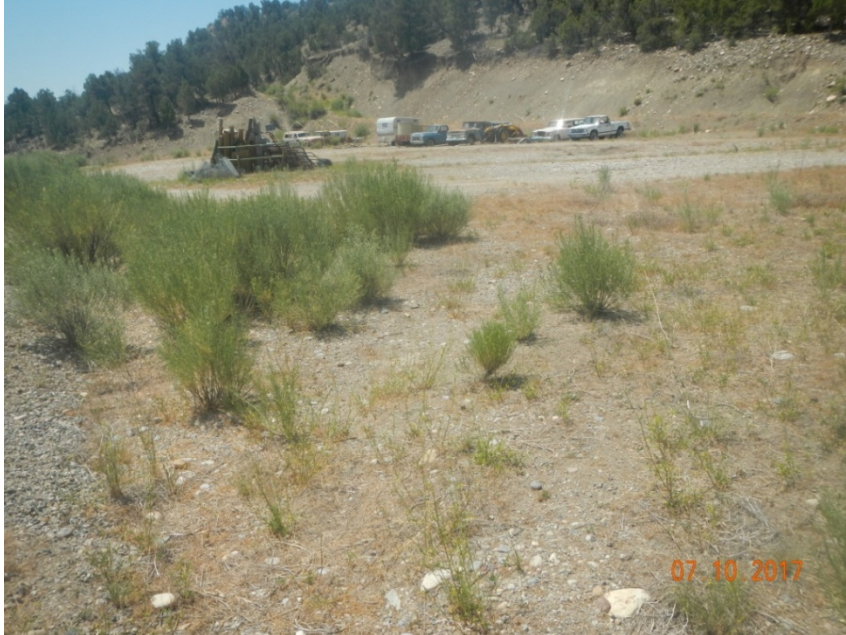
Photo 1: View of the project area from the northeastern corner of the well pad facing center. Portions of the well pad are becoming revegetated with rubber rabbitbrush (*Chrysothamnus nauseosus*), western wheatgrass (*Pascopyrum smithii*), and crested wheatgrass (*Agropyron smithii*).

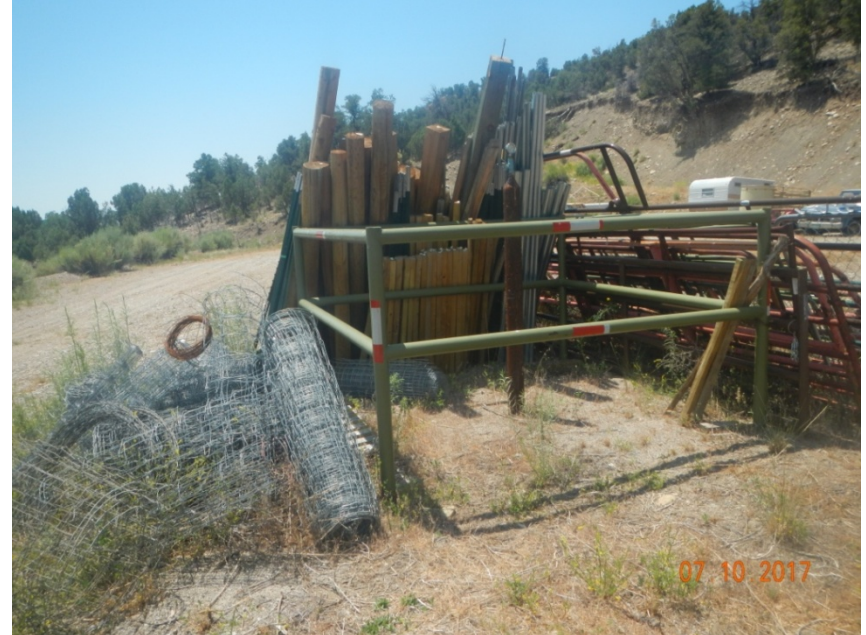
Photo 2: View of the wellhead facing center. What appears to be surface owner equipment is stored at the well head.

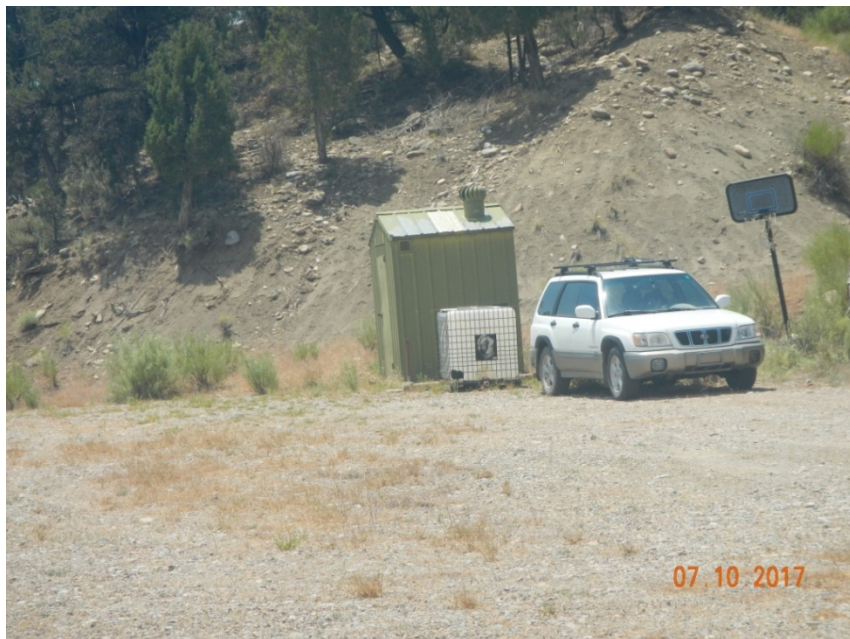
Photo 3: View of meter shed in the southwestern corner of the well pad.

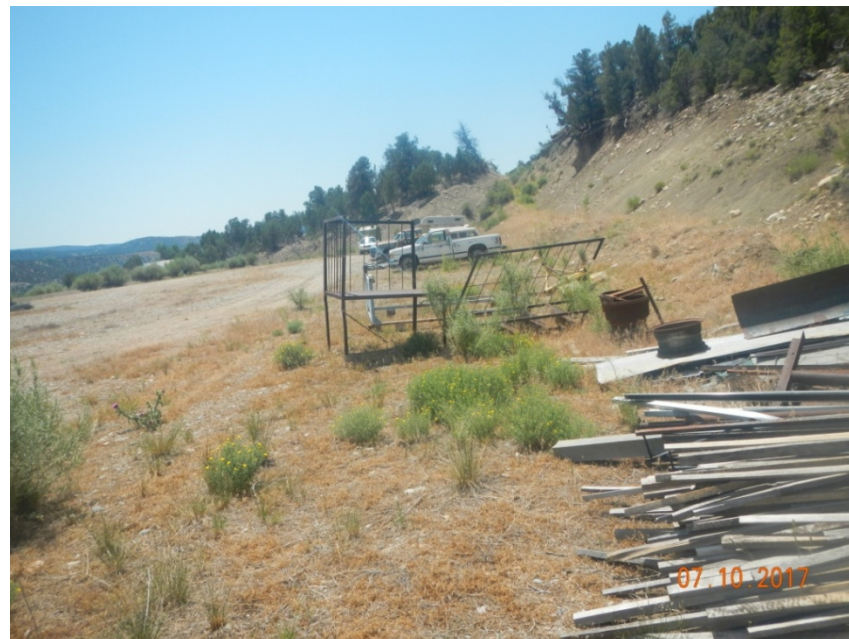
Photo 4: View of the western portion of the project area from the northwestern corner facing southward. What appears to be surface owner equipment is being stored in the western portion of the well pad area.

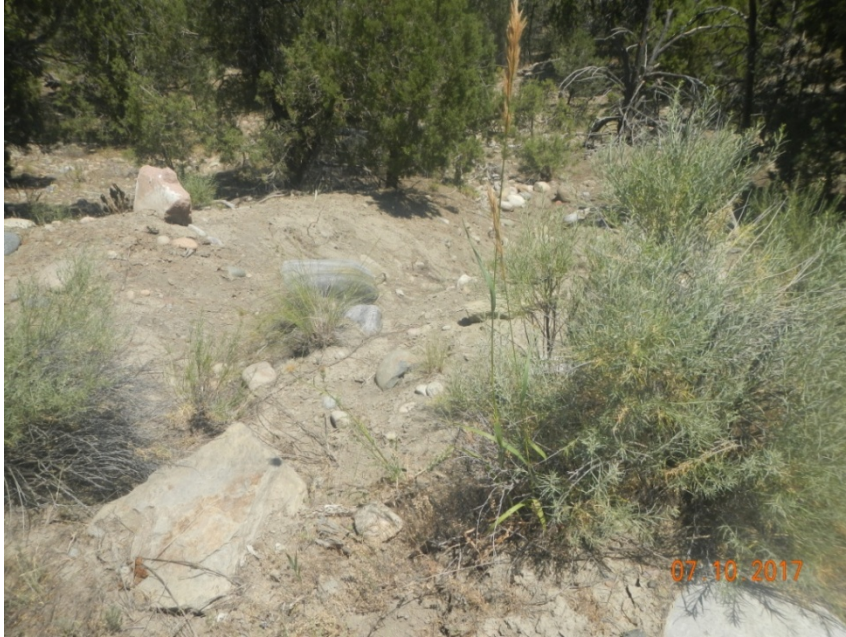
Photo 5: View of area in the northwestern corner of the project area where diverted stormwater flows are directed down slope and it appears to be eroding the slope. Long term stormwater controls are needed in this area.

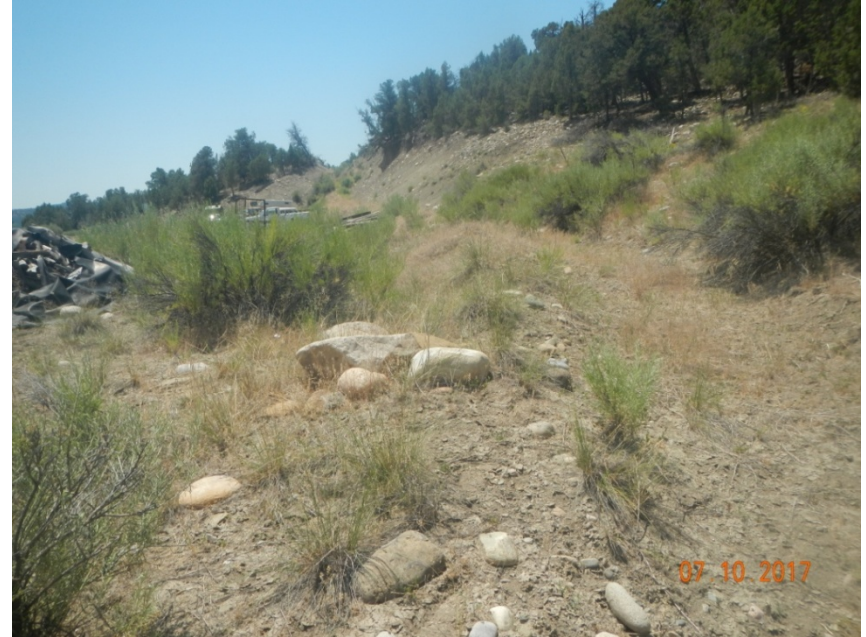
Photo 6: View of the western diversion within the project area, facing upstream from the northwestern corner.

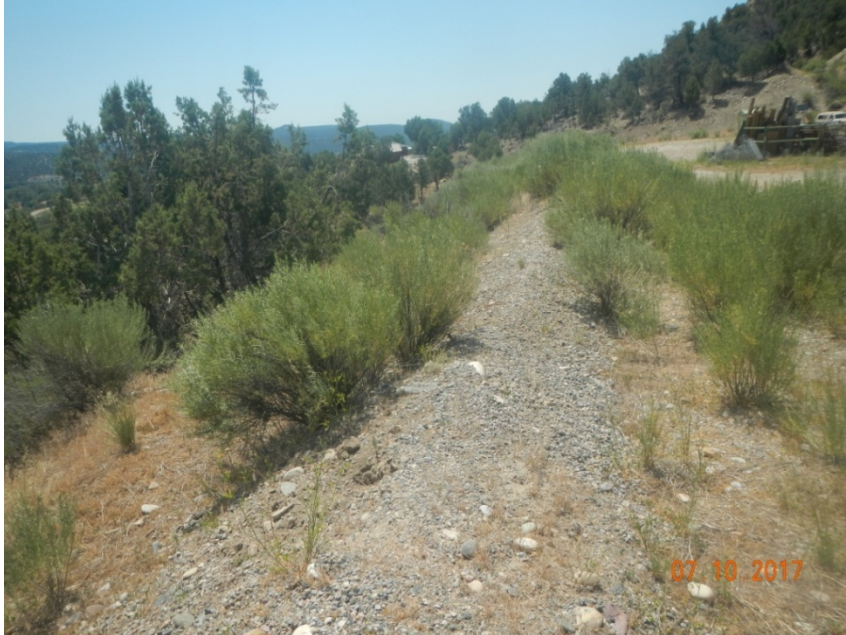
Photo 7: View of what berm that appears to be functioning along the eastern edge of the well pad.

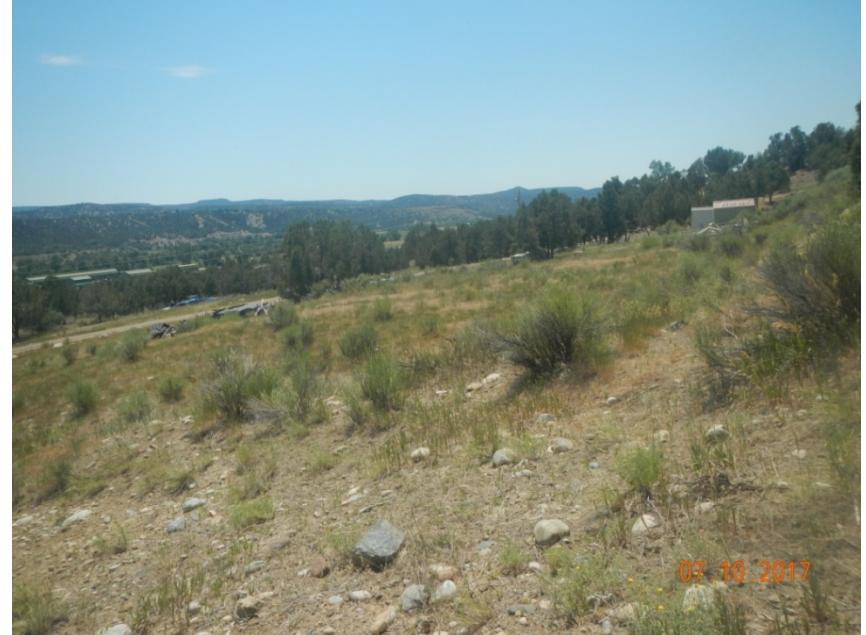
Photo 8: View of the eastern fill slope and vegetated area in the eastern portion of the project area, from the northeastern corner facing southward.
