Reclamation and Stormwater Inspection

July 11, 2017

Operator: NOBLE ENERGY INC- #100322

Location ID: 433936

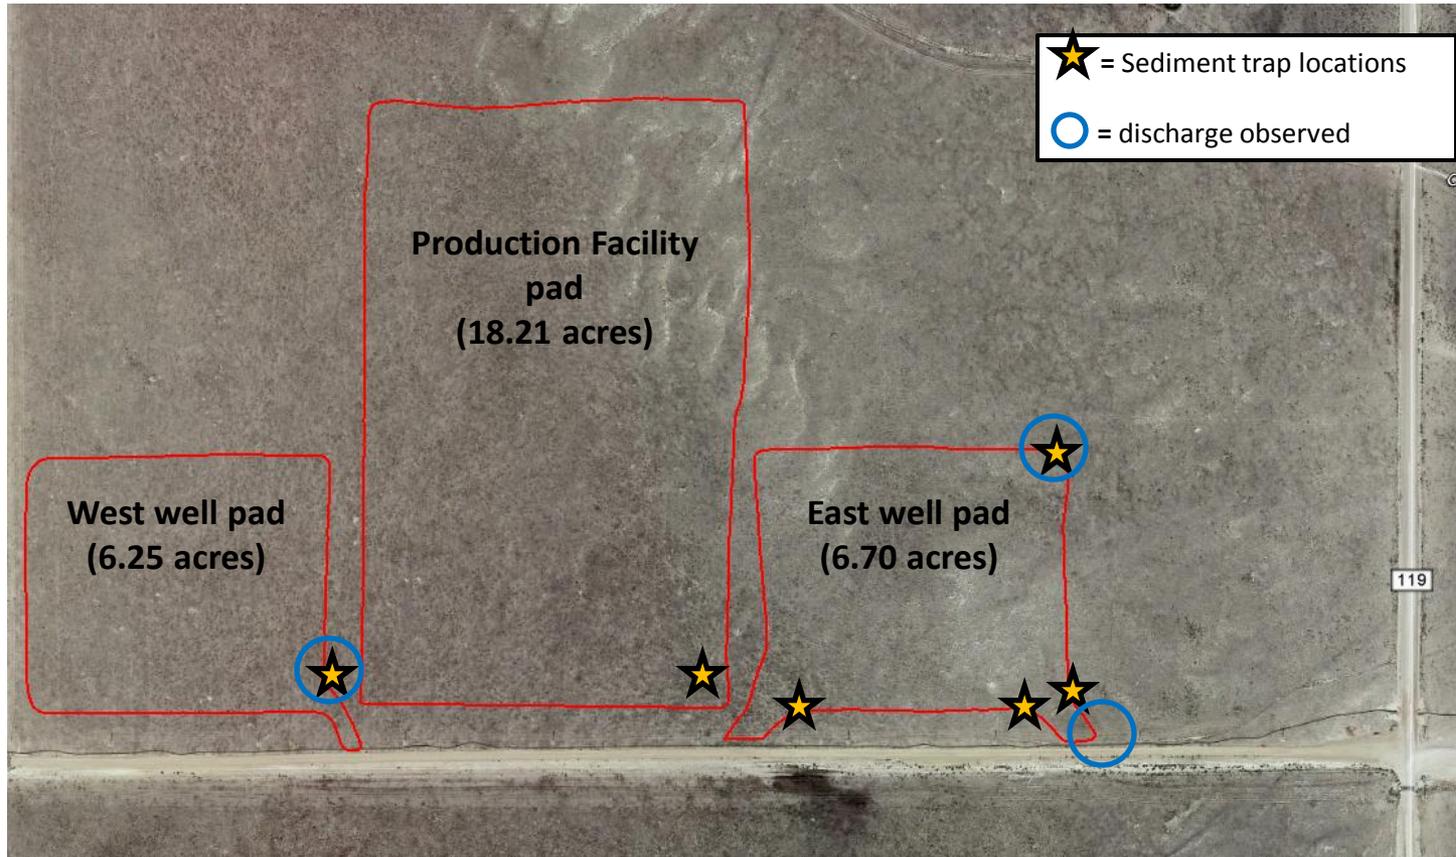
Overview of Location ID 433936 and the associated well pads and production facility. Total area of each pad was mapped using a Trimble Juno 3B handheld device on November 23, 2016. The star indicates the approximate sediment trap locations. Perimeter of each location was mapped and highlighted in red. Blue circles indicate a discharge was observed.

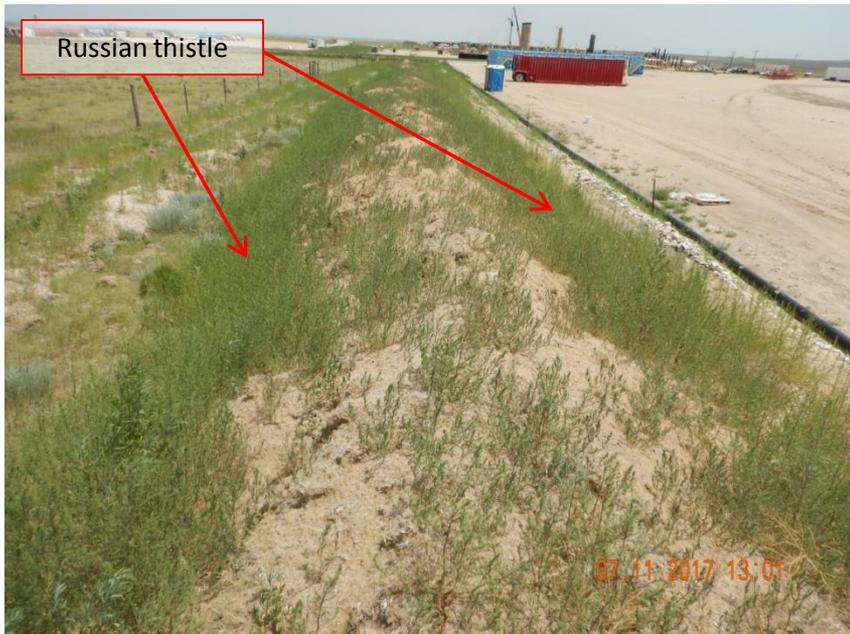
Photo 1. Photo taken from the northern west well pad on top of the topsoil stockpile, facing East. Topsoil stockpiles have predominately Russian thistle growth and Kochia growth which is not in compliance with Rule 1002.c. and Rule 1003. Hydromulch application was observed on the topsoil stockpile but is only a temporary BMP.

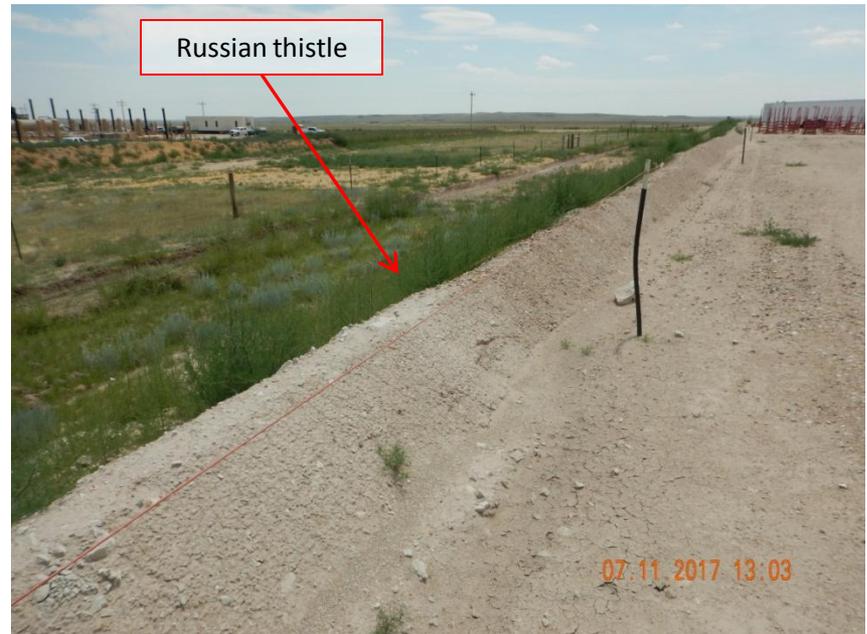
Photo 2. Photo taken from the eastern west well pad, facing Southeast. A berm ~18" has been constructed along the west, east and south pad perimeter, but does not appear to be properly compacted. Russian thistle growth was observed along the east-facing fill slope.

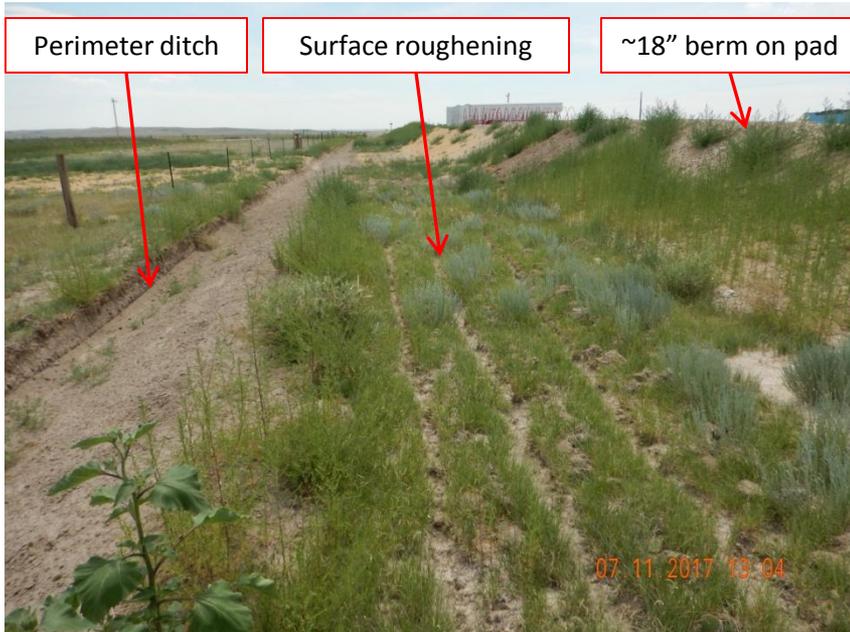
Photo 3. Photo taken along the outer eastern west well pad perimeter, facing South. Hydromulch application was observed along fill slopes but is only a temporary BMP. Russian thistle growth observed throughout most disturbance areas. Vegetative buffer area with surface roughening and a perimeter ditch outside of the ~18" berm constructed on the pad.

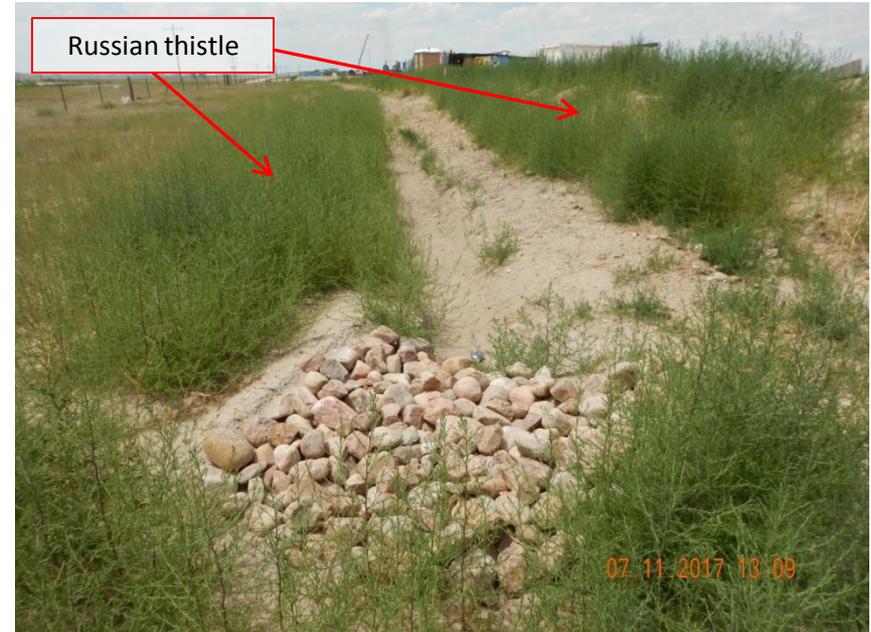
Photo 4. Photo taken from the west well pad, east entrance, facing West. Operator has installed a stabilized outlet at the end of the perimeter ditch but no sediment trap. Filtrexx wattle was installed beyond the outlet area to control runoff from the entrance of the access road but was not included because it was difficult to observe with the high density of Russian thistle. Refer to the next photo taken from the same area but on 4/3/2017.

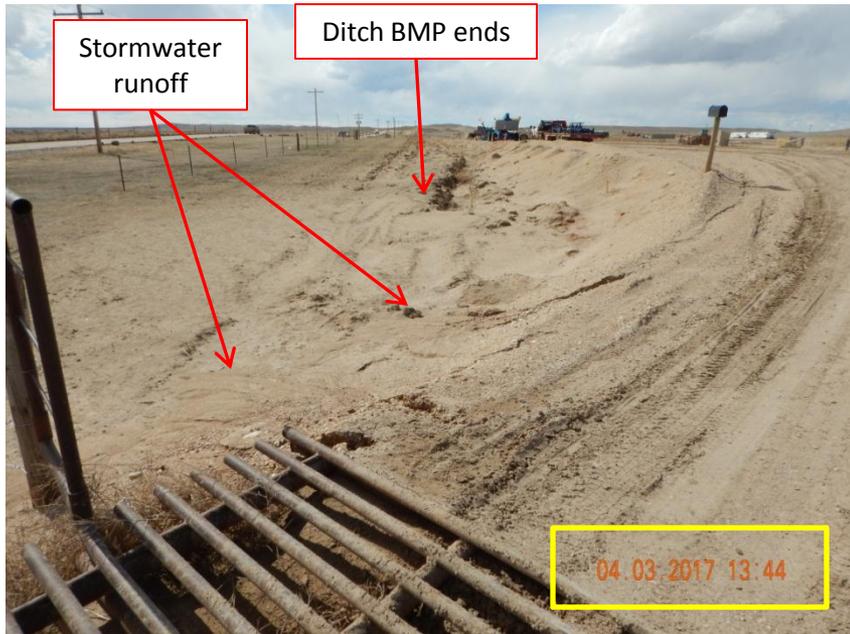
Photo 5. Photo taken 4/3/2017 from the west well pad, east entrance, facing West. Wind and stormwater runoff erosion evident along portions of the location perimeter. Fill slopes have not been stabilized along the location perimeter to prevent wind erosion.

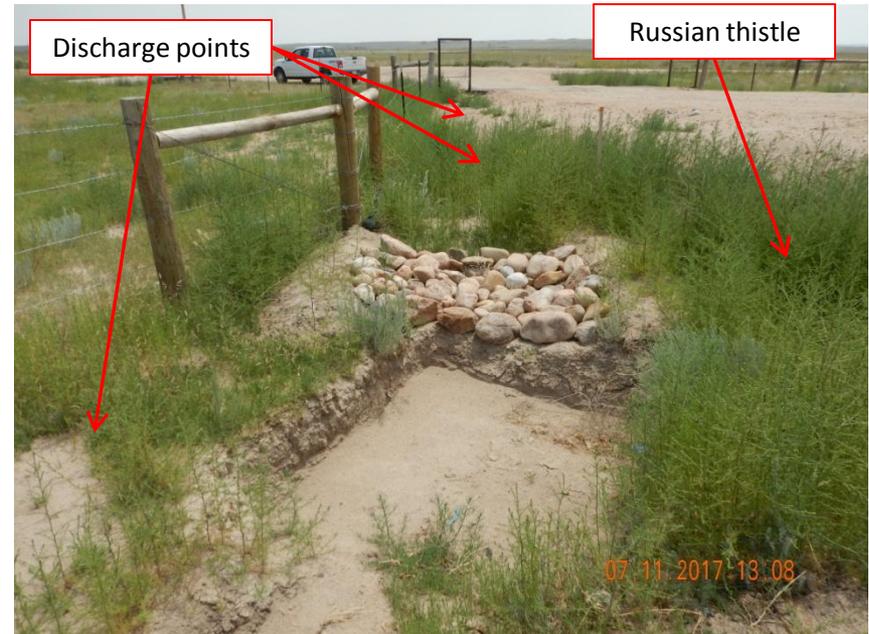
Photo 6. Photo taken from the west well pad, east entrance, facing South. Sediment trap does not appear to be sufficient as sediment is discharging from the eastern side. Sediment trap size was measured at ~5'x6'x1' (width x length x depth= 30ft³) with a stabilized outlet. Sediment discharge is also occurring from the entrance of the access road, south of the sediment trap. Refer to photos 7 & 8.

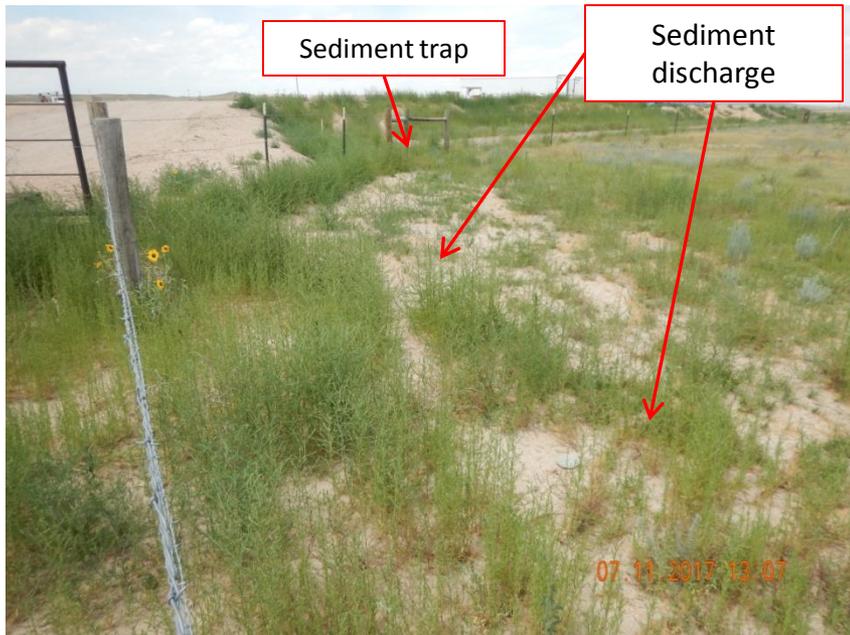
Photo 7. Photo taken from the west well pad, east entrance, facing Northwest. Sediment discharge and sediment build up beyond the sediment trap area were observed. Portions of this sediment discharge coming from the entrance of the access road.

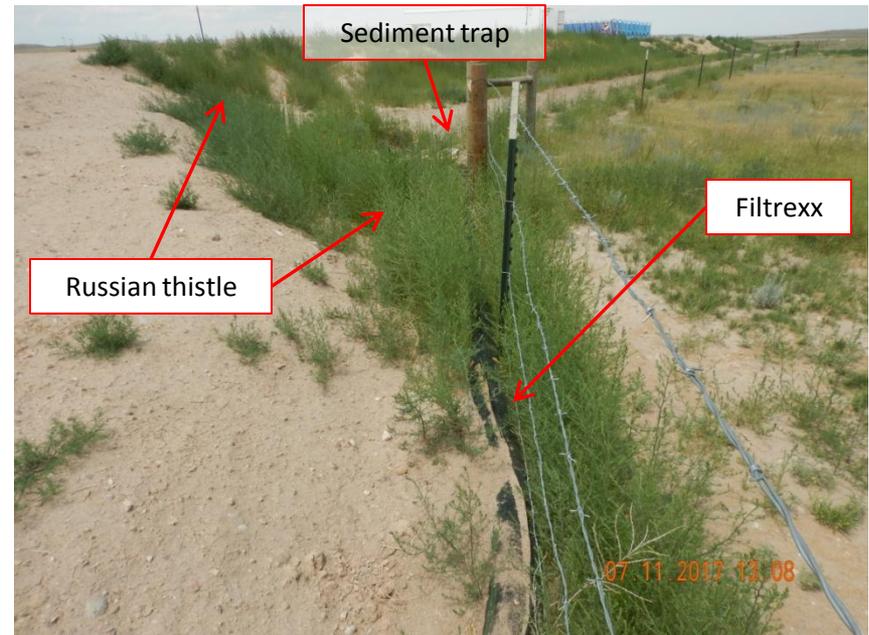
Photo 8. Photo taken from the west well pad, east entrance, facing Northwest. Appears stormwater runoff from the entrance access road is causing sediment discharge and the filtrex BMP does not appear to be a sufficient BMP.

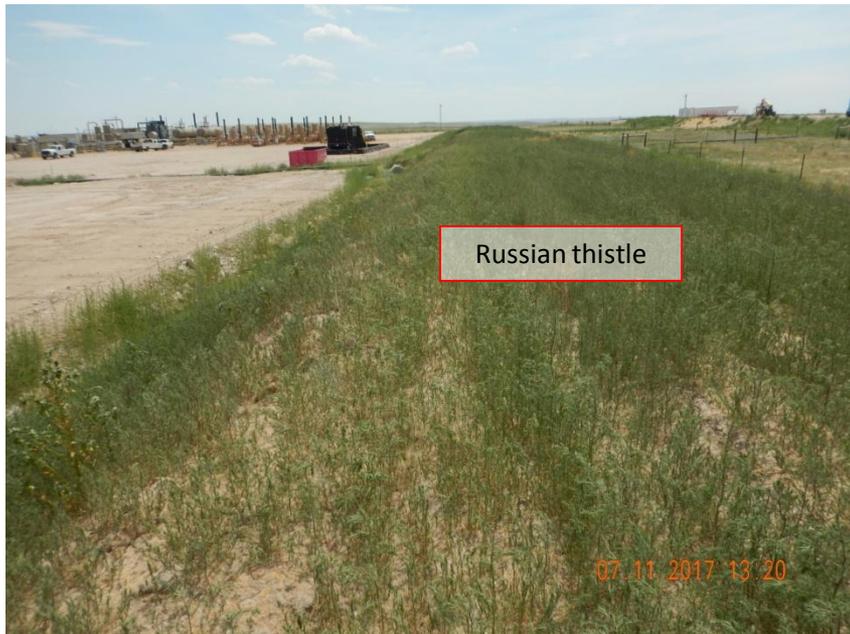
Photo 9. Photo taken from the western production facility pad on top of the topsoil stockpile, facing South. Topsoil stockpile has predominately Russian thistle growth and Kochia growth which is not in compliance with Rule 1002.c. and Rule 1003. Hydromulch application was observed on the topsoil stockpile but is only a temporary BMP..

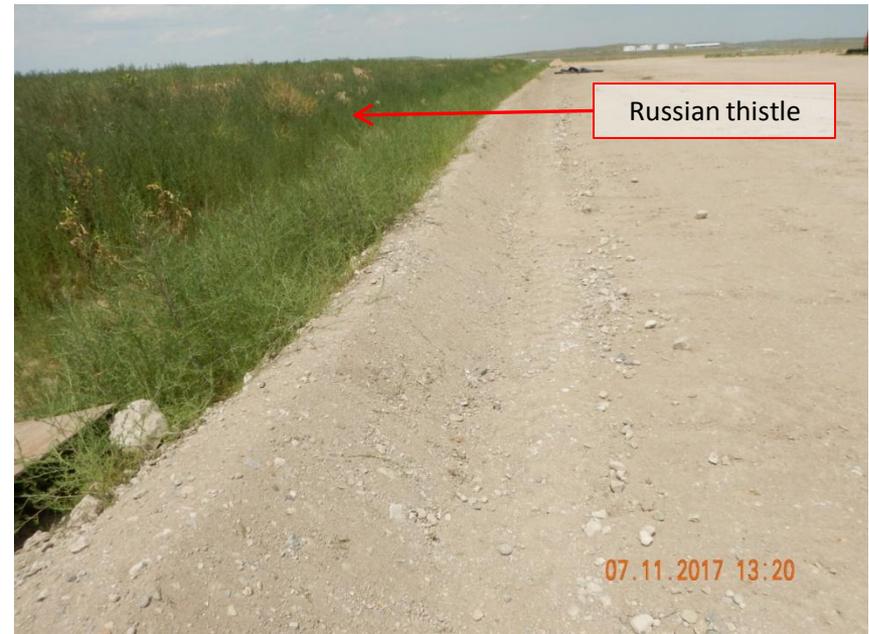
Photo 10. Photo taken from the western production facility pad, facing North. A berm ~18" has been constructed along the west and south pad perimeter, but does not appear to be properly compacted. Russian thistle growth was observed throughout the topsoil and perimeter areas.

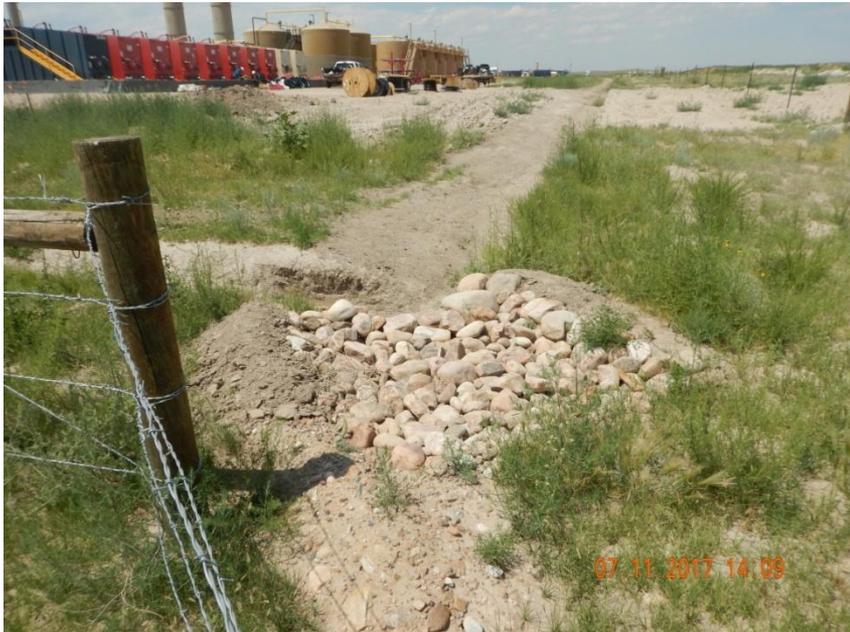
Photo 11. Photo taken from the southeast production facility pad, facing North. Sediment trap size was measured at $\sim 5.5' \times 4' \times 1.5'$ (width x length x depth= 33ft³) with a stabilized outlet.

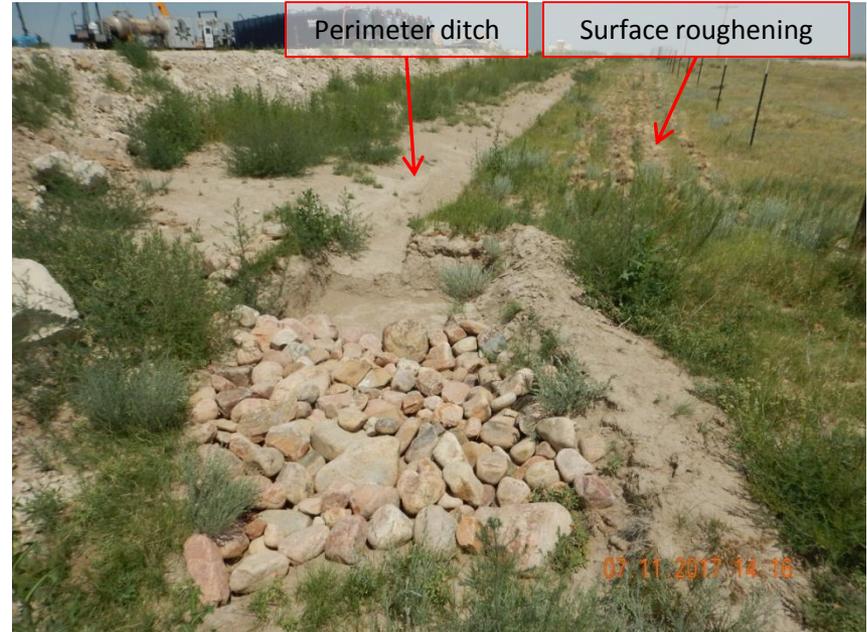
Photo 12. Photo taken from the southwest east well pad, facing East. Sediment trap size was measured at $\sim 5' \times 4.5' \times 2'$ (width x length x depth= 45ft³) with a stabilized outlet. Surface roughening outside of the perimeter ditch.

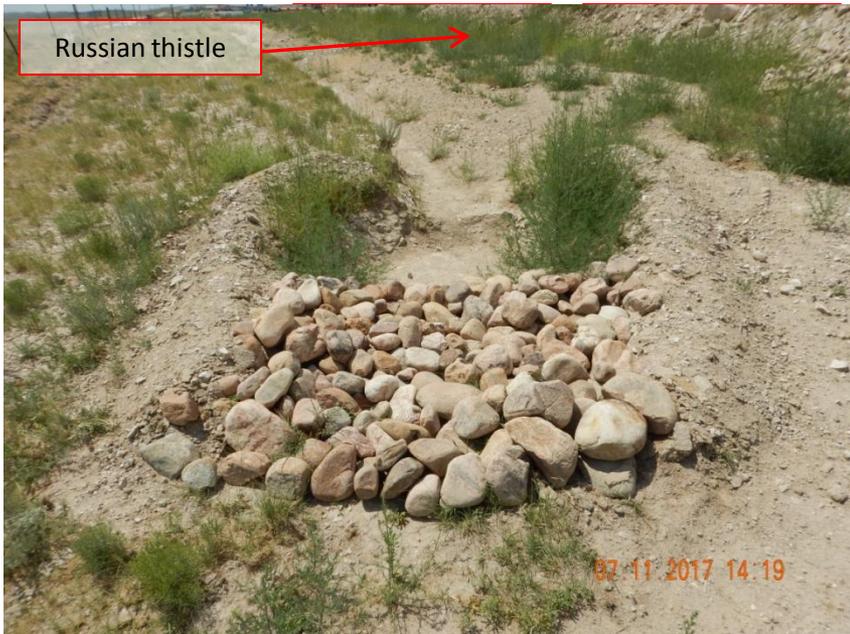
Photo 13. Photo taken from the east well pad, east entrance along the west side, facing West. Sediment trap size was measured at ~5'x4.5'x1.5' (width x length x depth= 33.75ft³) with a stabilized outlet.

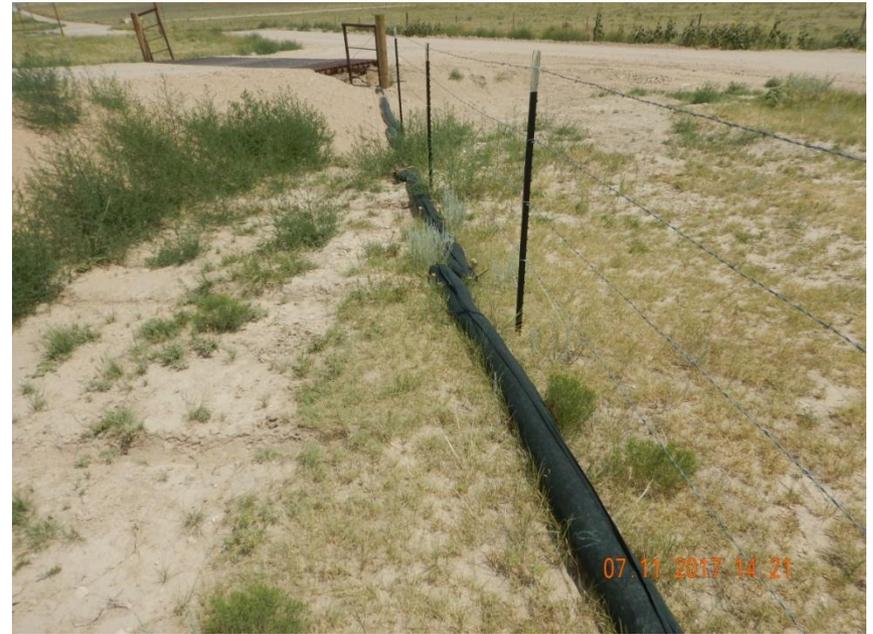
Photo 14. Photo taken from the east well pad, east entrance along the west side, facing East. Filtrexx wattle was installed beyond the outlet area to control runoff from the entrance of the access road which appears to be properly functioning.

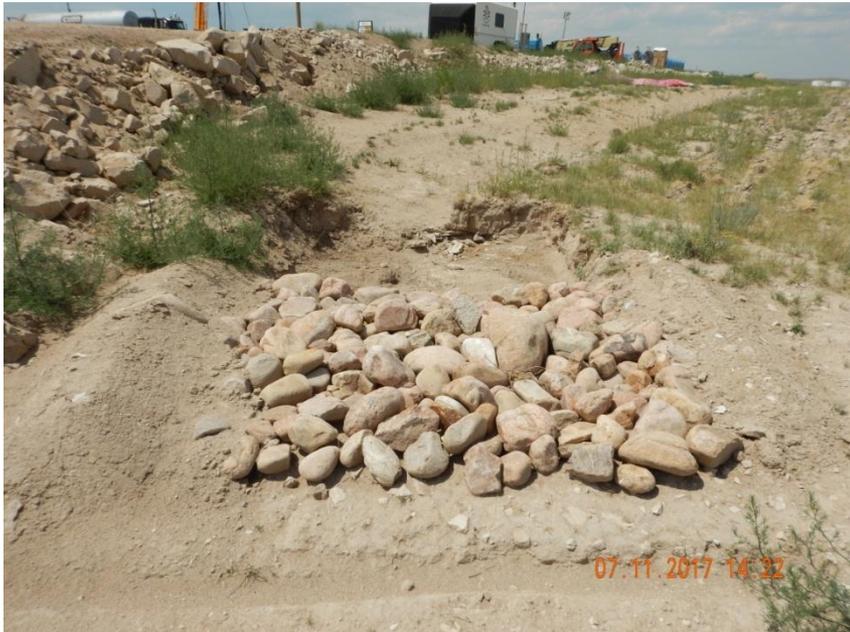
Photo 15. Photo taken from the east well pad, east entrance along the east side, facing Northwest. Sediment trap size was measured at ~6.5'x5'x1' (width x length x depth= 32.5ft³) with a stabilized outlet. Fence line has been moved to facilitate maintenance for the sediment trap.

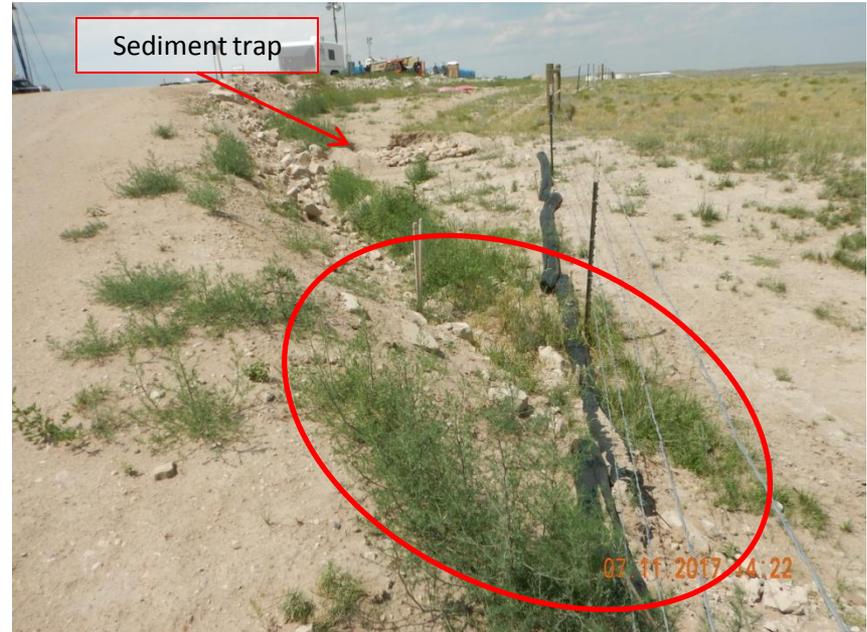
Photo 16. Photo taken from the east well pad, east entrance along the east side, facing Northwest. Appears stormwater runoff from the entrance access road is causing sediment discharge and the filterxx BMP does not appear to be a sufficient BMP.

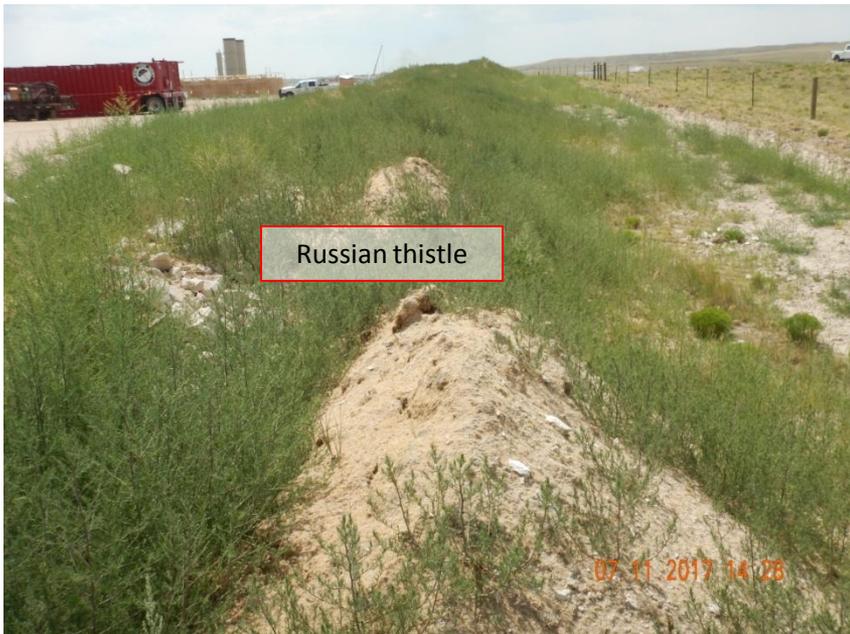
Photo 17. Photo taken from the northeast east well pad on top of the topsoil stockpile, facing West. Topsoil stockpile has predominately Russian thistle growth and Kochia growth which is not in compliance with Rule 1002.c. and Rule 1003. Hydromulch application was observed on the topsoil stockpile but is only a temporary BMP.

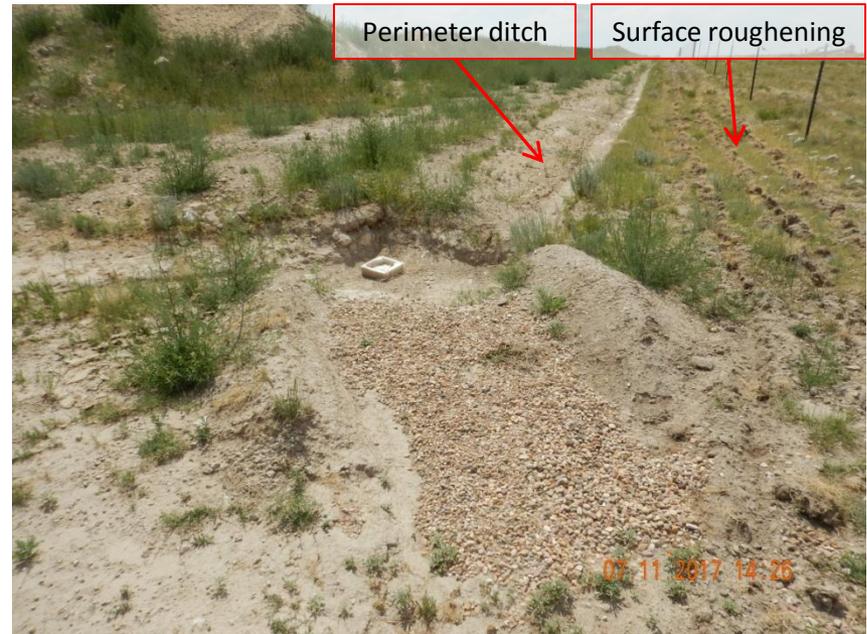
Photo 18. Photo taken from the northeast east well pad, facing West. Sediment trap does not appear to be sufficient or properly constructed. Sediment trap does not have a stabilized outlet installed. Sediment trap size was measured at ~6'x5'x1.5' (width x length x depth= 45ft³). Sediment discharge is evident. Refer to photos 19 & 20.

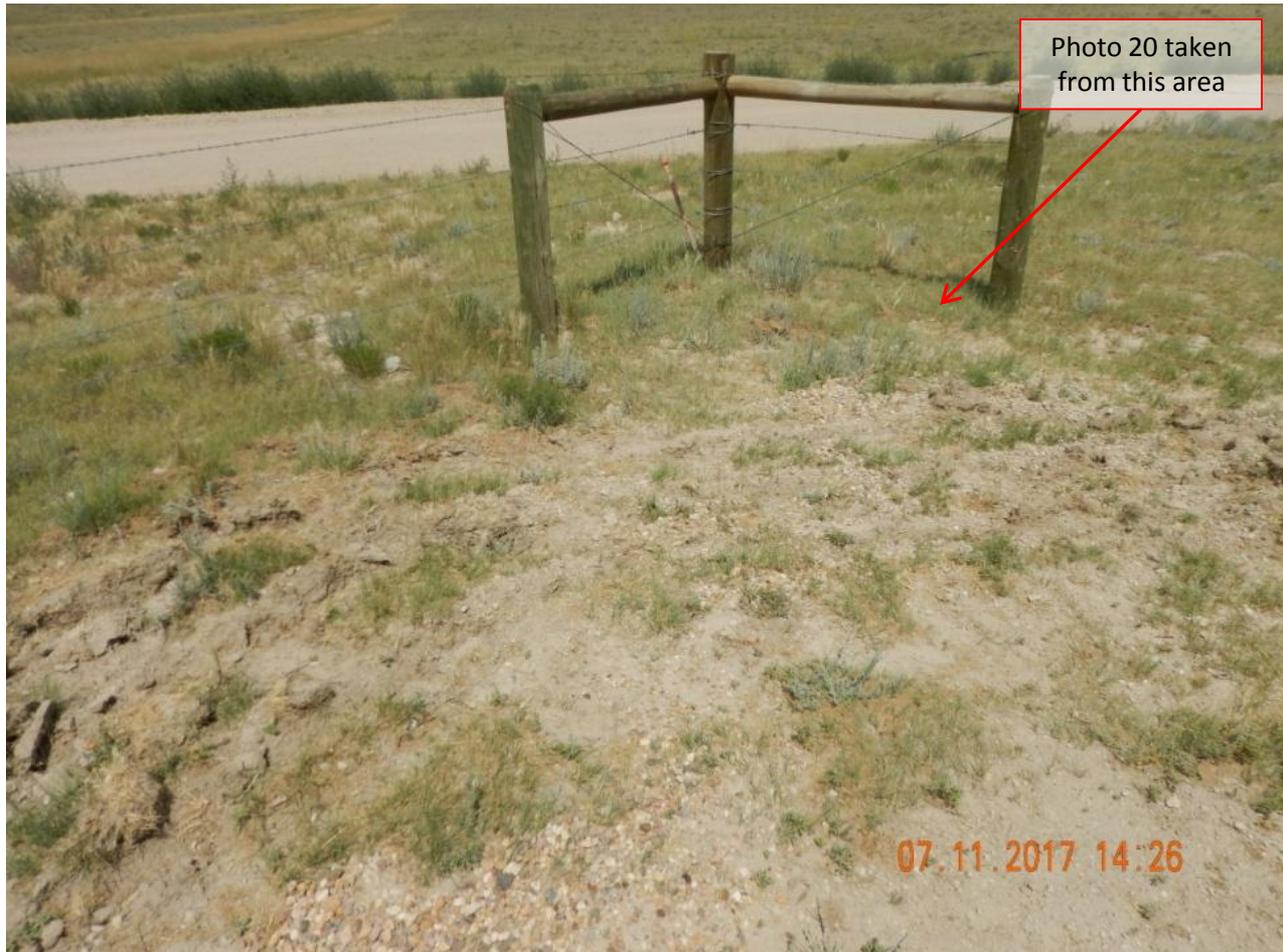
Photo 19. Photo taken just beyond the sediment trap, facing Northeast. Photo illustrates the surface roughening BMP is no longer in proper functioning condition, as it appears sediment discharge has filled in the BMP.

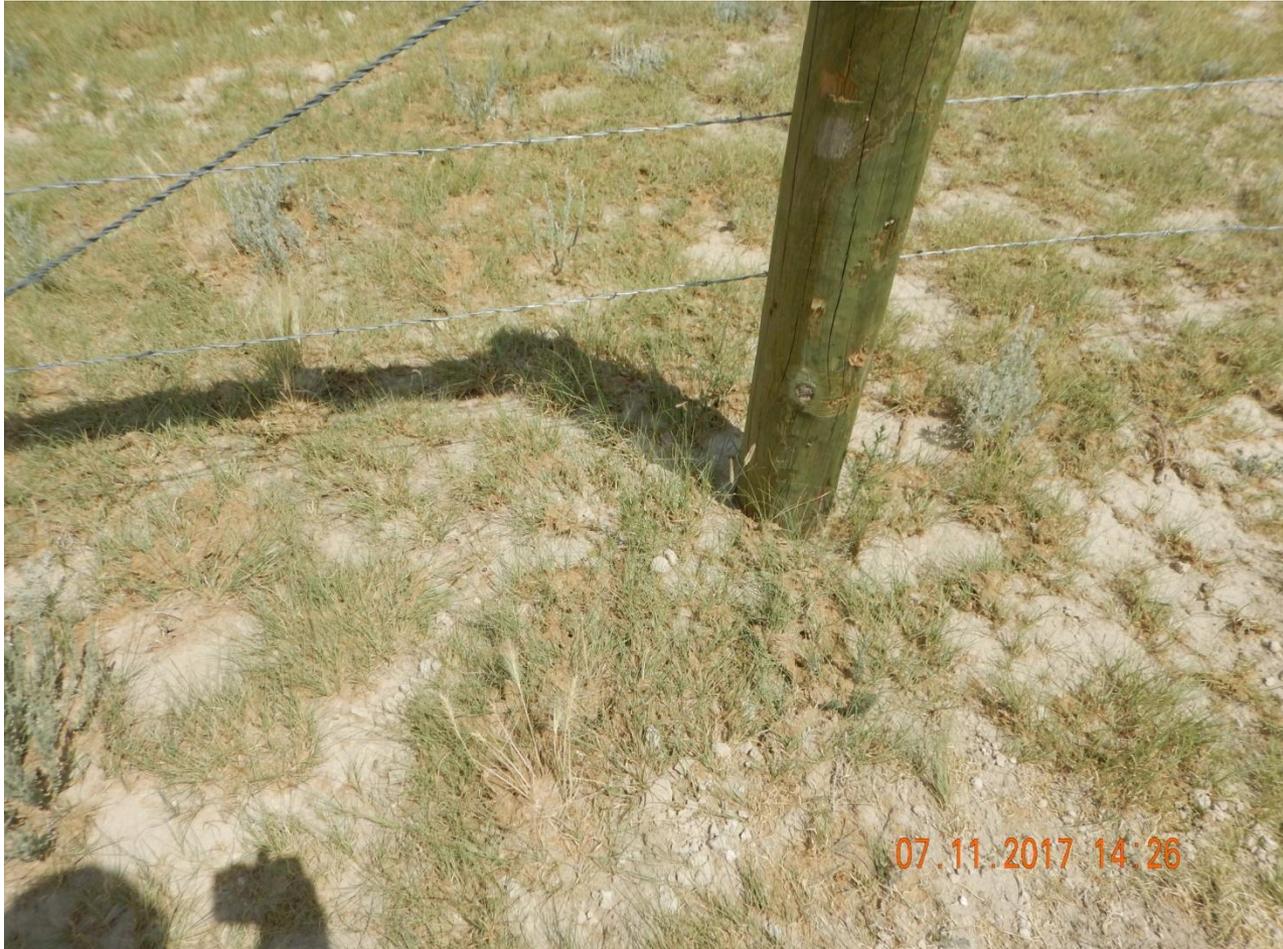
Photo 20. Close up photo taken just beyond the sediment trap, illustrating stormwater runoff appears to be washing hydromulch material off location.
