# Reclamation and Stormwater Inspection

July 11, 2017

Operator: NOBLE ENERGY INC- #100322

Location ID: 445191

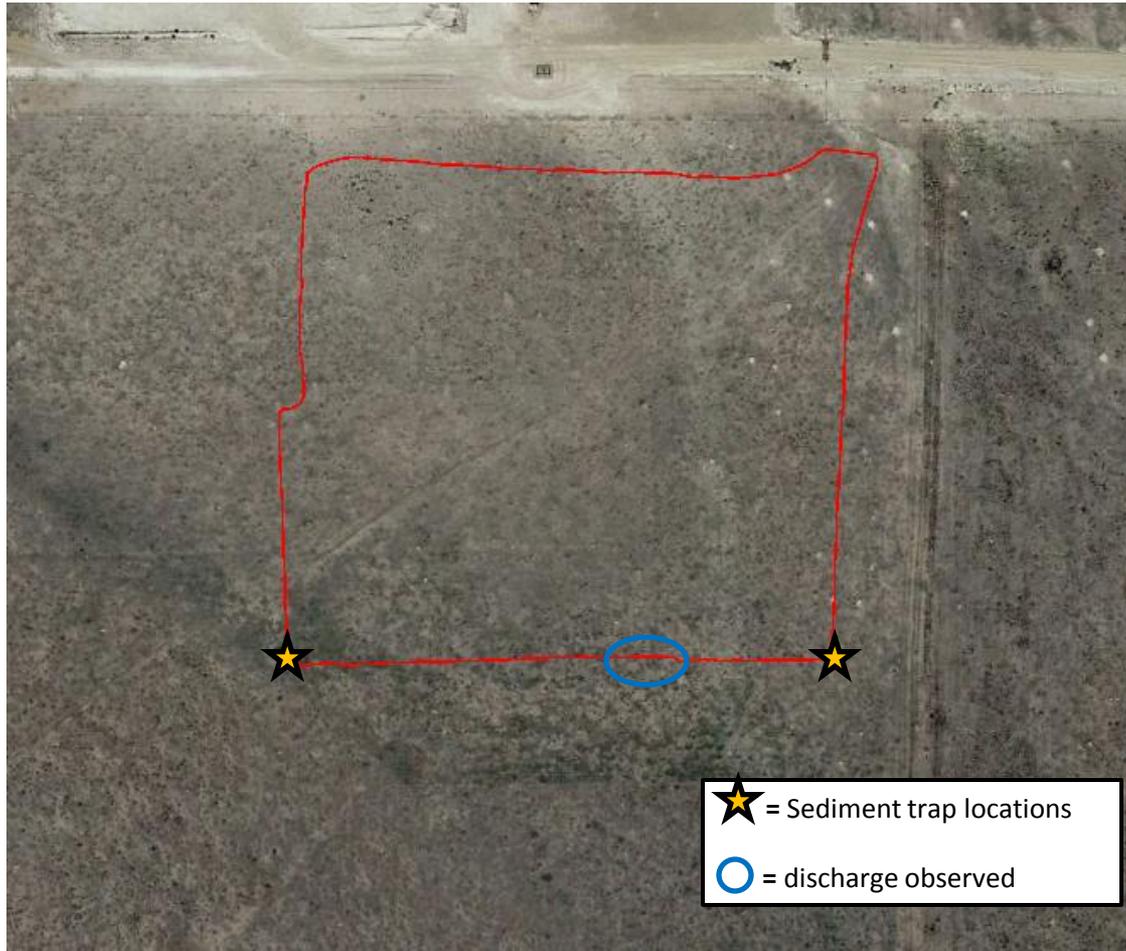
Overview of Location ID 445191 with total area of 6.44 acres mapped using a Trimble Juno 3B handheld device on July 11, 2017. The star indicates the approximate sediment trap locations. Perimeter of the location was mapped and highlighted in red. Blue circles indicate a discharge was observed.

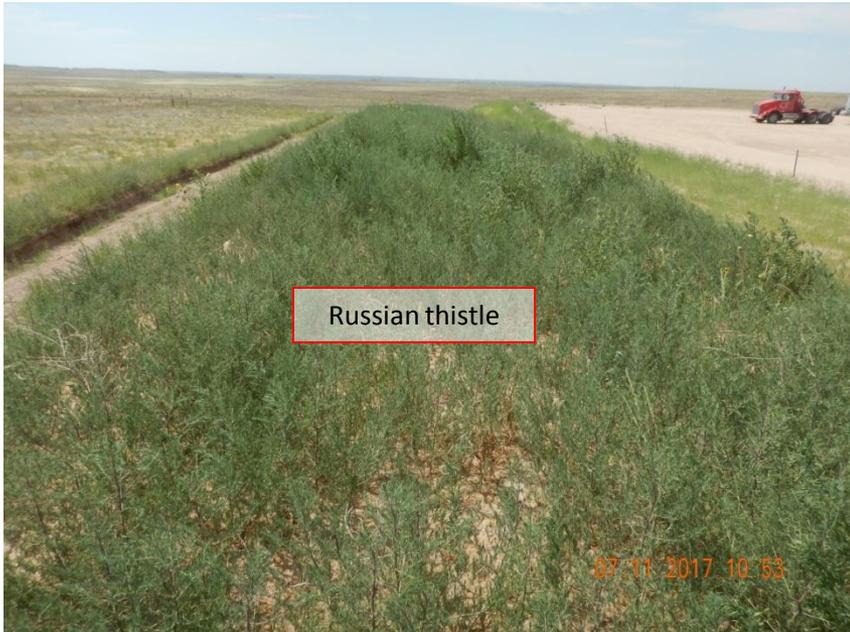
**Photo 1.** Photo taken from the eastern pad on top of the topsoil stockpile, facing South. Topsoil stockpiles have predominately Russian thistle growth and Kochia growth which is not in compliance with Rule 1002.c. and Rule 1003. Hydromulch application was observed on the topsoil stockpile but is only a temporary BMP.

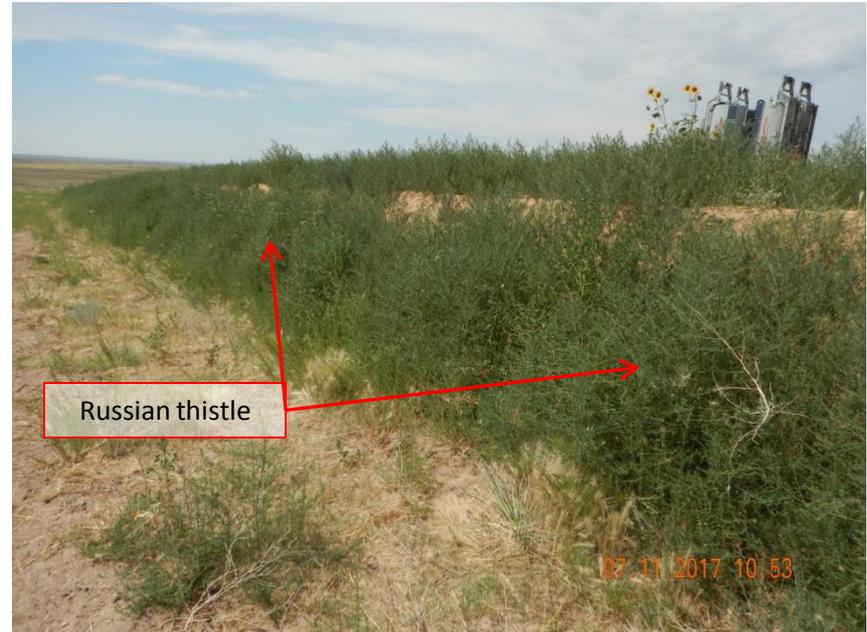
**Photo 2.** Photo taken from the eastern pad by the topsoil stockpile, facing South. Topsoil stockpiles were left with steep sides making it difficult to seed into for long-term stabilization and to prevent weed establishment.

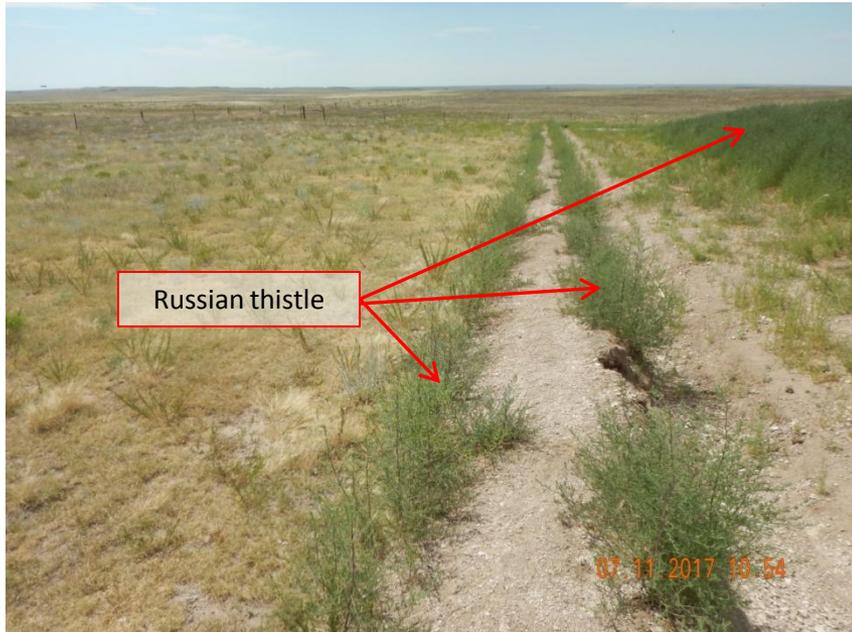
**Photo 3.** Photo taken from the eastern perimeter of the location facing South. Ditch and berm BMP installed along the entire perimeter of the location.

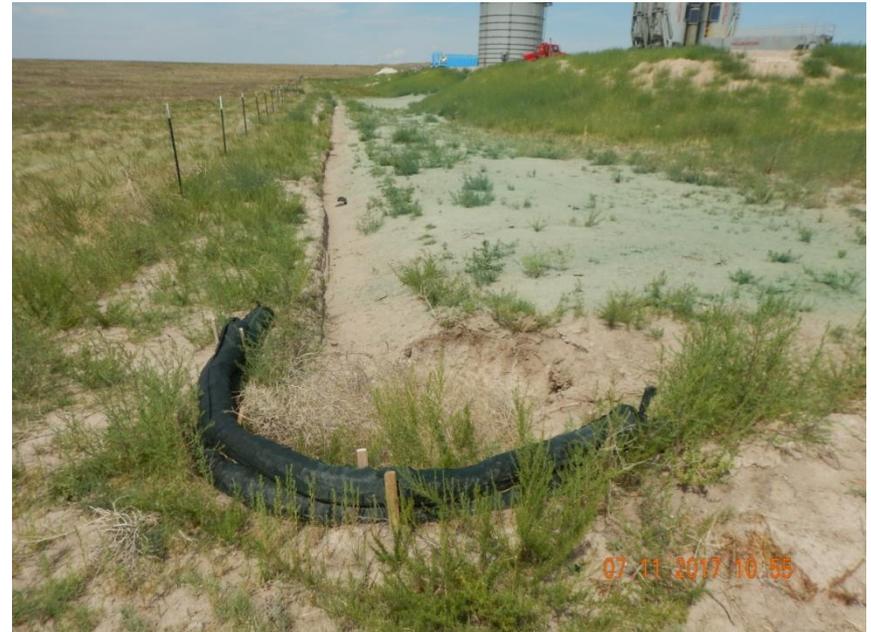
**Photo 4.** Photo taken from the southeast location, facing West. Sediment trap size was measured at ~6'x6'x2' (width x length x depth= 72ft<sup>3</sup>) with filtrex at the overflow point of the trap.

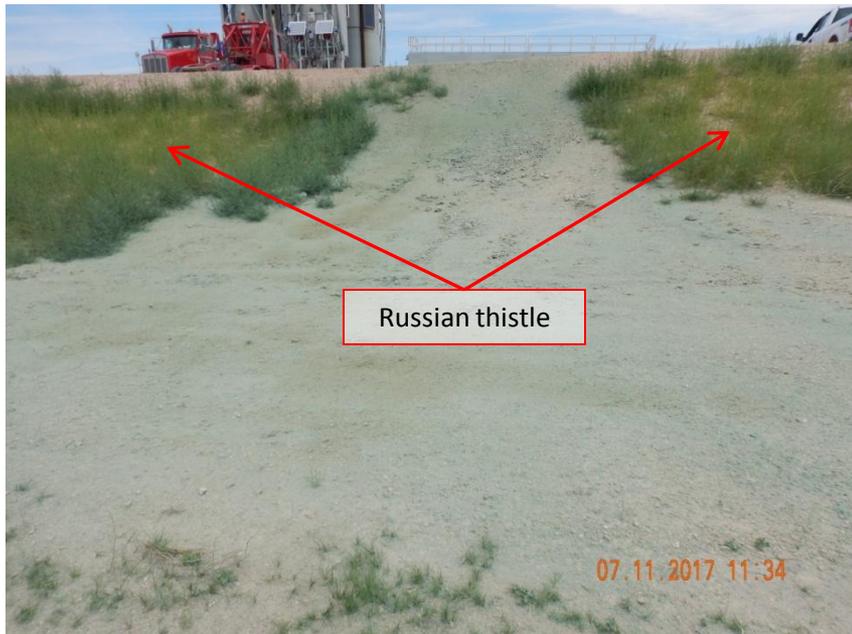
**Photo 5.** Photo taken from the southern perimeter of the location, facing North. Appears repairs have been conducted based off lack of vegetative growth, recent hydromulch application, and evidence of sediment discharge beyond the perimeter ditch and berm BMP.

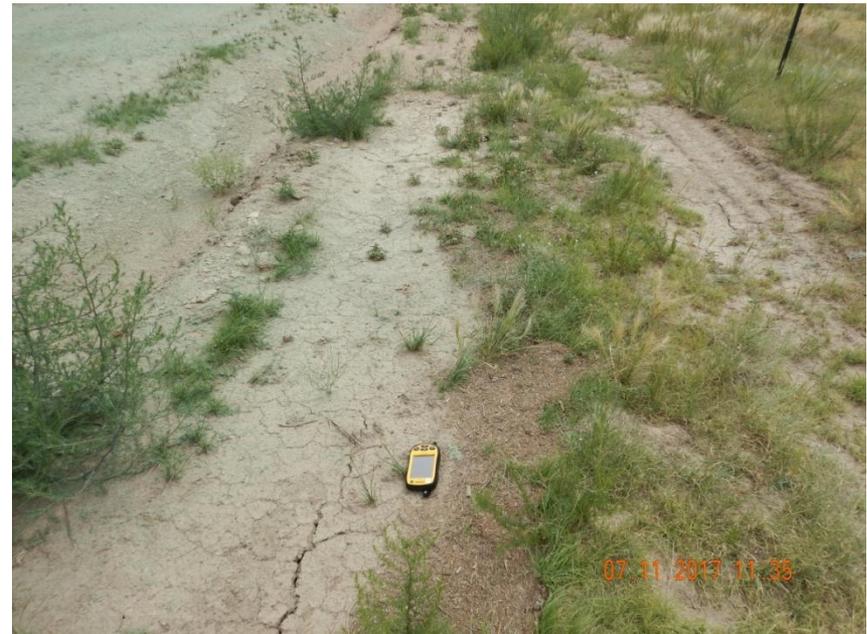
**Photo 6.** Photo taken from the previous photo location, facing East. Photo illustrates stormwater runoff appears to be washing sediment over the ditch and berm BMP off location. Refer to photo 7 for more detail.

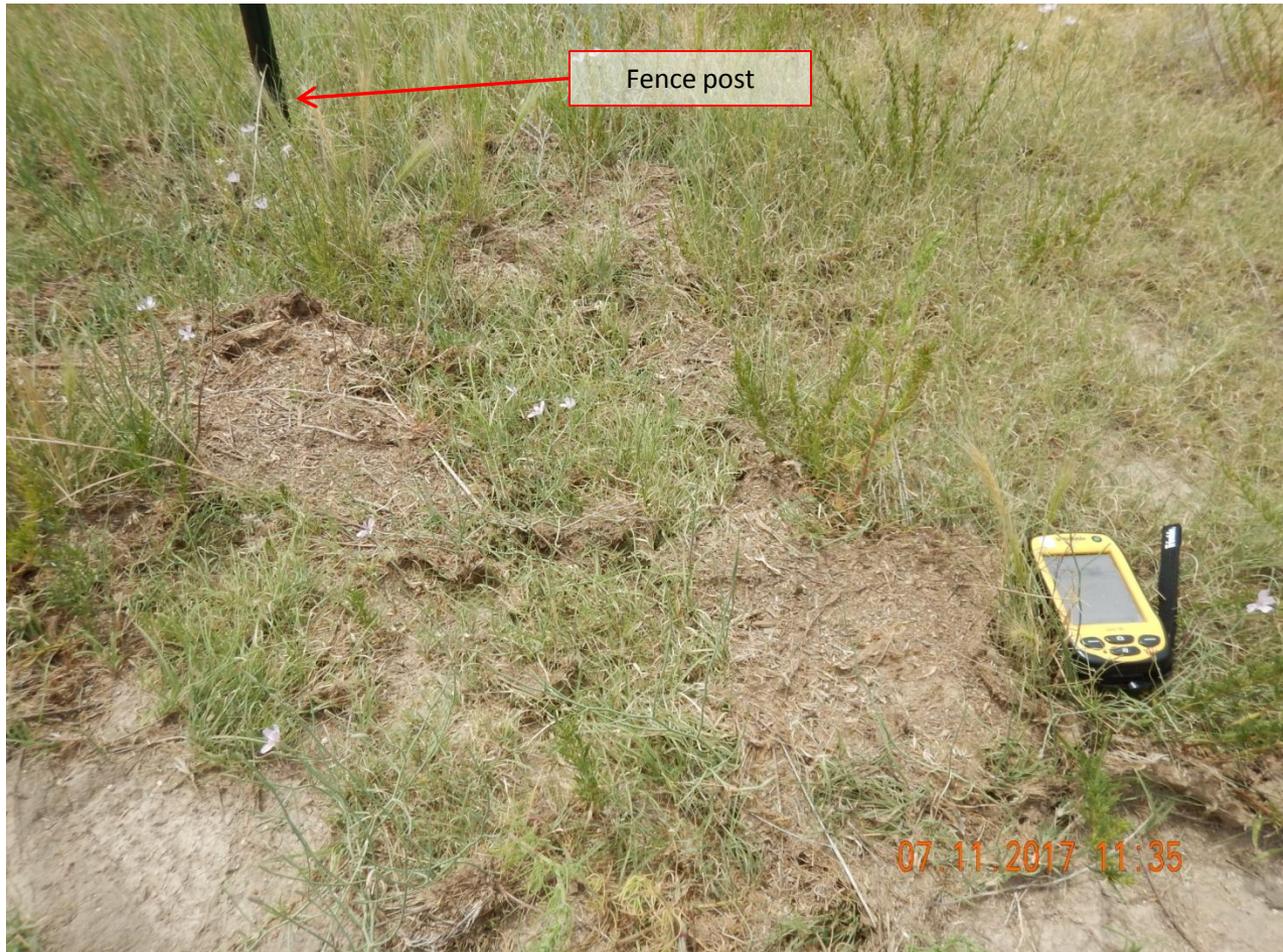
**Photo 7.** Close up photo taken from the southern perimeter of the location, illustrating stormwater runoff appears to be washing sediment over the ditch and berm BMP off location.

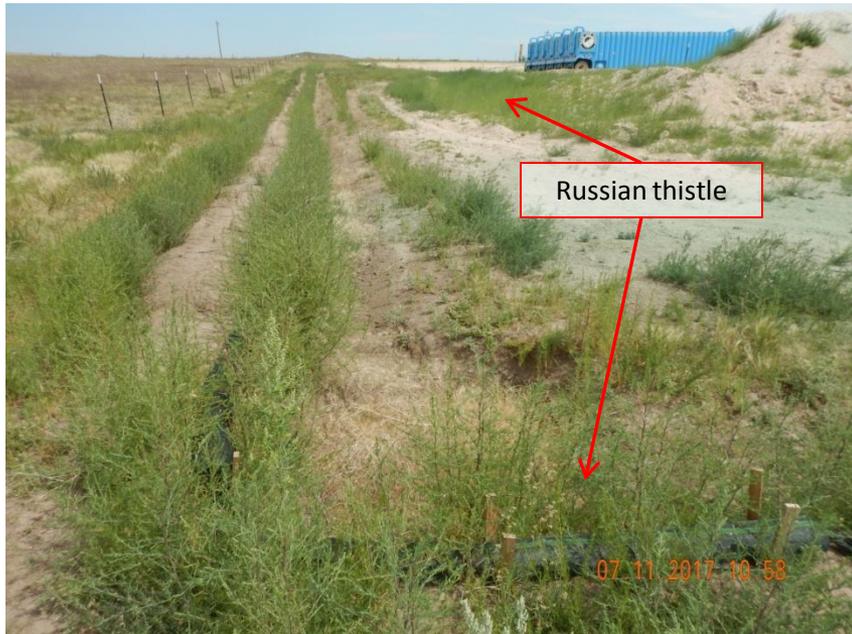
**Photo 8.** Photo taken from the southeast location, facing West. Sediment trap size was measured at ~6'x6'x2' (width x length x depth= 72ft<sup>3</sup>) with filtrex at the overflow point of the trap.

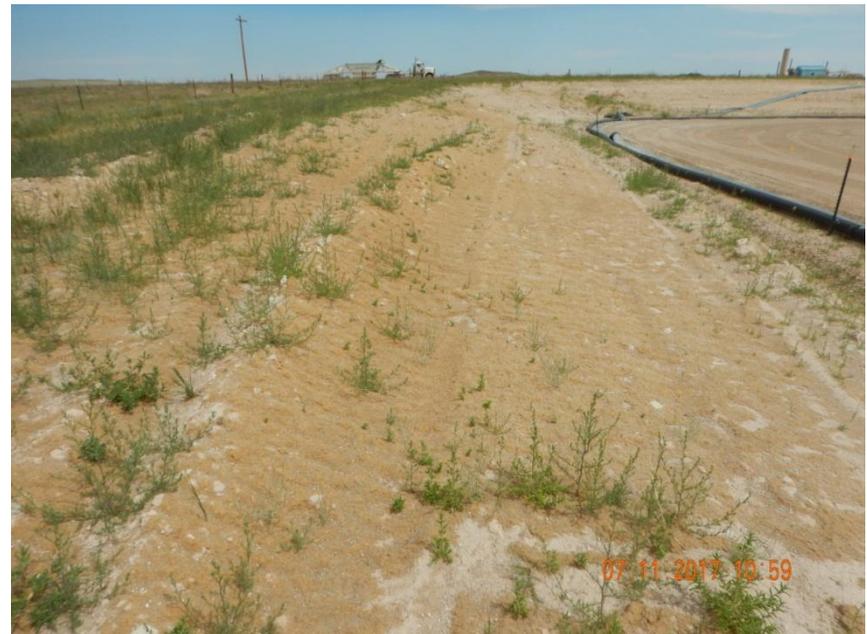
**Photo 9.** Photo taken from the western perimeter of the location, facing North. Cut slope appears to be stabilized with hydromulch but is only a temporary BMP.

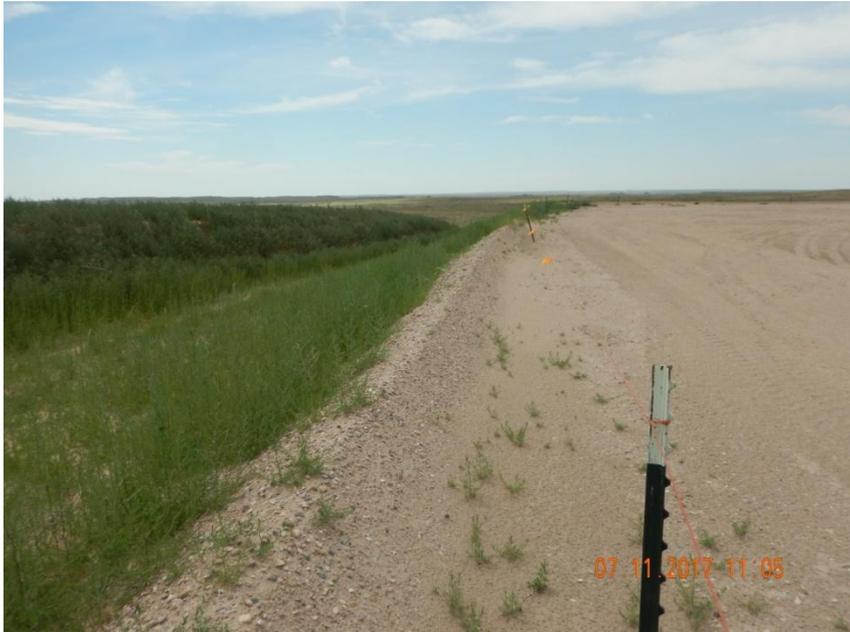
**Photo 10.** Photo taken from the eastern pad, facing South. A berm ~18" has been constructed along the west, east and south pad perimeter, but does not appear to be properly compacted.
