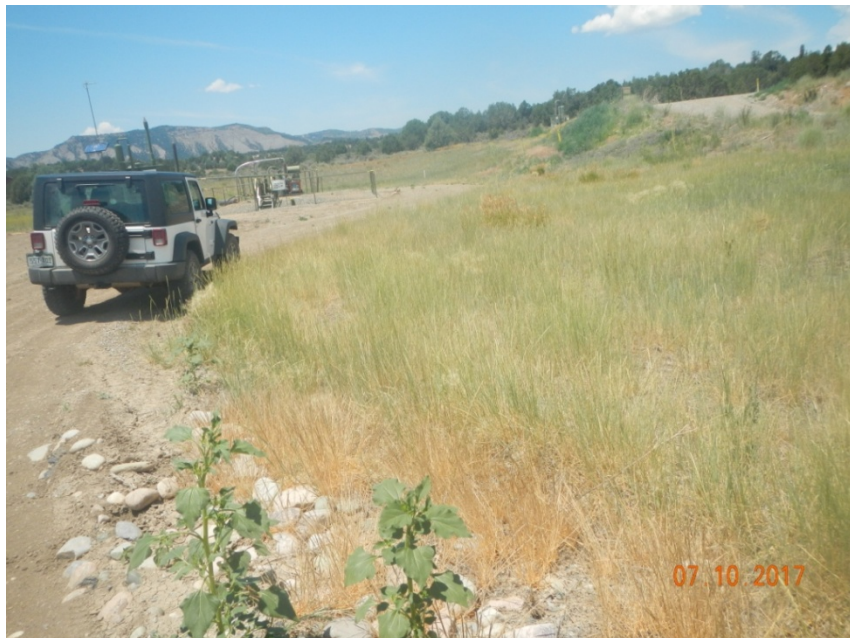
**Photo 1: View of the northern portion of the project area from the northeastern corner facing westward.**

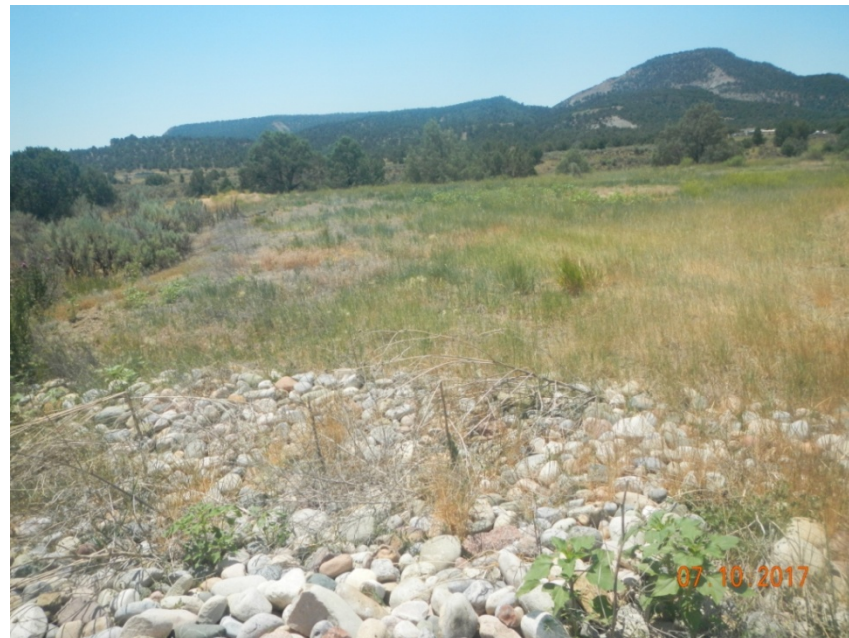
**Photo 2: View of the southern portion of the project area from the southeastern edge facing westward.**

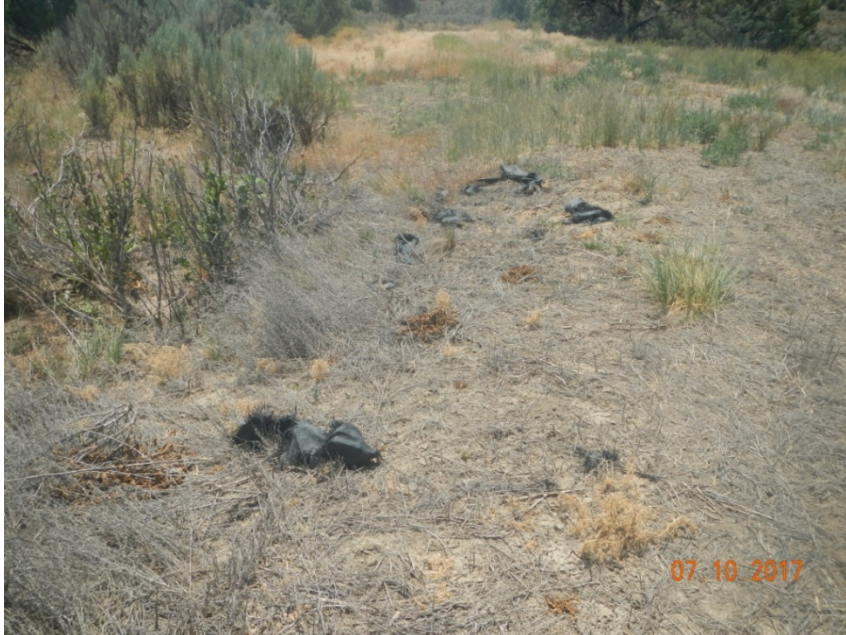
**Photo 3: View of liner debris within the eastern portion of the project area.**

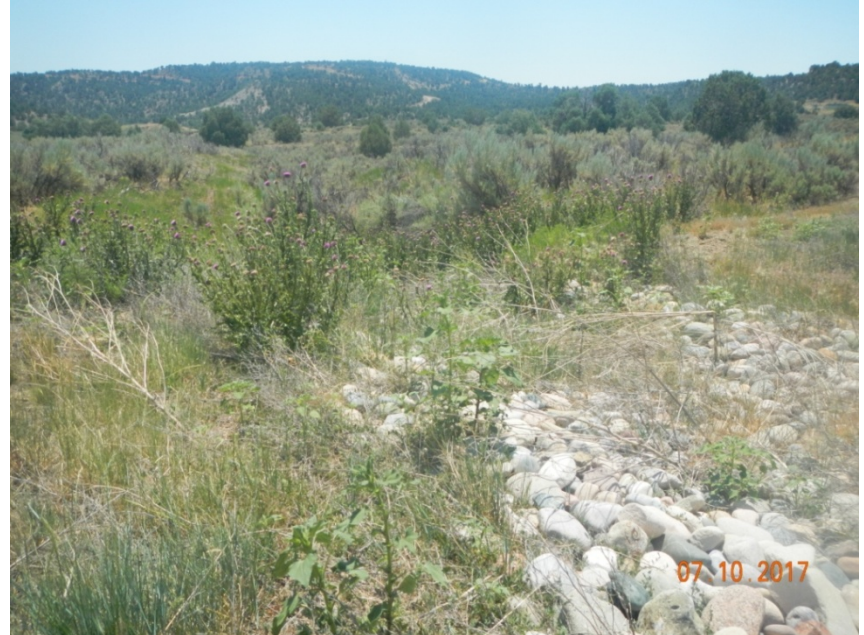
**Photo 4: View of musk thistles (*Carduus nutans*) growing within the cobble run-down at the entrance to the well pad.**
