**Inspection Photos**  
**Location Name: DOC Showers #32-12-10**  
**API: 05-123-19437**

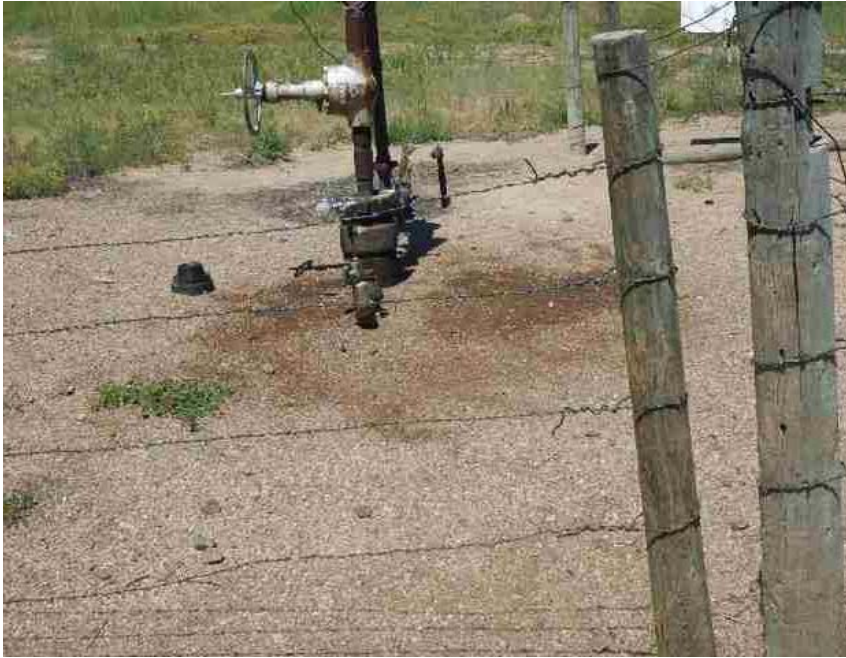
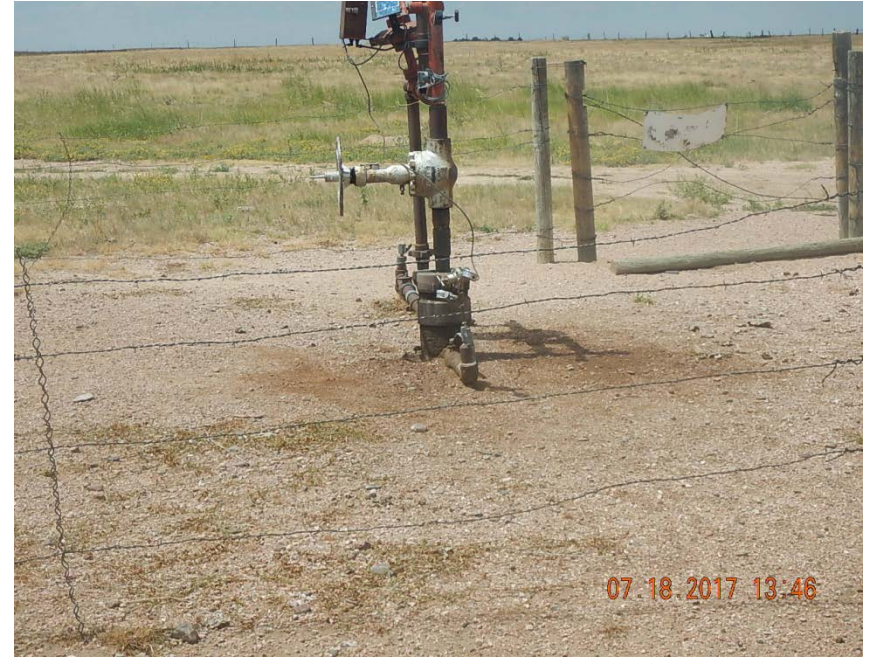
**Photo 1: Some stained soil has been remediated**

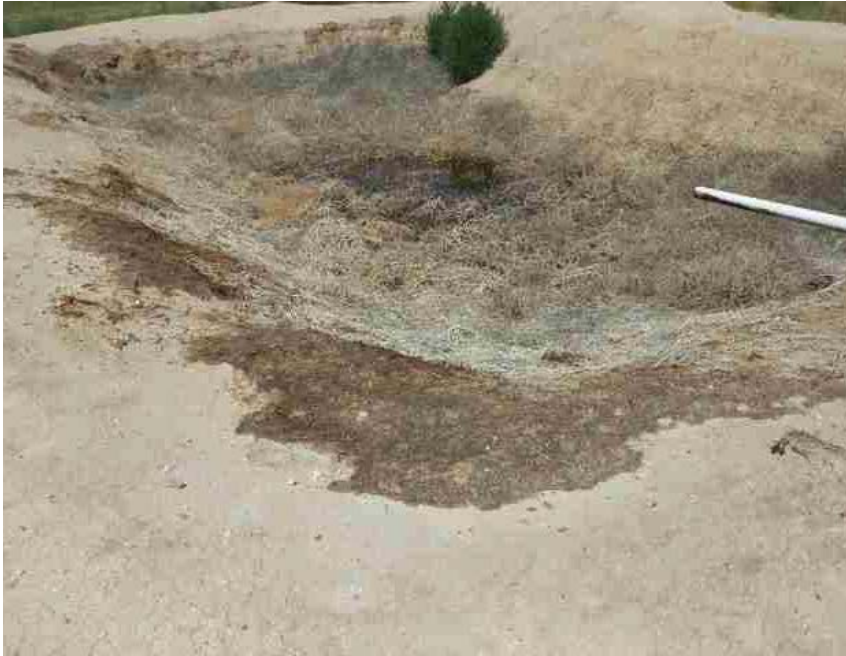
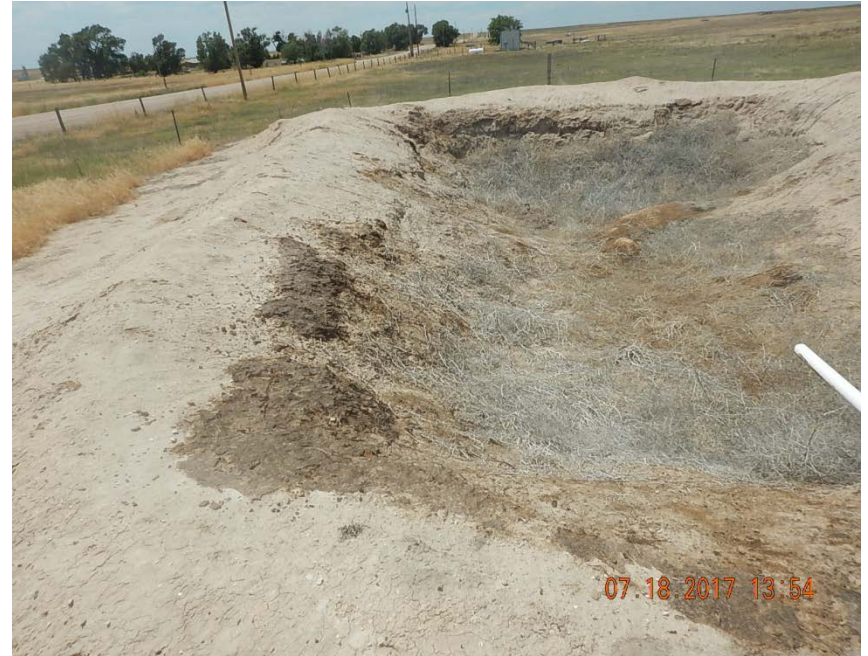
**Photo 2: Stained soil on pit**

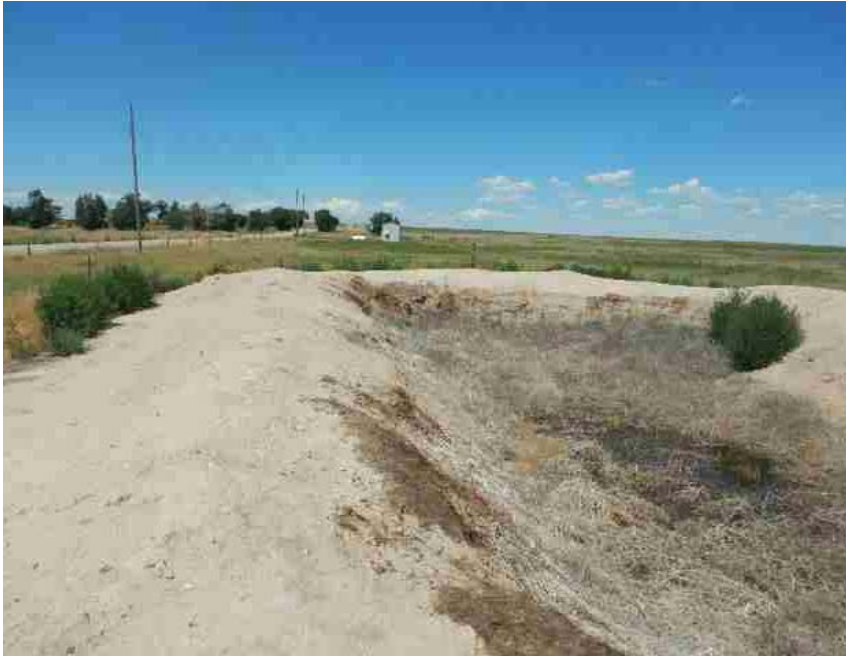
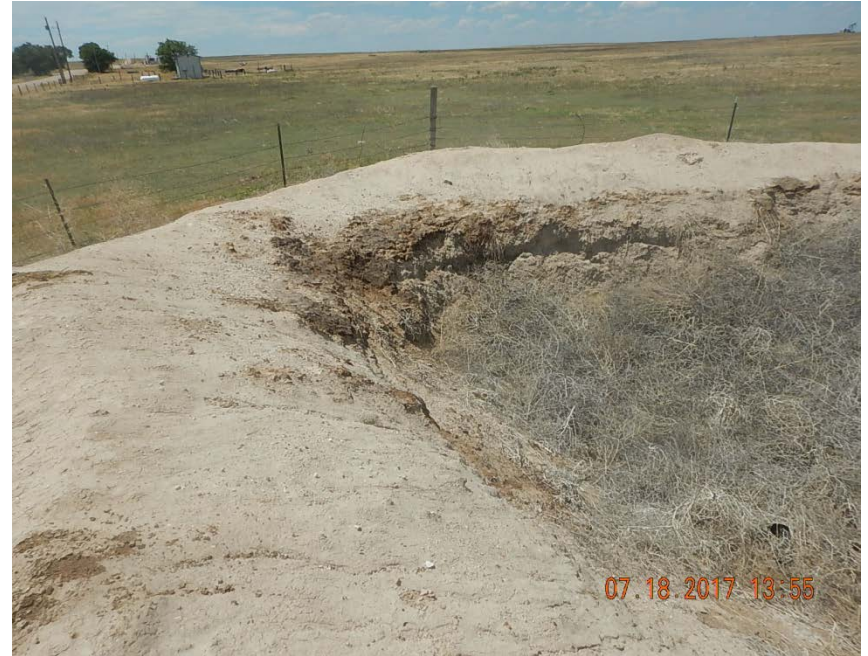
**Photo 3: Stained soil on pit**

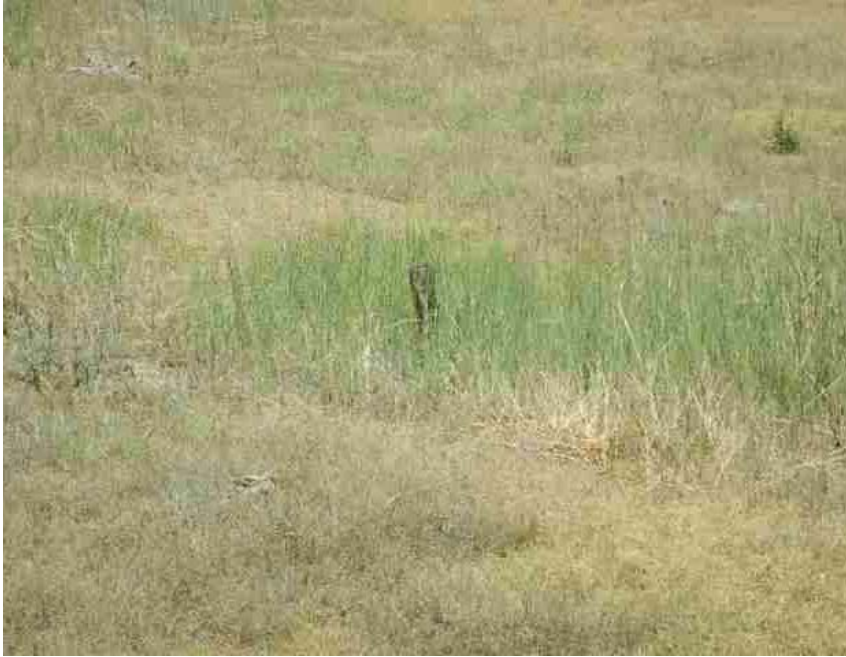
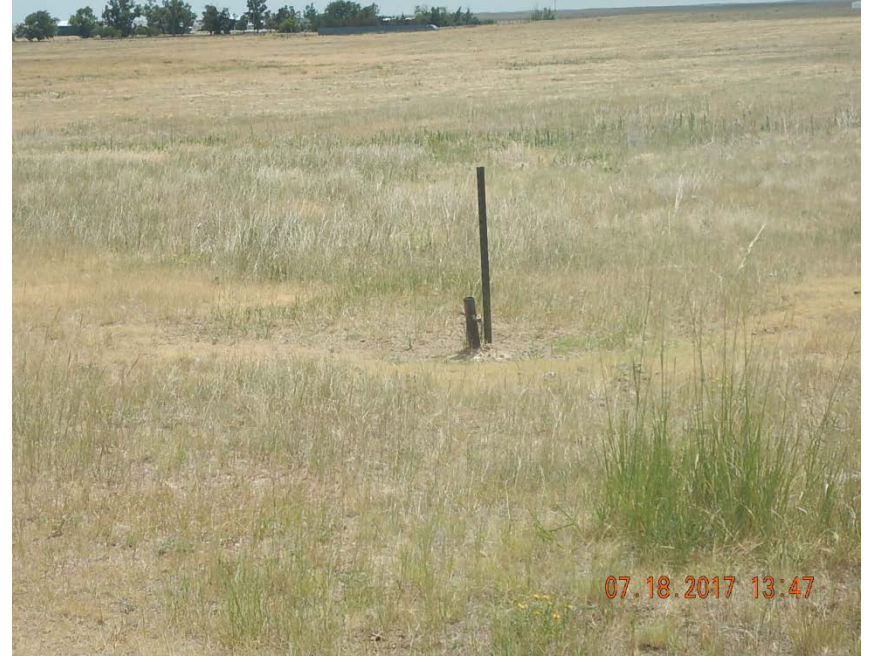
**Photo 4: Marked deadman**

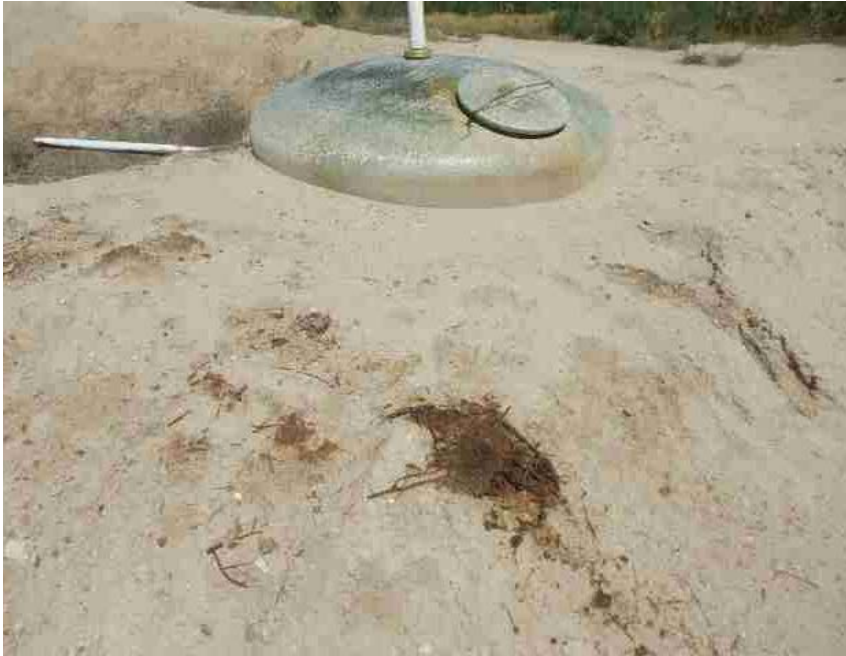
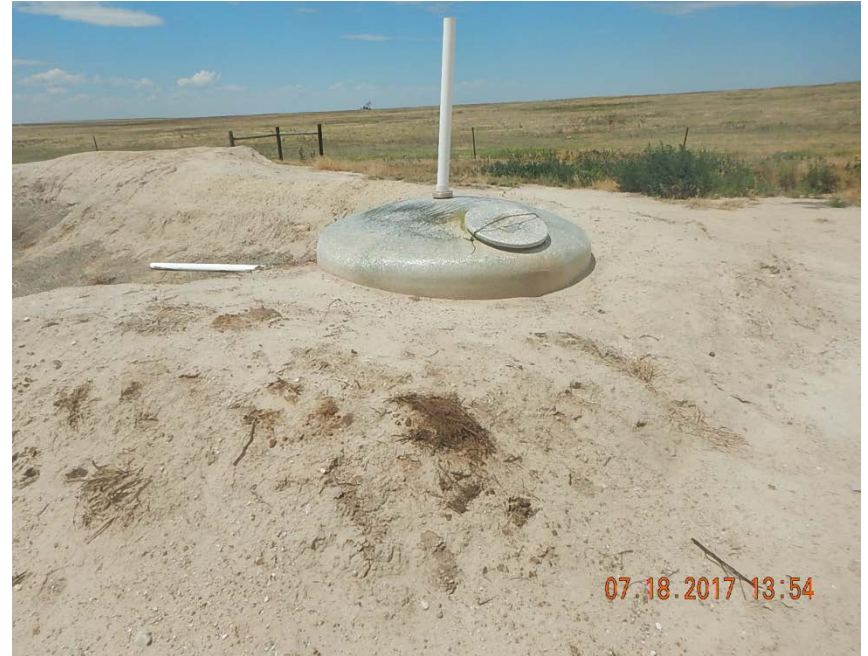
**Photo 5: Stained soil at fiberglass skim**

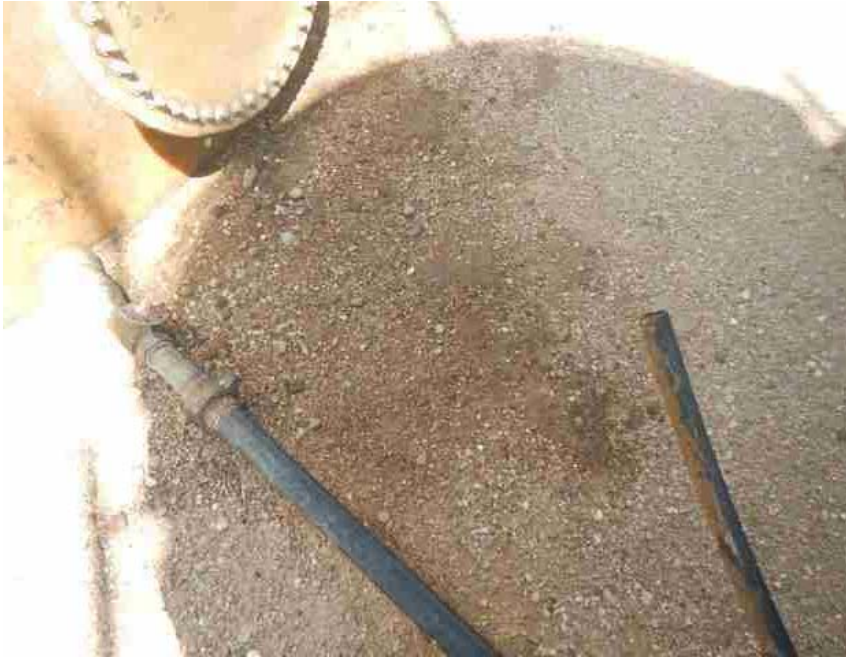
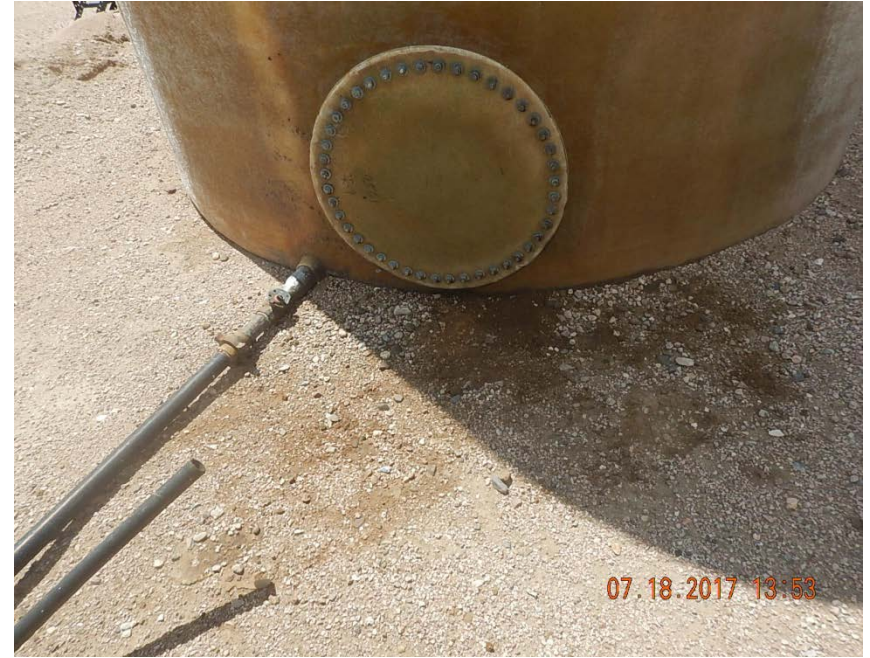
**Photo 6: Stained soil at produced water tank**

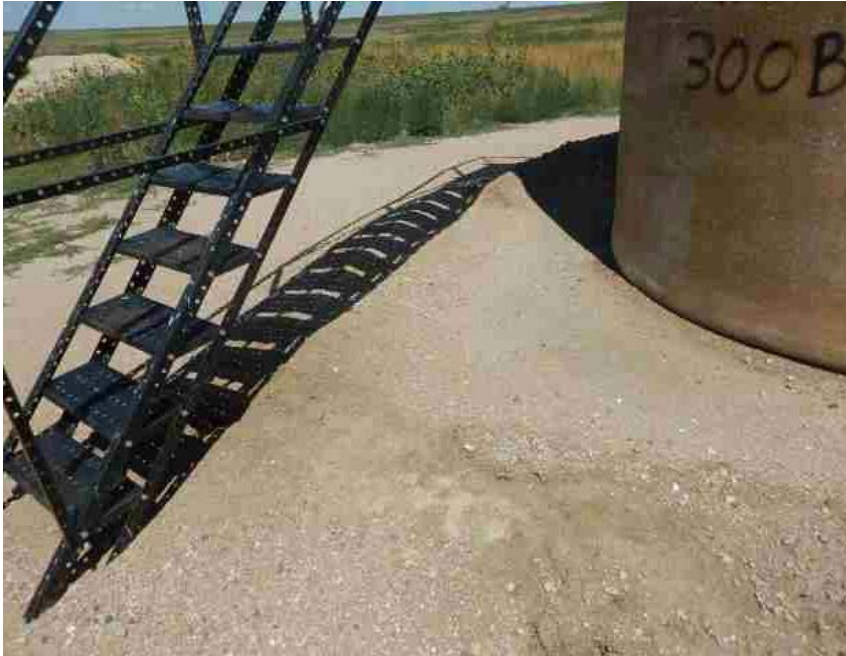
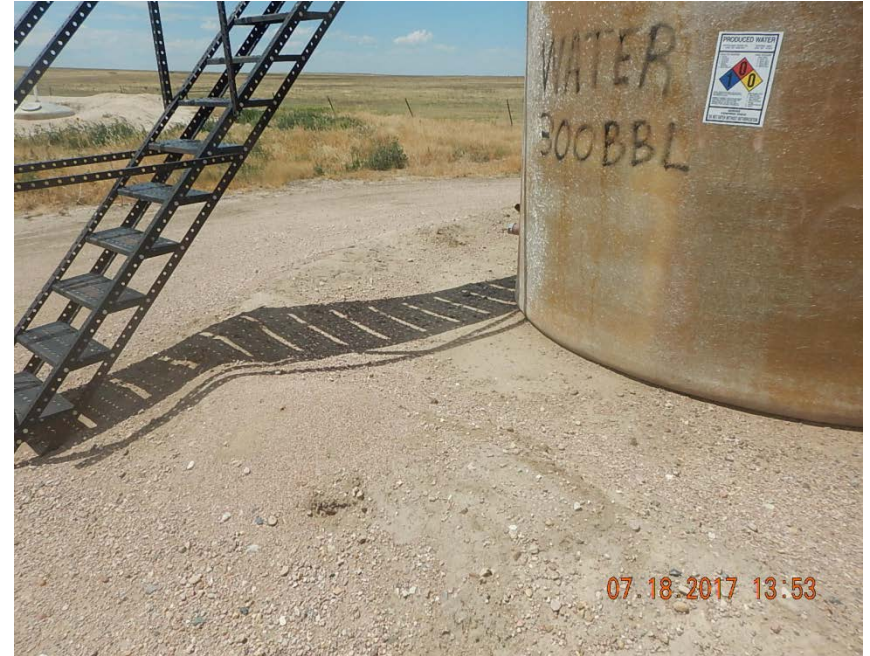
**Photo 7: Inadequate berms at produced water tank**

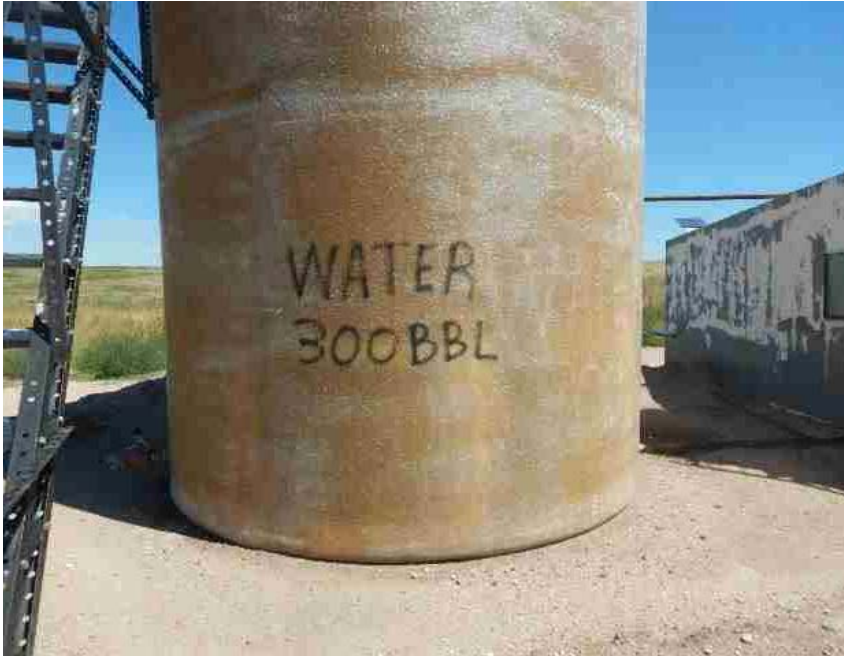
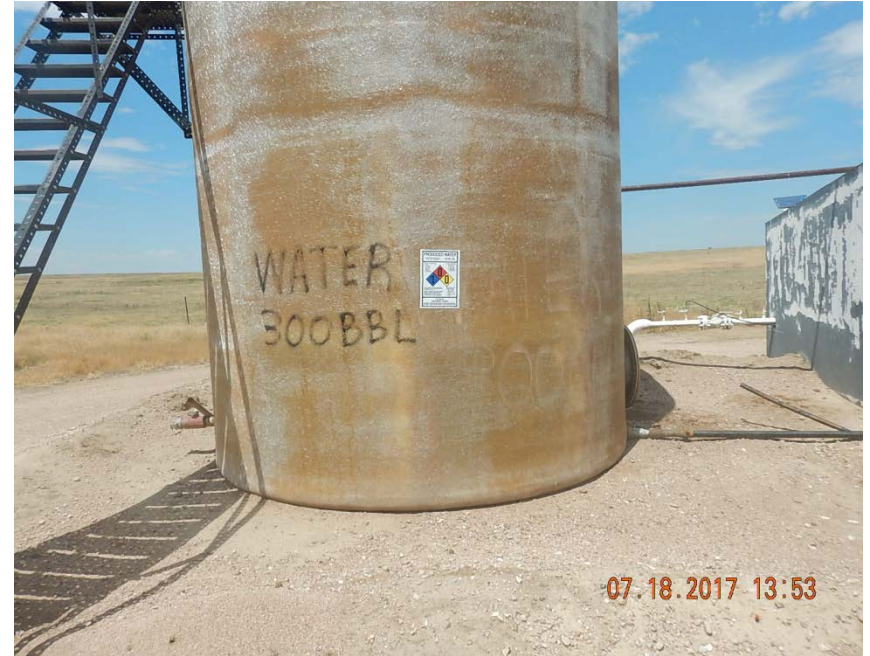
**Photo 8: Production tank properly placarded**

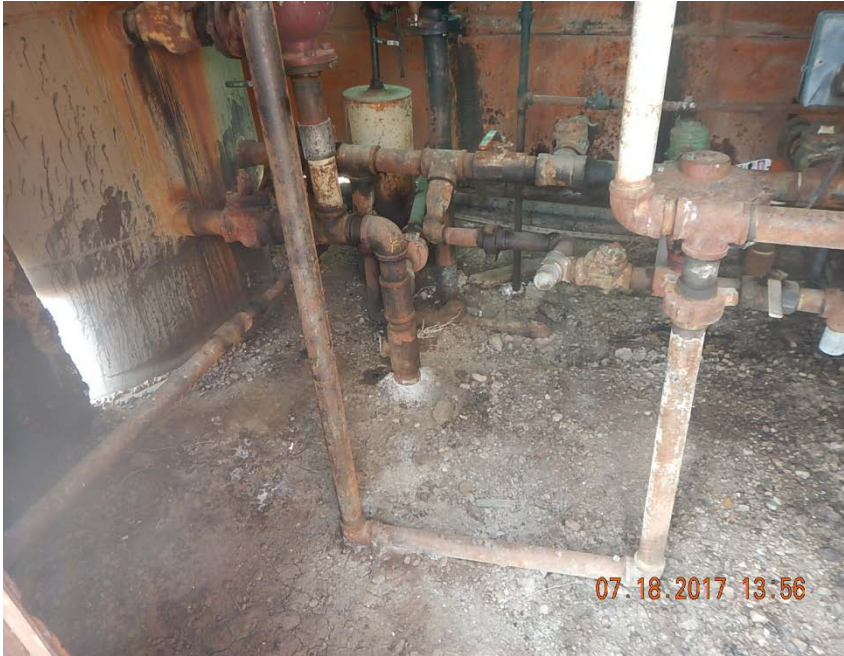
**Photo 9: Stained soil, debris inside treater house**

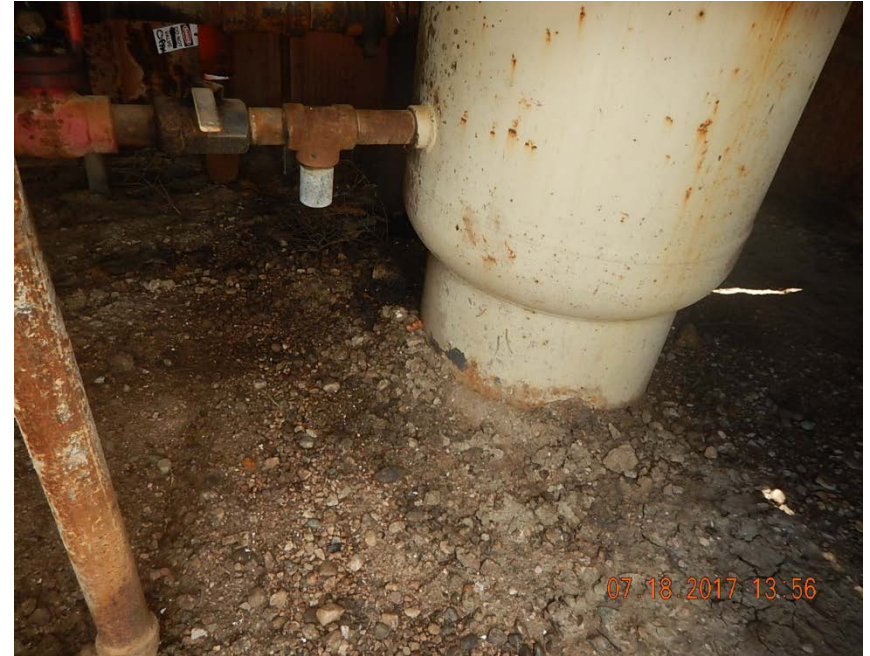
**Photo 10: Stained soil at vertical separator**

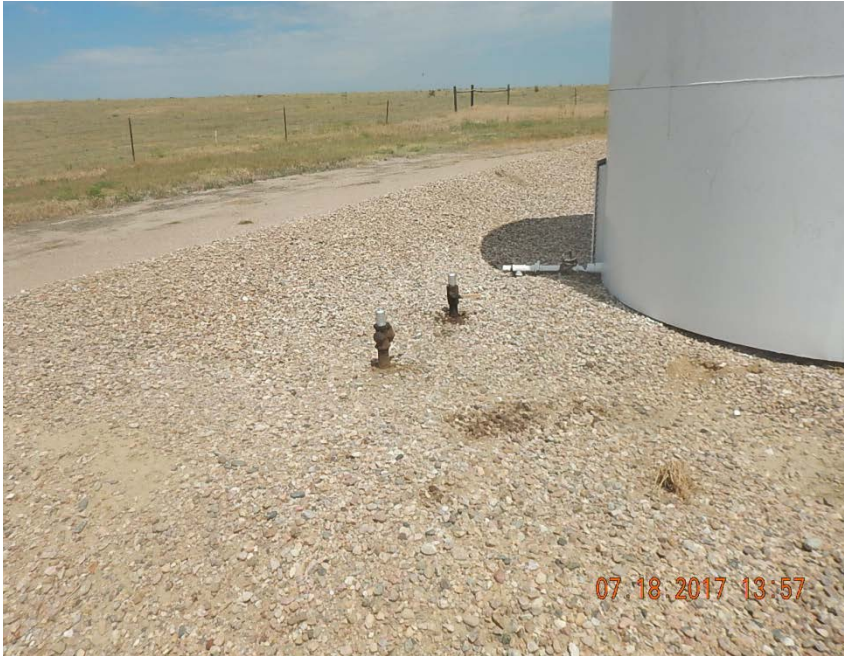
**Photo 11: Disconnected risers at crude oil tanks**
