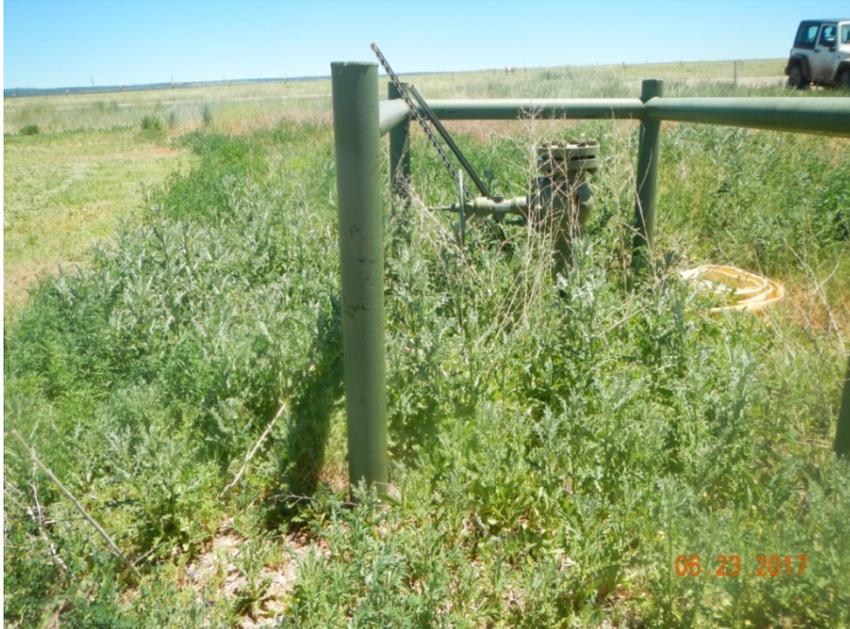
Photo 1: View of riser at 37.64415, -108.77412, at entrance to access road.

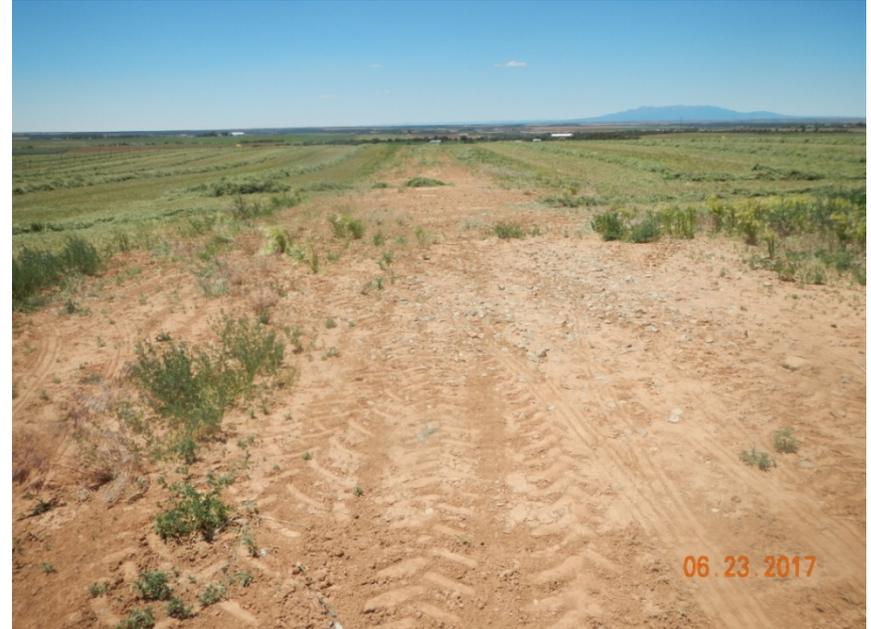
Photo 2: View of the beginning of access road facing toward the well pad (westward). Vegetation is sparse and does not appear sufficiently reclaimed.

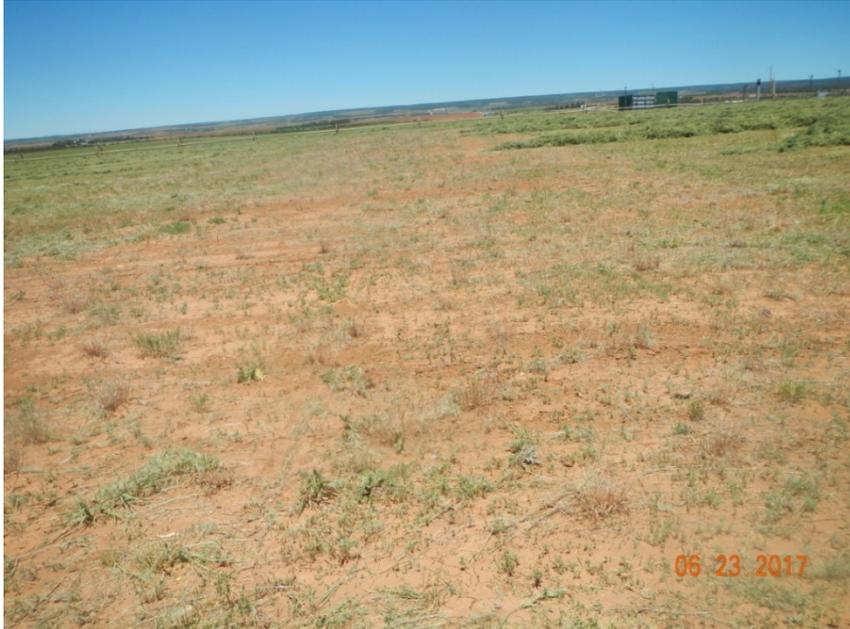
Photo 3: View of the eastern edge of the well pad facing northward.

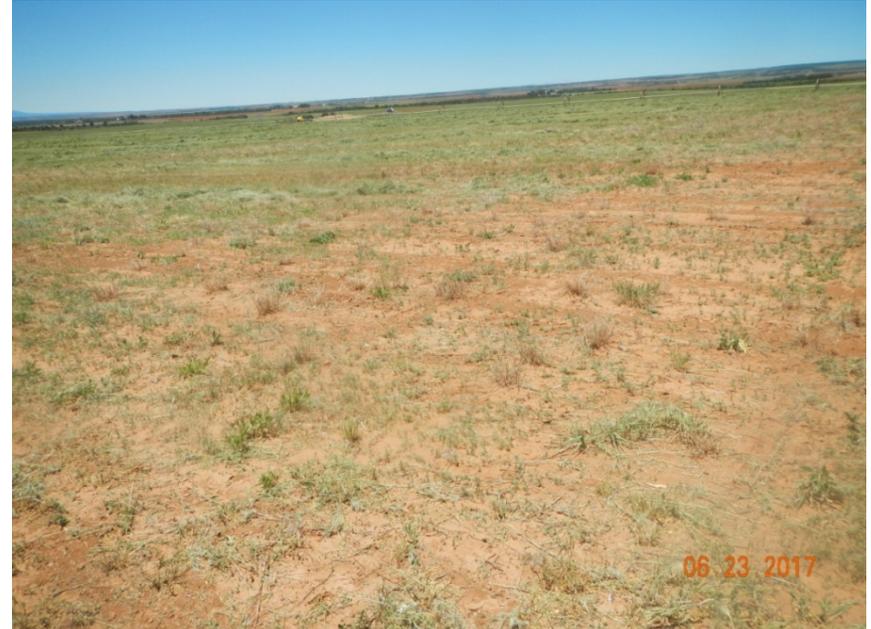
Photo 4: View of the project area from the southeastern corner facing center.

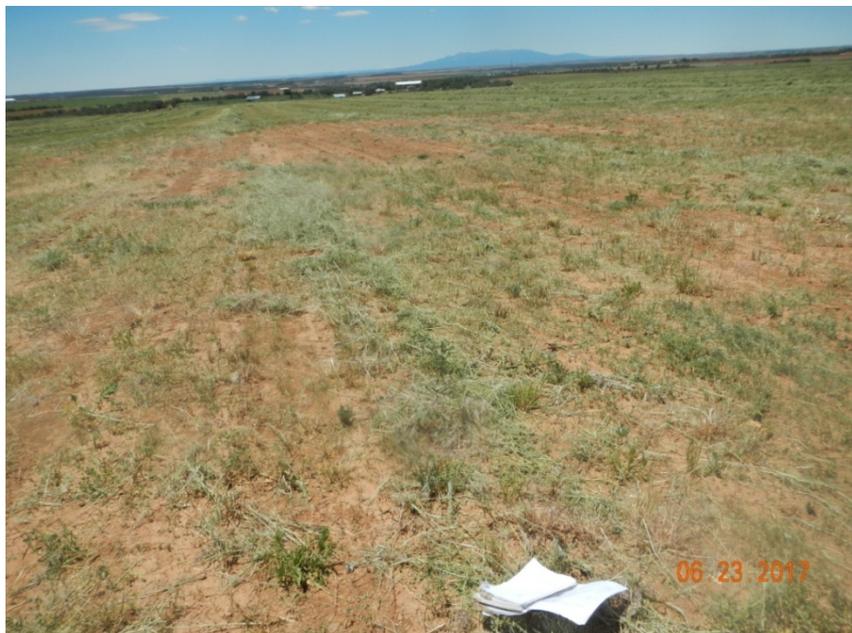
Photo 5: View of hay production within the well pad area. Production is significantly less than reference area (Photo 6). This is an indication that reclamation on the well pad may not be sufficient. A future vegetation assessment will be conducted.

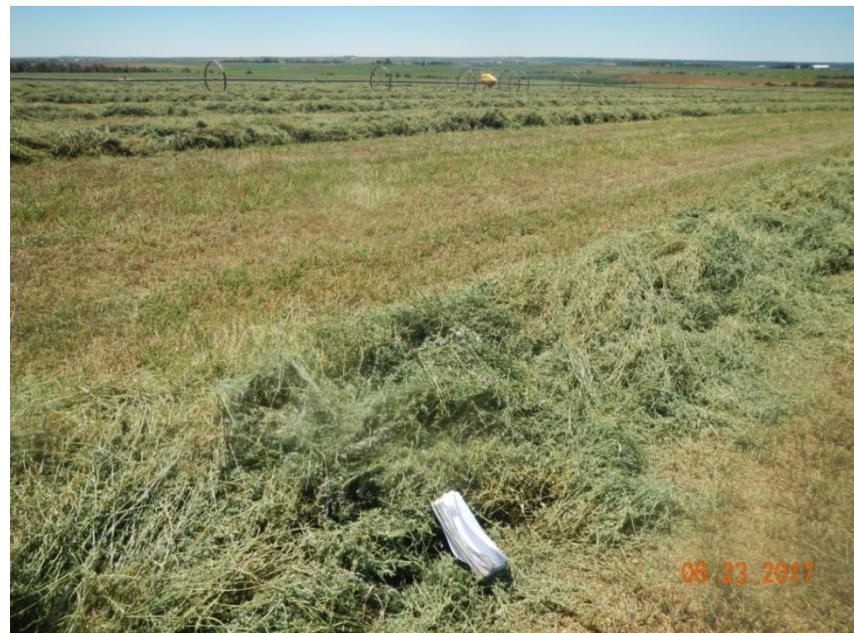
Photo 6: View of hay production outside and adjacent to the project area in the reference area. Hay production is significantly higher than within the project area.
