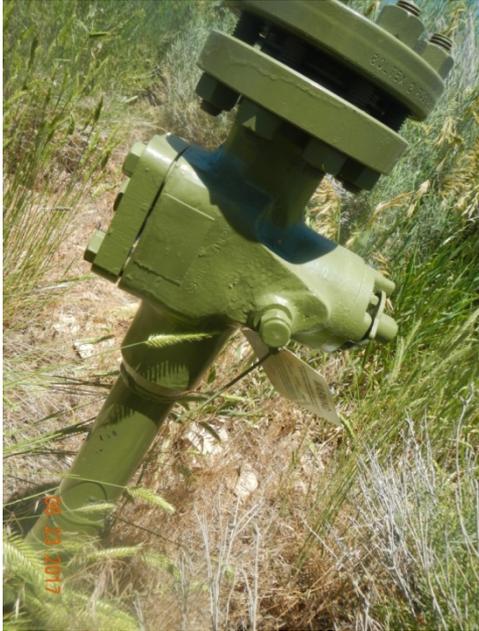
Photo 1: View of riser at 37.63271, -108.77362, at entrance to access road. Riser is tagged with DO NOT OPERATE sign.

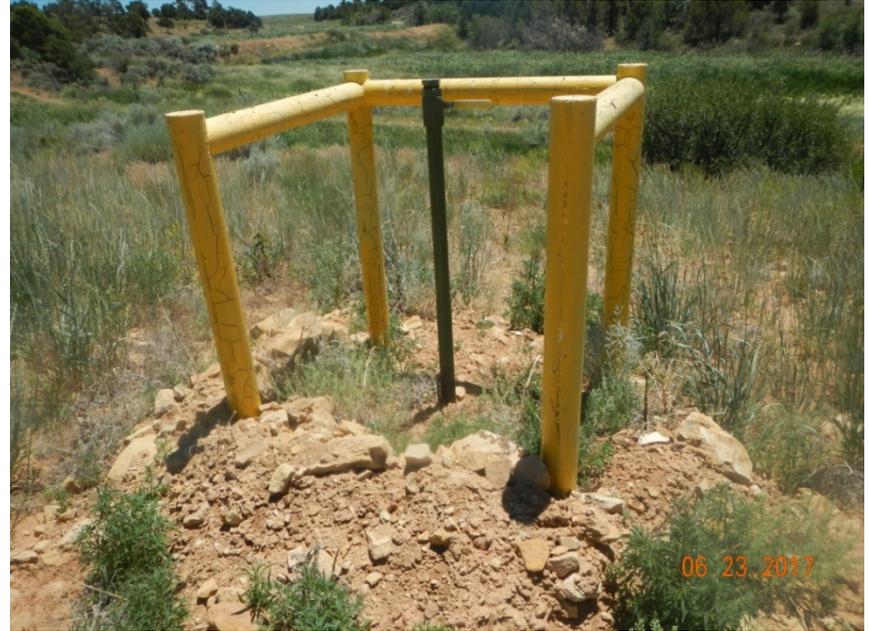
Photo 2: View of a second riser at 37.63208, -108.77241. This riser appears to be associated with the former well and is not locked or tagged out.

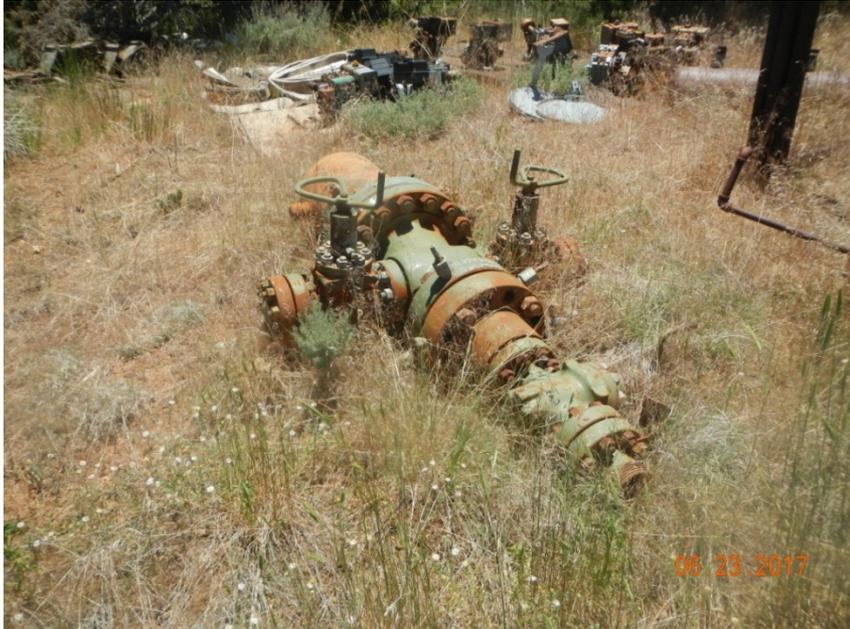
Photo 3: View of wellhead and other metal debris in southern portion of the project area.

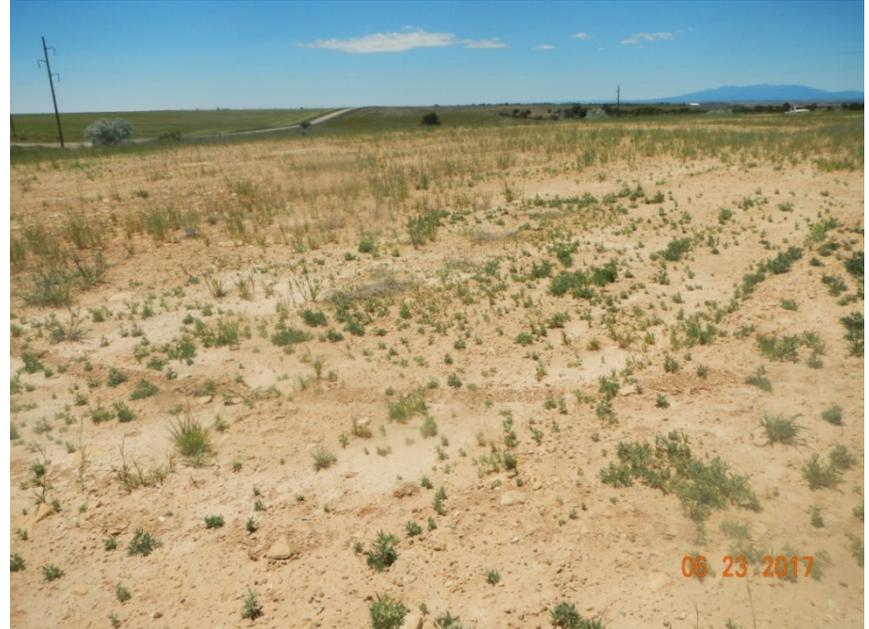
Photo 4: View of the project area from the southeastern corner facing center.

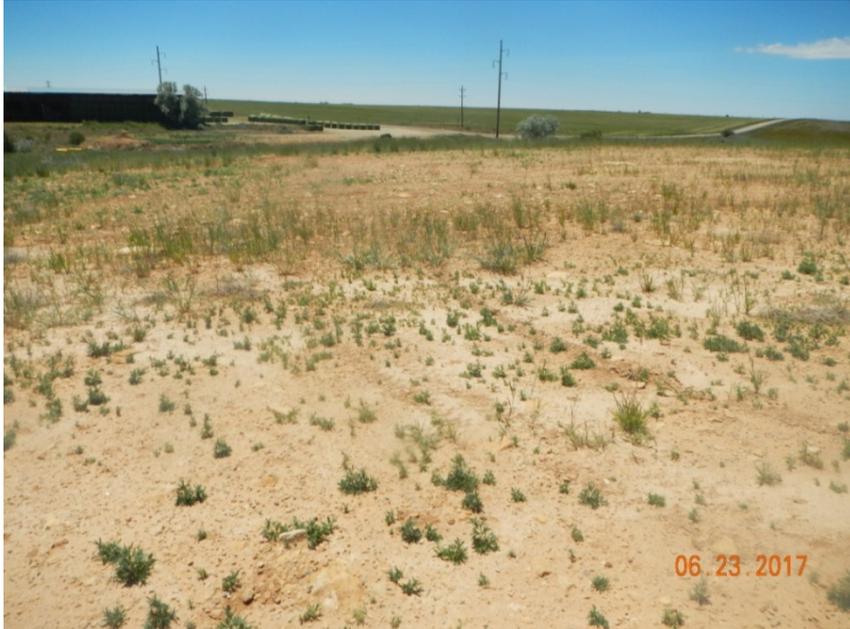
Photo 5: View of the southern portion of the former well pad surface with poor revegetation.

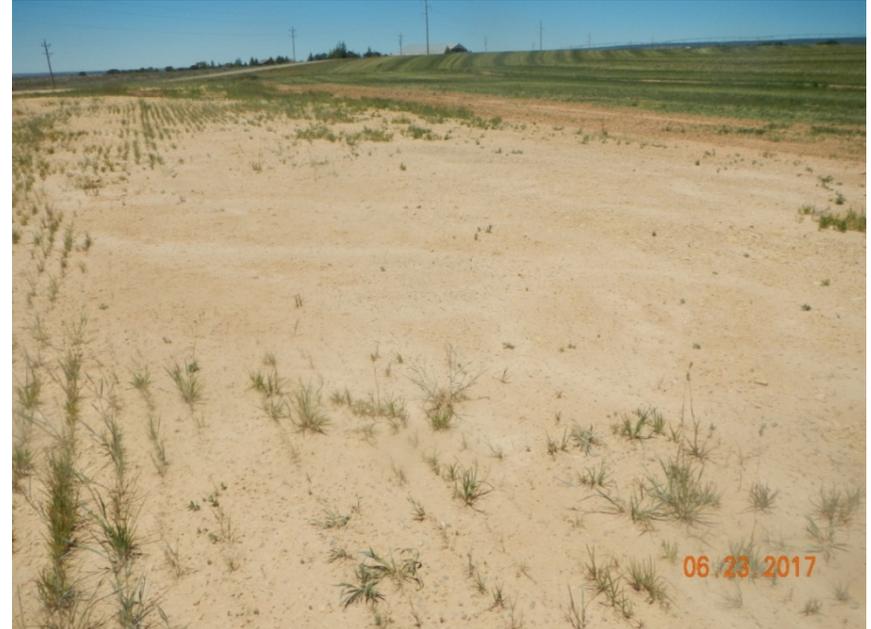
Photo 6: View of the eastern portion of the project area from the southeastern corner facing northwestward. Large areas with little to no vegetation remain. Surrounding cropland vegetation in background.
