Inspection Photos
Location Name: Showers #5-4
API: 05-123-19939

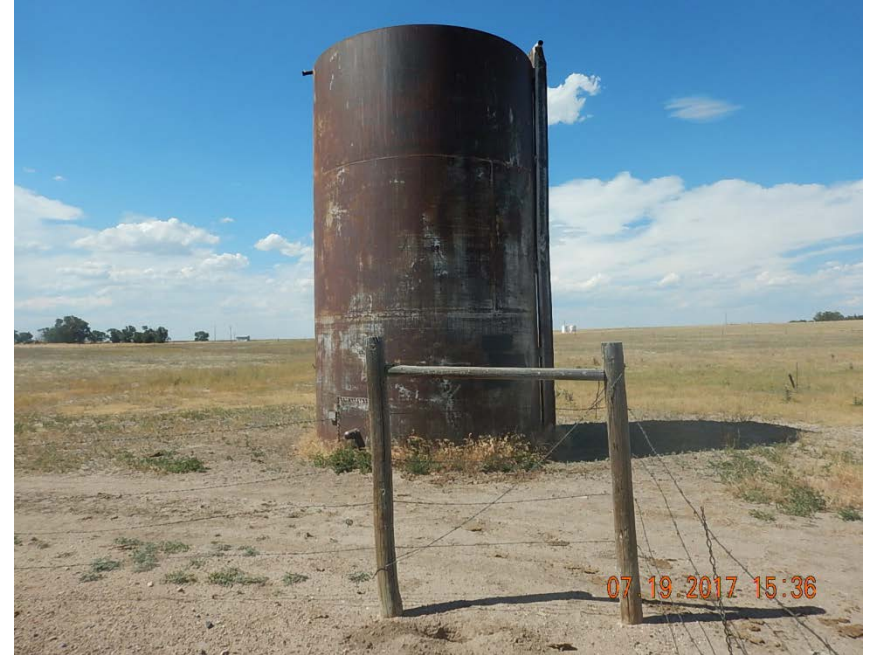
Photo 1: Unused production tank

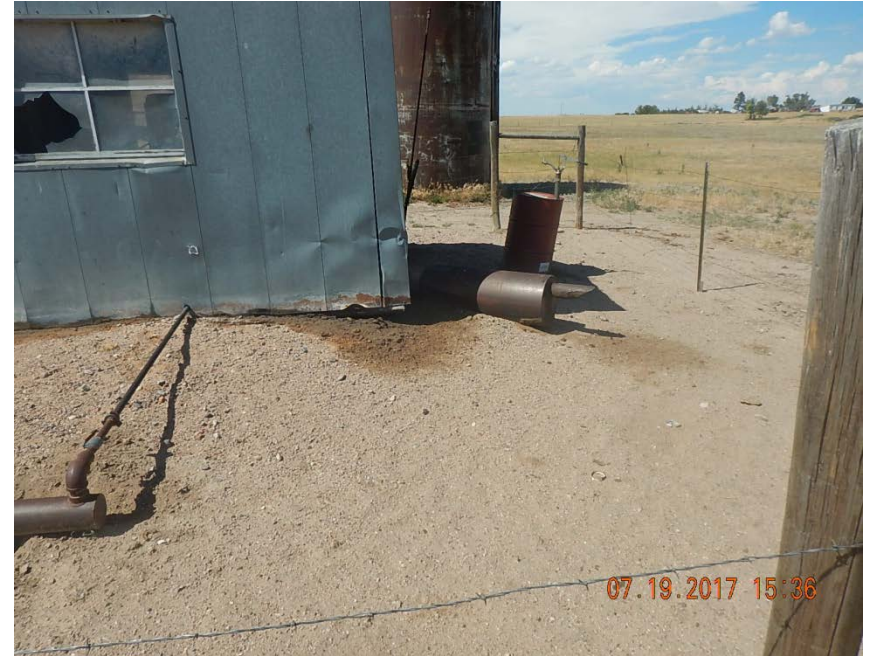
Photo 2: Stained soil at housing, exhaust

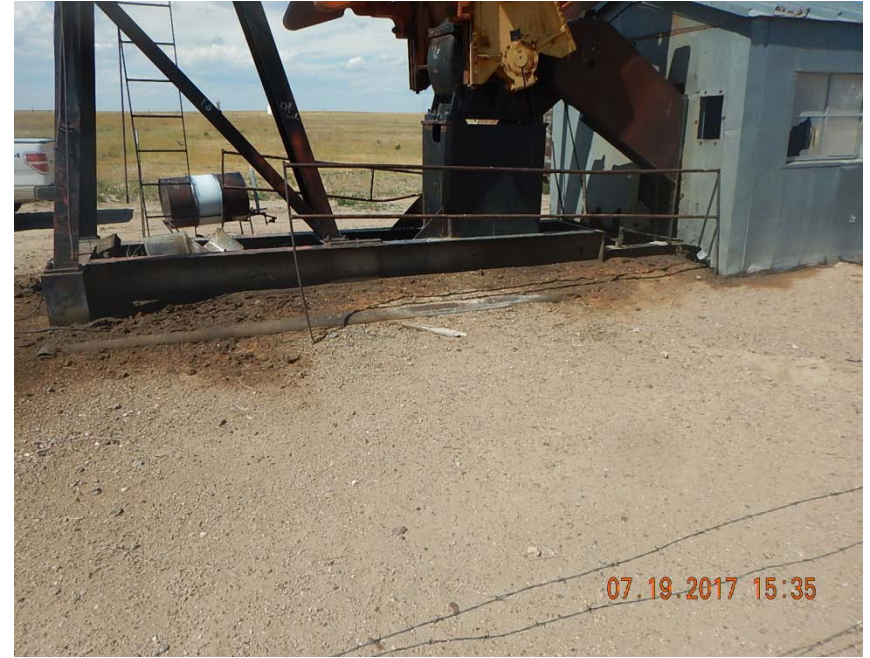
Photo 3: Stained soil at pump jack

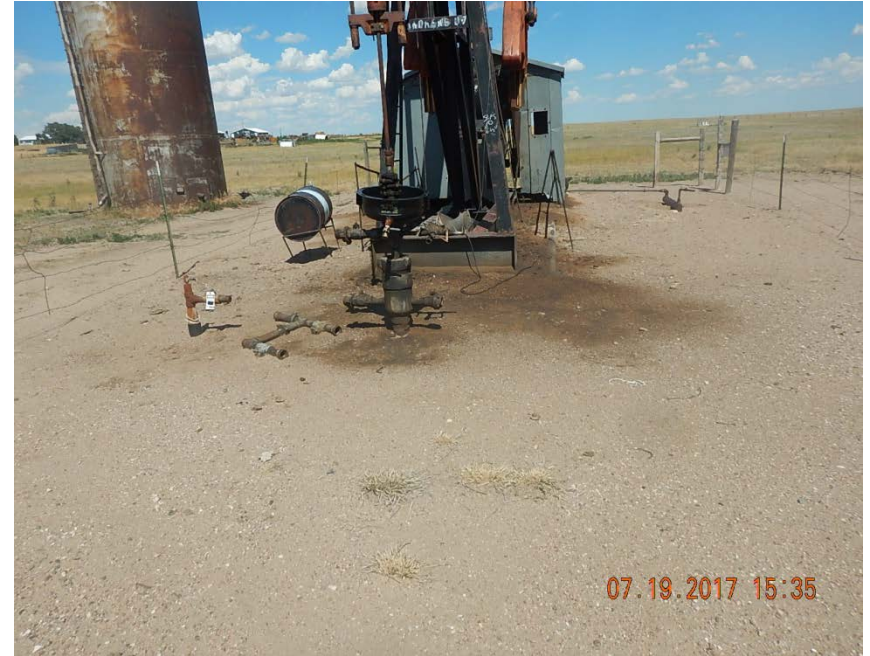
Photo 1: Stained soil at wellhead. TA well. Bradenhead not plumbed to surface.
